Inspection Photos

Operator: TEP ROCKY MOUNTAIN LLC #96850

Location ID: 335636

Inspection Doc: 718100904

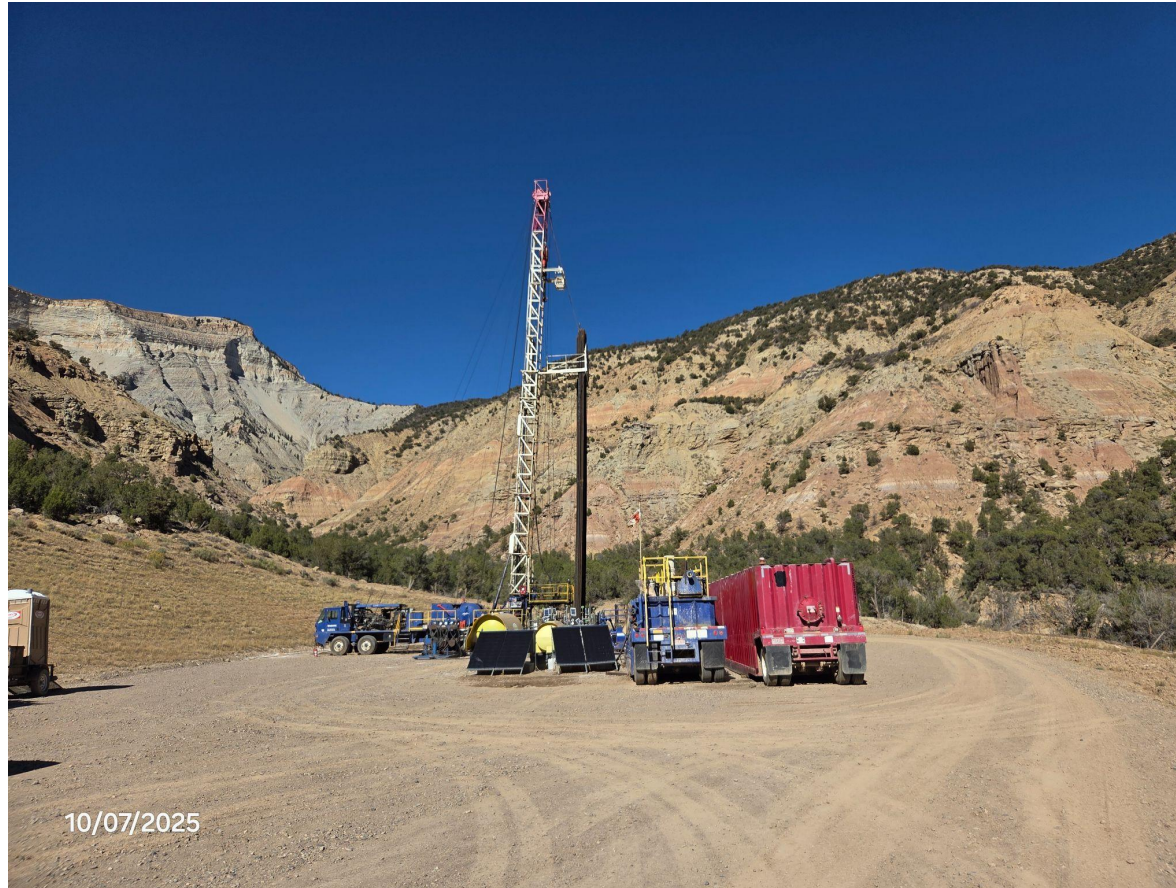
Photo 1: Photo shows work over rig on Location at time of inspection.

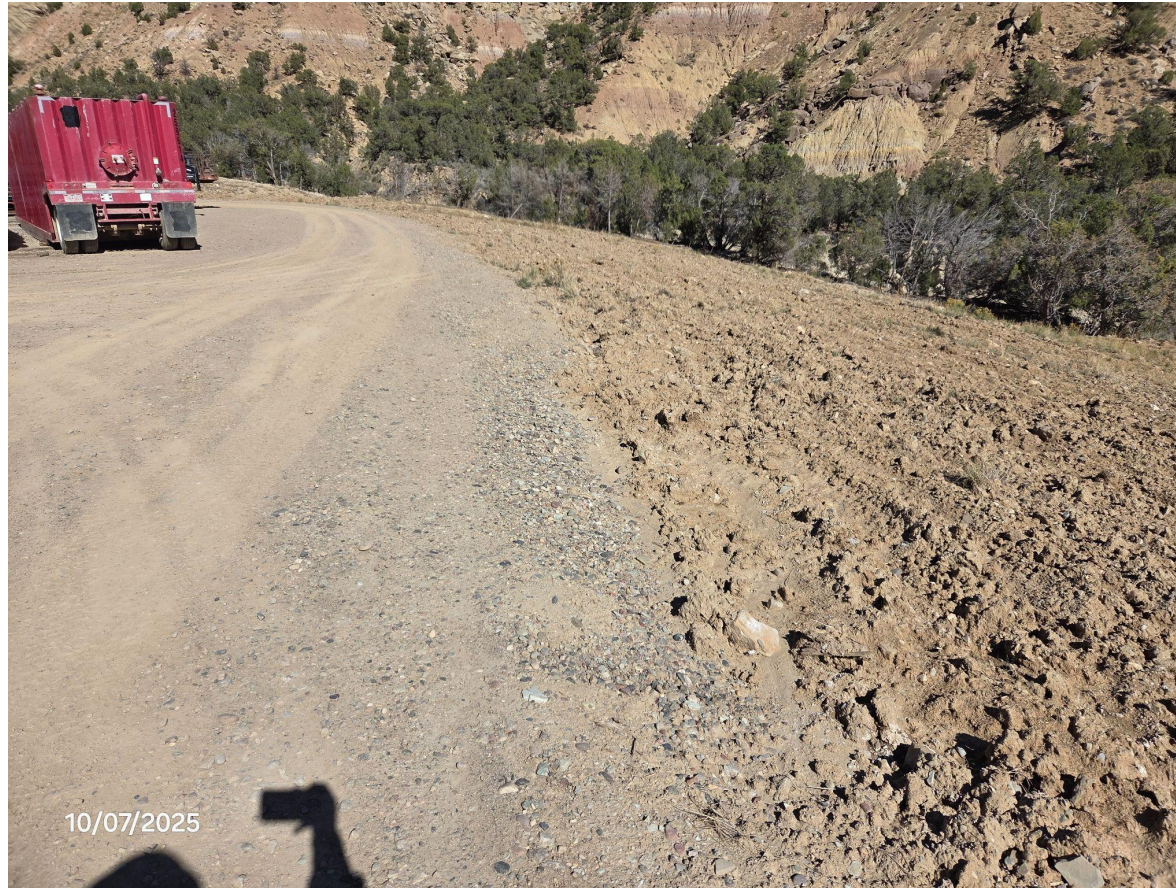
Photo 2: Photos taken from the edge of the working pad surface on the east end of the Location, facing north. Additional reclamation efforts apparent. Unable to find evidence that BMPs to manage runoff from the working pad surface have been installed.

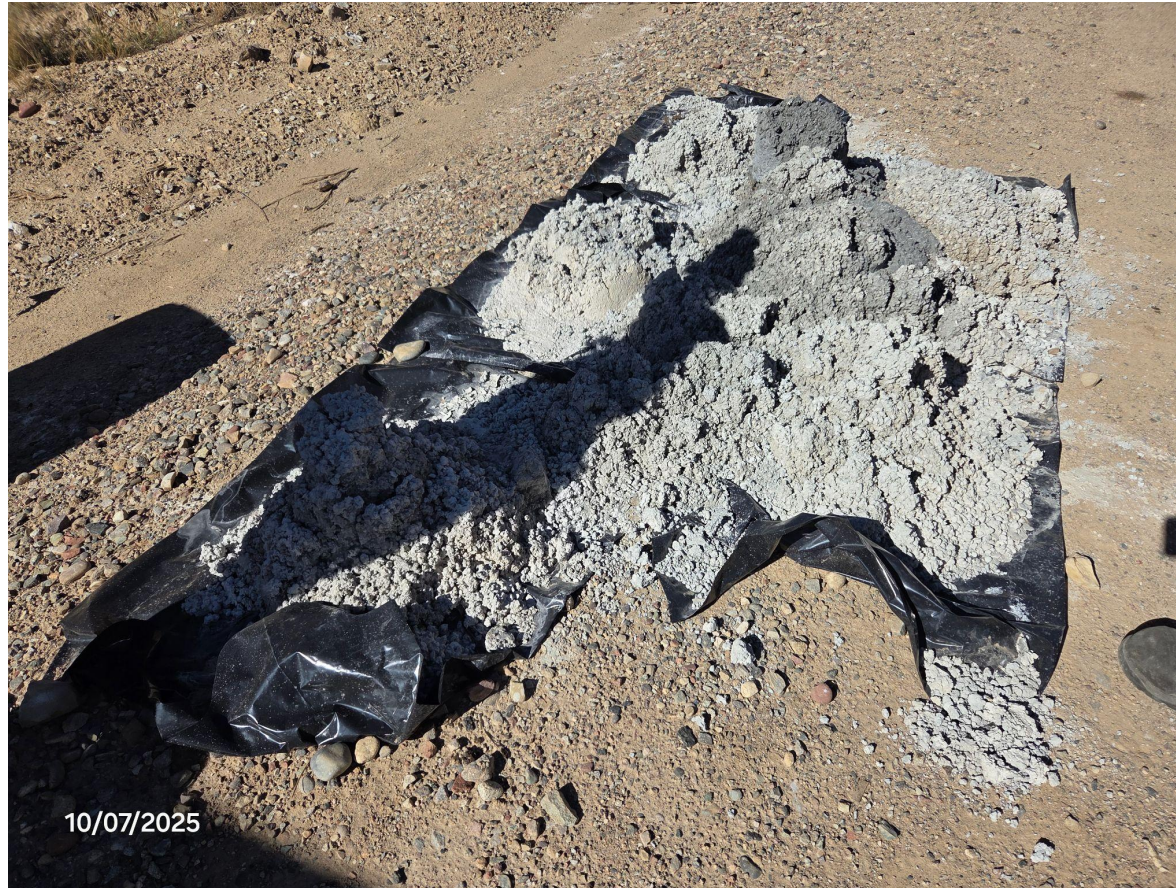
Photo 3: Photo taken from the west end of the Location. Photo shows what appears to be cement waste has been improperly stored on the Location near the stormwater diversion ditch. Materials observed spilling beyond the liner.

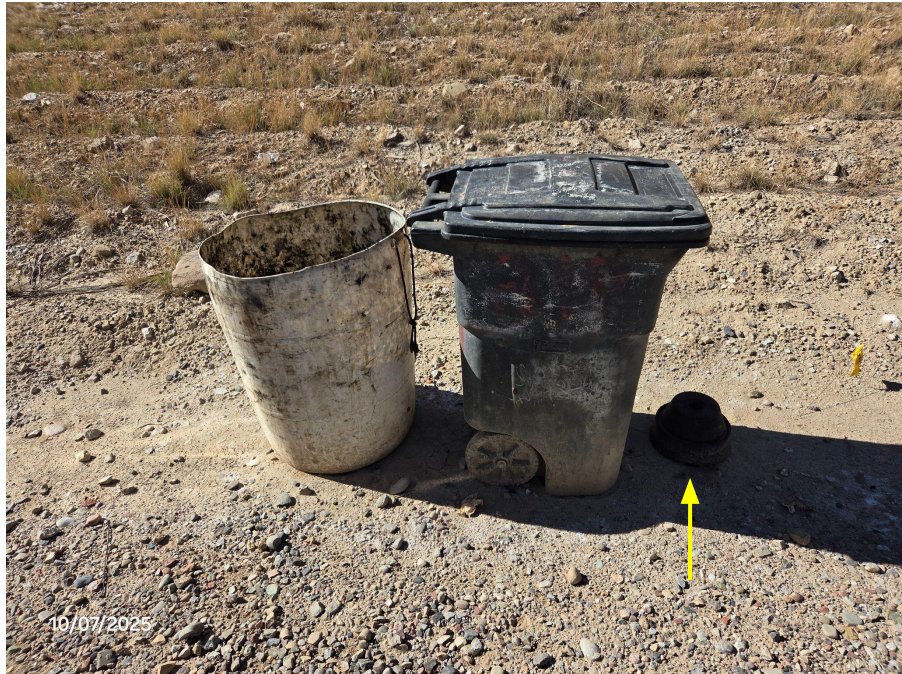
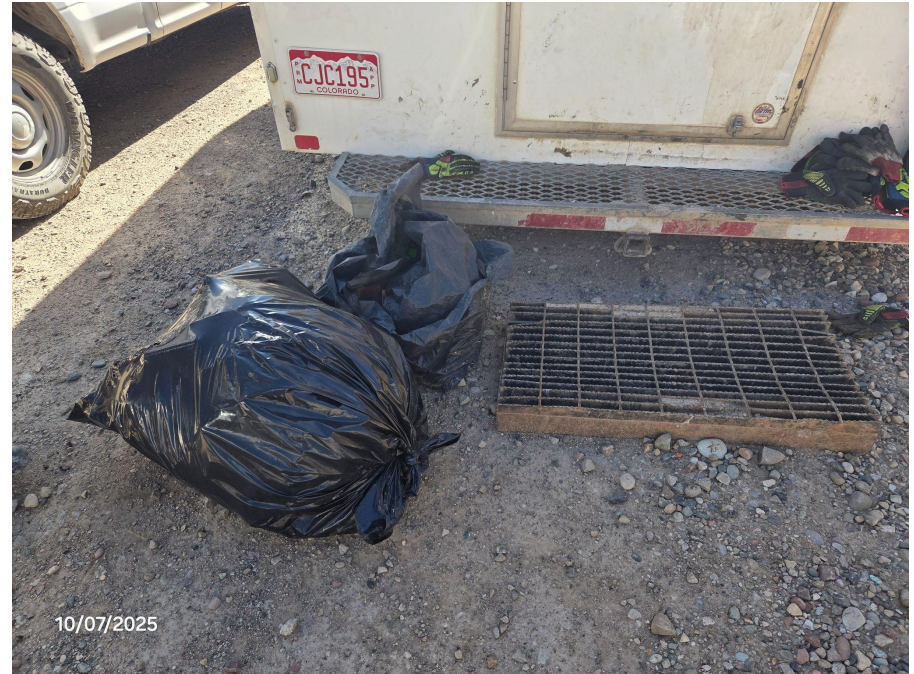
Photo 4: Photos taken from the west end of the Location. Photos show trash debris improperly stored on the Location, rather than an appropriate receptacle.

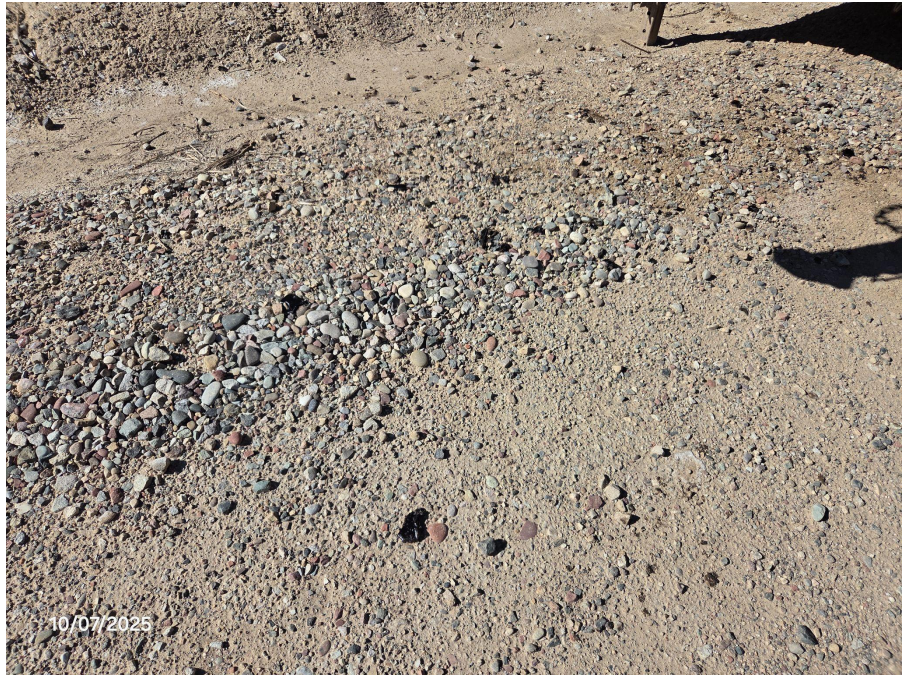
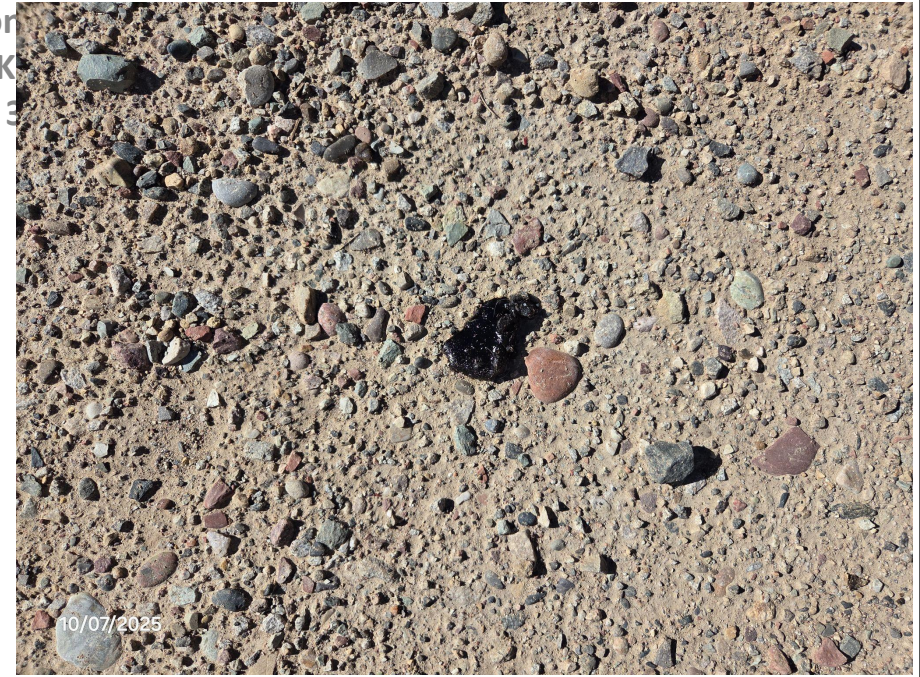
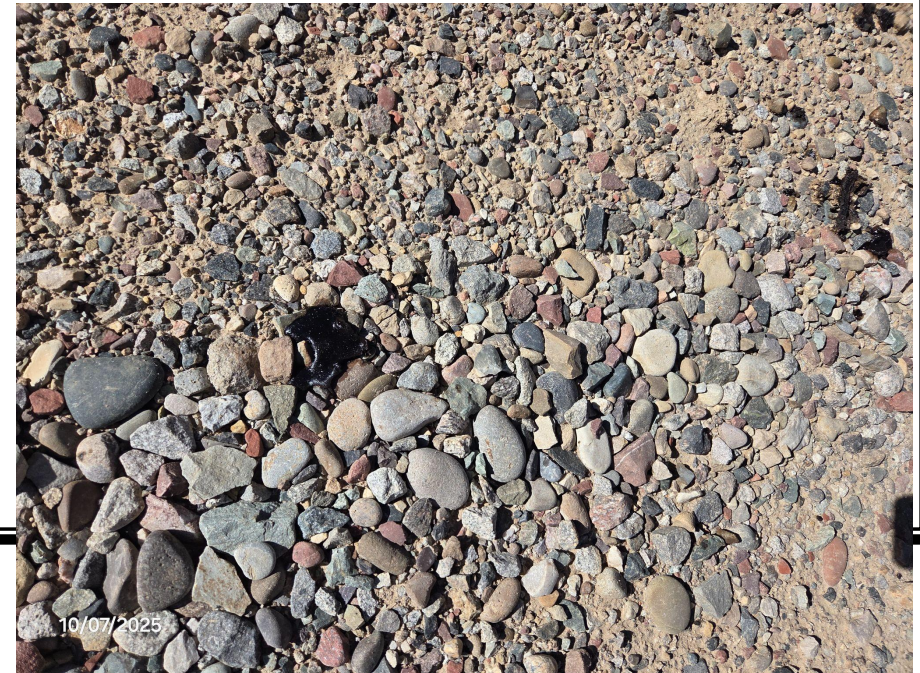
Photo 5: What appears to be oily waste observed spilled around areas of the trailer on the west end of the Location.
