# Final Reclamation Inspection

Operator: NOBLE ENERGY INC - 100322

Location ID: 462005

Inspection Photos  
Location Name: Kissler  
Location ID: 462005

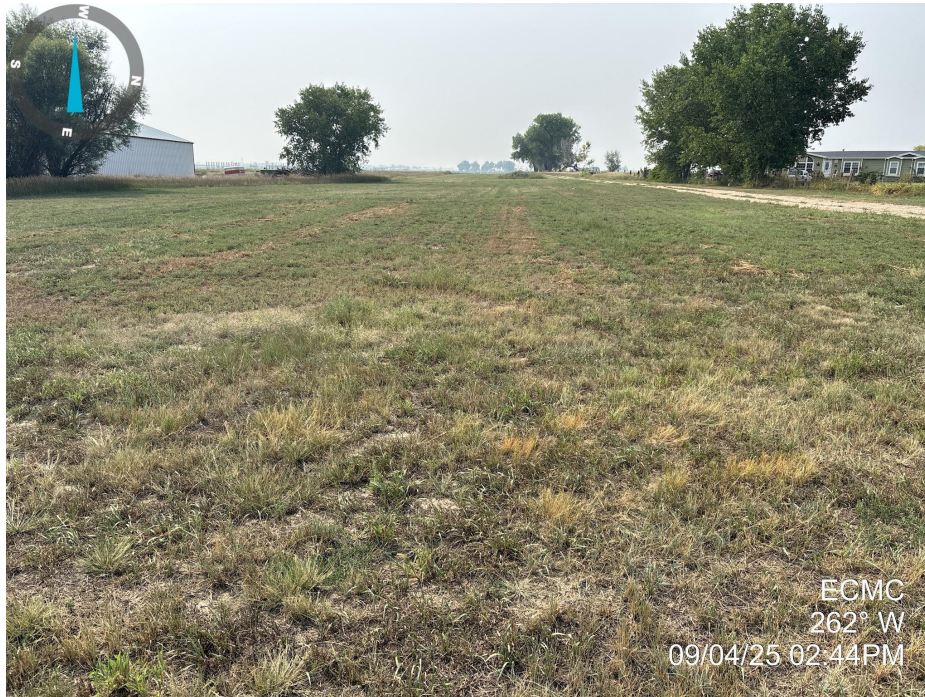
**Photo 1.** Photo taken of the tank battery location, facing west. Photo illustrates that final reclamation activities have taken place, but vegetation establishment does not appear to meet Rule 1004 standards and weedy annual vegetation including kochia (*Bassia scoparia*) was observed across the location.

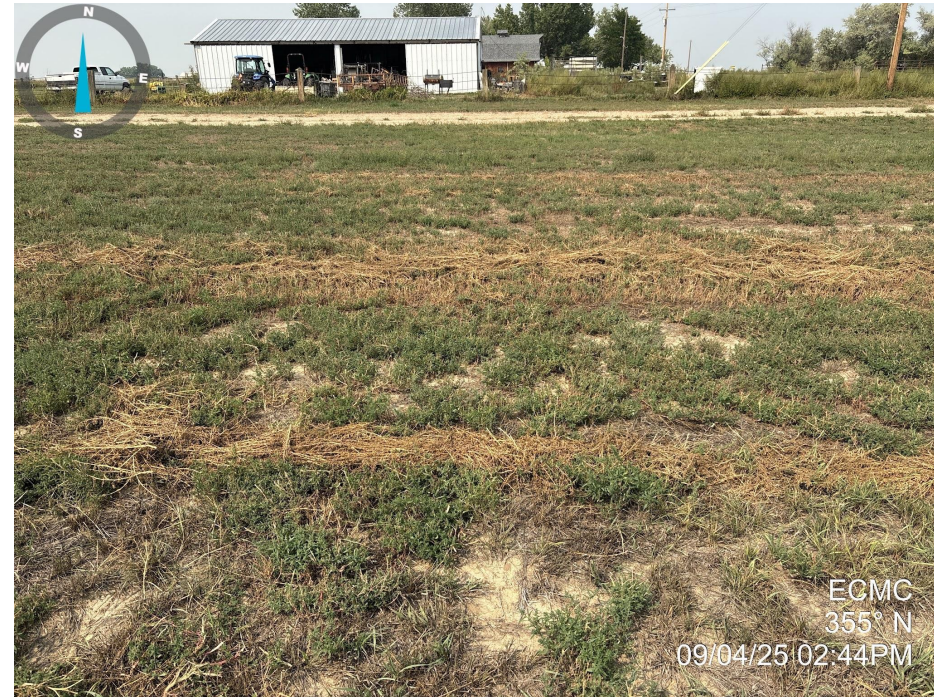
**Photo 2.** Photo taken of the tank battery location, facing north. See comments under Photo 1.

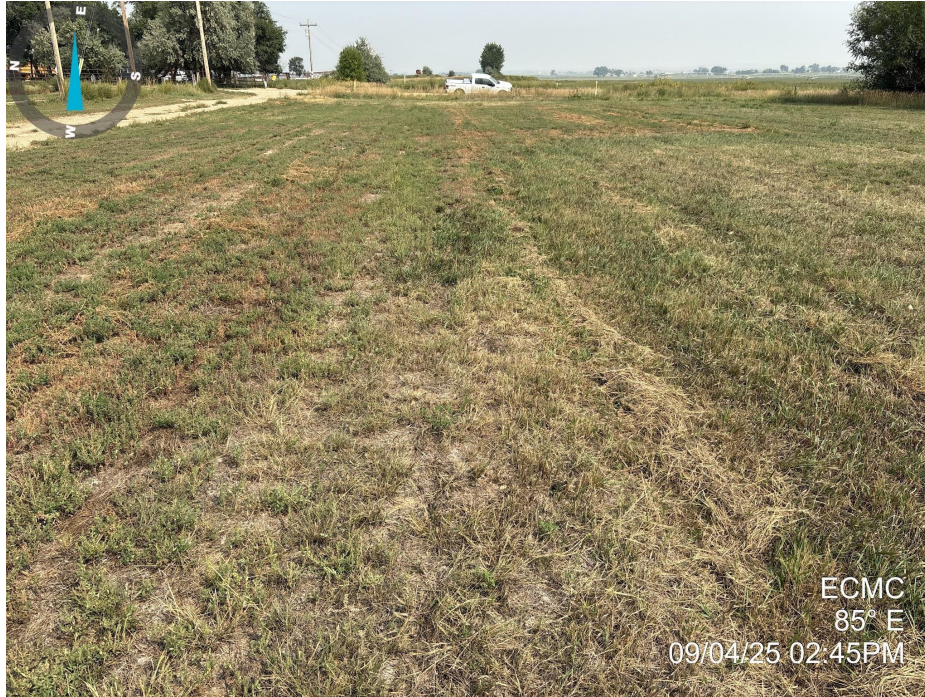
**Photo 3.** Photo taken of the tank battery location, facing east.  
See comments under Photo 1.

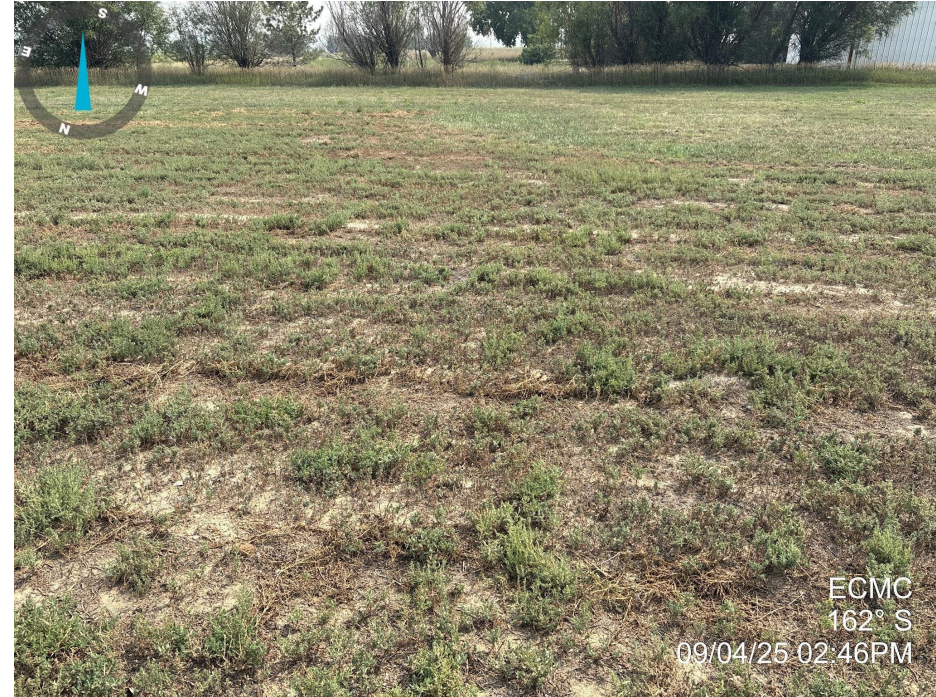
**Photo 4.** Photo taken of the tank battery location, facing south.  
See comments under Photo 1.

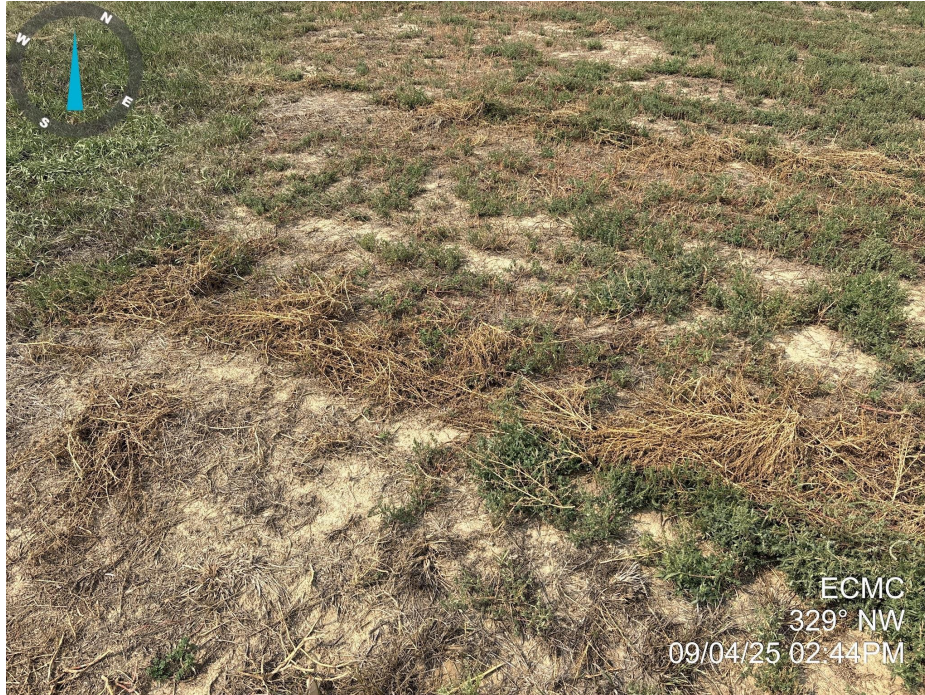
**Photo 5.** Photo taken of ground cover at the tank battery location, facing east. Photo illustrates perennial grass and kochia (*Bassia scoparia*) which has recently been mowed at the time of this inspection.

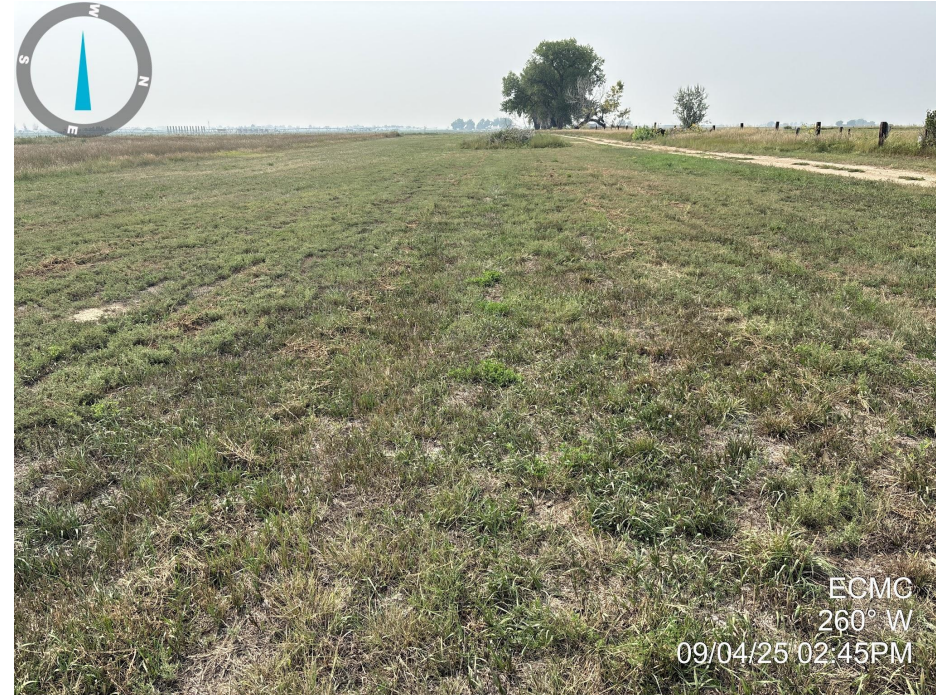
**Photo 6.** Photo taken of the reference area to the location, west of the location, facing west. Photo illustrates perennial grass that has been mowed.
