Final Reclamation Inspection

September 4, 2025

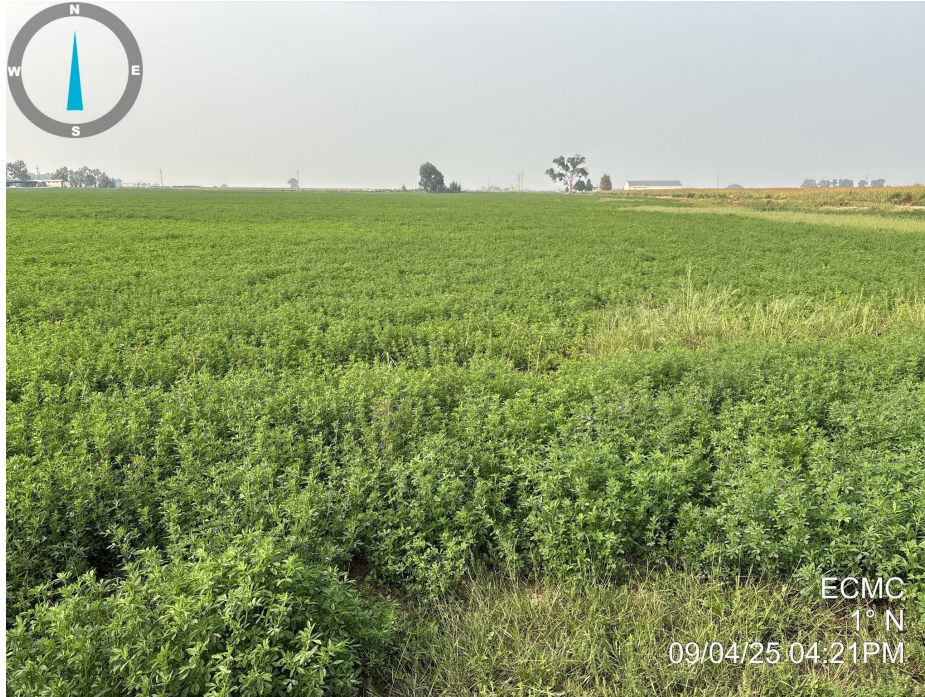
Photo 3. Photo taken of the well location, facing north. Photo illustrates that final reclamation activities have taken place, but vegetation establishment does not meet Rule 1004 standards as weedy annual vegetation including kochia (*Bassia scoparia*) was observed across the location.

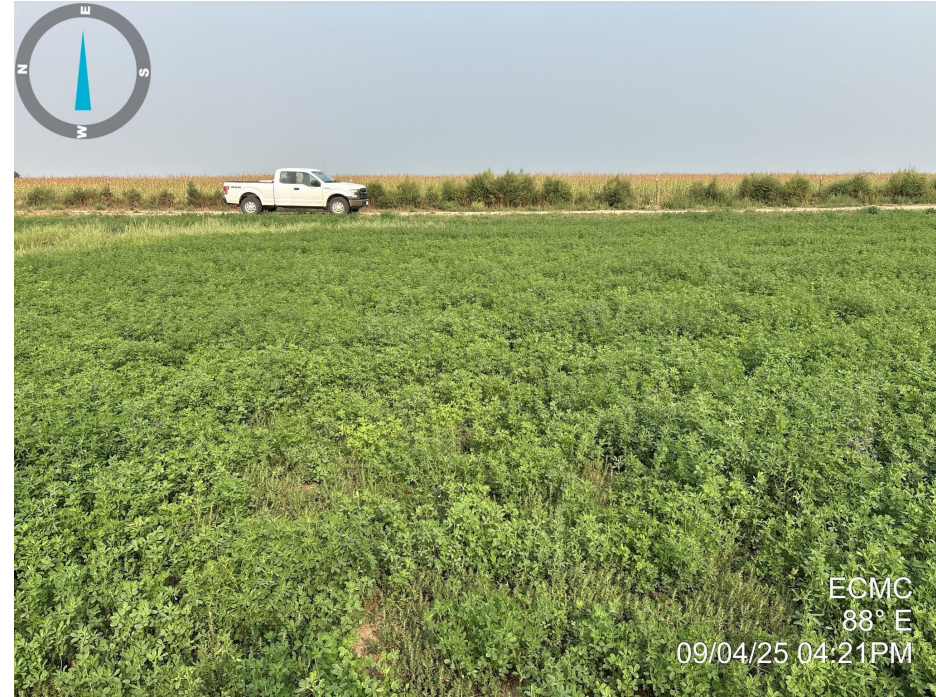
Photo 4. Photo taken of the well location, facing east. See comments under Photo 3.
