Final Reclamation Inspection

Operator: NOBLE ENERGY INC - 100322

Location ID: 421391

Inspection Photos
Location Name: EMBREE C #10-20D TANK
Location ID: 421391

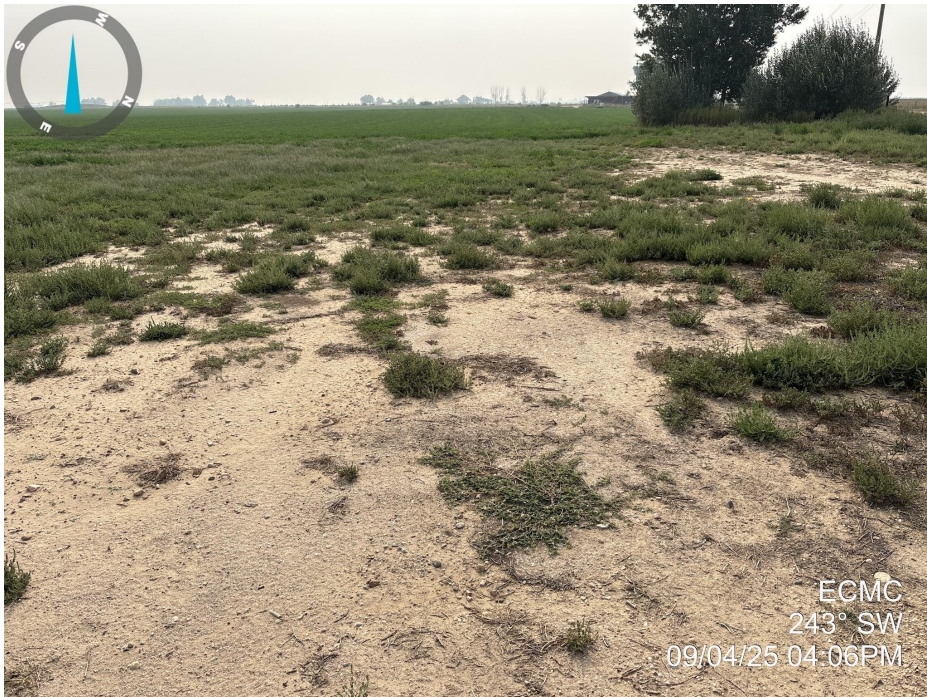
Photo 1. Photo taken of the tank battery location, from the northeastern perimeter, facing southwest. Photo illustrates that final reclamation activities have taken place, but vegetation establishment does not meet Rule 1004 standards. Bare ground and weedy annual vegetation, including kochia (*Bassia scoparia*) and puncture vine (*Tribulus terrestris*), were observed across the location.

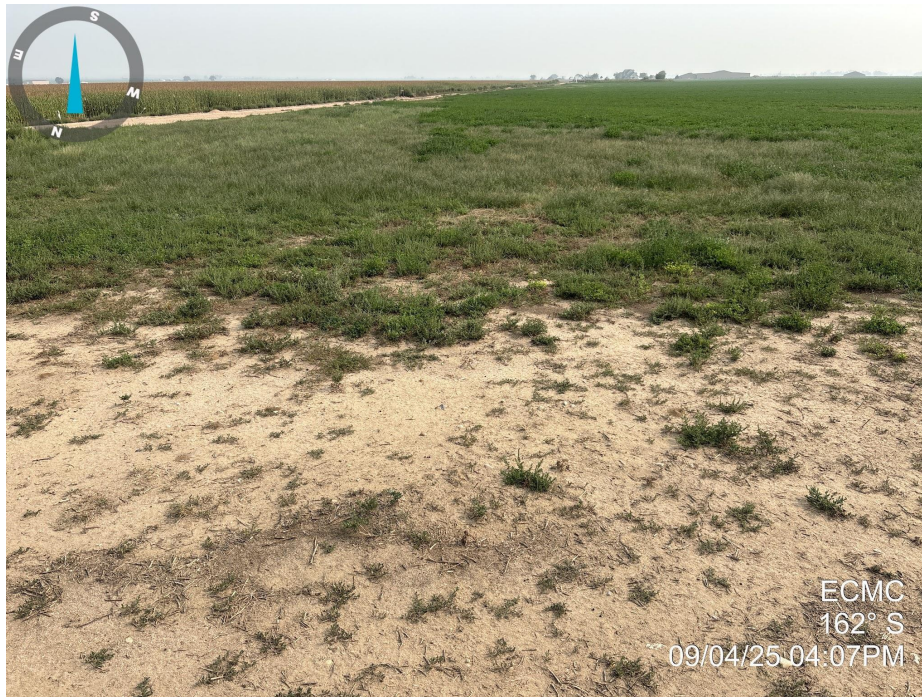
Photo 2. Photo taken of the tank battery location, facing south. See comments under Photo 1.

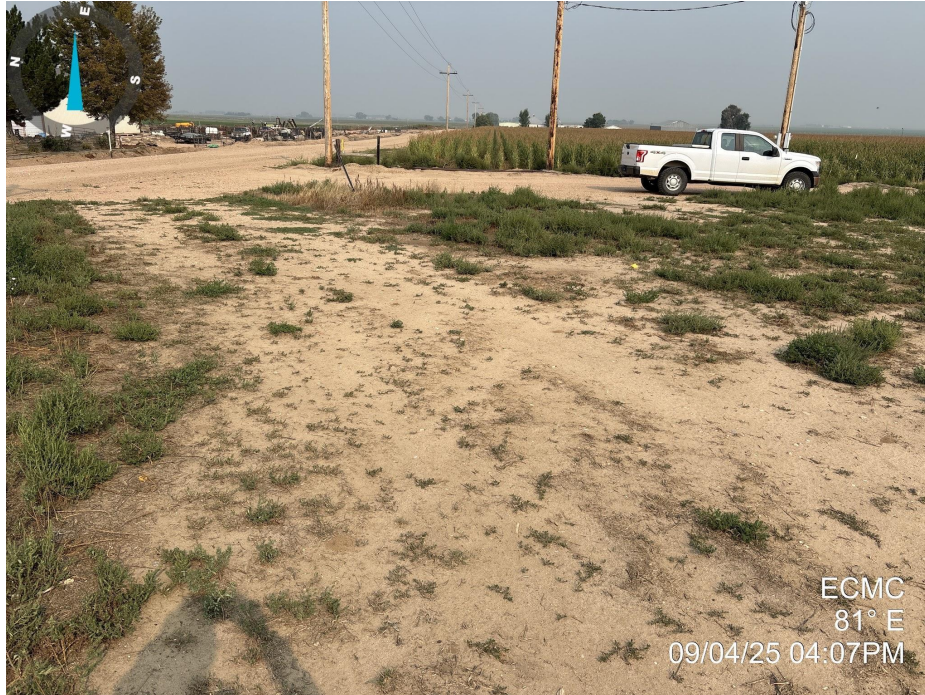
Photo 3. Photo taken of the tank battery location, facing east. See comments under Photo 1.

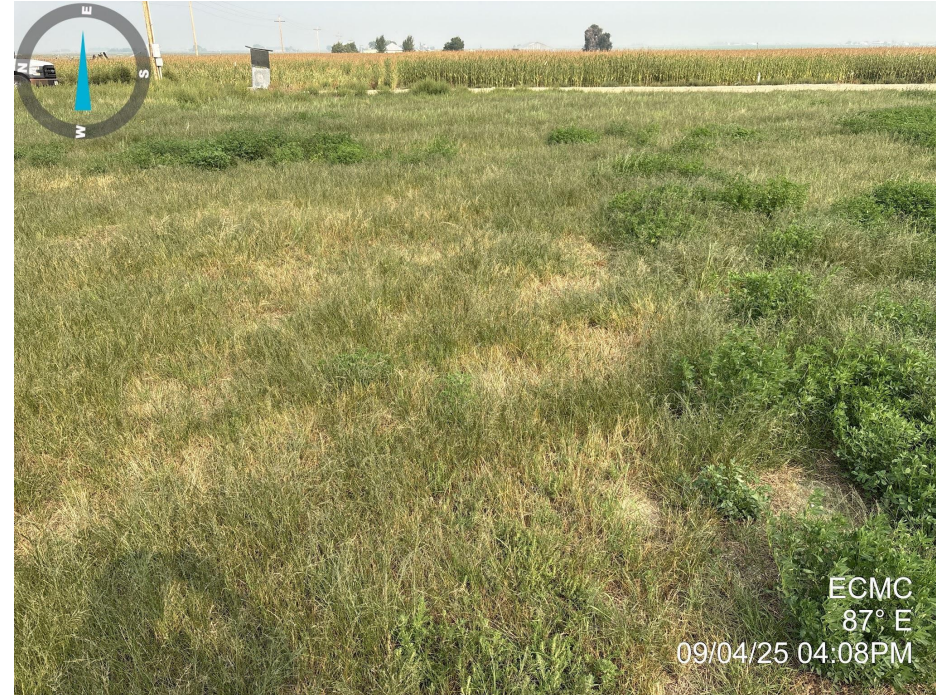
Photo 4. Photo taken of the tank battery location, from the southwestern portion of the location, facing east. Photo illustrates that perennial grass has established over this portion of the location.

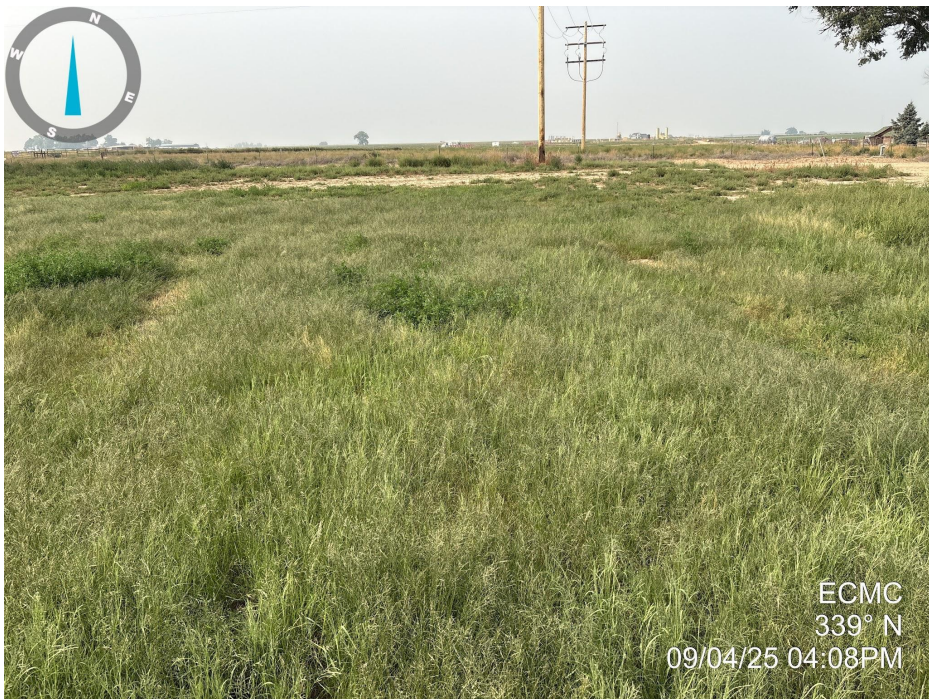
Photo 5. Photo taken of the tank battery location, from the southwestern portion of the location, facing north. See comments under Photo 4.

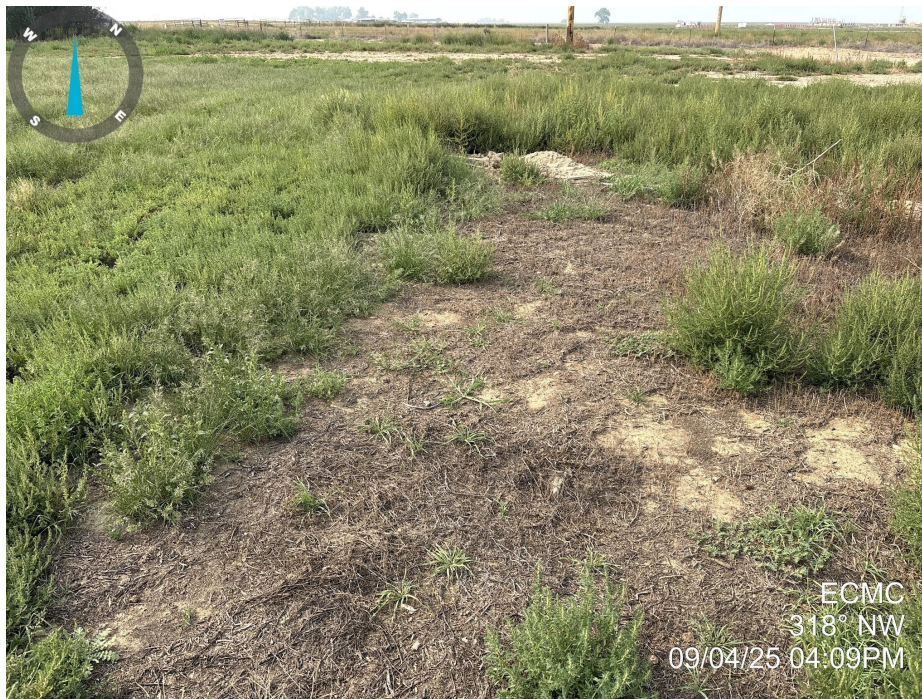
Photo 6. Photo taken of the tank battery location, facing northwest. See comments under Photo 1.

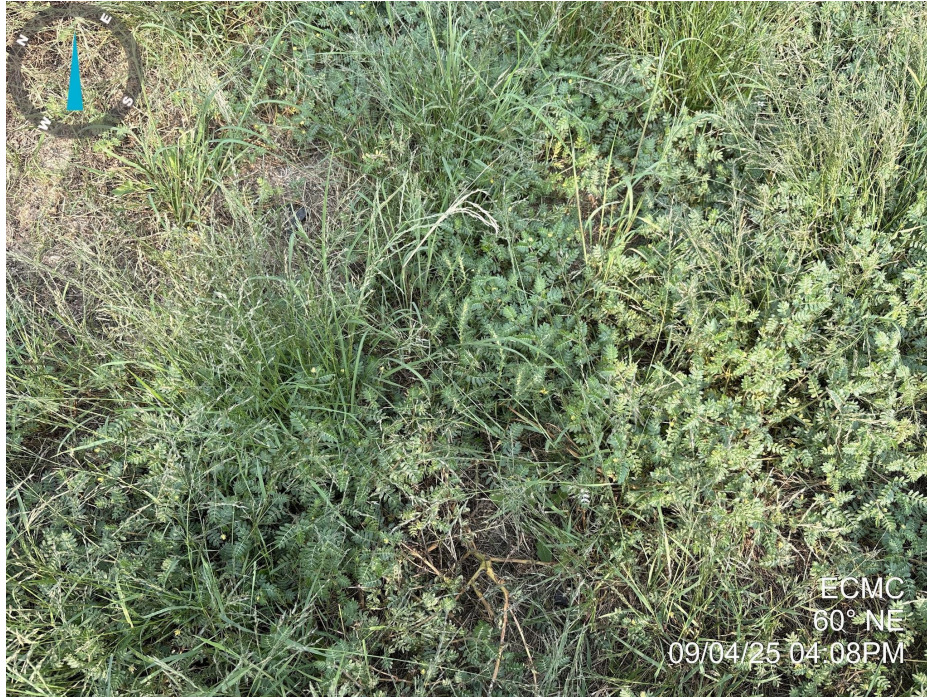
Photo 7. Photo taken of ground cover at the tank battery location. Photo illustrates weedy annual vegetation including puncture vine (*Tribulus terrestris*), a List C Noxious Weed species.

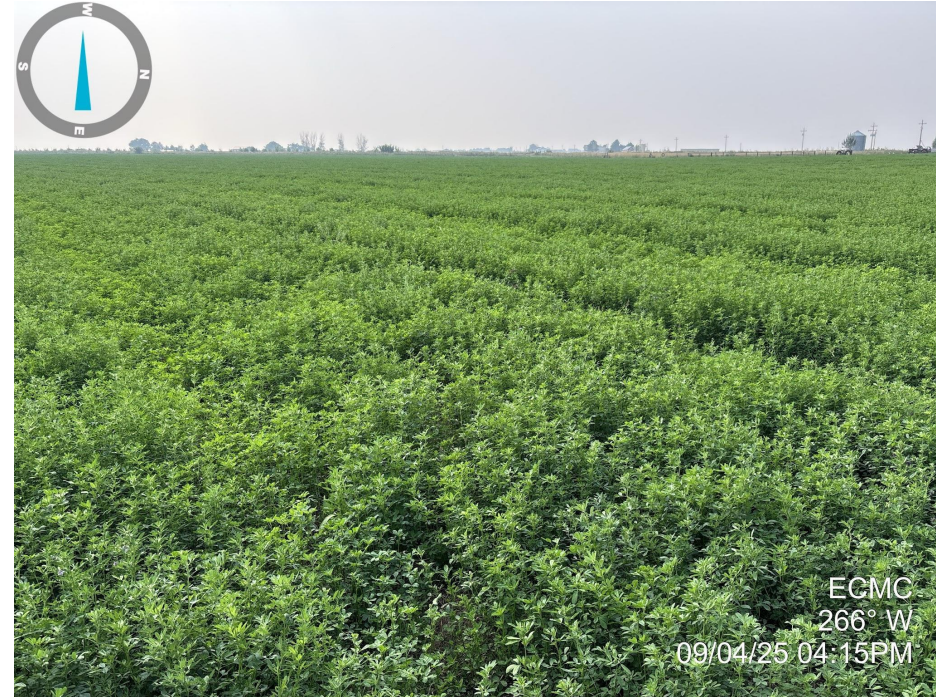
Photo 8. Photo taken of the reference area to the tank battery location, southwest of the location, facing west. Photo illustrates alfalfa cropland which is adjacent to the tank battery location.
