# Final Reclamation Inspection

Operator: PDC ENERGY INC - 69175

Location ID: 471829

Inspection Photos  
Location Name: BUJALSKI 25NENE  
Location ID: 471829

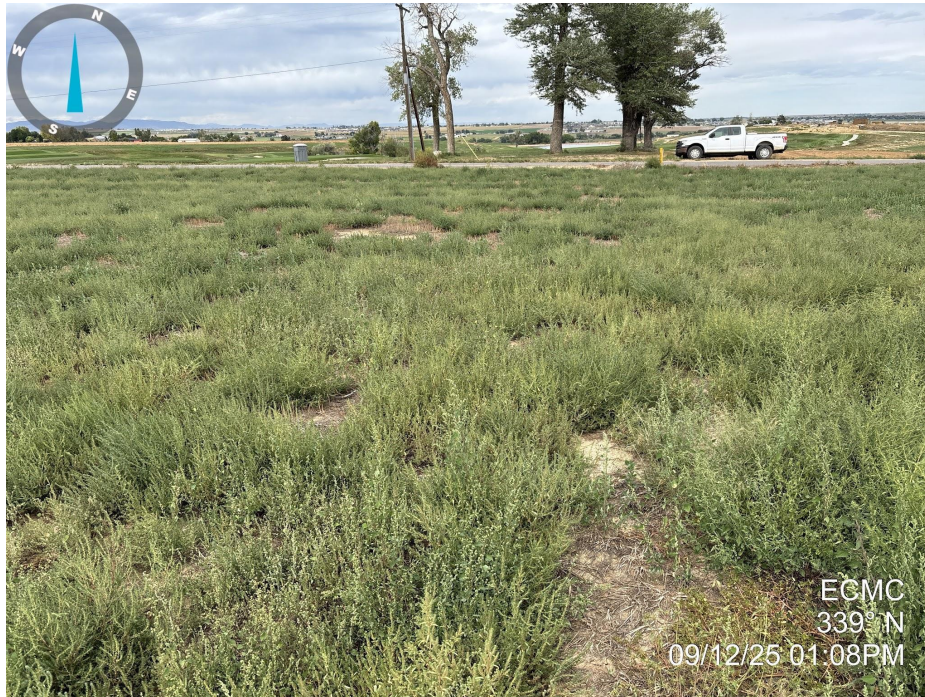
**Photo 1.** Photo taken of the tank battery location, facing north. Photo illustrates that final reclamation activities have taken place, but vegetation establishment does not meet Rule 1004 standards. Weedy annual vegetation including kochia (*Bassia scoparia*) was observed across the location.

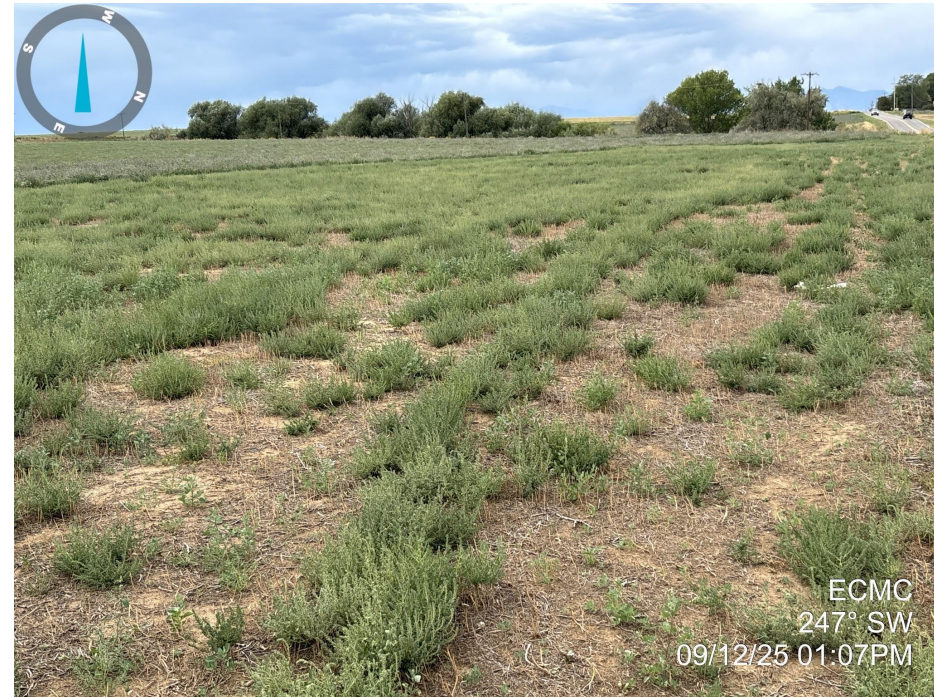
**Photo 2.** Photo taken of the tank battery location, facing southwest. See comments under Photo 1.

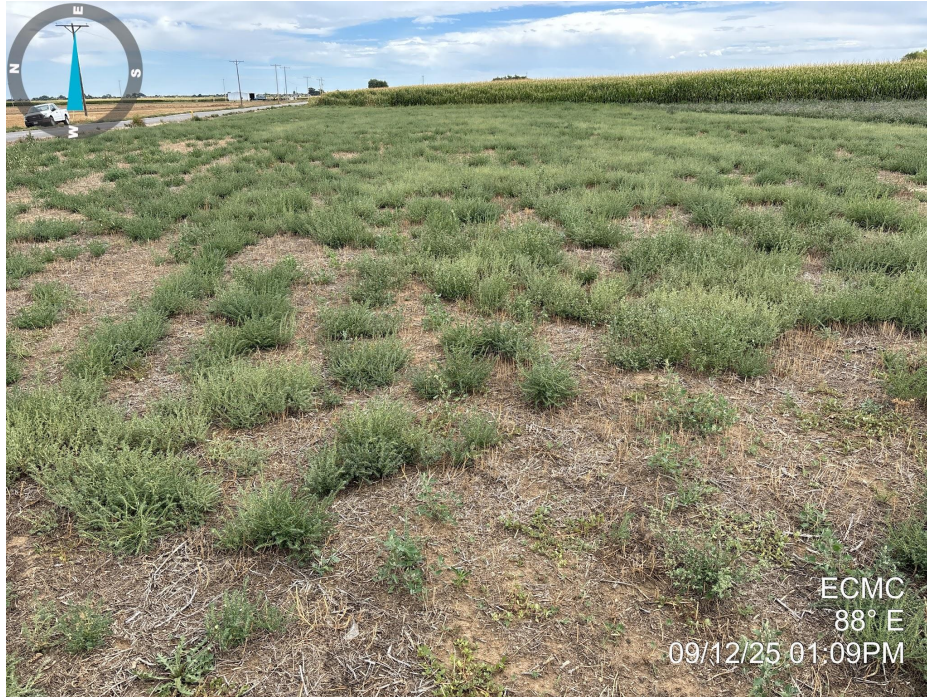
**Photo 3.** Photo taken of the tank battery location, facing east. See comments under Photo 1.

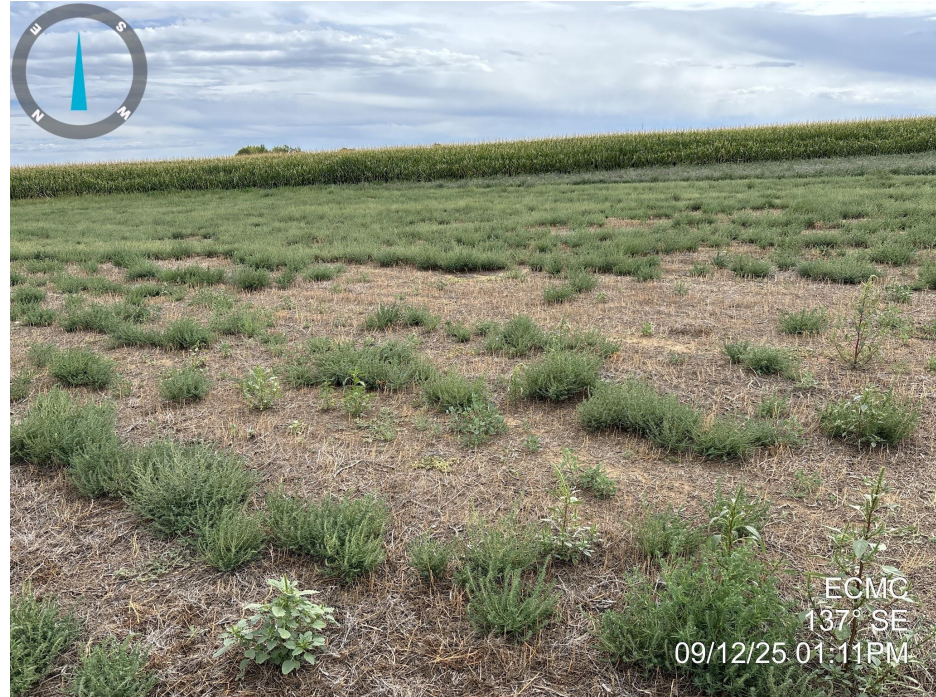
**Photo 4.** Photo taken of the tank battery location, facing southeast. See comments under Photo 1.

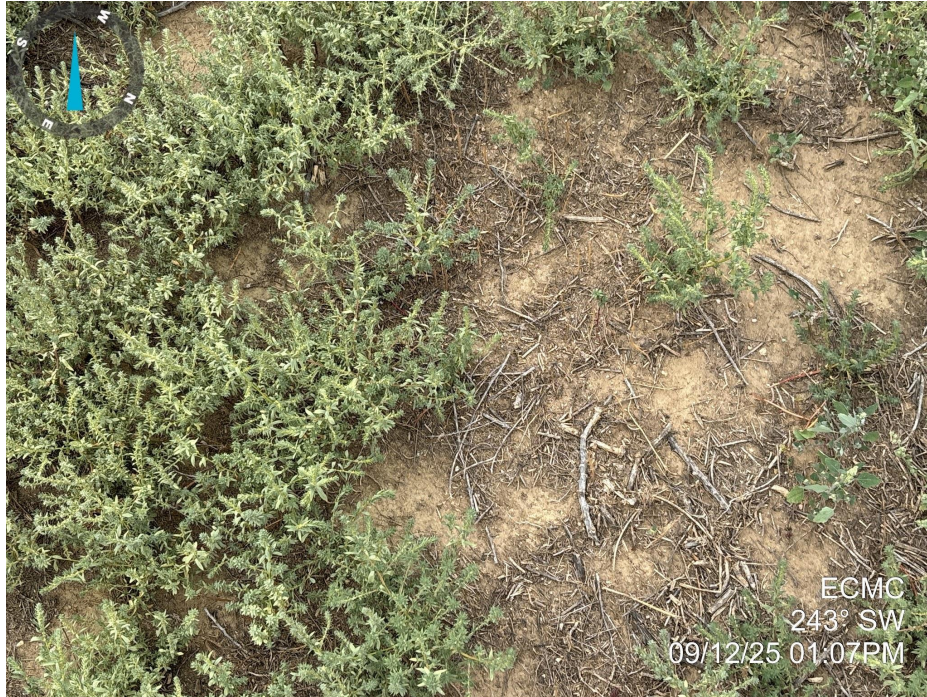
**Photo 5.** Photo taken of ground cover at the tank battery location. Photo illustrates weedy annual vegetation including kochia (*Bassia Scoparia*).

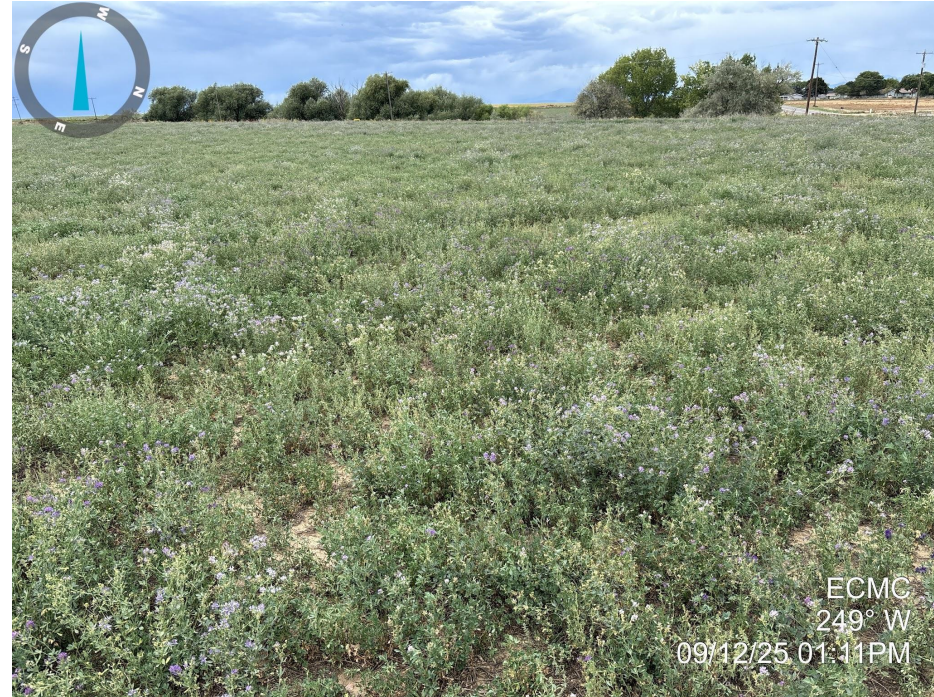
**Photo 6.** Photo taken of the reference area to the location, west of the location, facing west. Photo illustrates alfalfa cropland.
