Final Reclamation Inspection

Operator: NOBLE ENERGY INC - 100322

Location ID: 415721

Inspection Photos
Location Name: GUTTERSEN D #16-28
Location ID: 415721

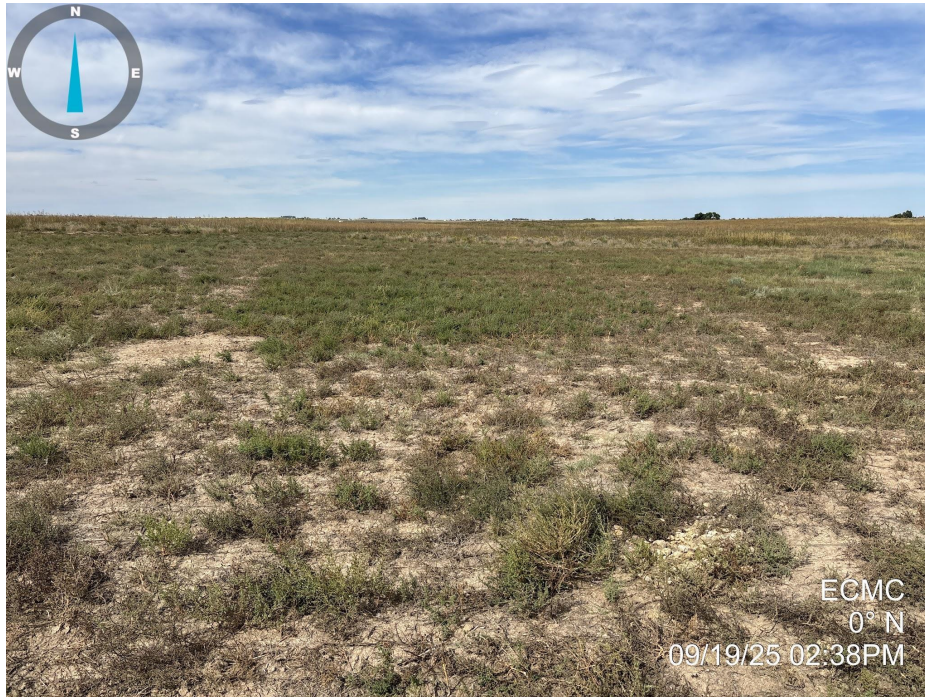
Photo 1. Photo taken of the well location, facing north. Photo illustrates that final reclamation activities have taken place, with evidence of drill row seeding, but vegetation establishment does not meet Rule 1004 standards. Weedy annual vegetation including russian thistle (*Salsola tragus*) was observed across the location.

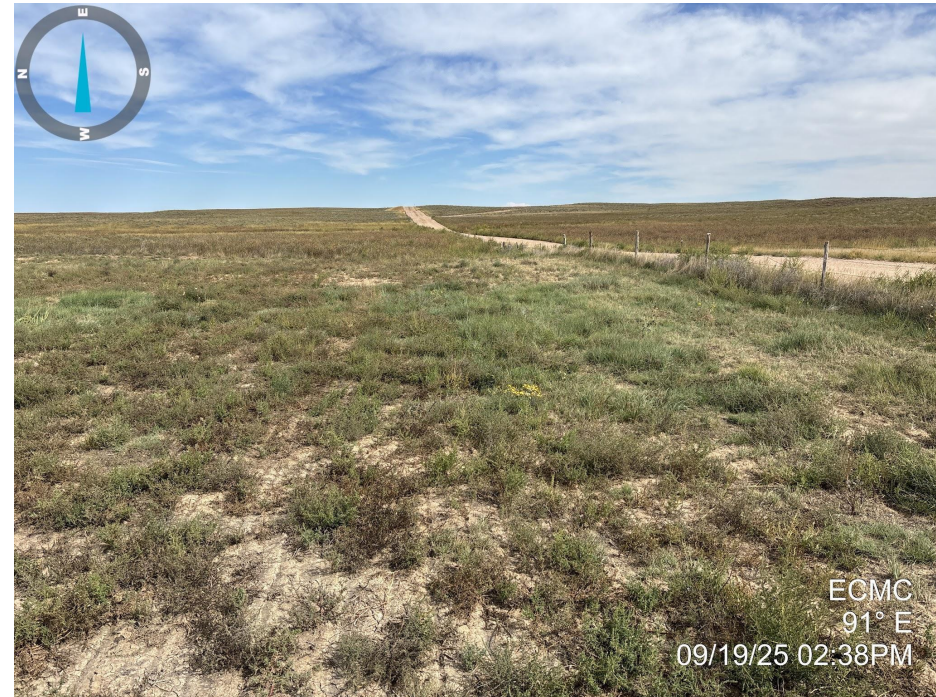
Photo 2. Photo taken of the well location, facing east. See comments under Photo 1.

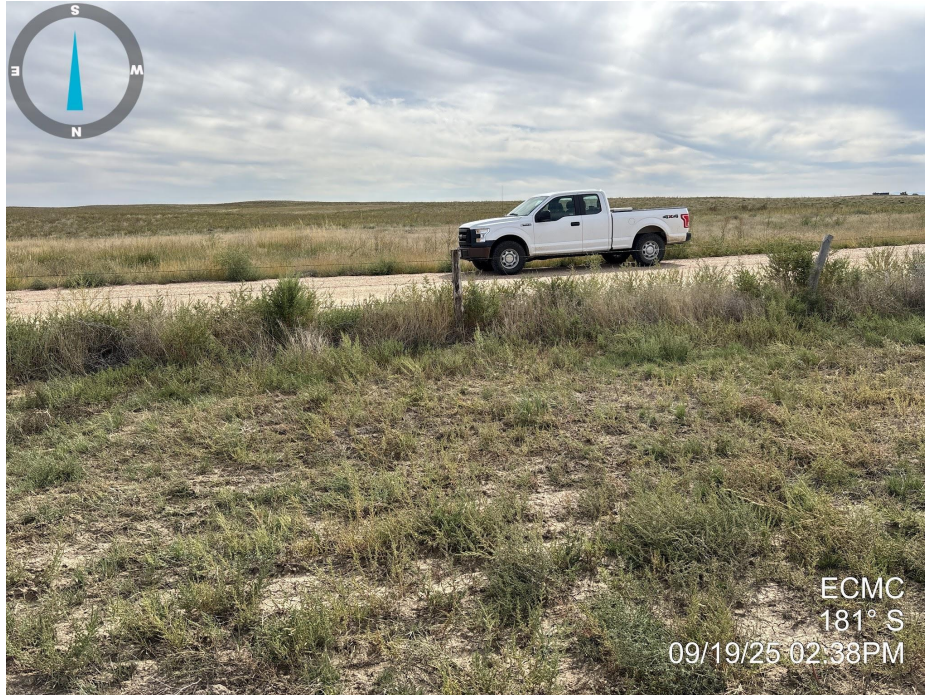
Photo 3. Photo taken of the well location, facing south. See comments under Photo 1.

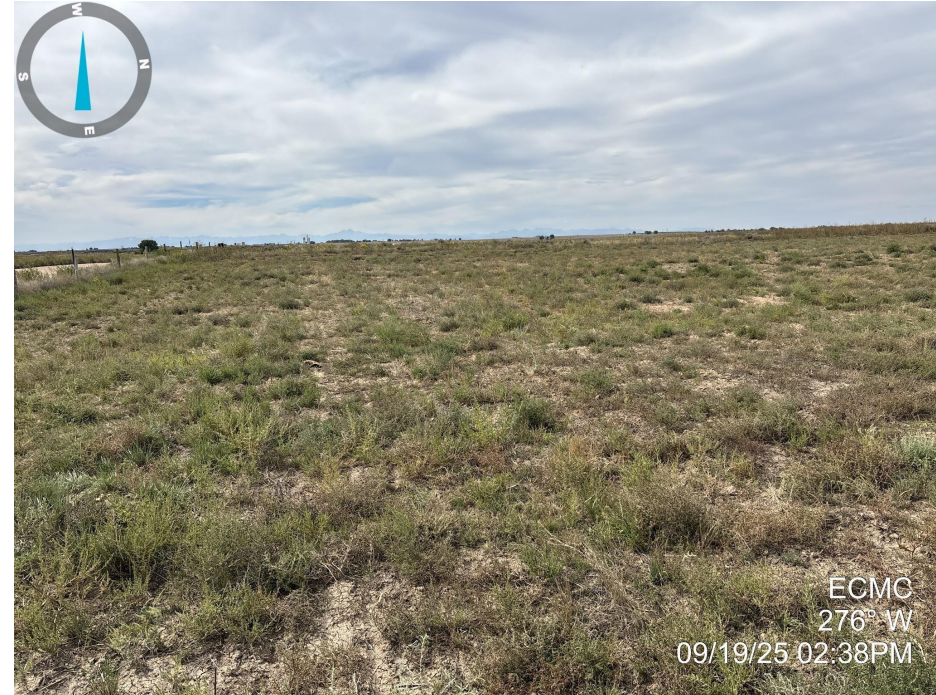
Photo 4. Photo taken of the well location, facing west. See comments under Photo 1.

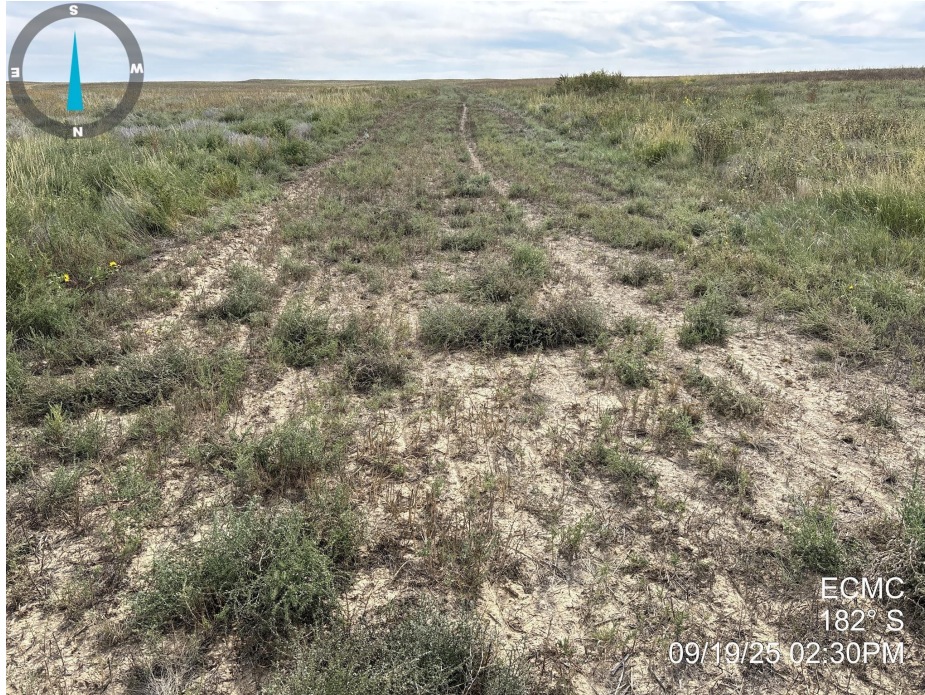
Photo 5. Photo taken of the access road to the well location, facing south, towards the location. Photo illustrates that final reclamation activities have taken place, with evidence of drill row seeding, but vegetation has not established to Rule 1004 standards.

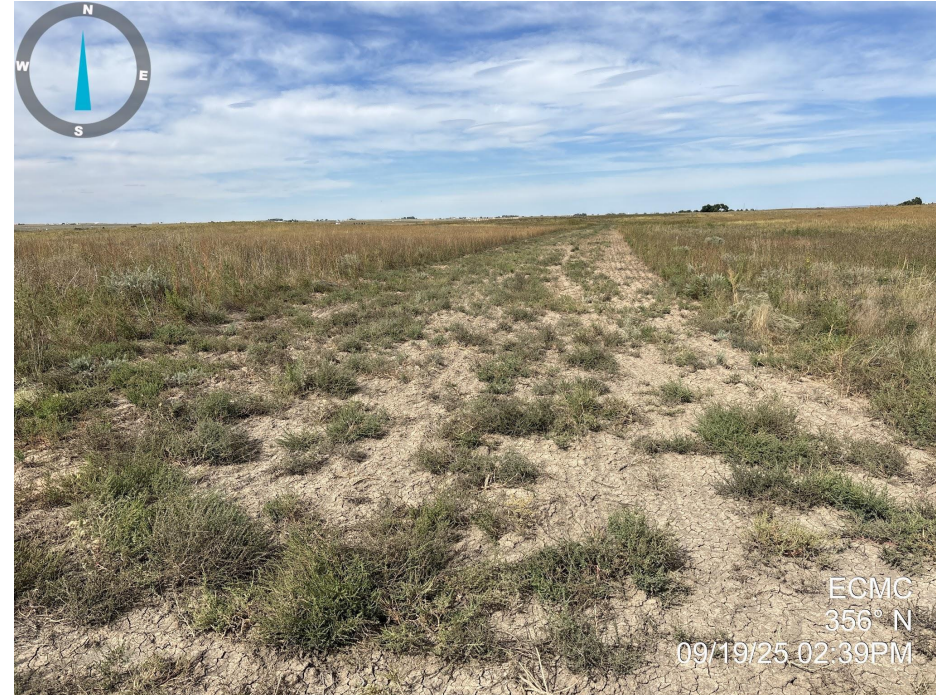
Photo 6. Photo taken of the access road to the well location, facing north, away from the location. See comments under Photo 5.

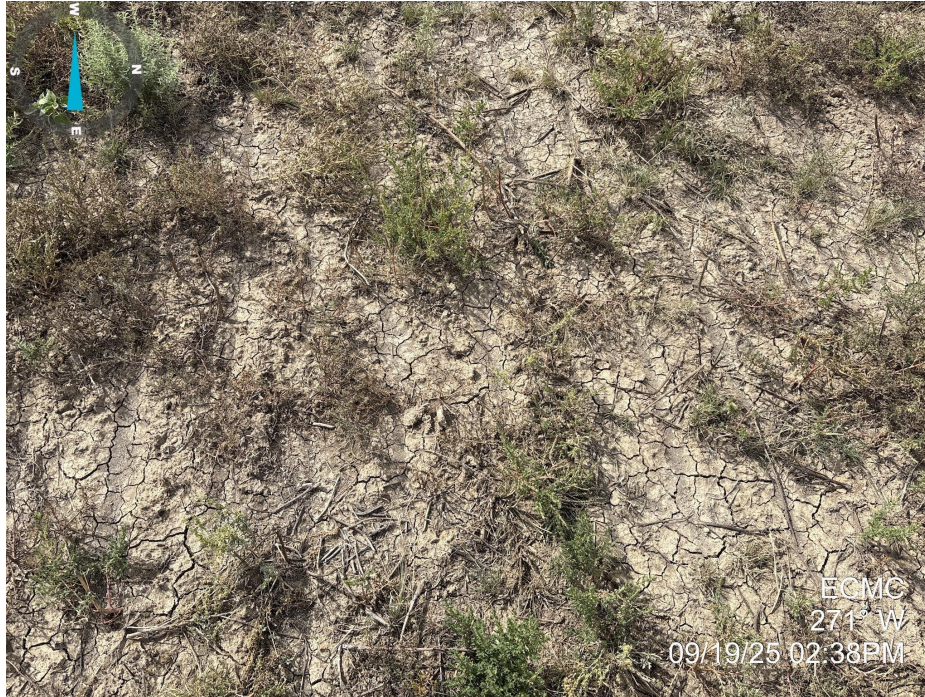
Photo 7. Photo taken of ground cover at the well location. Photo illustrates evidence of drill rows from seeding and weedy annual vegetation including russian thistle (*Salsola tragus*).

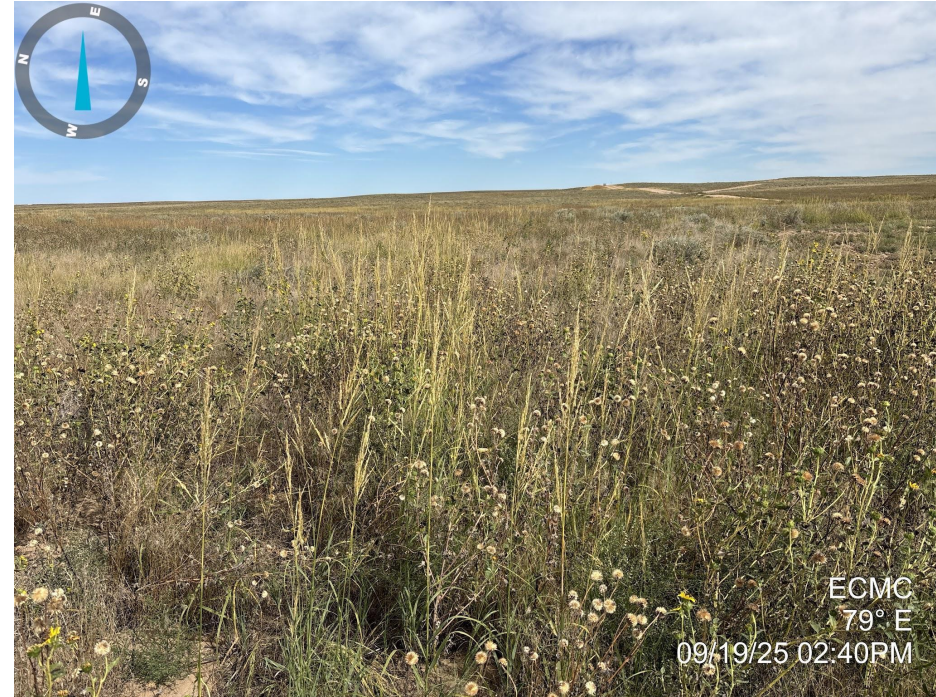
Photo 8. Photo taken of the reference area to the well location, northeast of the location, facing east. Photo illustrates perennial grass vegetation, prairie sunflower, and weedy annual vegetation.
