Final Reclamation Inspection

Operator: NOBLE ENERGY INC - 100322

Location ID: 329157

Inspection Photos
Location Name: ART RED D #9-16
Location ID: 329157

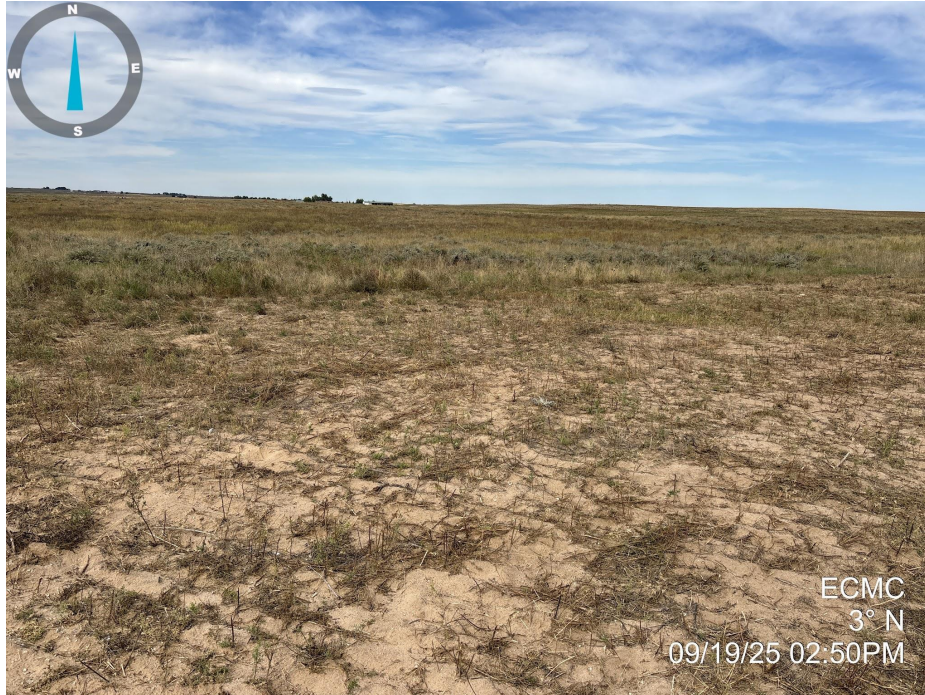
Photo 1. Photo taken of the well location, facing north. Photo illustrates that final reclamation activities have taken place, with evidence of drill row seeding, but vegetation establishment does not meet Rule 1004 standards. Weedy annual vegetation including russian thistle (*Salsola tragus*) was observed across the location.

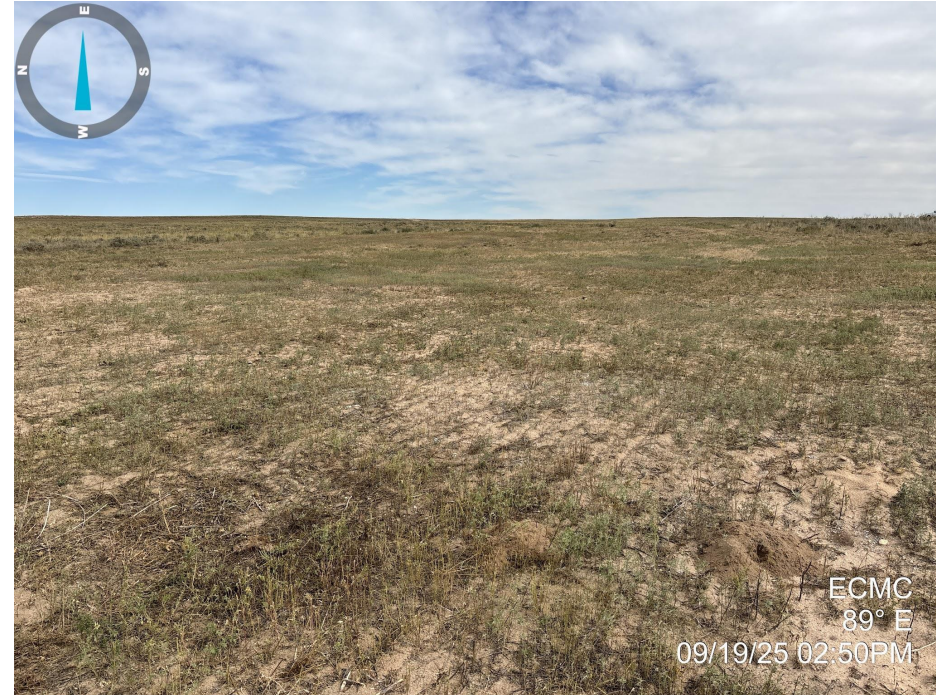
Photo 2. Photo taken of the well location, facing east. See comments under Photo 1.

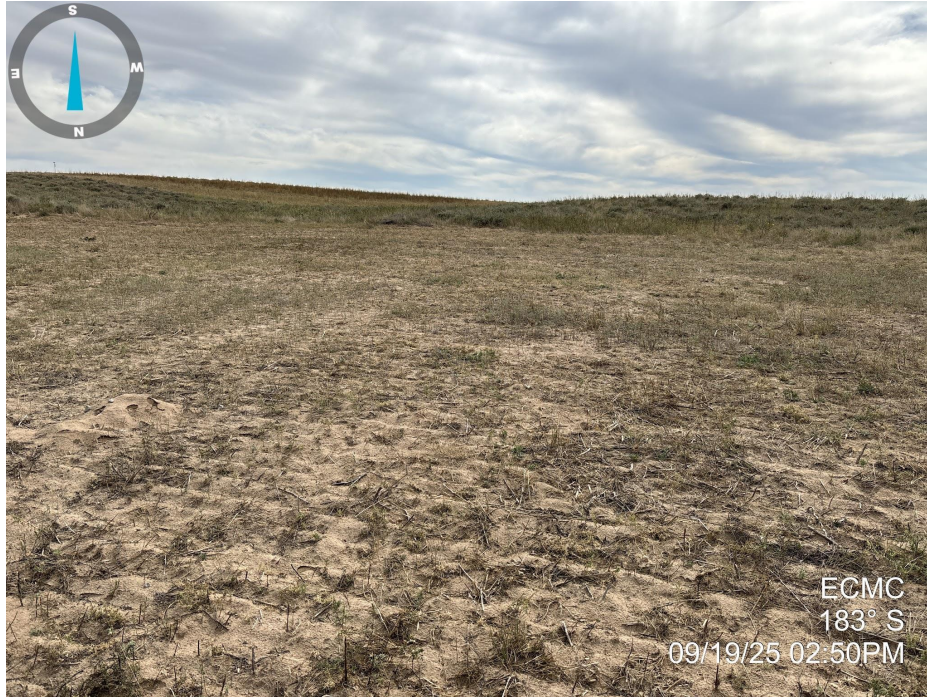
Photo 3. Photo taken of the well location, facing south. See comments under Photo 1.

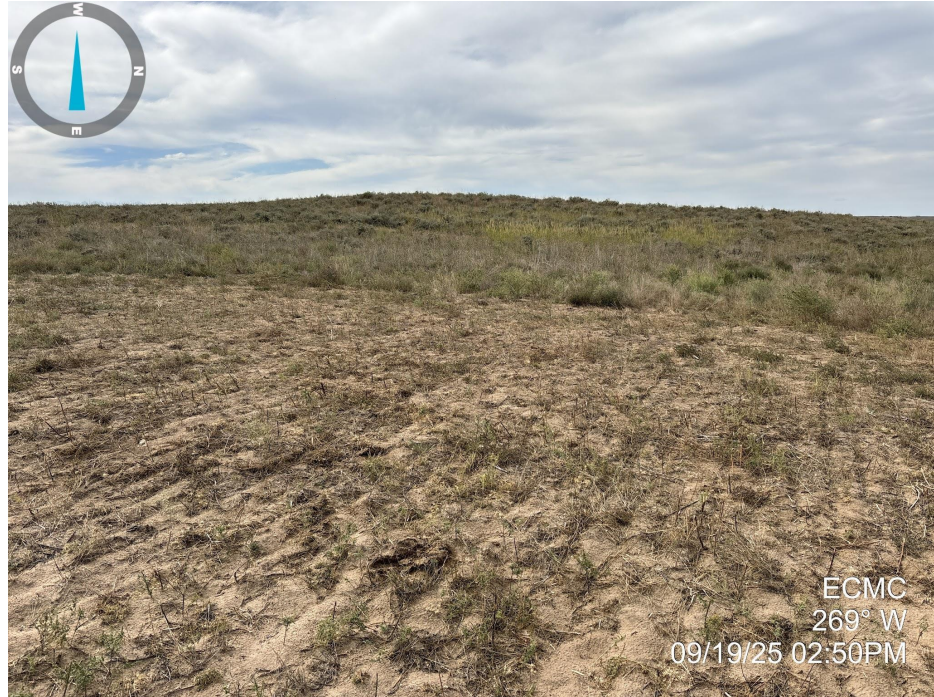
Photo 4. Photo taken of the well location, facing west. See comments under Photo 1.

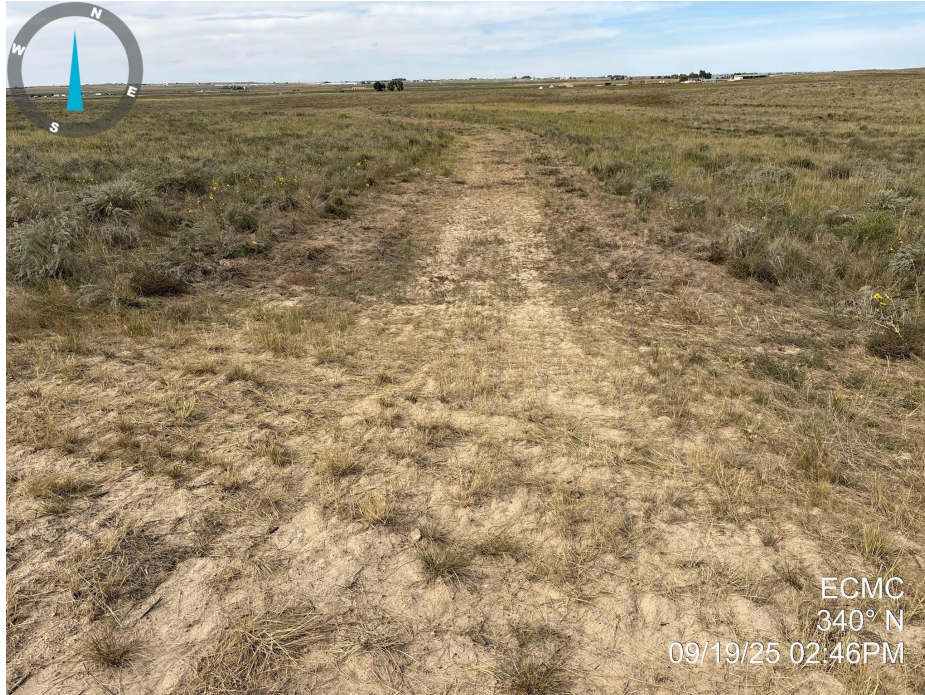
Photo 5. Photo taken of the access road to the well location, facing north, towards the location. Photo illustrates that final reclamation activities have taken place, with evidence of drill row seeding, but gravel remains and vegetation has not established to Rule 1004 standards.

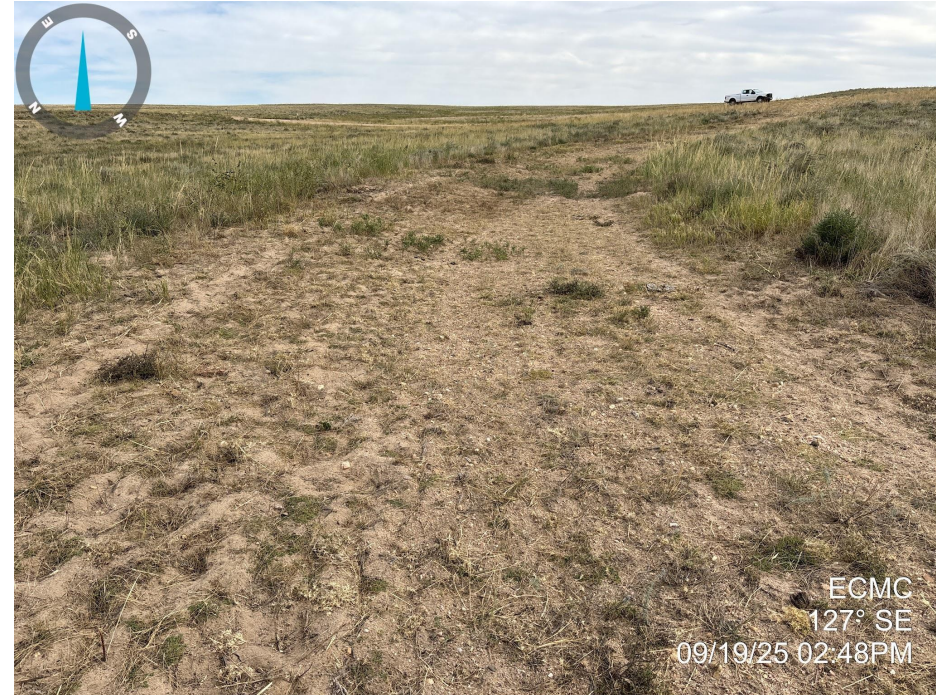
Photo 6. Photo taken of the access road to the well location, facing southeast, away from the location. See comments under Photo 5.

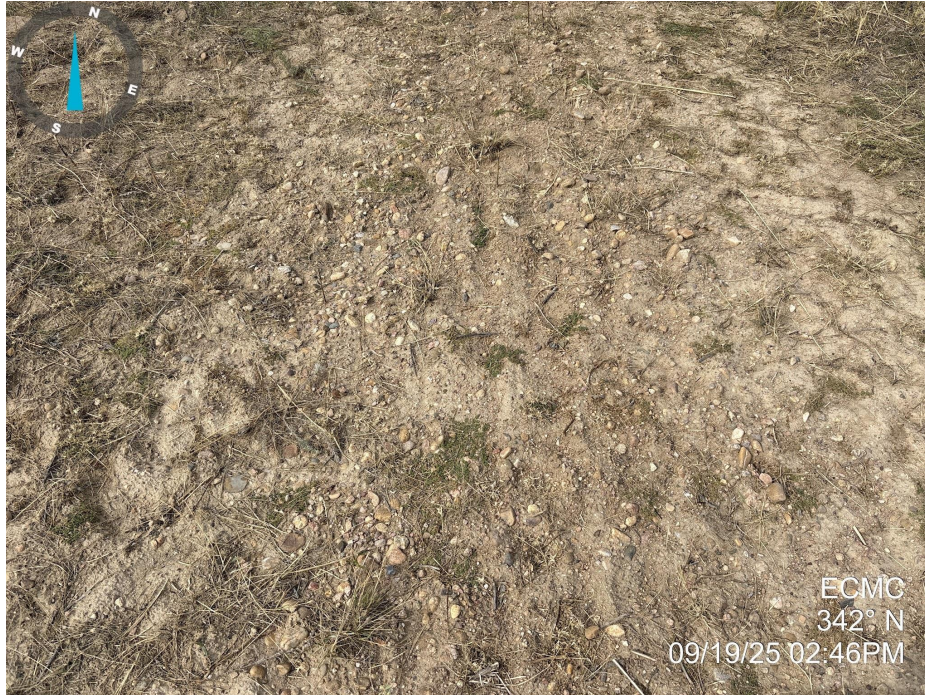
Photo 7. Photo taken of ground cover along the access road. Photo illustrates that gravel remains across the road.

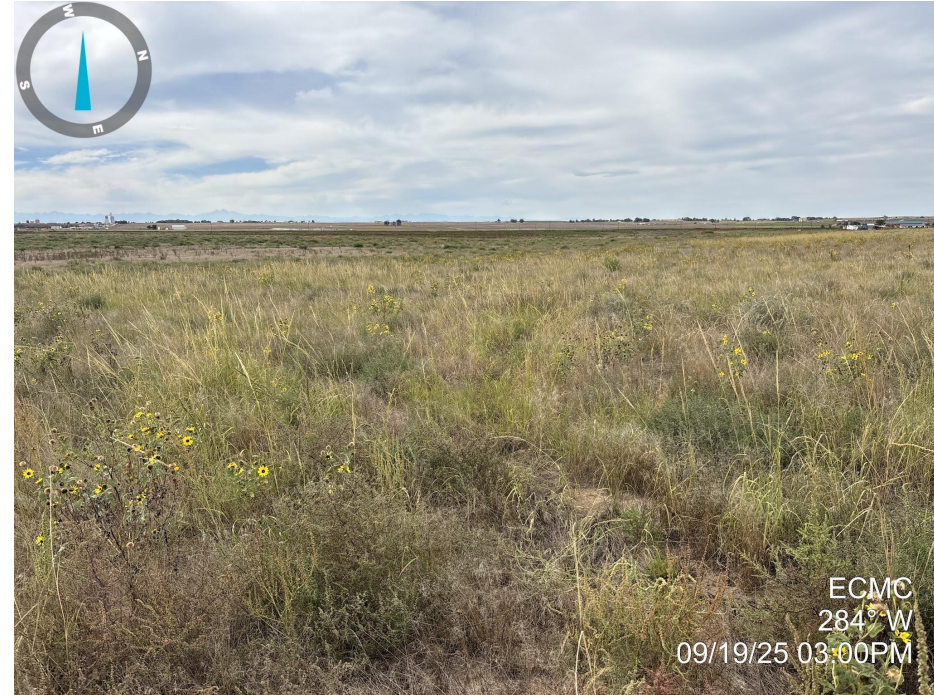
Photo 8. Photo taken of the reference area to the well location, west of the location, facing west. Photo illustrates perennial grass vegetation, prairie sunflower, and weedy annual vegetation.
