Final Reclamation Inspection

Operator: NOBLE ENERGY INC - 100322

Location ID: 328312

Inspection Photos
Location Name: GITTLEIN-UPRC #9-12
Location ID: 328312

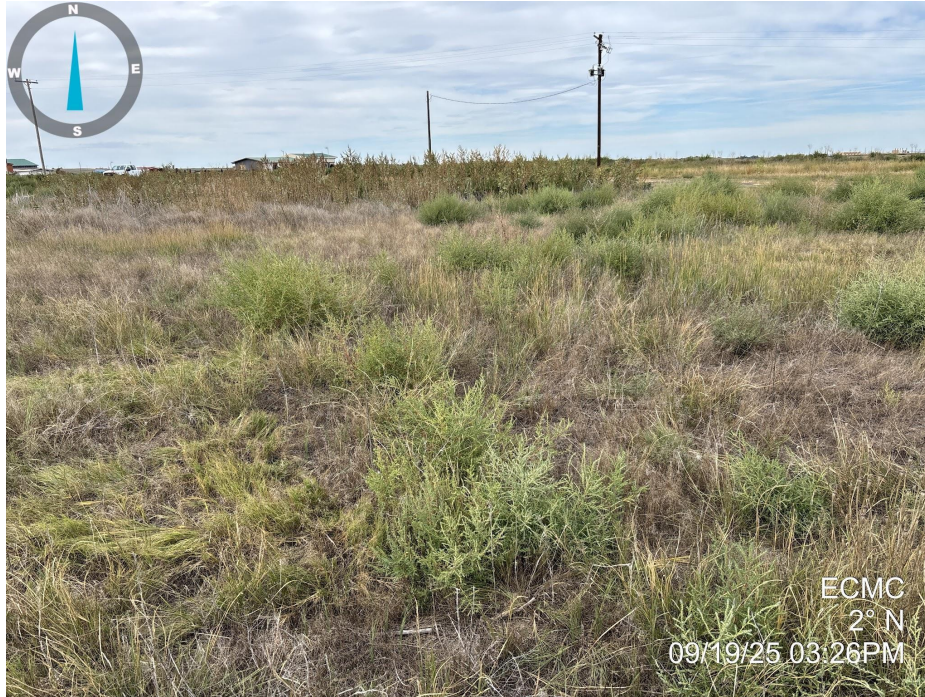
Photo 1. Photo taken of the well location, facing north. Photo illustrates that final reclamation activities have taken place, but vegetation establishment does not meet Rule 1004 standards. Weedy annual vegetation including kochia (*Bassia scoparia*) and cheatgrass (*Bromus tectorum*), a List C Noxious Weed species, were observed across the location.

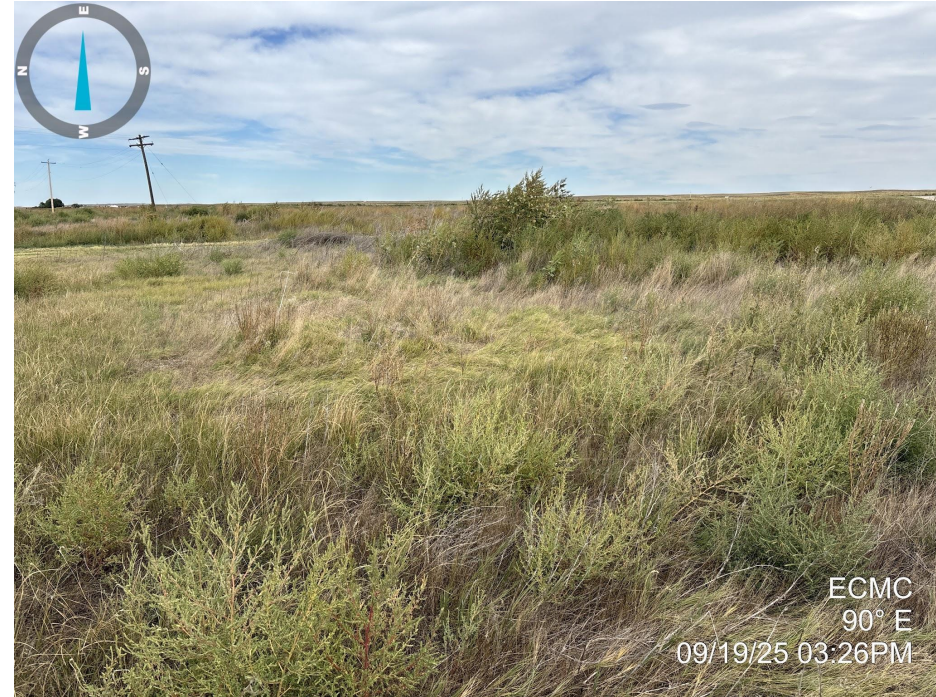
Photo 2. Photo taken of the well location, facing east. See comments under Photo 1.

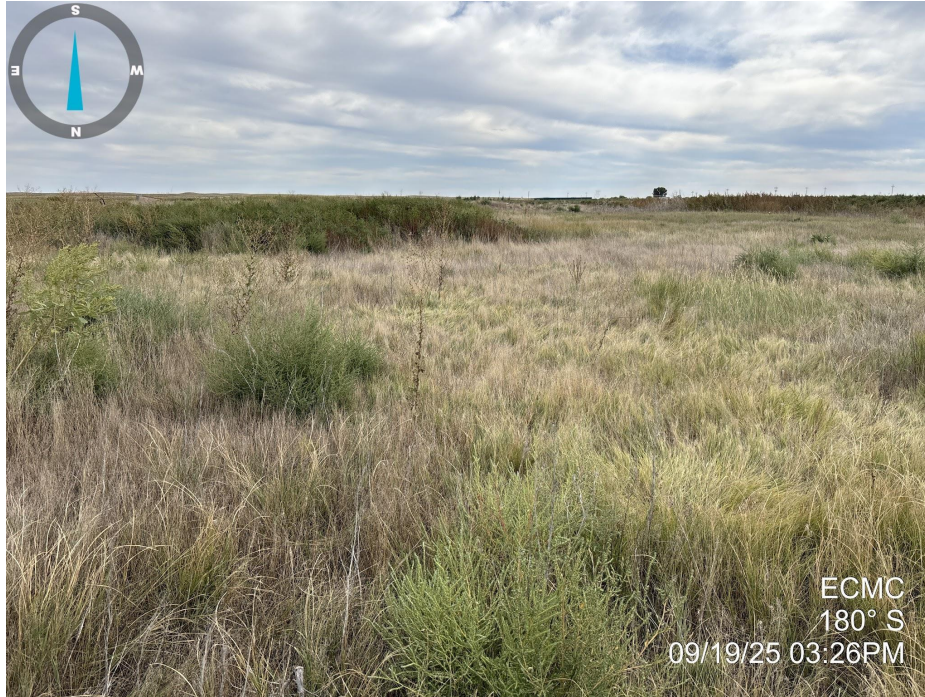
Photo 3. Photo taken of the well location, facing south. See comments under Photo 1.

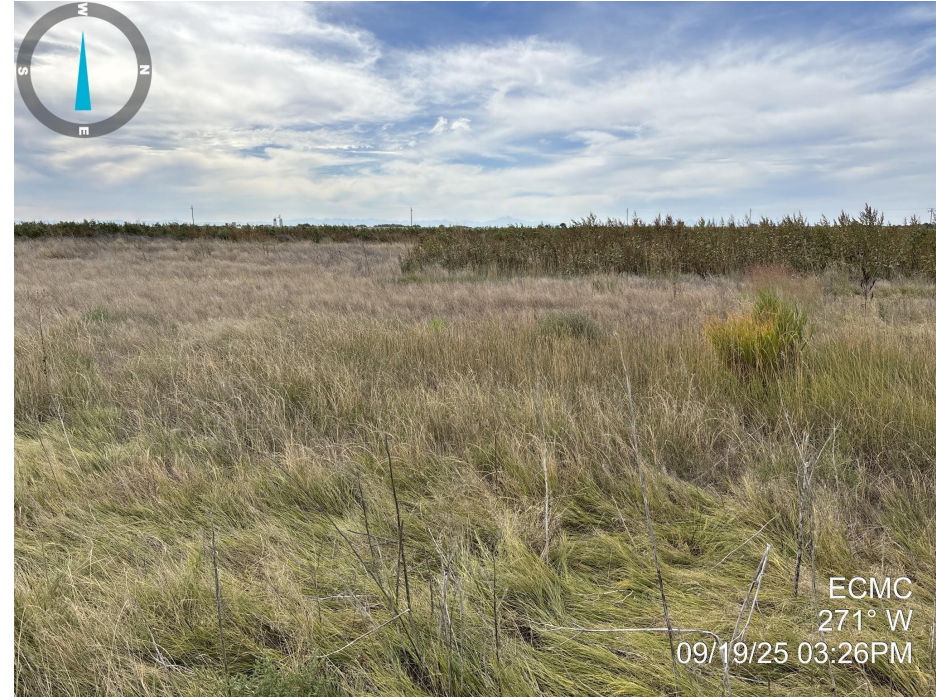
Photo 4. Photo taken of the well location, facing west. See comments under Photo 1.

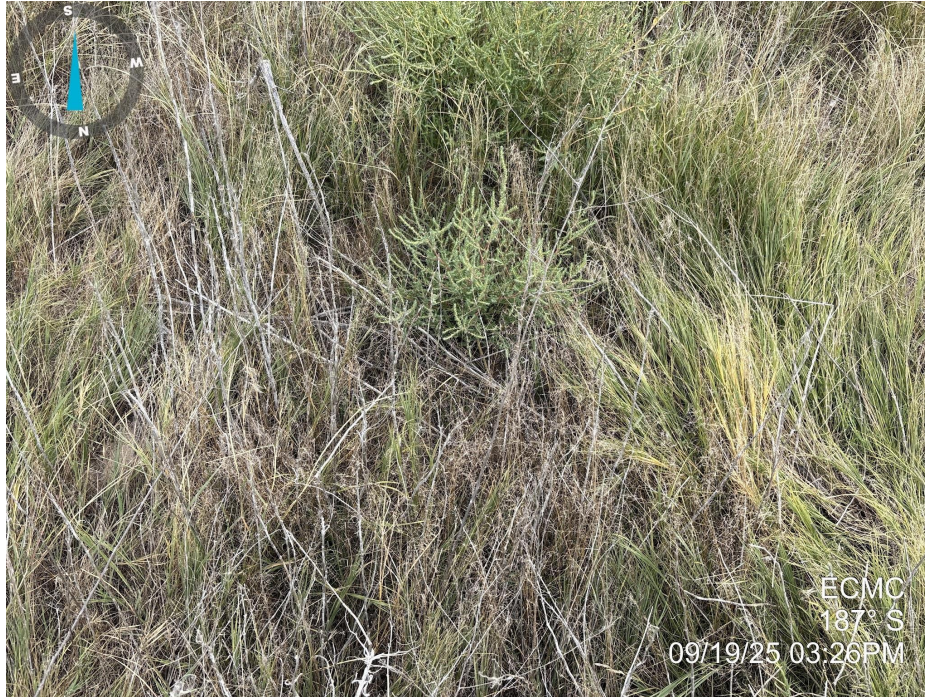
Photo 5. Photo taken ground cover at the well location, facing south. Photo illustrates weedy annual vegetation including cheatgrass (*Bromus tectorum*), a List C Noxious Weed species, and kochia (*Bassia scoparia*).

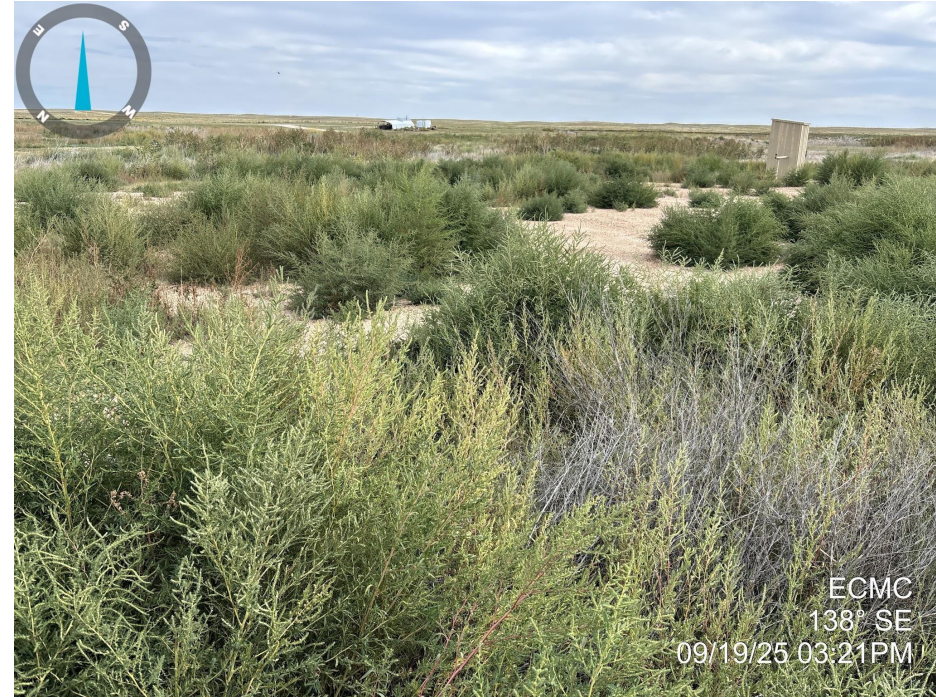
Photo 6. Photo taken of the tank battery location, facing southeast. Photo illustrates that final reclamation activities do not appear to have taken place as bare ground, gravel, and weedy annual vegetation were observed across the location. Midstream equipment also remains at the location, see Photo 8.

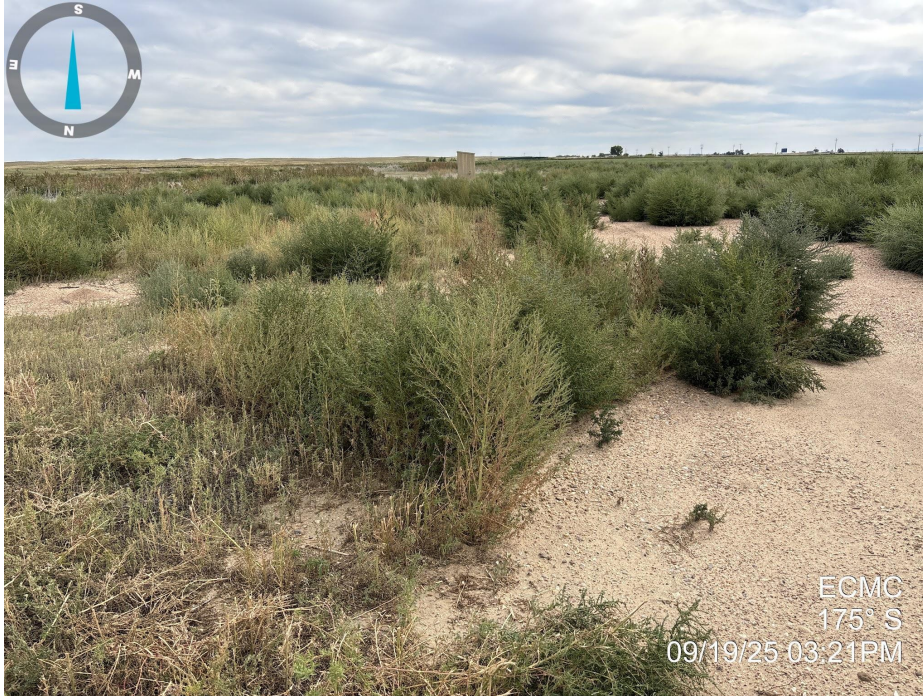
Photo 7. Photo taken of the tank battery location, facing south. See comments under Photo 6.

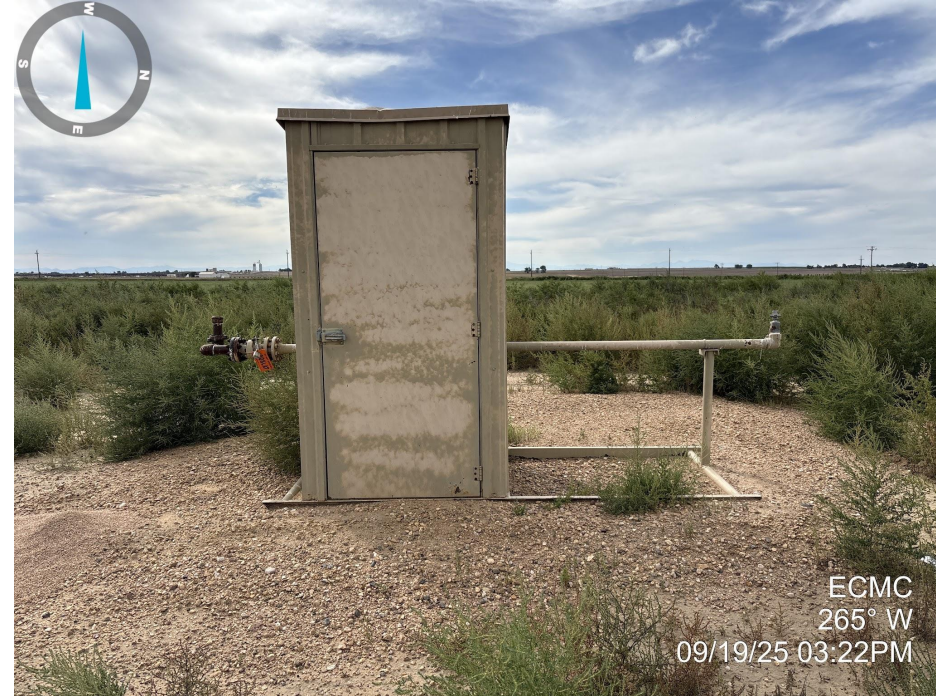
Photo 8. Photo taken of the tank battery location, facing west. Photo illustrates that a meter house remains at the location.

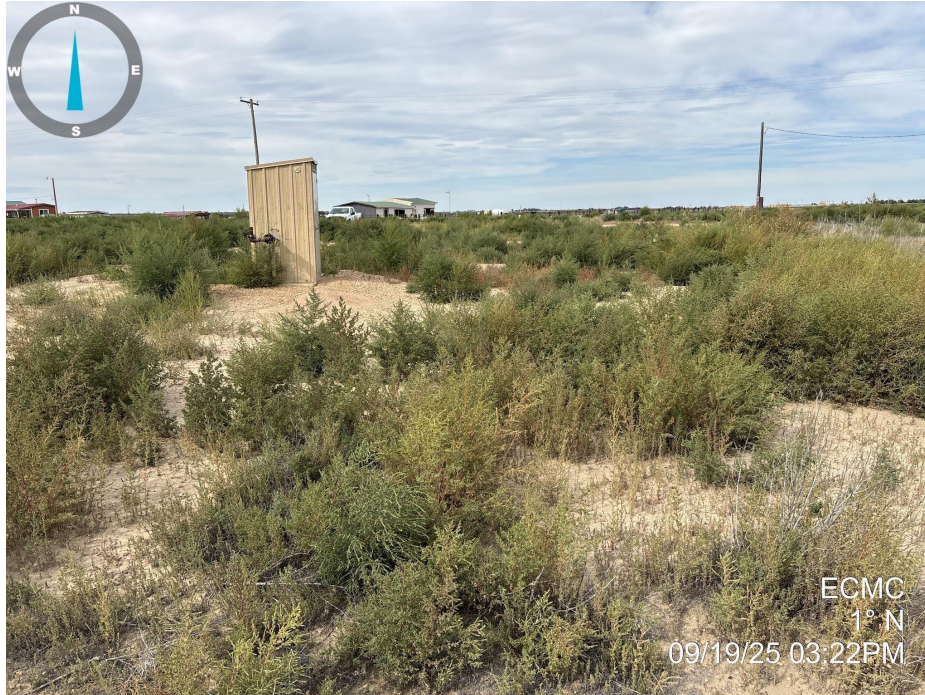
Photo 9. Photo taken of the tank battery location, facing north. See comments under Photo 6.

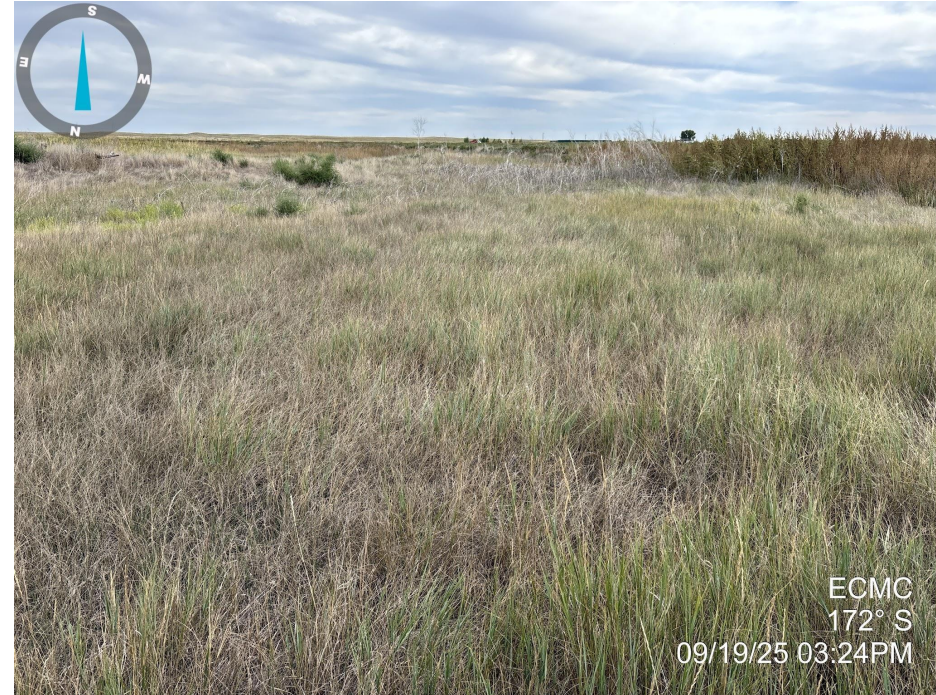
Photo 10. Photo taken of the reference area, south of the location, facing south. Photo illustrates perennial grass and weedy annual vegetation.
