Inspection Photos

Operator: QB Energy Operating LLC #10844

Location ID: 335444

Inspection Doc: 719200300

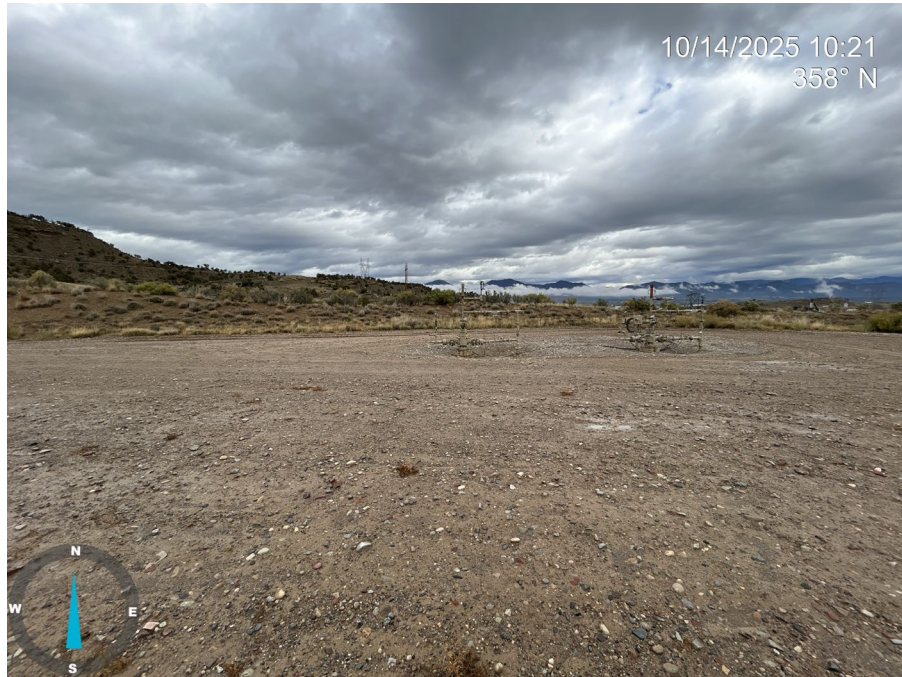
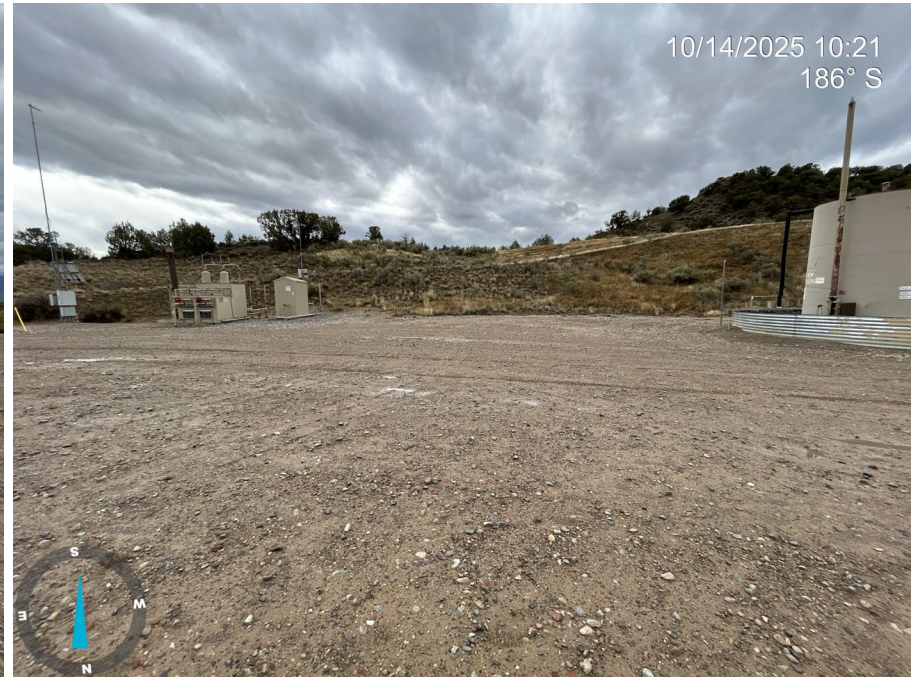
Photo 1: Photos showing an overview of the location looking north and south, respectively.

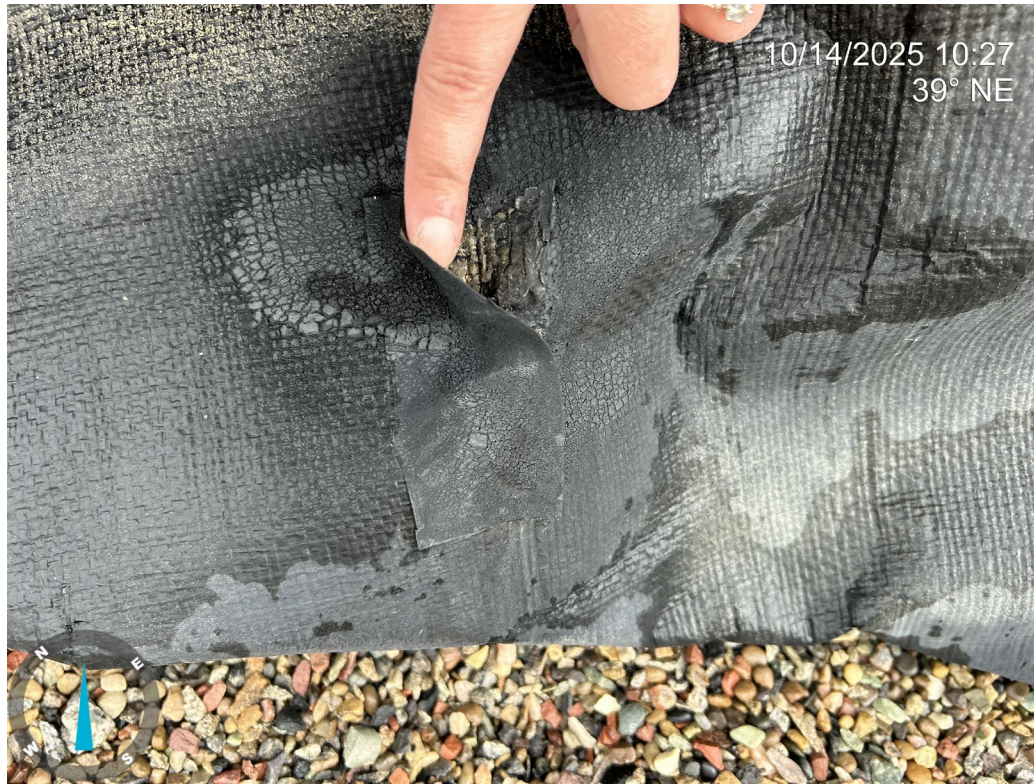
Photo 3: Photo showing an example of patches on secondary containment liner that are weathered and appear to be insufficient to contain a spill or release. Comply with Rule 603.o.

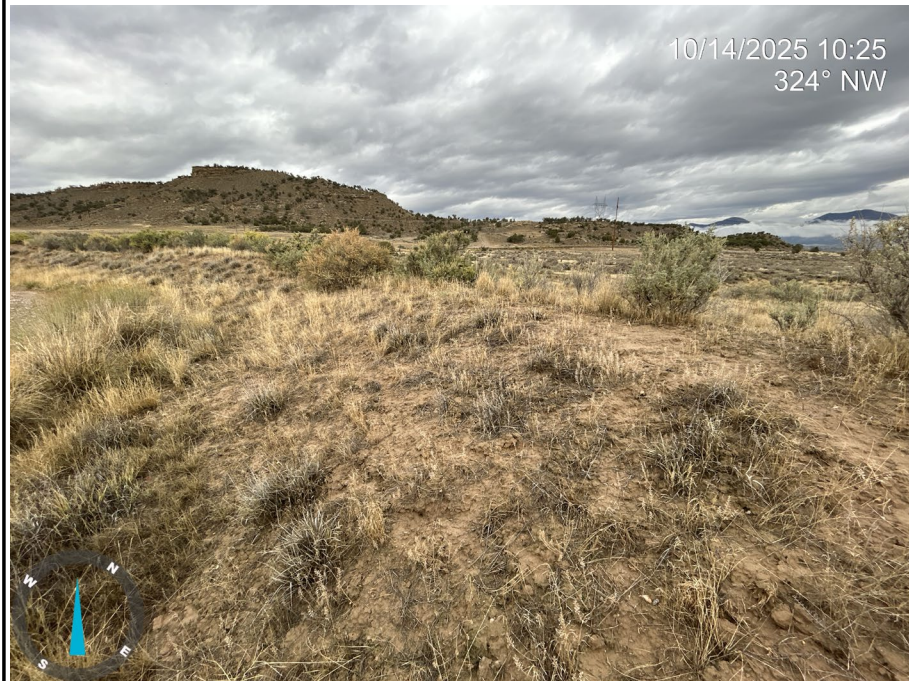
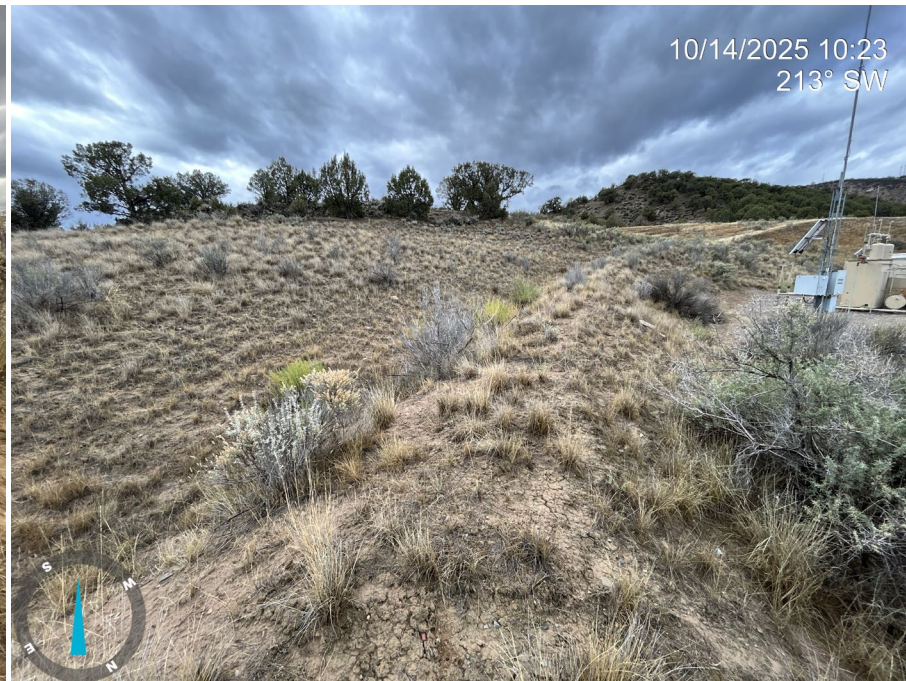
Photo 4: Photos showing an overview of the northern and southern interim areas, respectively. Interim areas are composed of fourwing saltbush, western, crested and intermediate wheatgrass, rubber rabbitbrush and trace amounts of alkali sacaton. Interim areas are In Process.
