WELL NAME: NEW ELK 25-14, API #: 071-09537, INSP. # 716301654

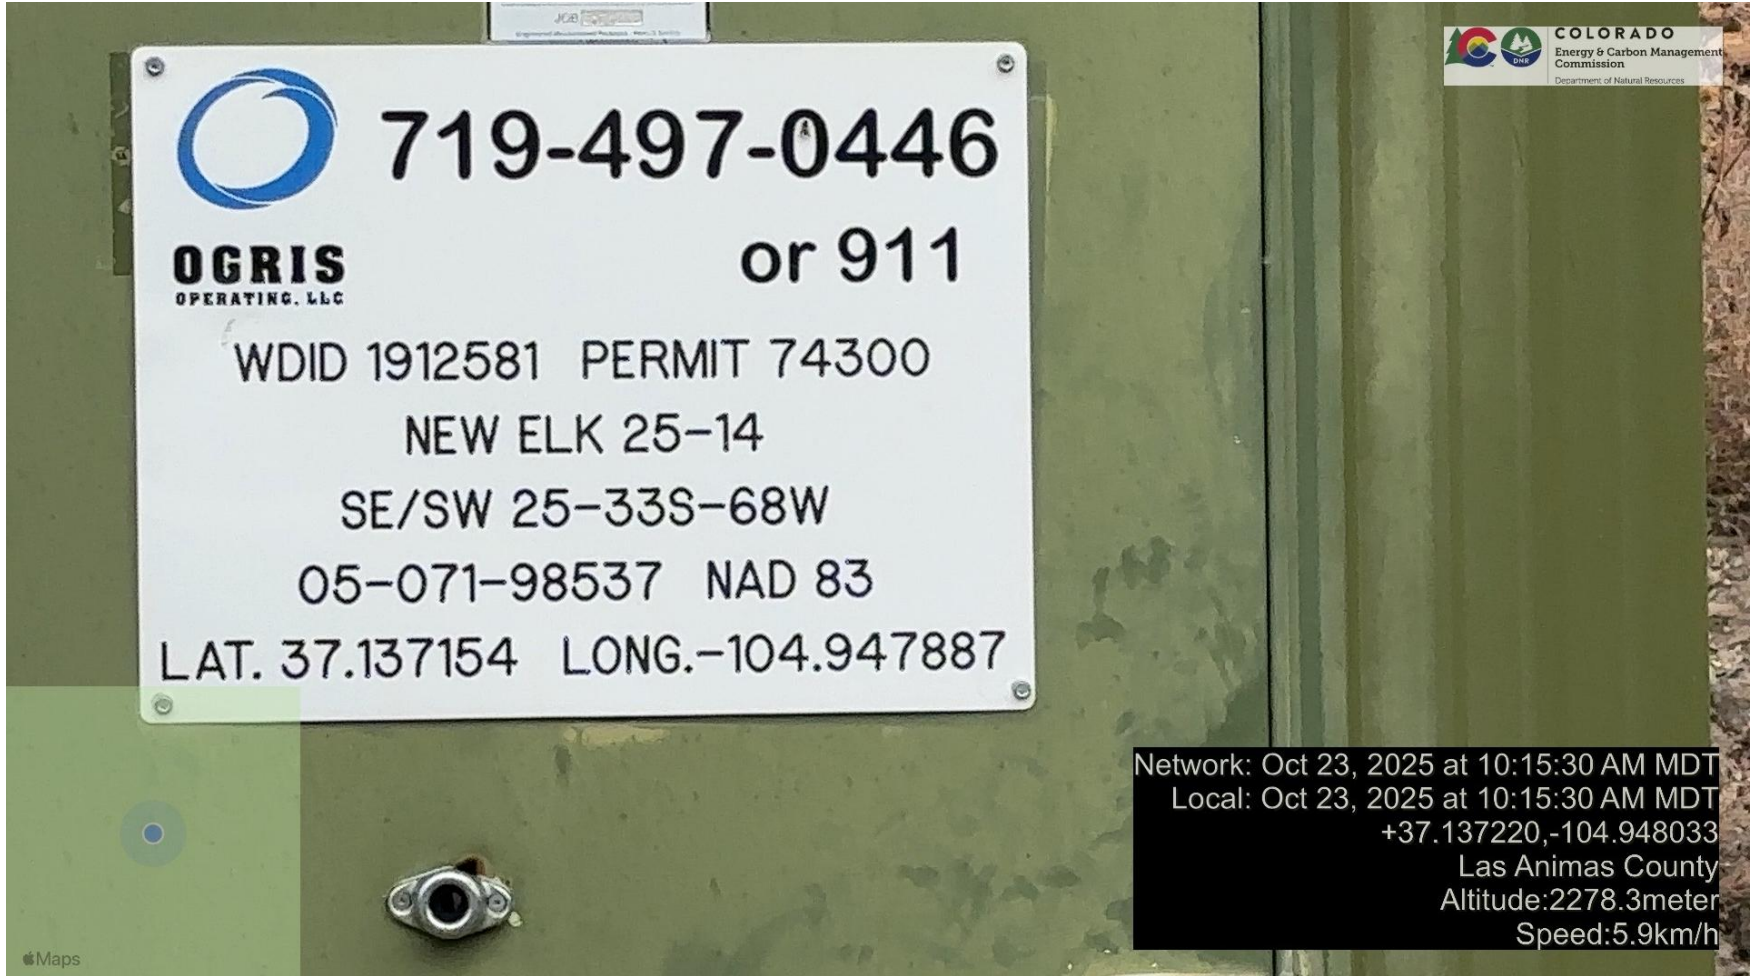
PHOTO 1: API # ON POSTED WELL SIGN IS INACCURATE. **POST SIGN PER RULE 605. CA DATE 11-23-2025.**

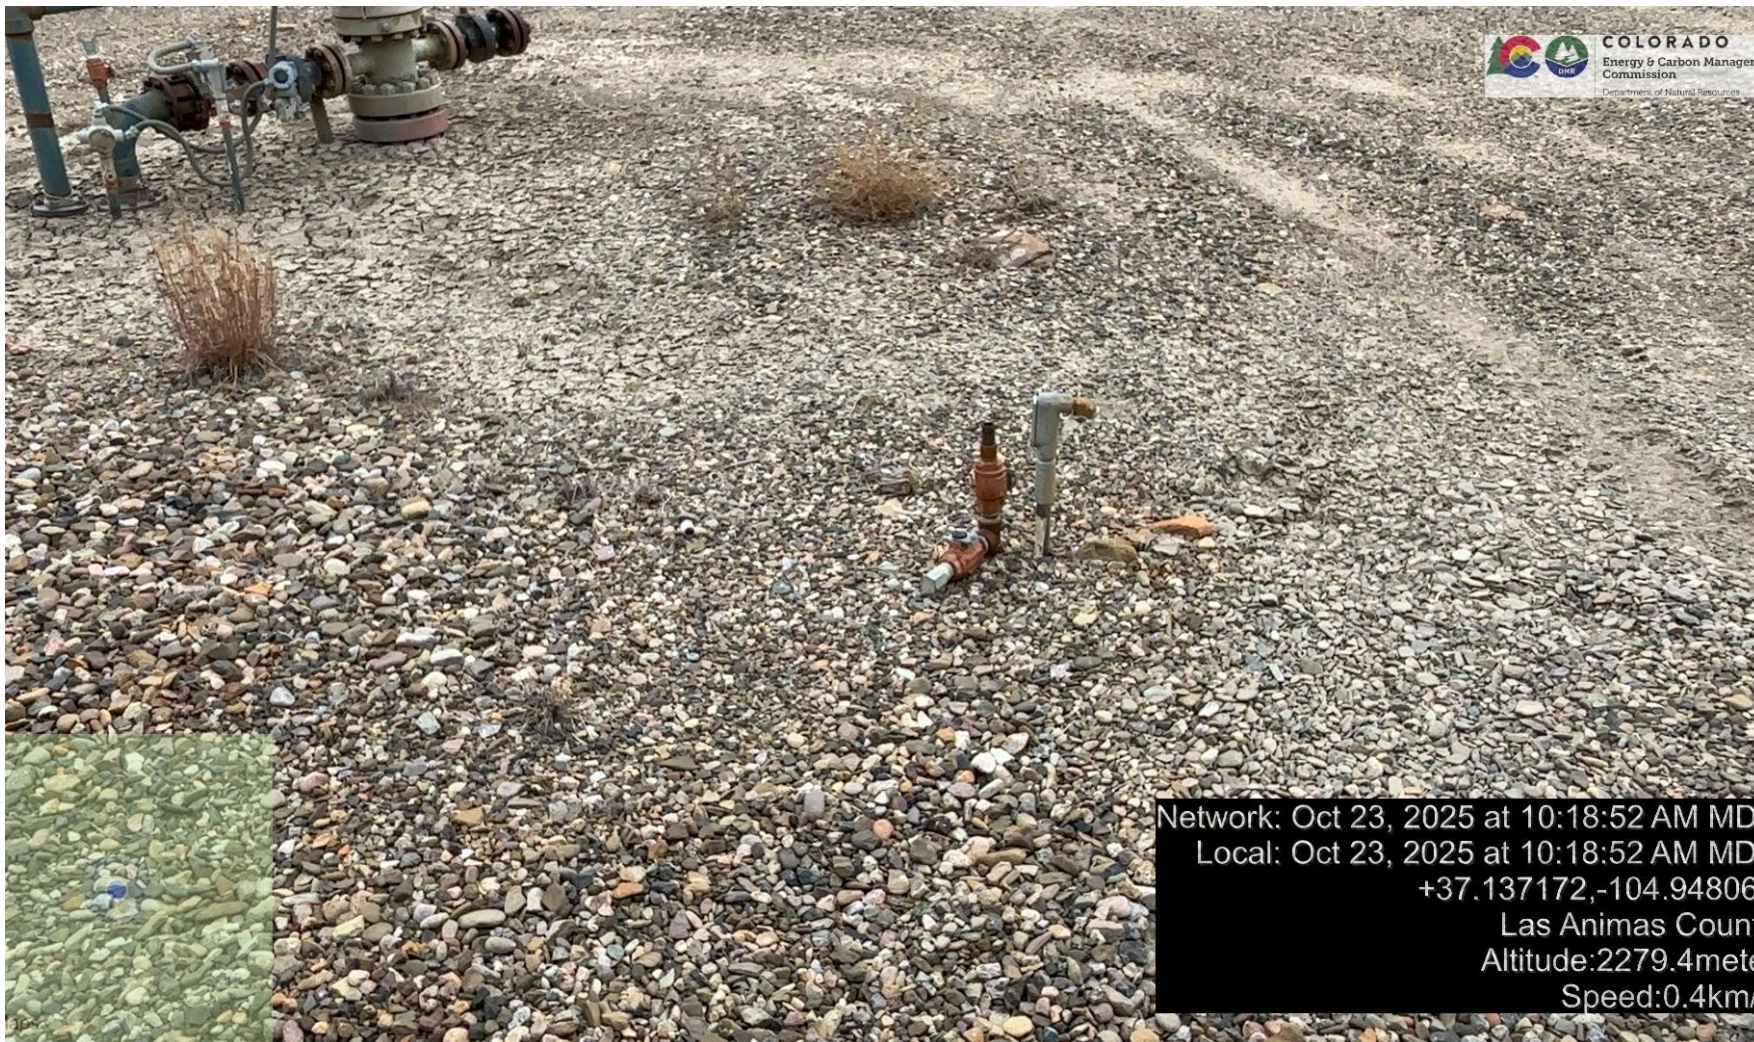
**PHOTO 3: UNUSED EQUIPMENT (1" RISER). REMOVE OR MARK RISER PER RULE 606. CA DATE 11-23-2025.**

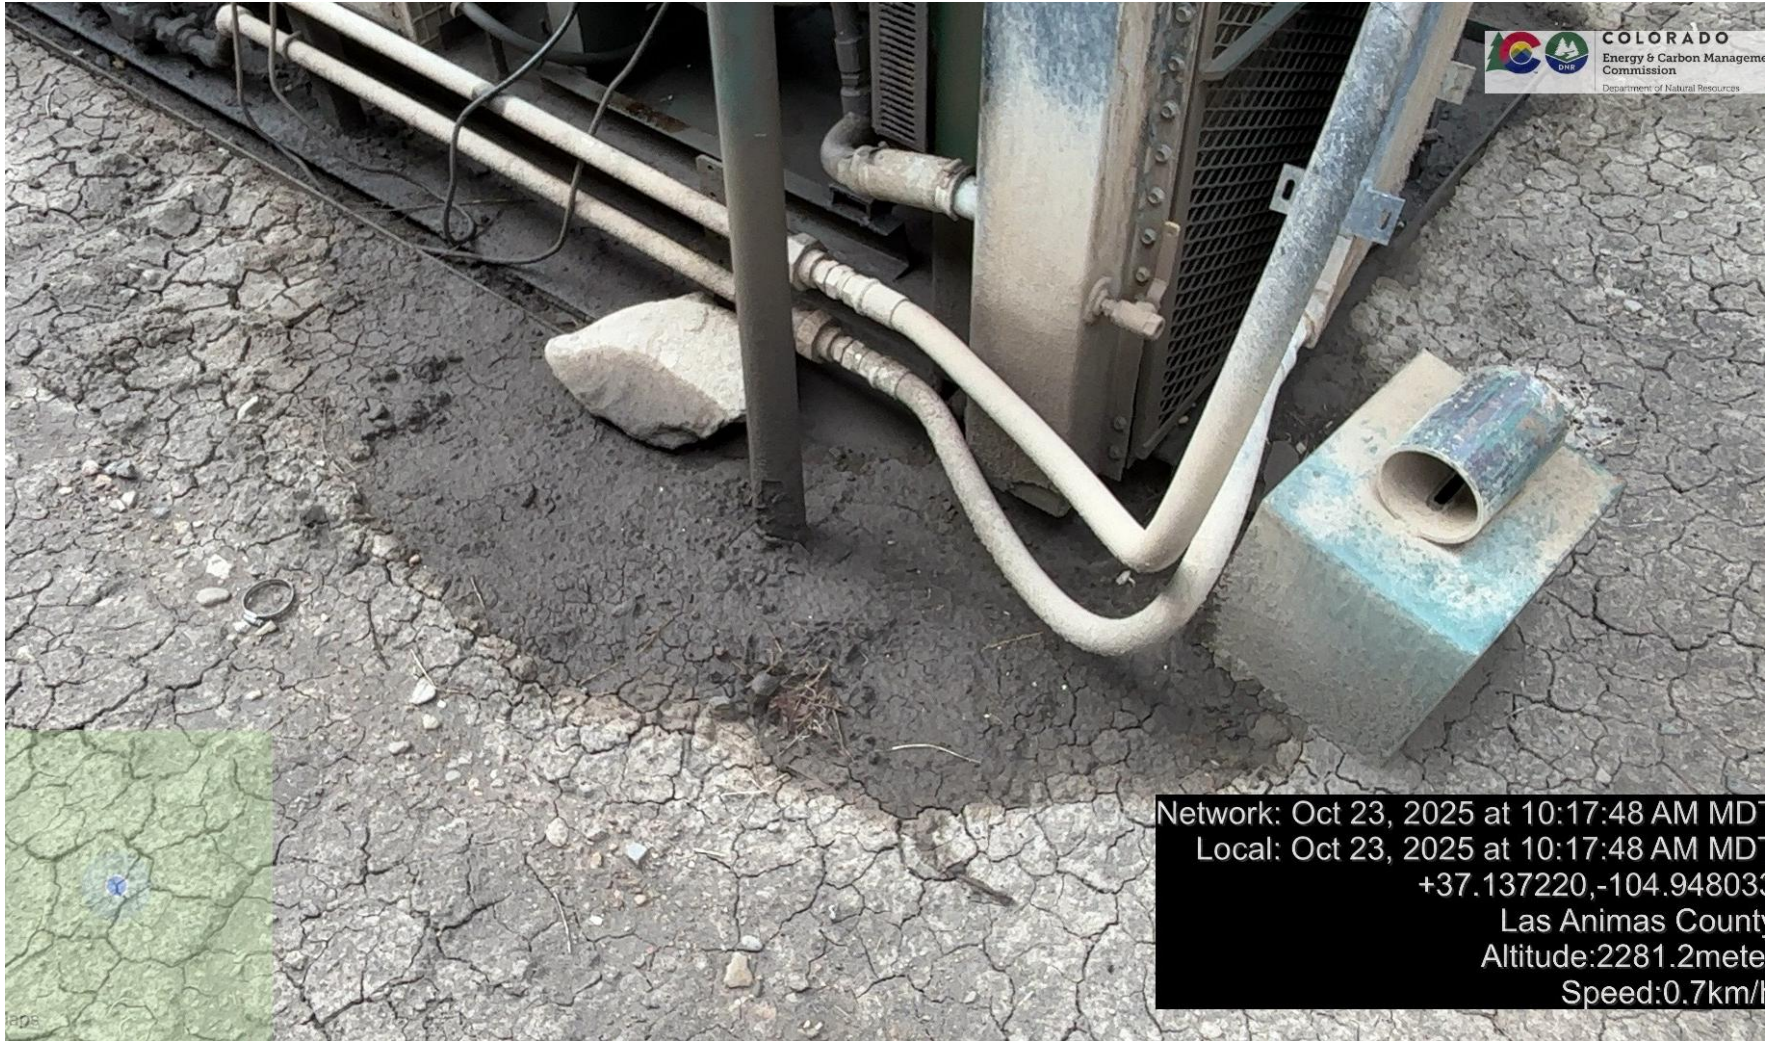
**PHOTO 4: THERE IS AN AREA OF IMPACTED SOIL NEAR COMPRESSOR SKID. Conduct maintenance on equipment, cleanup stained material and review self inspection processes COMPLY WITH RULE 1002.(2).D. THIS IS THE SECOND NOTICE FOR THIS CA IMMEDIATE ACTION IS REQUIRED.**

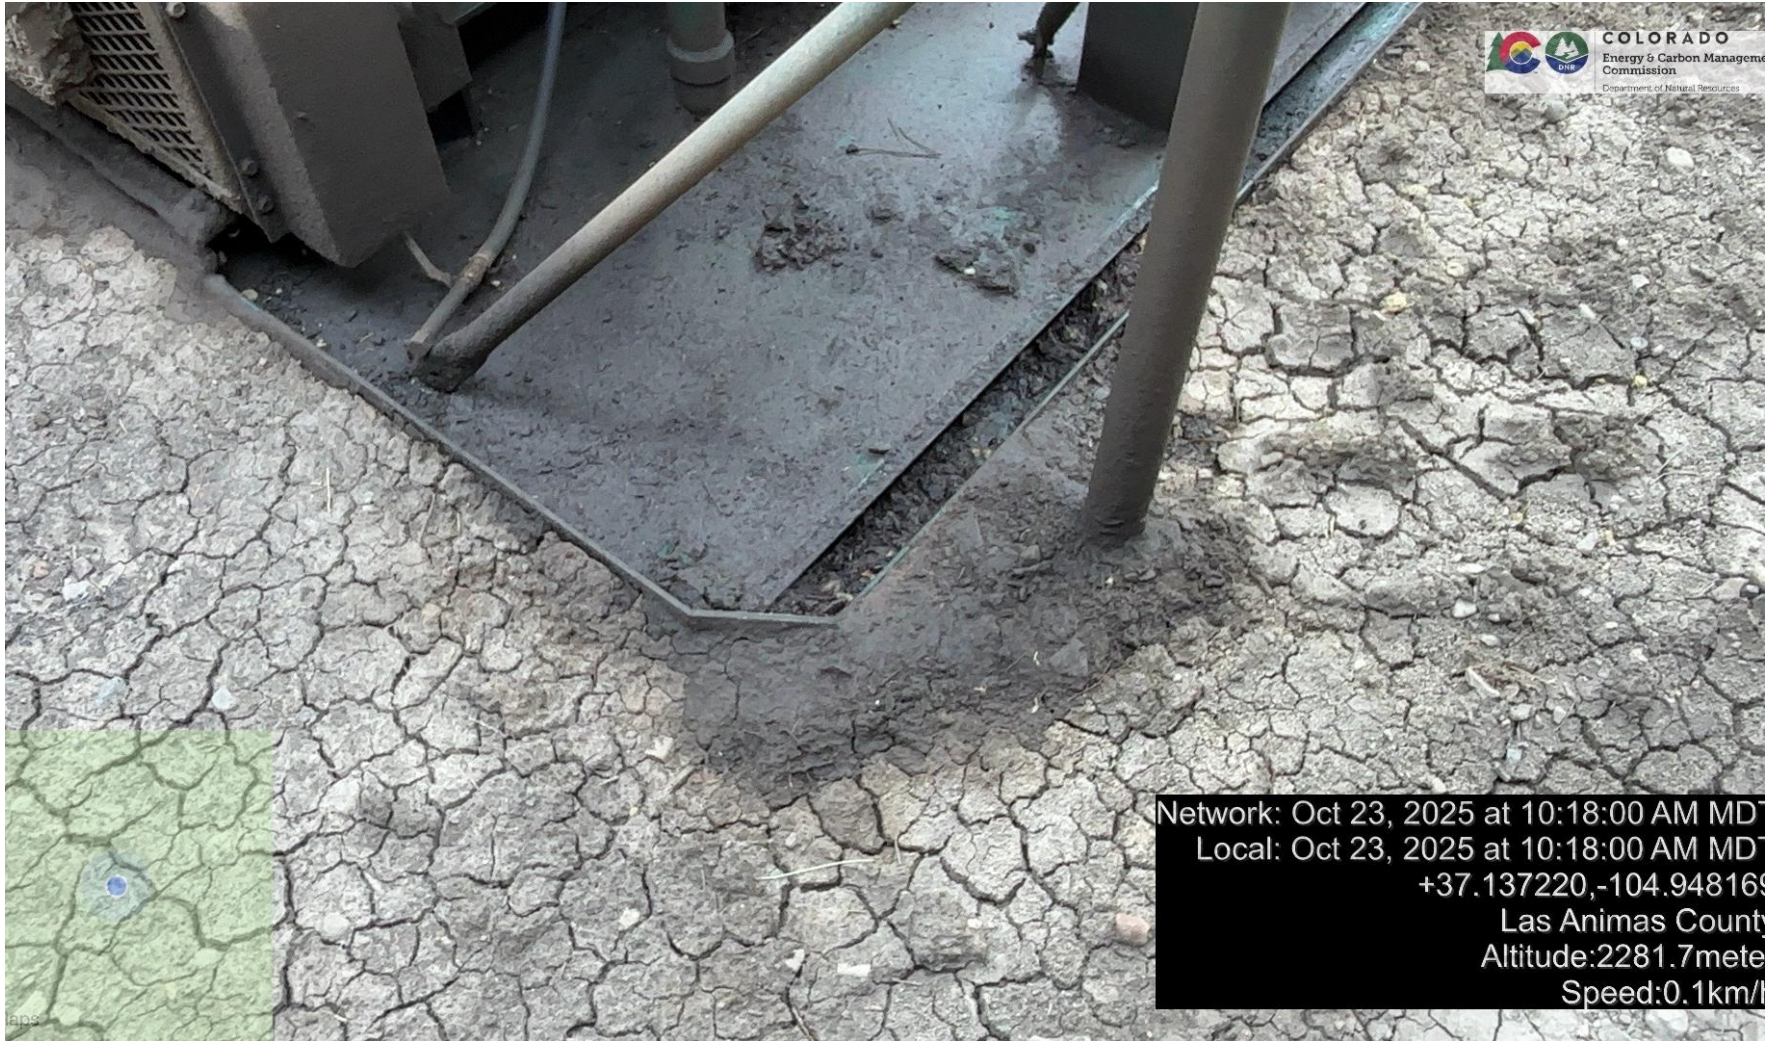
**PHOTO 5: THERE IS AN AREA OF IMPACTED SOIL NEAR COMPRESSOR SKID. Conduct maintenance on equipment, cleanup stained material and review self inspection processes COMPLY WITH RULE 1002.(2).D. THIS IS THE SECOND NOTICE FOR THIS CA IMMEDIATE ACTION IS REQUIRED.**

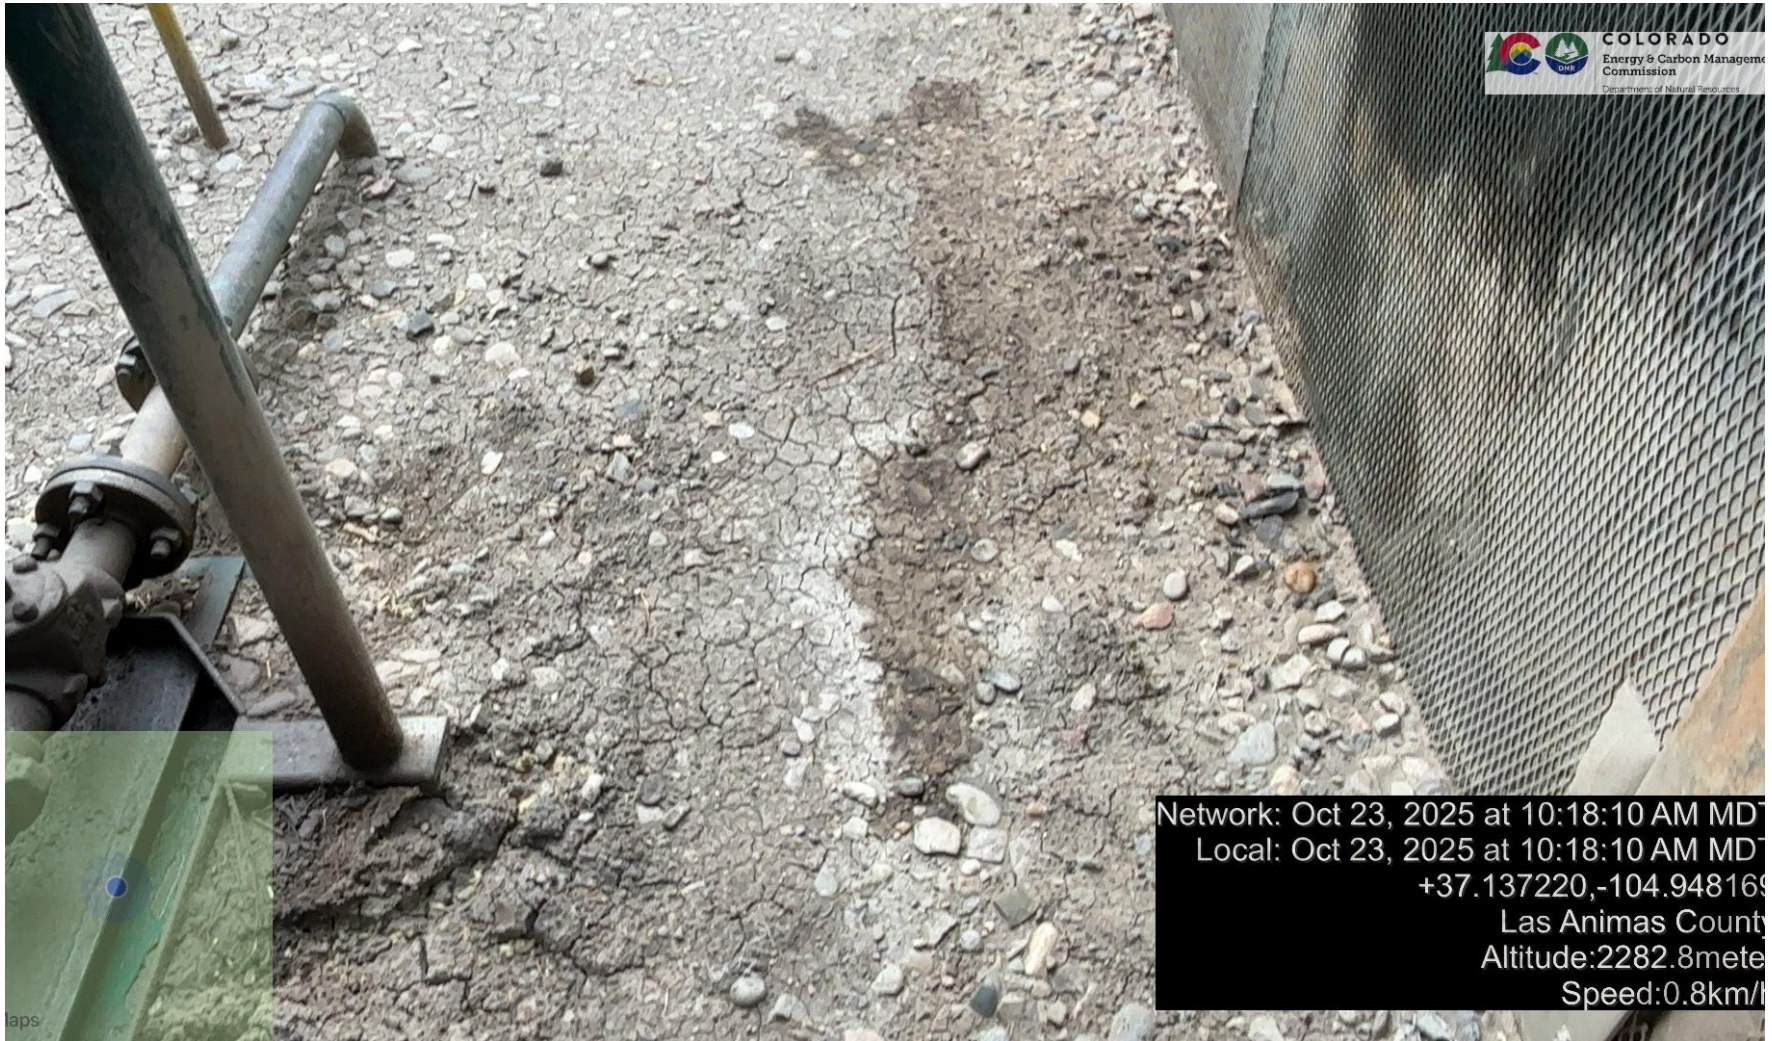
**PHOTO 6: THERE IS AN AREA OF IMPACTED SOIL NEAR COMPRESSOR SKID. Conduct maintenance on equipment, cleanup stained material and review self inspection processes COMPLY WITH RULE 1002.(2).D. THIS IS THE SECOND NOTICE FOR THIS CA IMMEDIATE ACTION IS REQUIRED.**

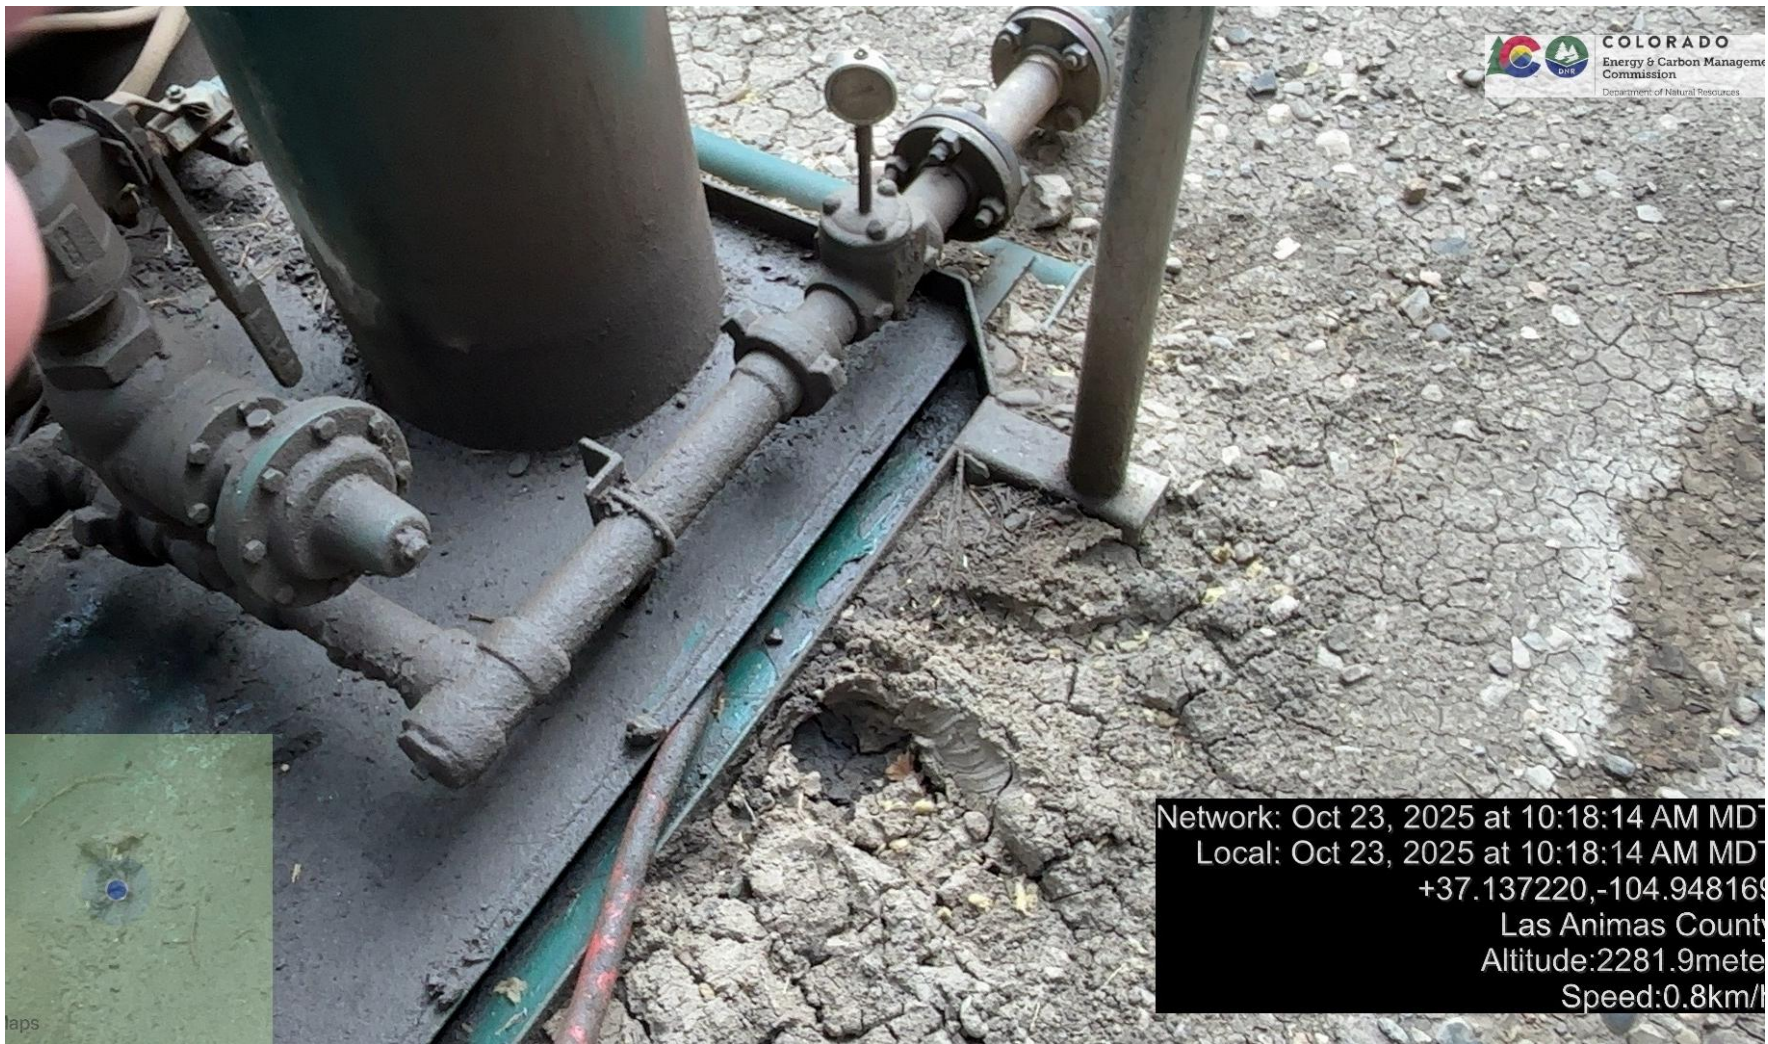
**PHOTO 7: THERE IS AN AREA OF IMPACTED SOIL NEAR COMPRESSOR SKID. Conduct maintenance on equipment, cleanup stained material and review self inspection processes COMPLY WITH RULE 1002.(2).D. THIS IS THE SECOND NOTICE FOR THIS CA IMMEDIATE ACTION IS REQUIRED.**
