Inspection Photos

Operator: TEP Rocky Mountain LLC #96850

Location ID: 335175

Inspection Doc: 719200342

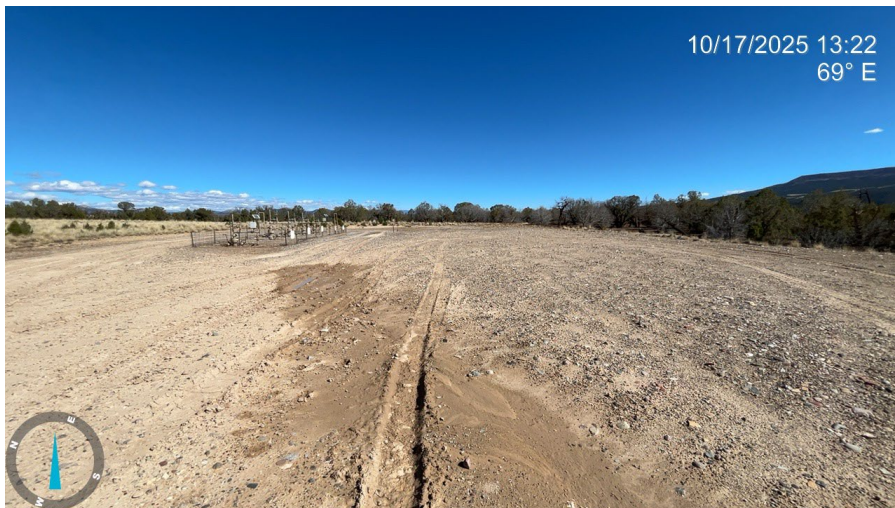
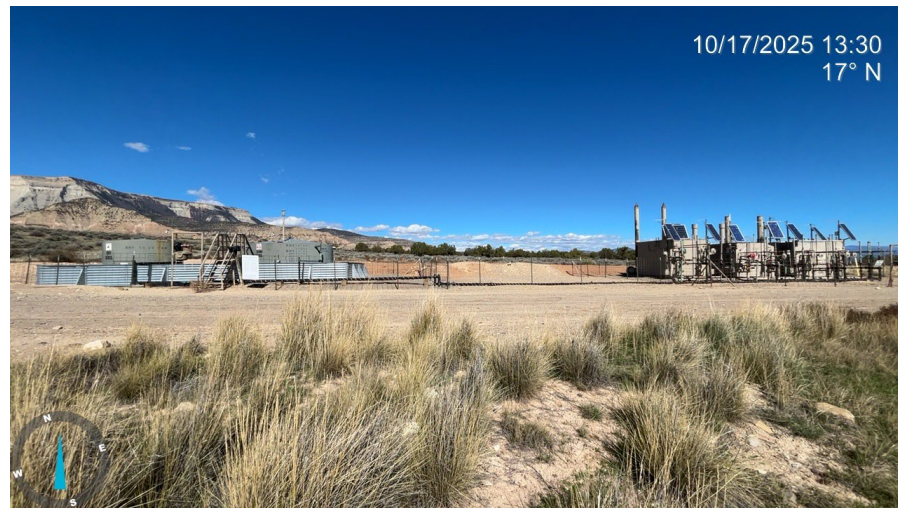
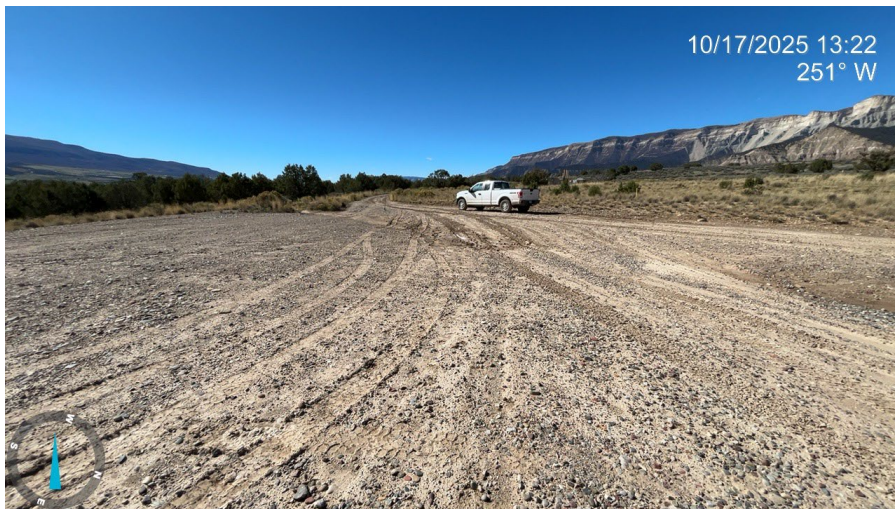
Photo 1: Photos showing an overview of the location looking east and west (left top and bottom, respectively) and the production equipment shared with location #335069 looking north (top right). Vehicle tracking on the working pad surface is evident and gravel is sparse in some areas. Comply with Rule 1002.f.

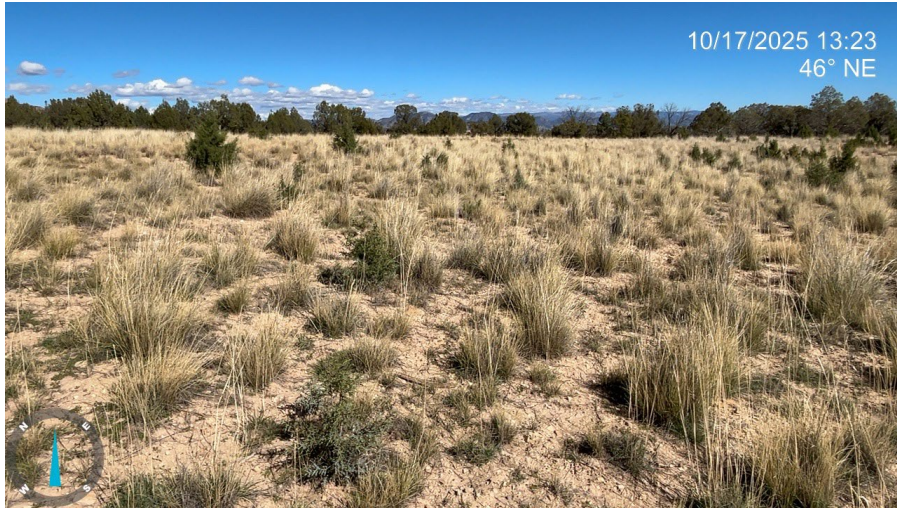
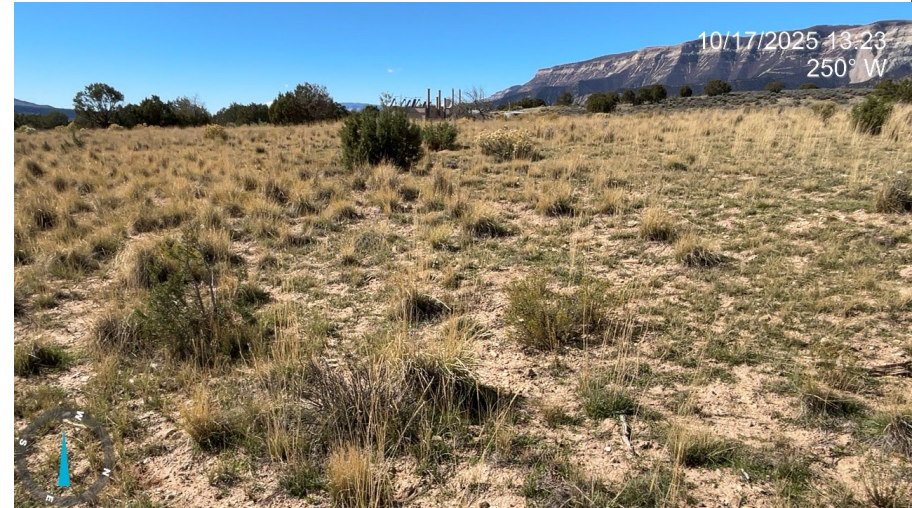
Photo 2: Photos showing an overview of the northeastern and northwestern interim areas, respectively. Interim areas are composed of Russian wildrye and intermediate wheatgrass, with secondary to trace amounts of broom snakeweed and Utah juniper. Desirable, perennial and uniform plant establishment is evident. Interim areas are progressing towards 1003 reclamation requirements.
