PDC Energy, Inc - 69175 - DJ Basin
Cornish 8-53
NESW, Section 8, Township 6 North, Range 63 West
Weld County, Colorado

**PDC Energy, Inc – 69175
 Cornish 8-53 Flowline**
 NWSW, Section 8, Township 6 North, Range 63 West
 Weld County, Colorado

TABLE 1
FIELD DATA SUMMARY TABLE
PDC ENERGY, INC. - 69175
CORNISH 8-53, WELD COUNTY, COLORADO
REM # 42201

FLOWLINE ABANDONMENT FORM

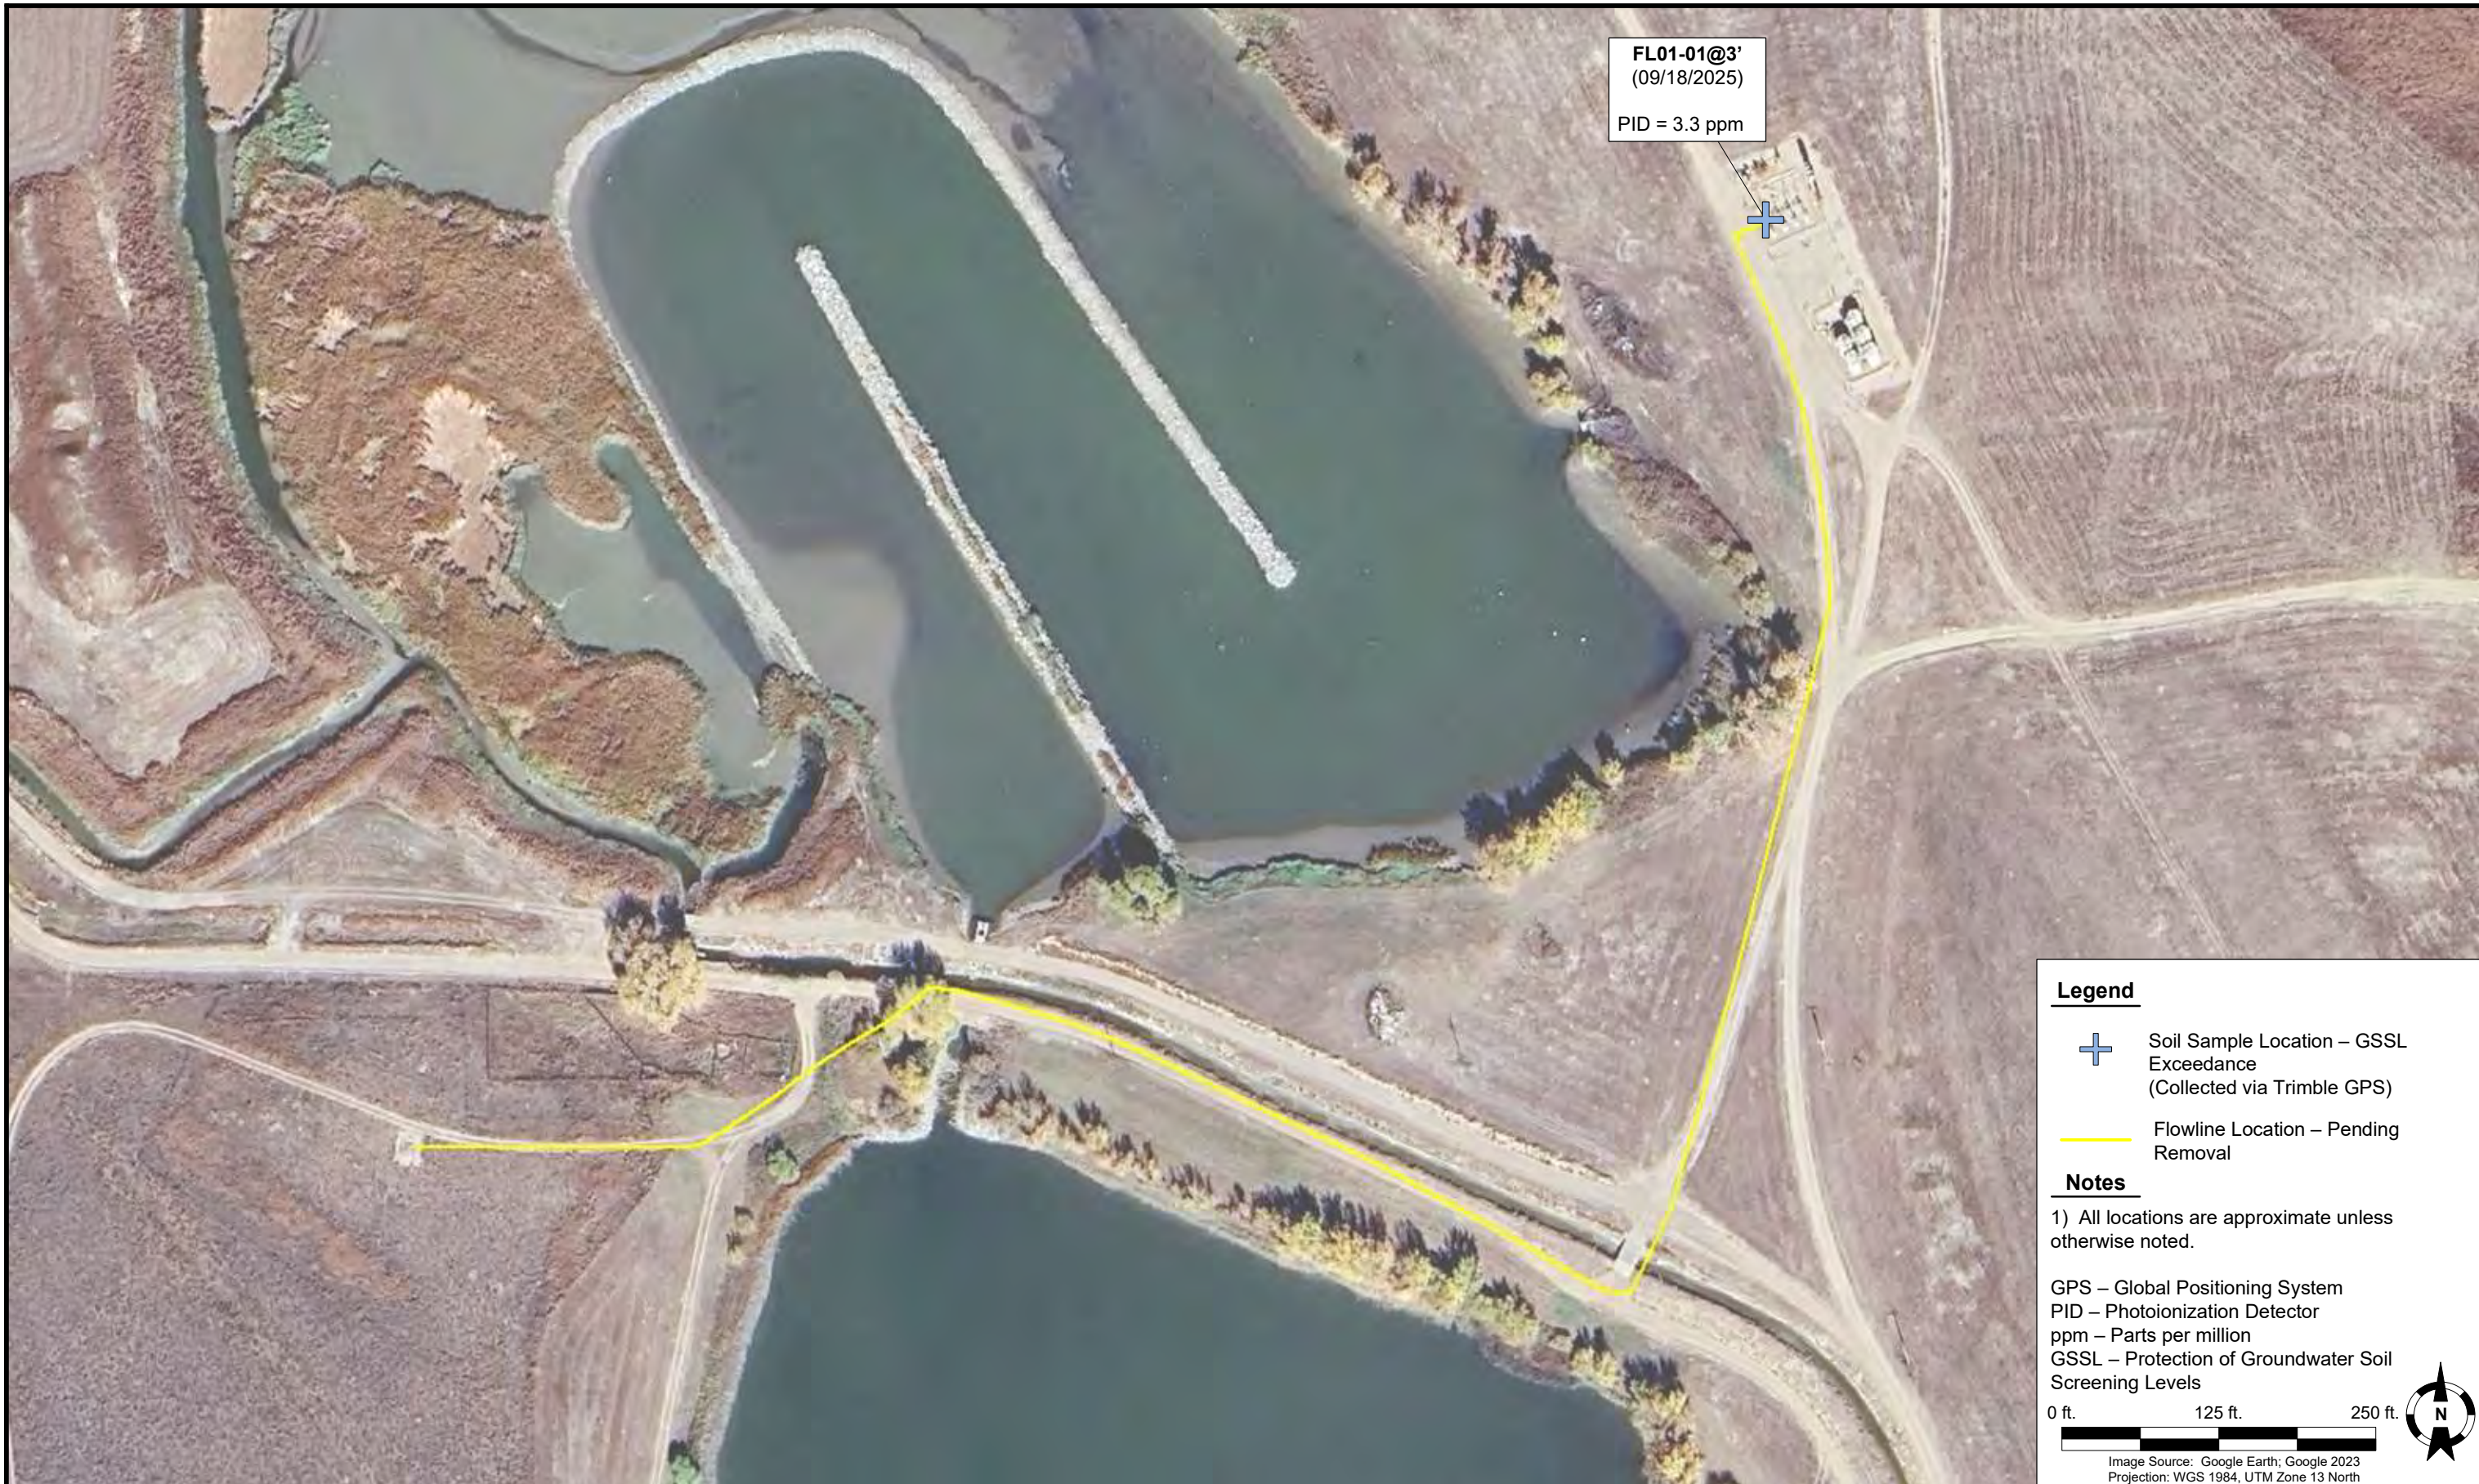
**FIGURE
 2**

FL01-01@3'
(09/18/2025)
PID = 3.3 ppm

**SOIL SAMPLE
 LOCATION MAP
 (FLOWLINE)**

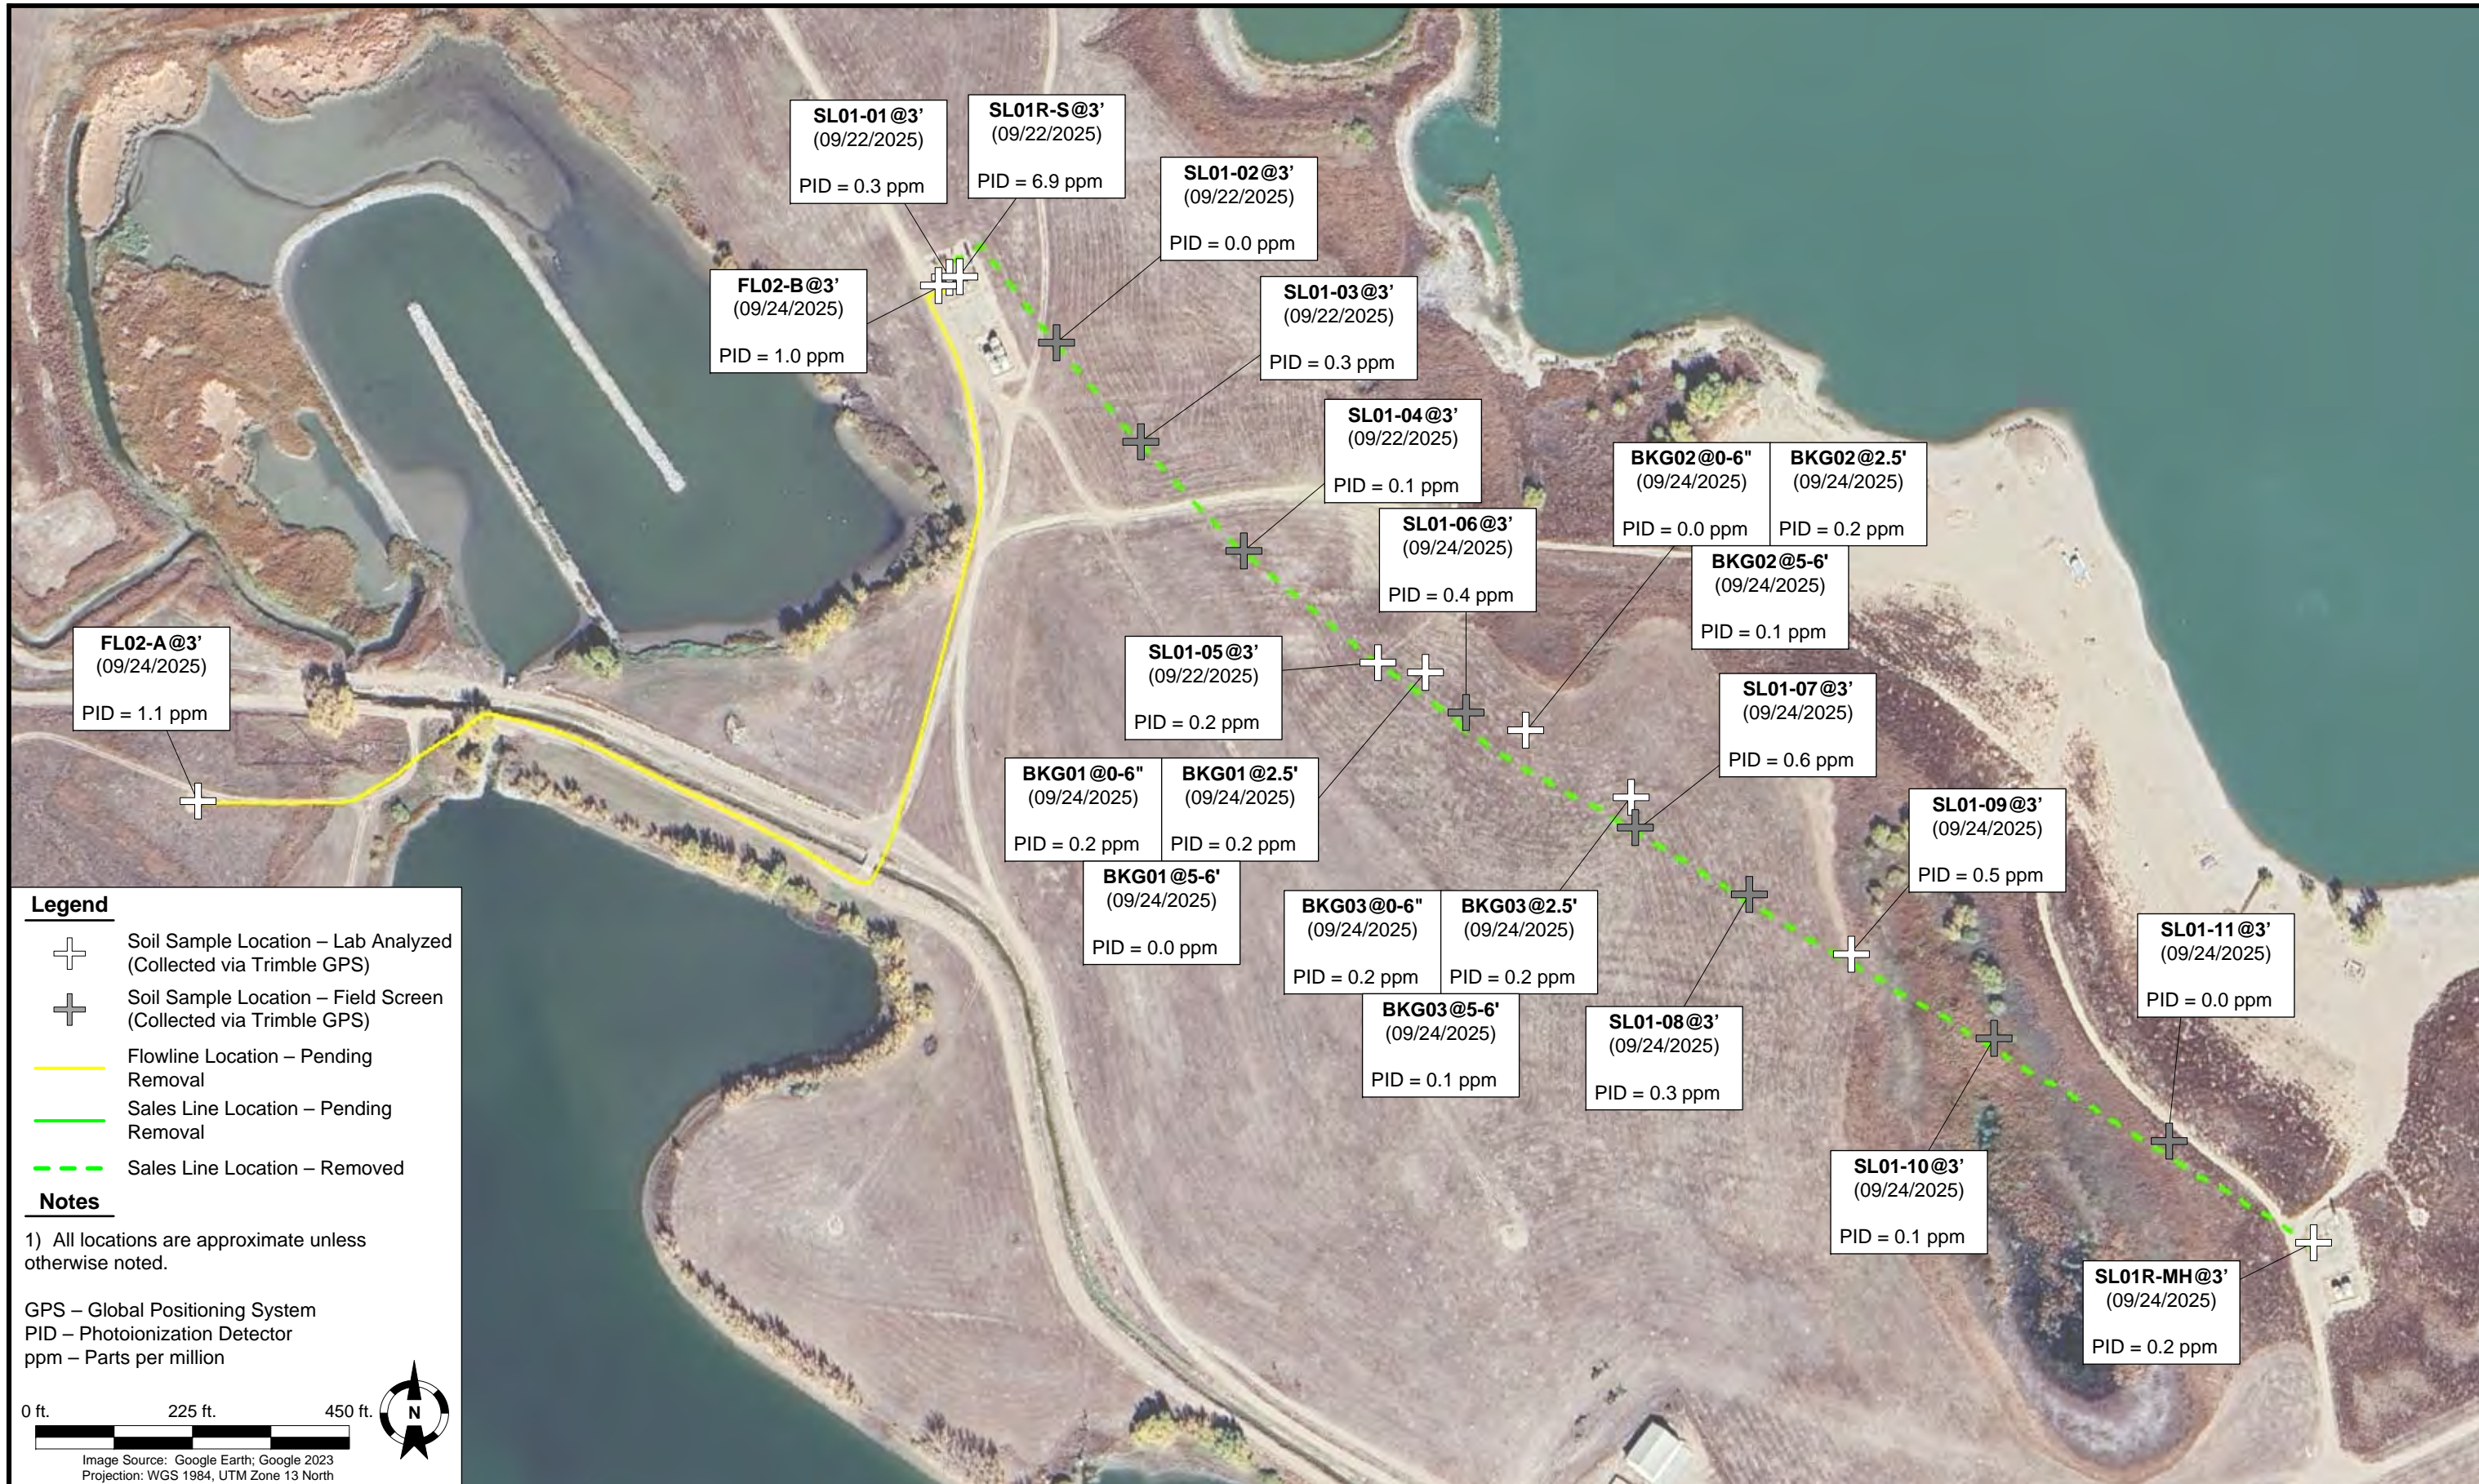
FIGURE
 3

SOIL SAMPLE
 LOCATION MAP
 (SALES LINE)

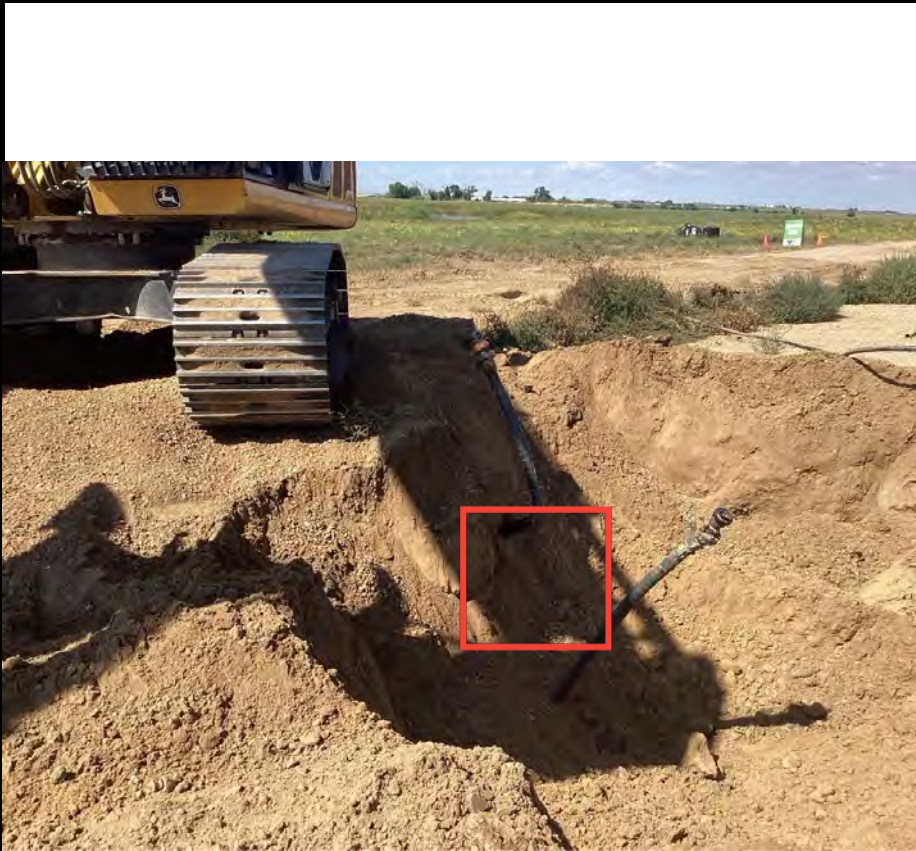
Equipment ID: FL01-01 @3'	Equipment Type: Flowline	
Material: Steel	Volume:	Contents: Crude Oil
Notes/Conditions: SW facing
