PDC Energy, Inc. – 69175
Cache 8-13, 24, 34; Cornish 8-53
 NESW, Section 8, Township 6 South, Range 63 West
 Weld County, Colorado

PDC Energy, Inc – 69175
Cache 8-13, 24, 34; Cornish 8-53 Tank Battery
 NESW, Section 8, Township 6 North, Range 63 West
 Weld County, Colorado

TANK BATTERY DECOMMISSIONING FORM

TANK BATTERY DECOMMISSIONING

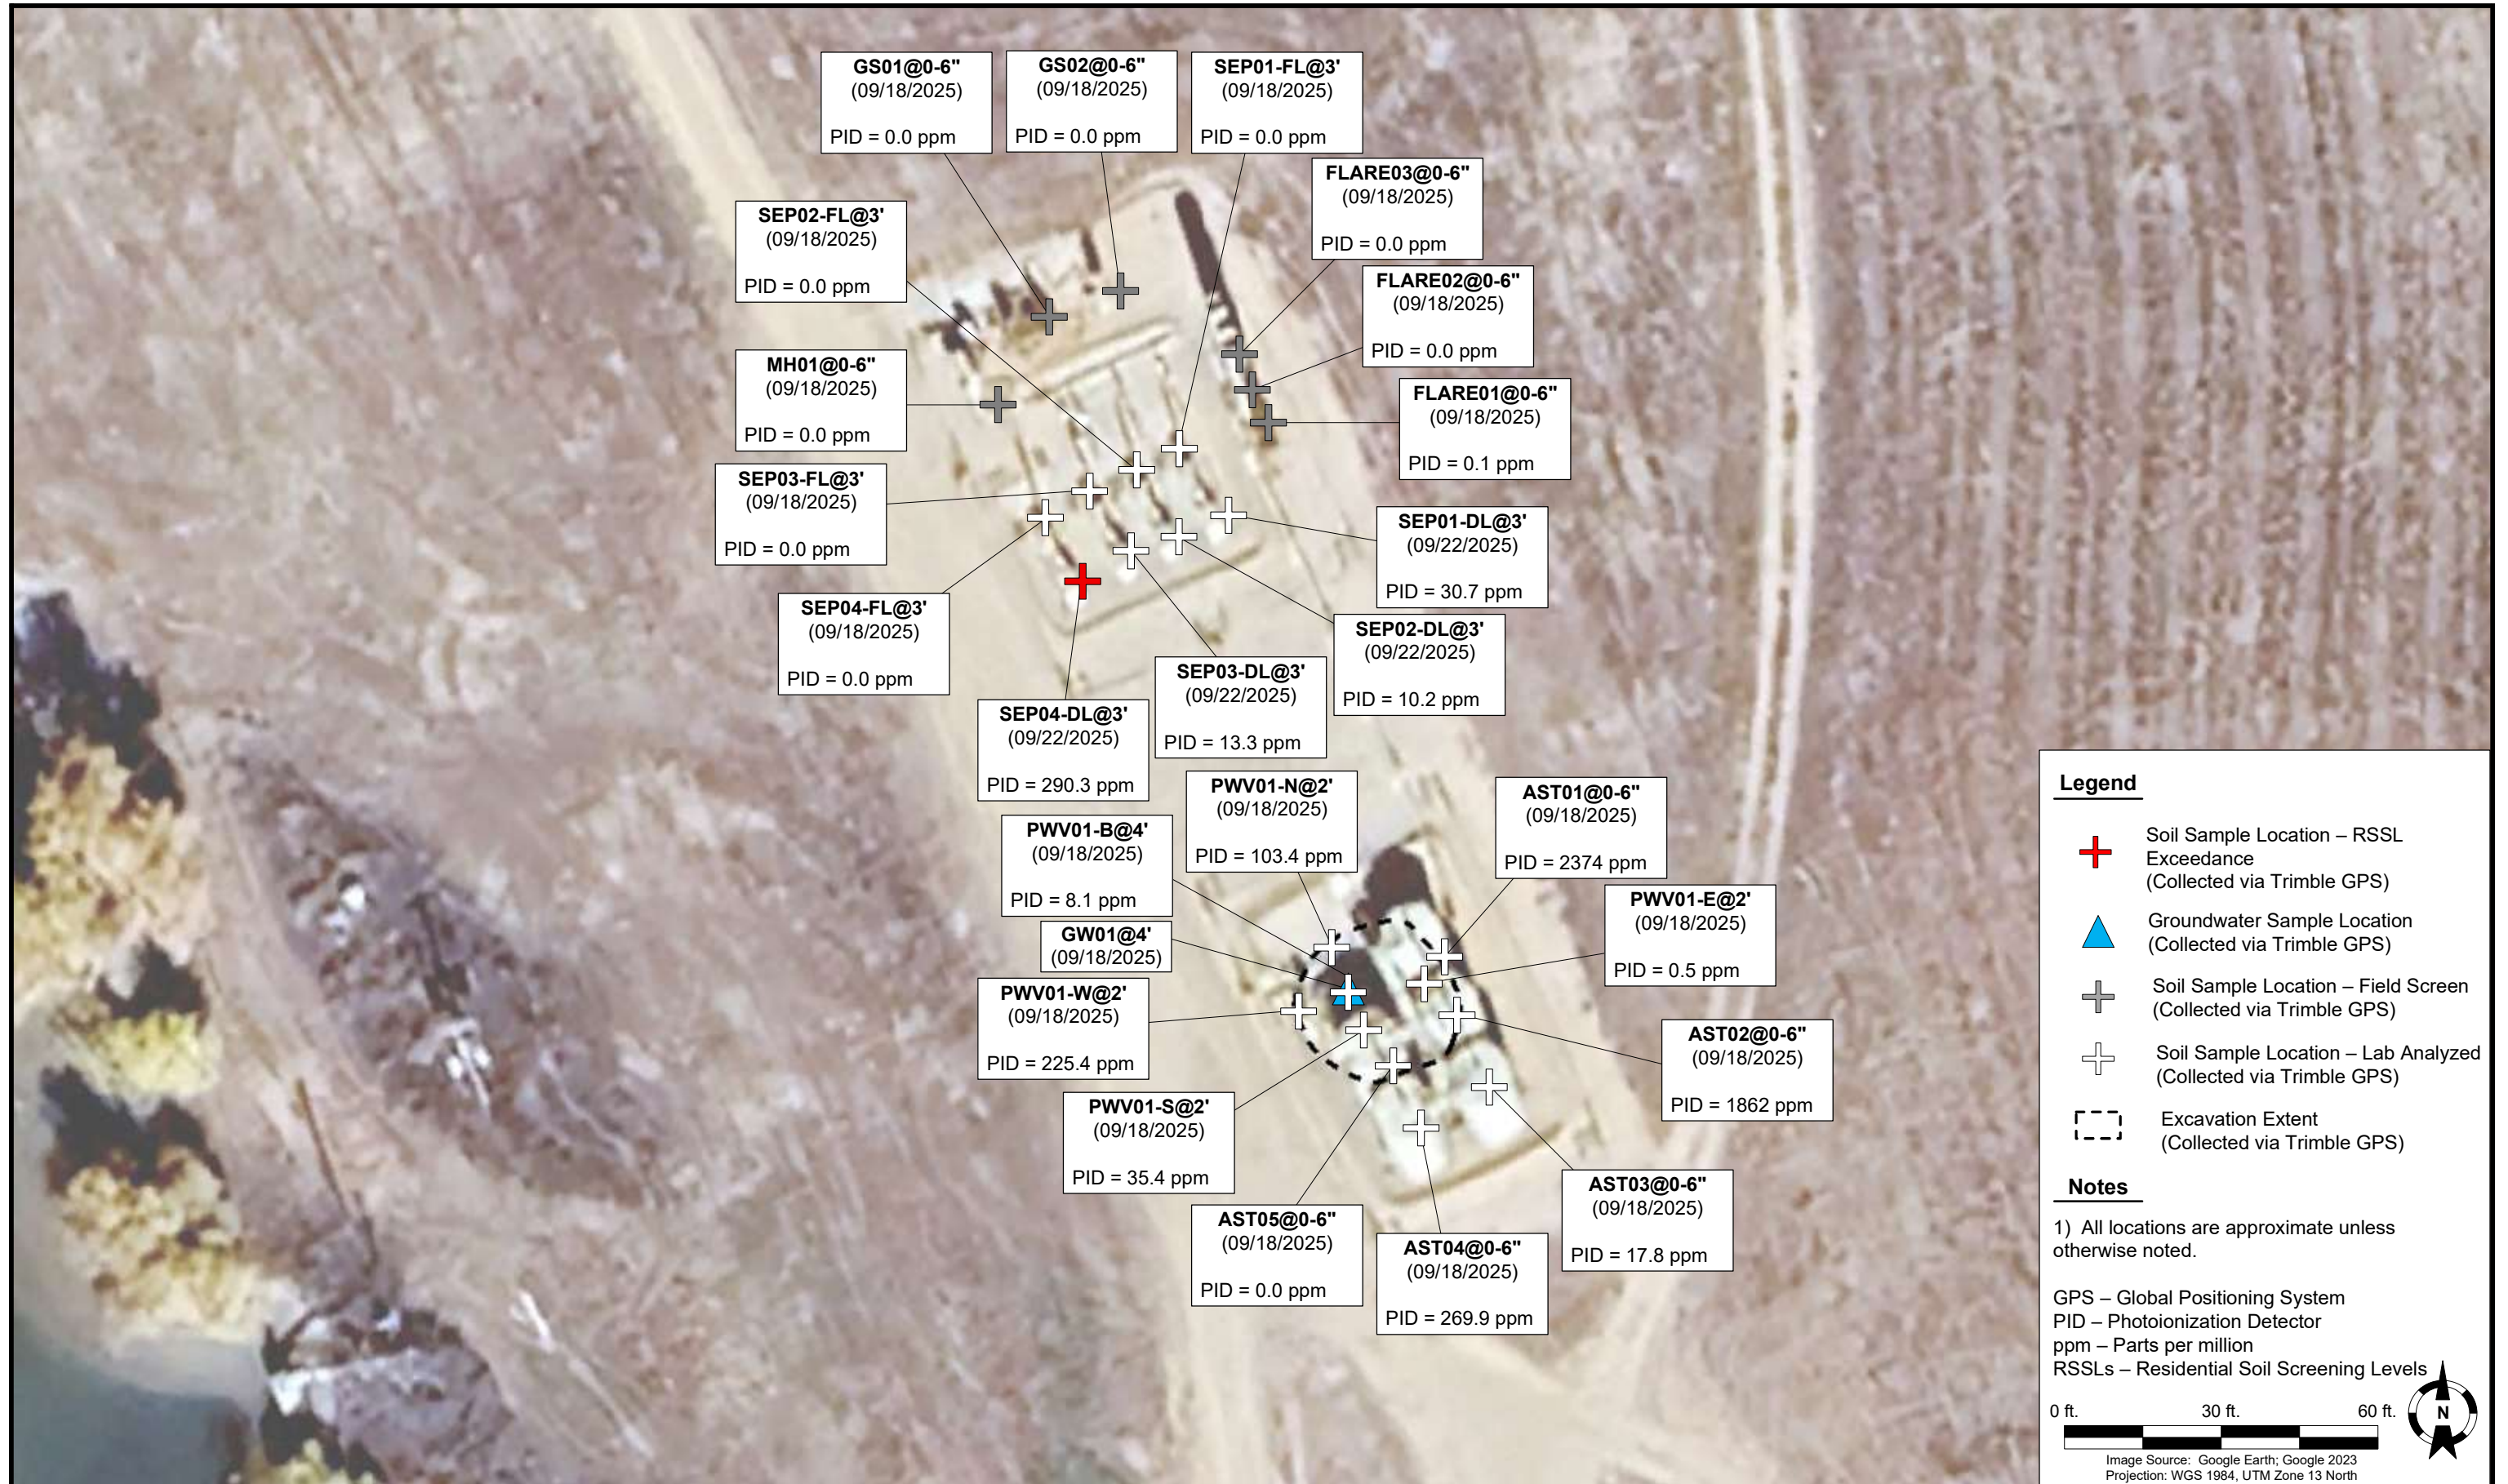
FIGURE
 2

SOIL SAMPLE
 LOCATION MAP
 (TANK BATTERY)

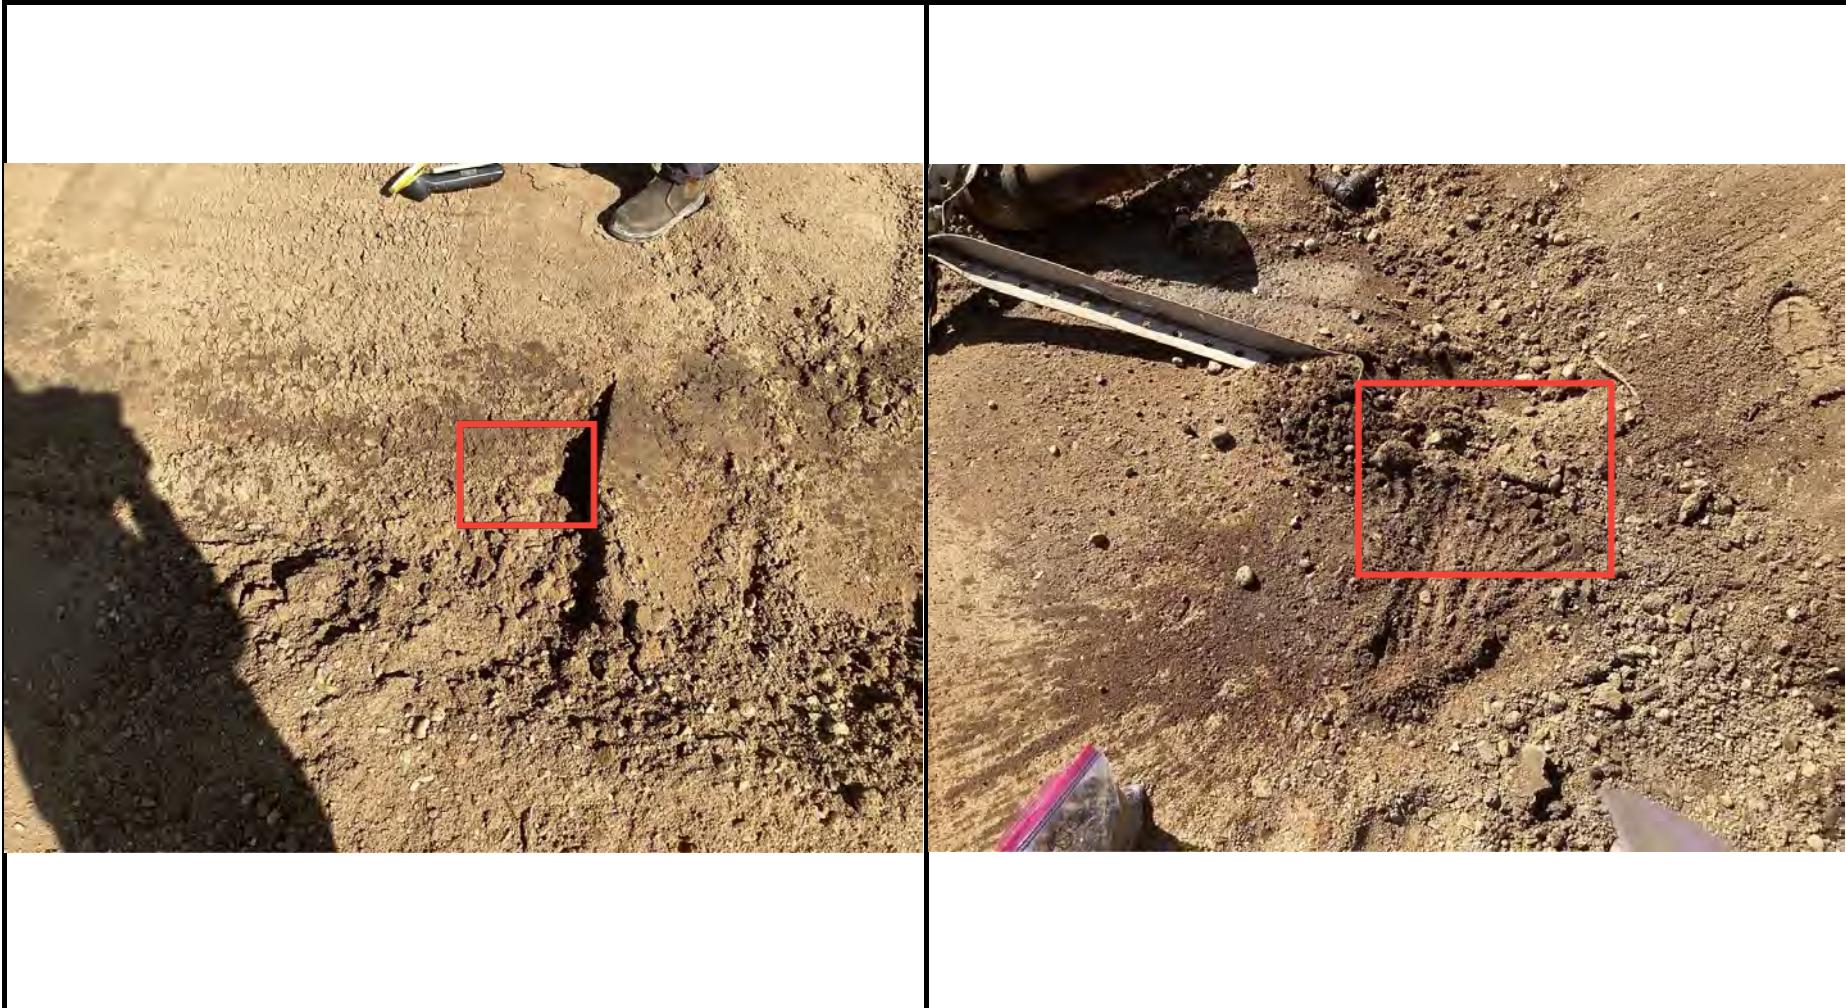
Equipment ID: AST01@0-6"			Equipment Type: Above Ground Storage Tank			Equipment ID: AST02@0-6"			Equipment Type: Above Ground Storage Tank		
Material: Steel		Volume: 100 BBL		Contents: Crude Oil		Material: Steel		Volume: 100 BBL		Contents: Crude Oil	
Notes/Conditions: West Facing						Notes/Conditions: North facing

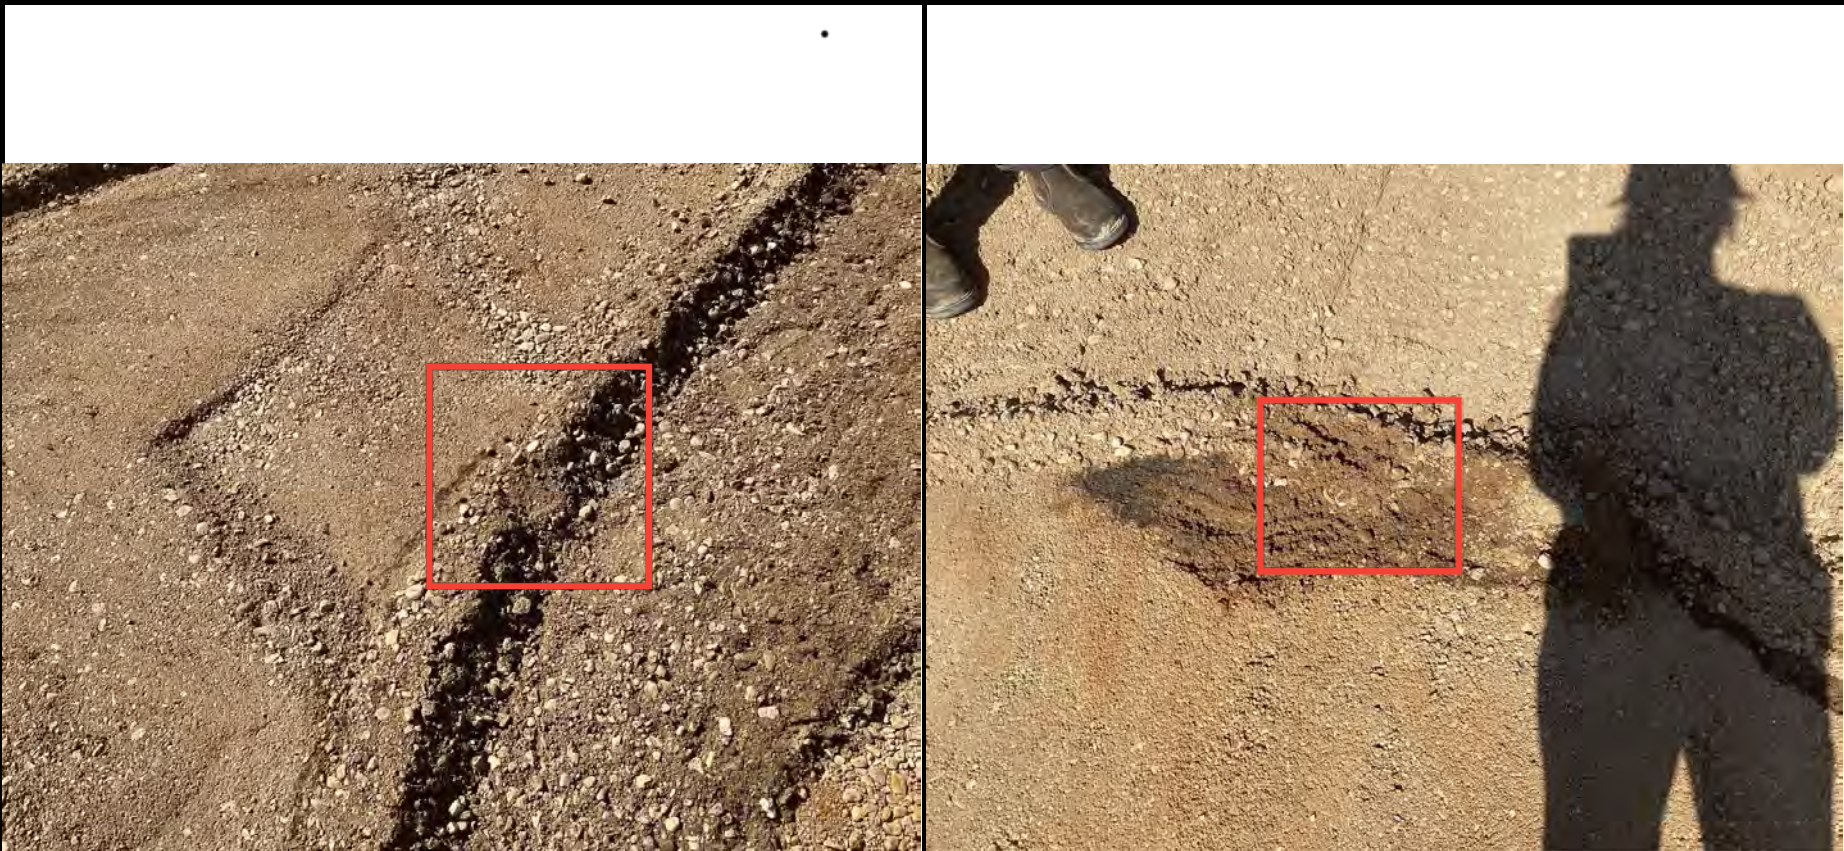
Equipment ID: AST003@0-6" **Equipment Type:** Above Ground Storage Tank
Material: Steel **Volume:** 100 BBL **Contents:** Crude Oil
Notes/Conditions: South Facing

Equipment ID: AST04@0-6" **Equipment Type:** Above Ground Storage Tank
Material: Steel **Volume:** 100 BBL **Contents:** Crude Oil
Notes/Conditions: West facing

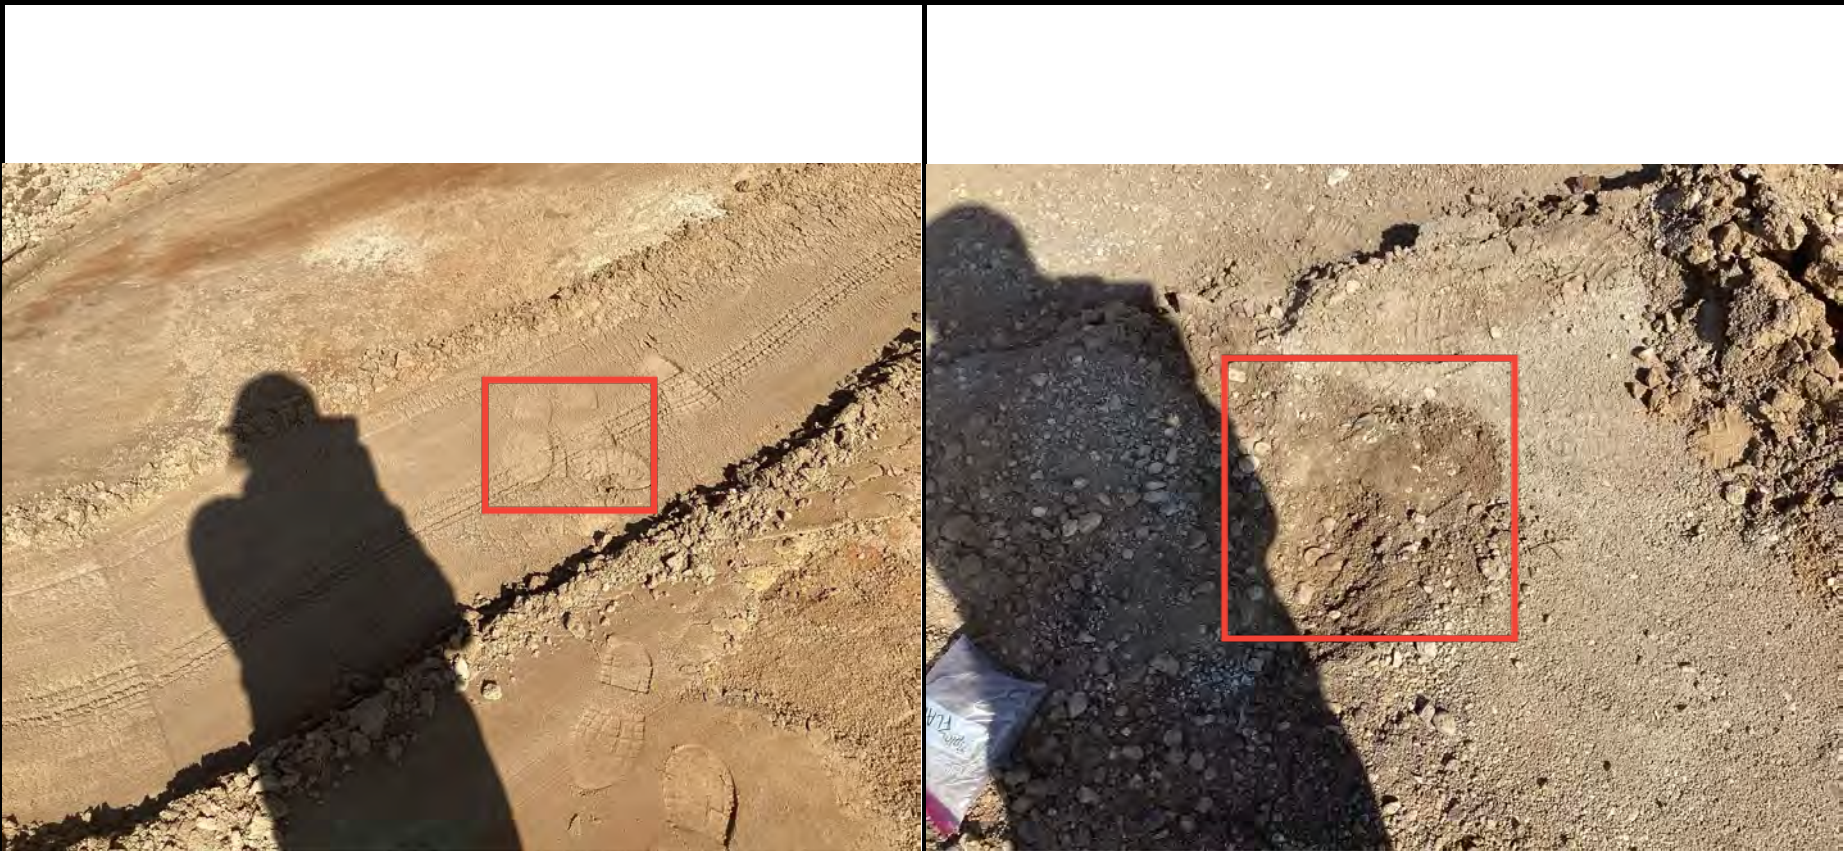
Equipment ID: AST05@0-6"		Equipment Type: Above Ground Storage Tank		Equipment ID: FLARE01@0-6"		Equipment Type: Emission Control Device	
Material: Steel	Volume: 100 BBL	Contents: Crude Oil		Material: Steel	Volume: 100 BBL	Contents: Condensate	
Notes/Conditions: West Facing				Notes/Conditions: West facing

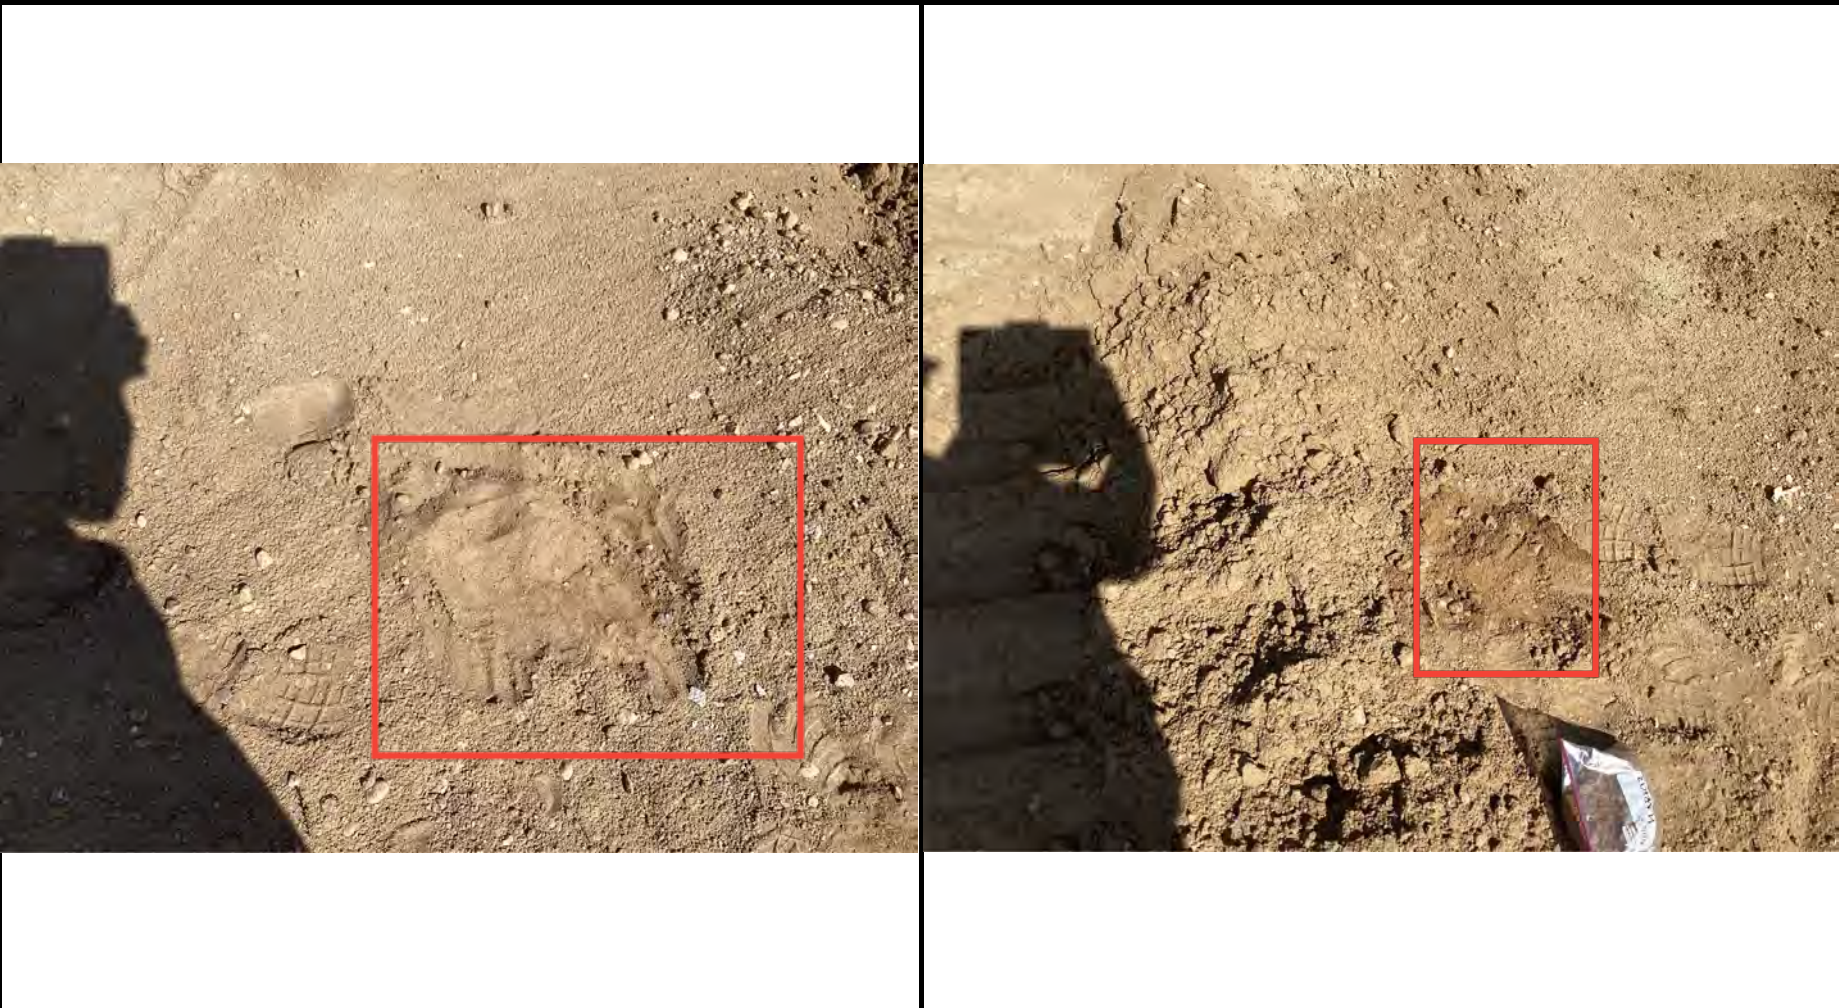
Equipment ID: FLARE02@0-6"	Equipment Type: Emission Control Device	
Material: Steel	Volume:	Contents: Condensate
Notes/Conditions: West Facing

Equipment ID: FLARE03@0-6"	Equipment Type: Emission Control Device	
Material: Steel	Volume:	Contents: Condensate
Notes/Conditions: West Facing

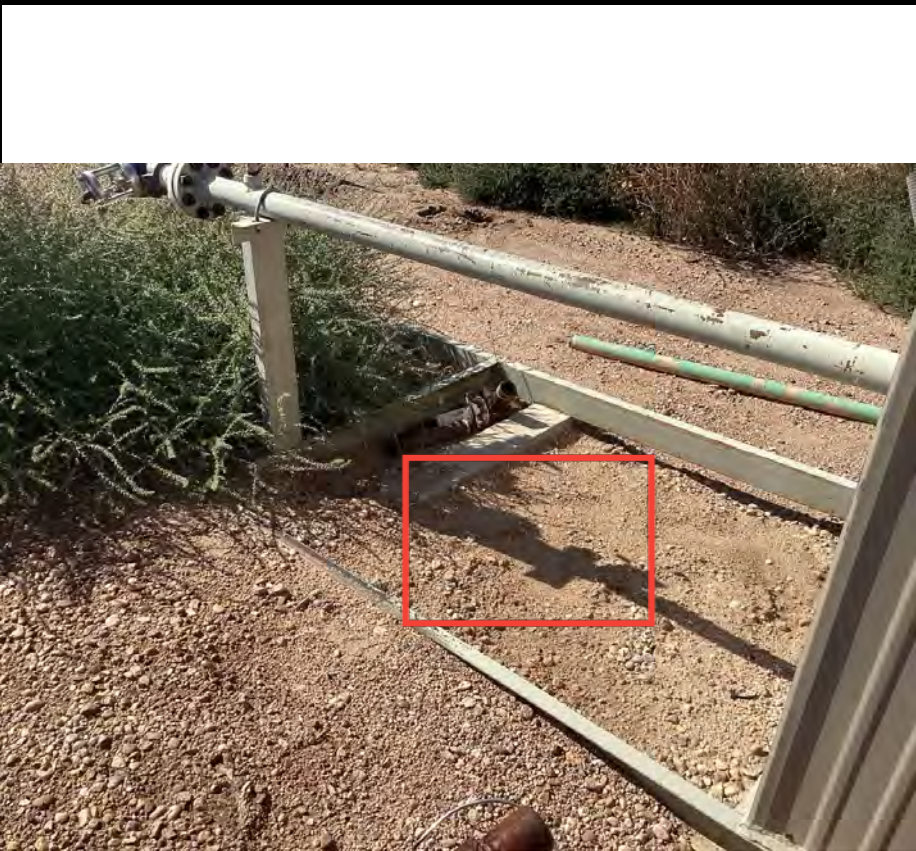
Equipment ID: MH01@0-6"		Equipment Type:	
Material:	Volume:	Contents:	
Notes/Conditions: South Facing

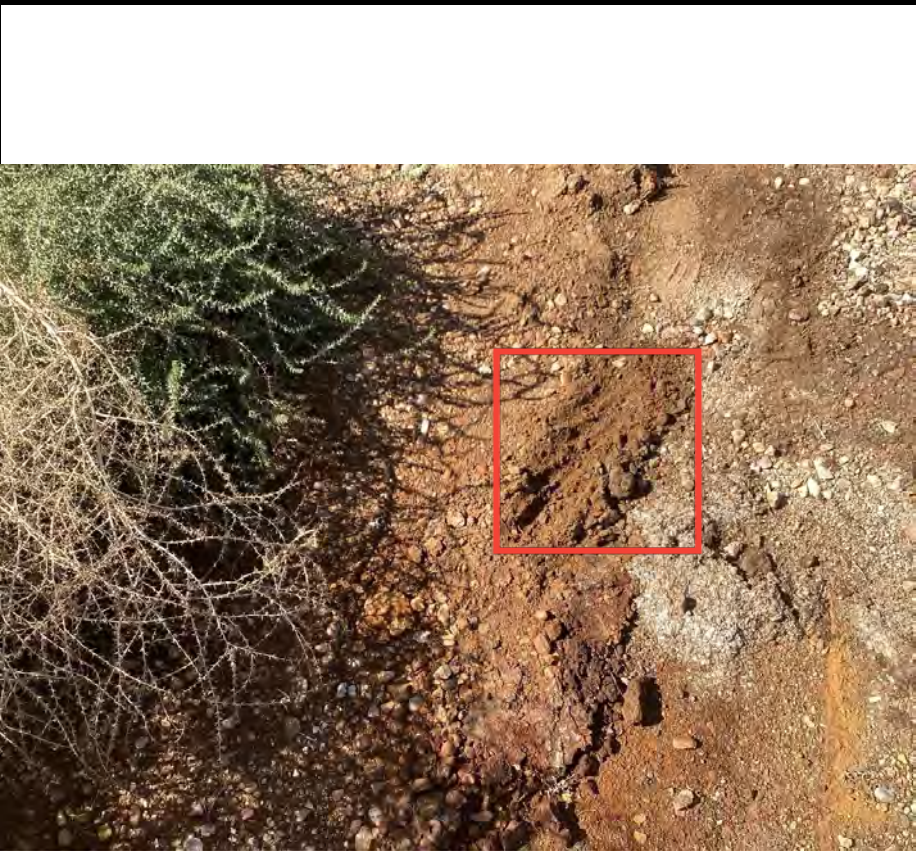
Equipment ID: GS01@0-6"		Equipment Type:	
Material:	Volume:	Contents:	
Notes/Conditions: West Facing, iron staining on surface

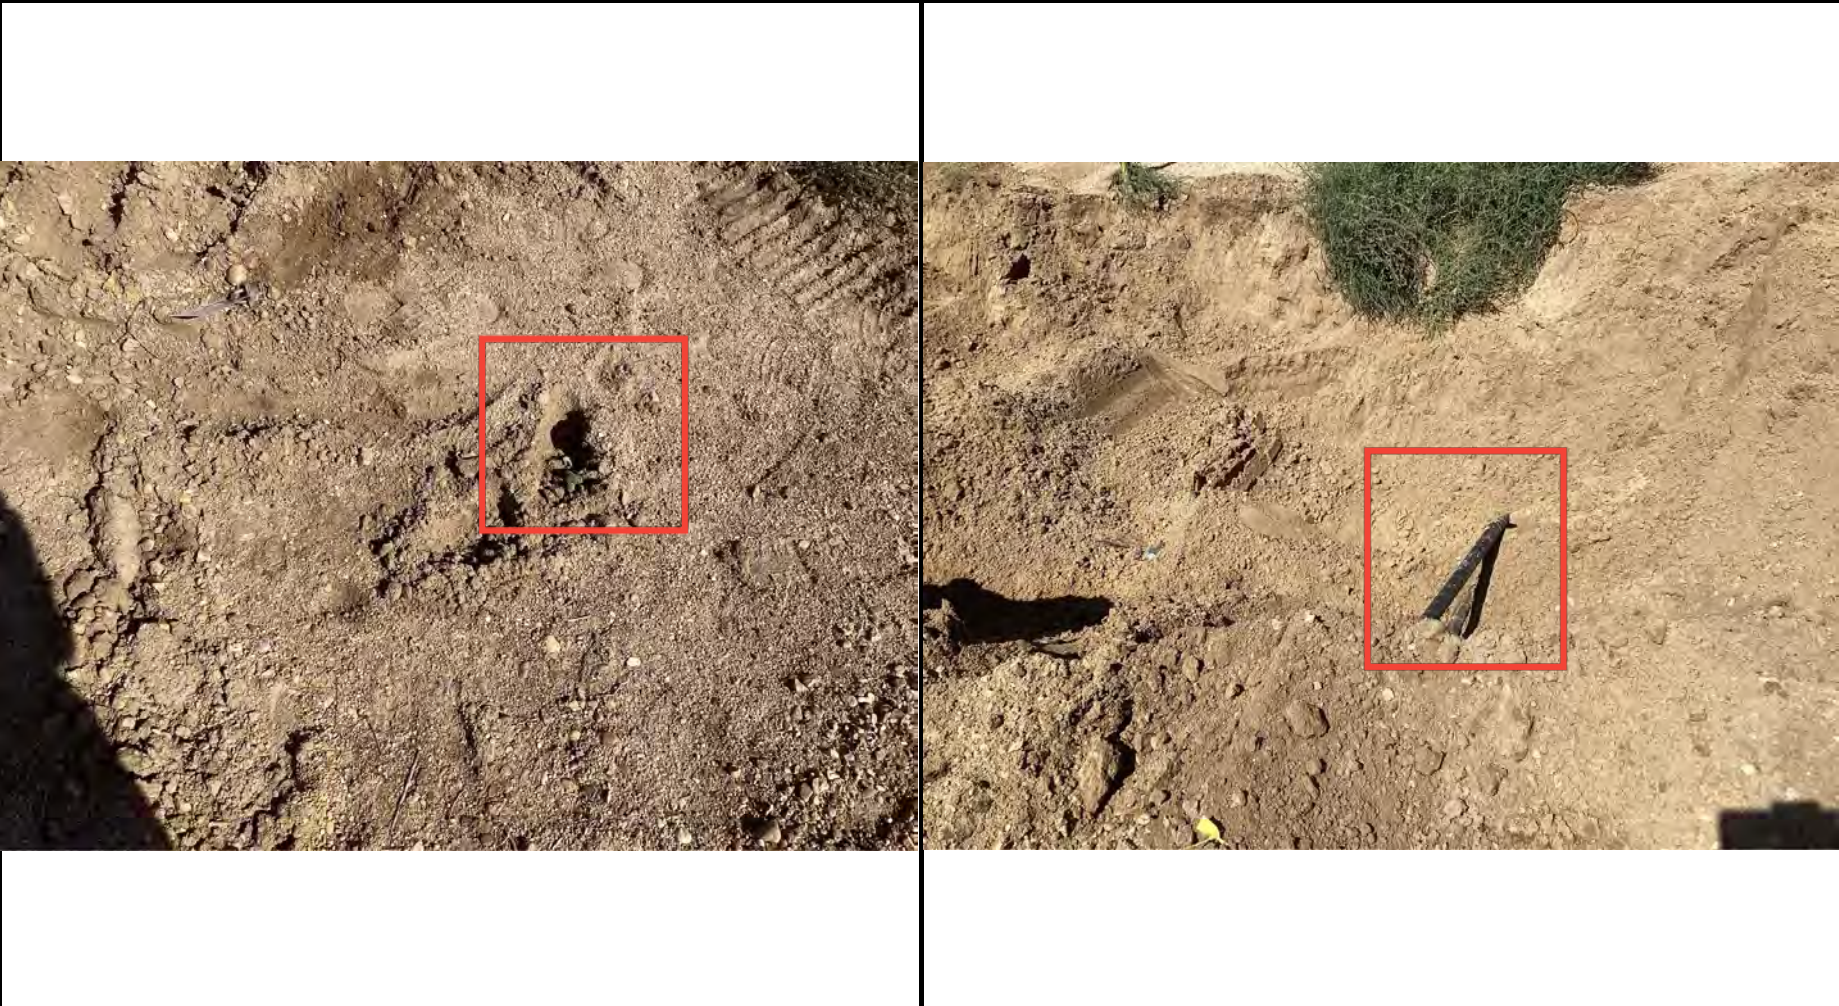
Equipment ID: GS02@0-6'		Equipment Type:	
Material:	Volume:	Contents:	
Notes/Conditions: West Facing

Equipment ID: SEP01-FL@3'		Equipment Type: Flowline	
Material: Steel	Volume:	Contents: Crude Oil	
Notes/Conditions: West Facing

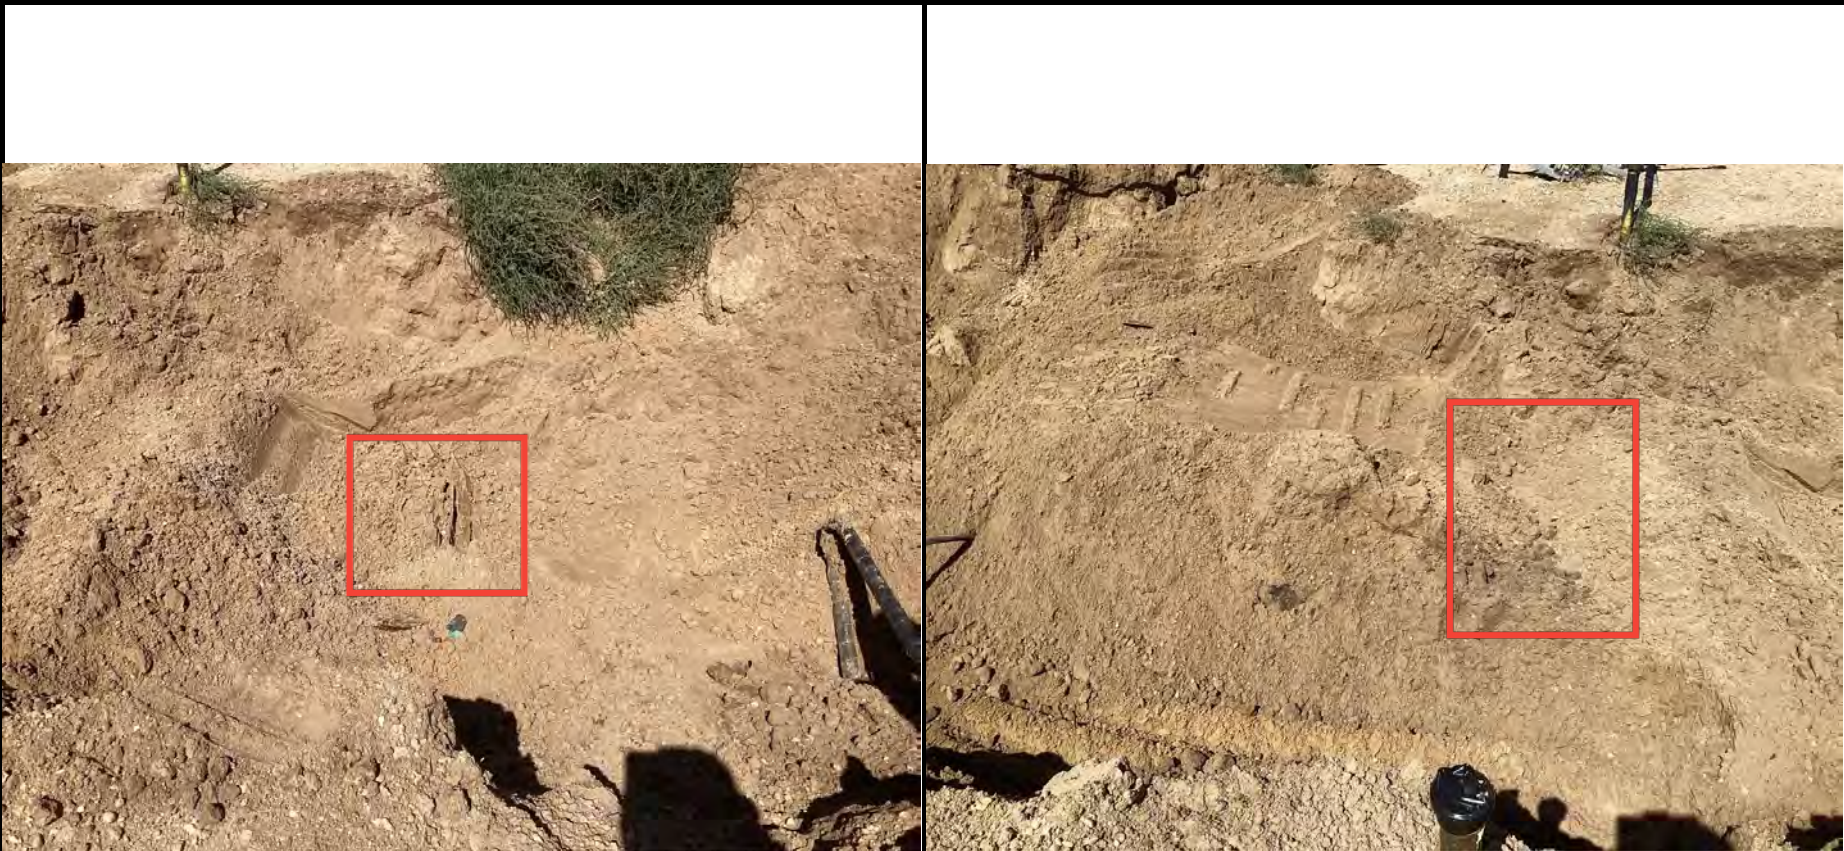
Equipment ID: SEP02-FL@3'		Equipment Type: Flowline		Equipment ID: SEP03-FL@3'		Equipment Type: Flowline	
Material: Steel		Volume:		Material: Steel		Volume:	
Contents: Crude Oil				Contents: Crude Oil			
Notes/Conditions: West Facing				Notes/Conditions: West Facing

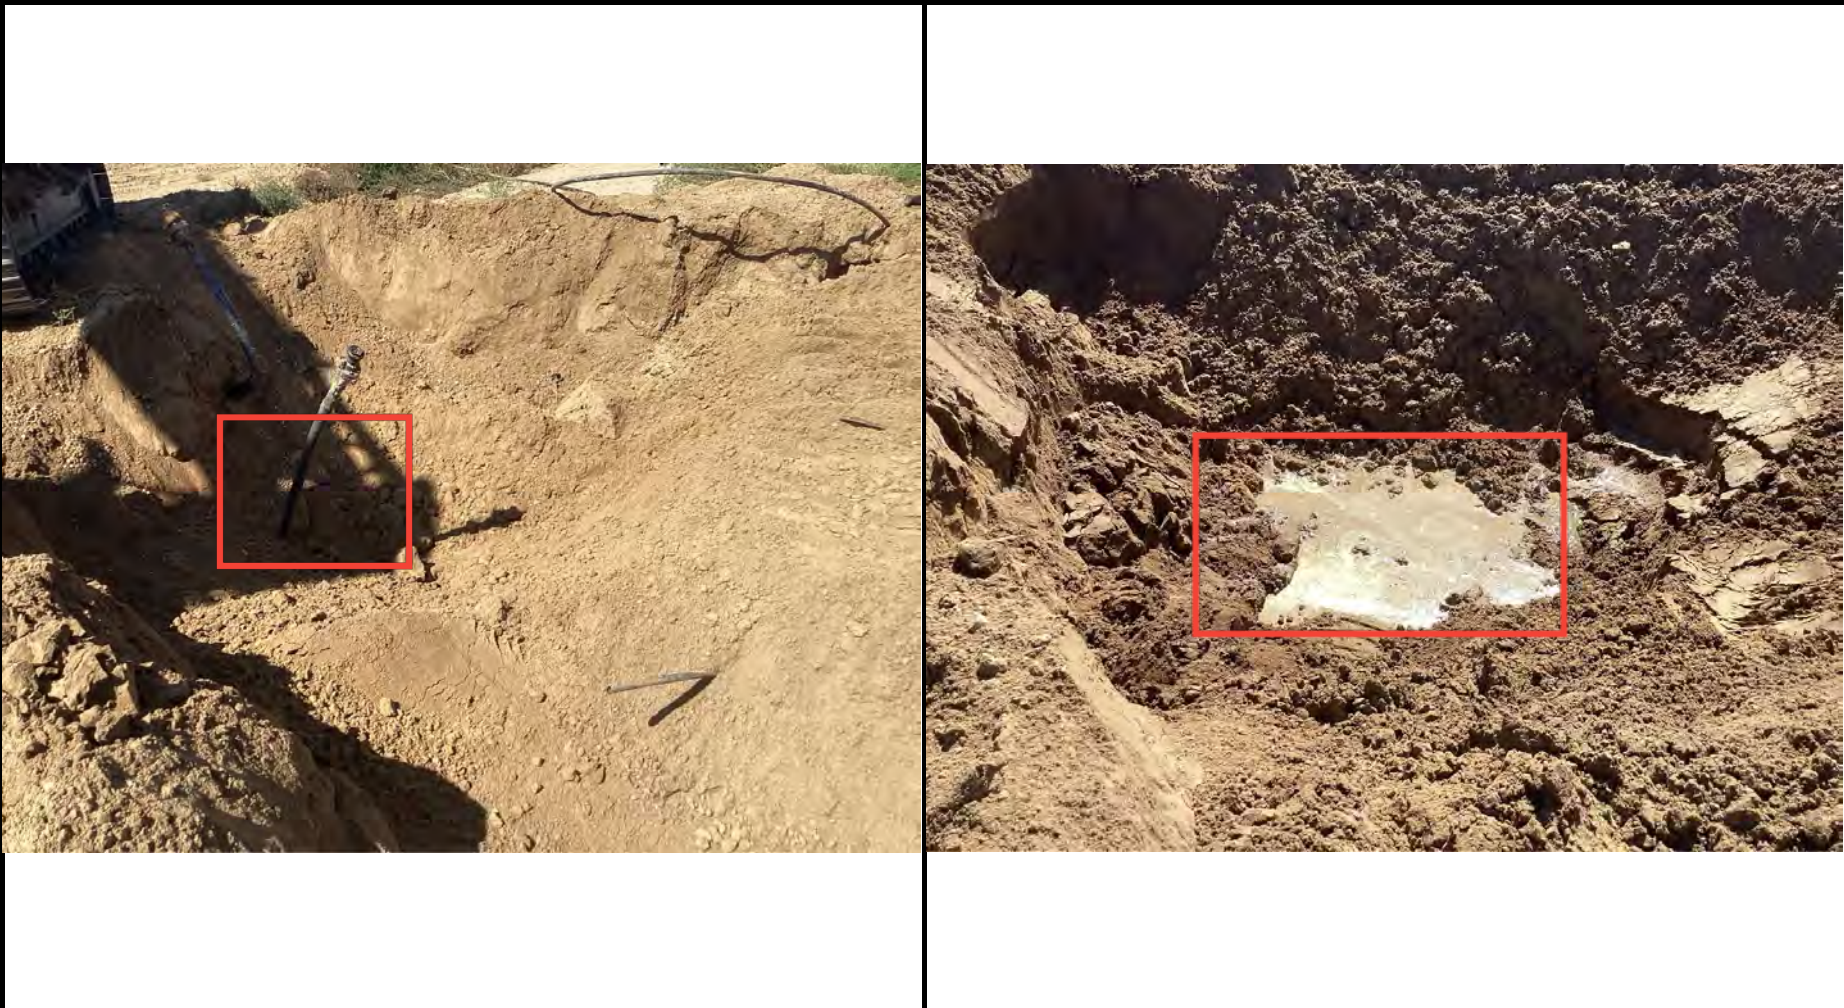
Equipment ID: SEP04-FL@3'		Equipment Type: Flowline		Equipment ID: PWV01-B@4'/GW01		Equipment Type: Partially Buried Vault	
Material: Steel	Volume:	Contents: Crude Oil		Material: Fiberglass	Volume: 100 BBL	Contents: Produced Water	
Notes/Conditions: West Facing				Notes/Conditions: North Facing

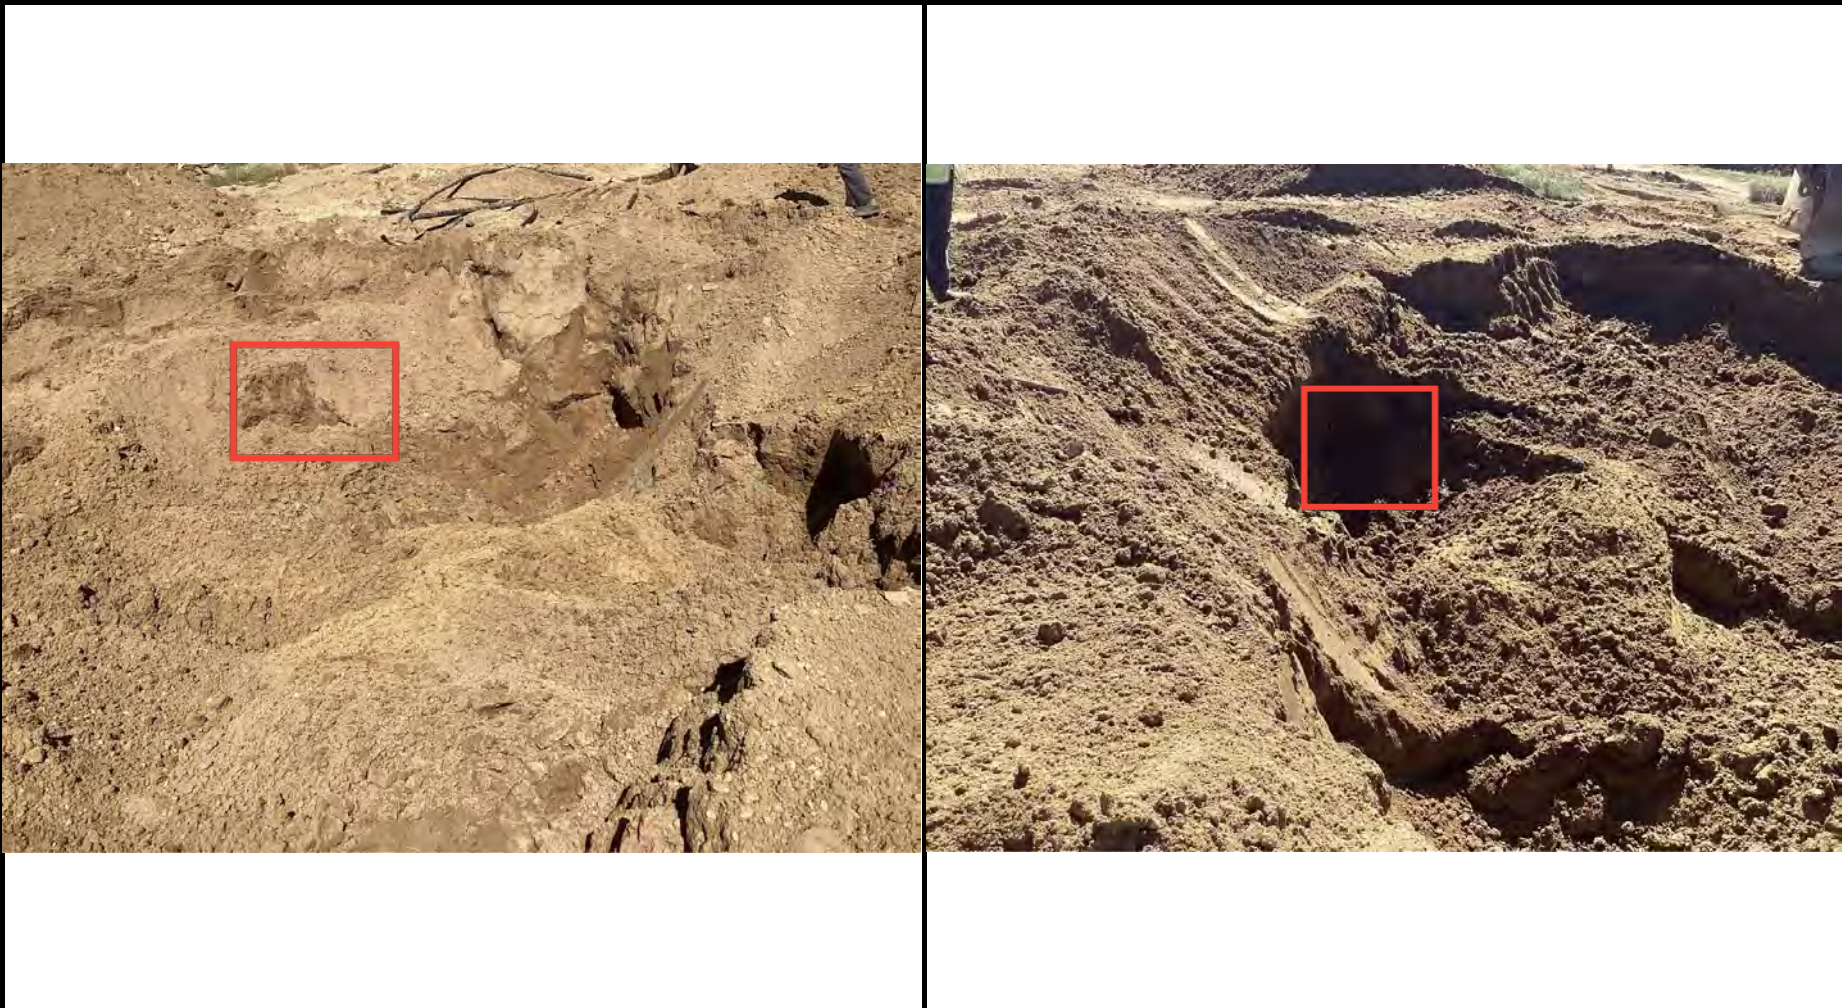
Equipment ID: PWV01-N@2'		Equipment Type: Partially Buried Vault		Equipment ID: PWV01-E@2'		Equipment Type: Partially Buried Vault	
Material: Fiberglass	Volume: 100 BBL	Contents: Produced Water		Material: Fiberglass	Volume: 100 BBL	Contents: Produced Water	
Notes/Conditions: North Facing				Notes/Conditions: East Facing

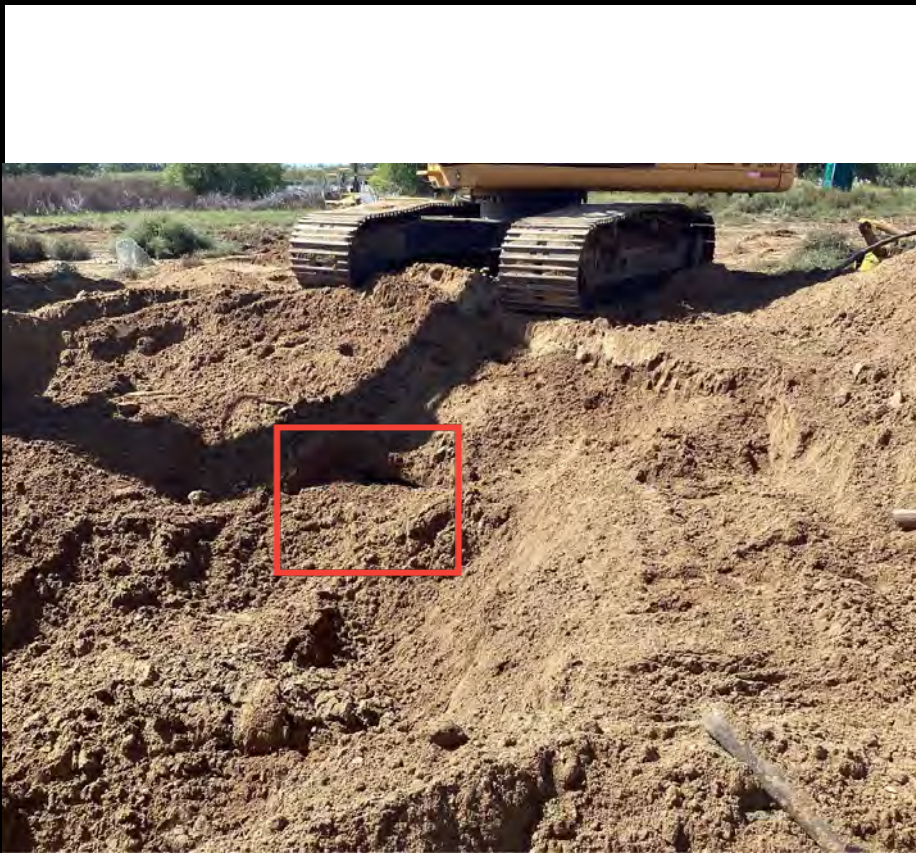
Equipment ID: PWV01-S@2'	Equipment Type: Partially Buried Vault	
Material: Fiberglass	Volume: 100 BBL	Contents: Produced Water
Notes/Conditions: South facing

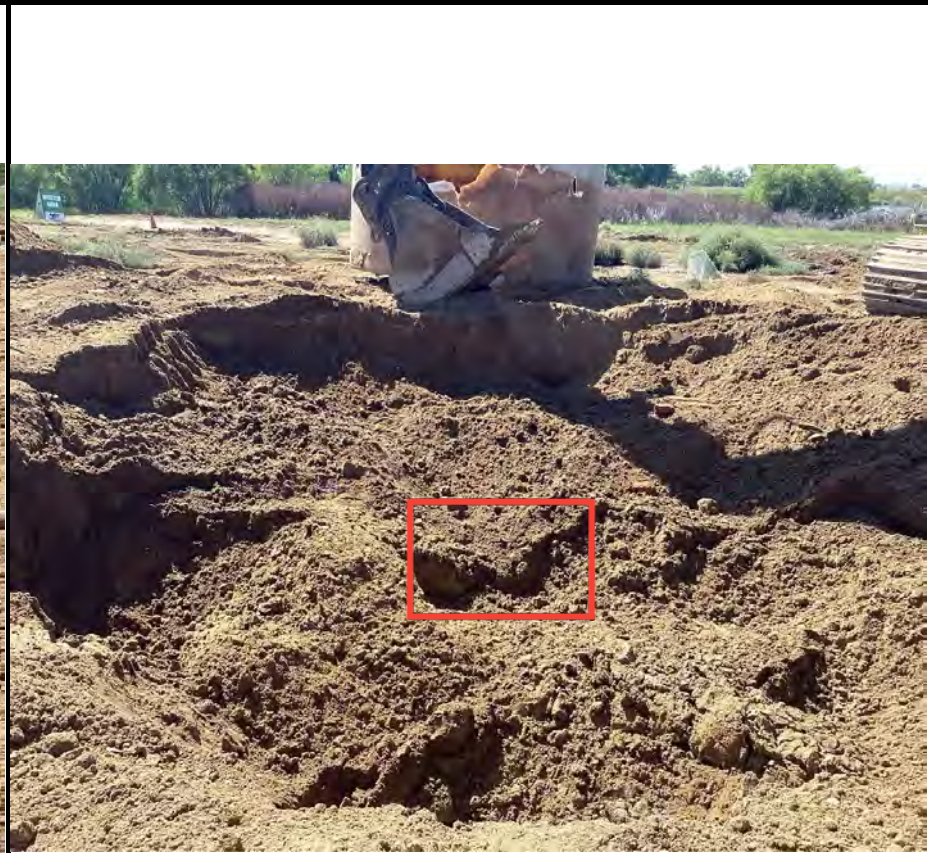
Equipment ID: PWV01-W@2'	Equipment Type: Partially Buried Vault	
Material: Fiberglass	Volume: 100 BBL	Contents: Produced Water
Notes/Conditions: West Facing

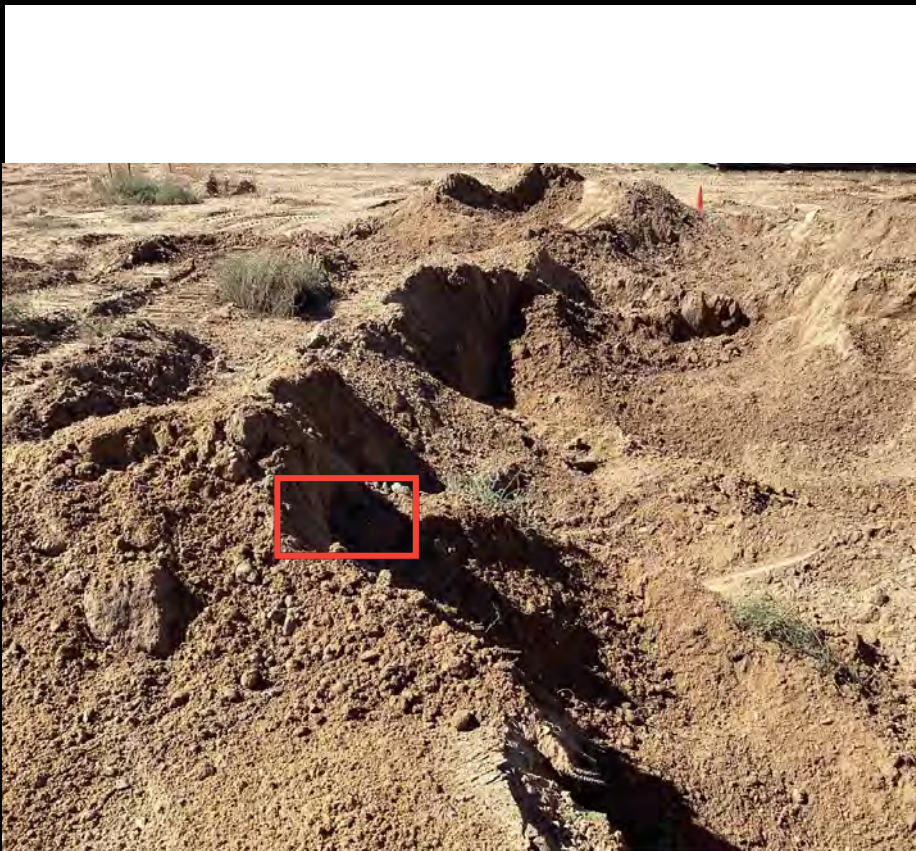
Equipment ID: SEP01-DL@3'		Equipment Type: Dump Line	
Material: Steel	Volume:	Contents: Crude Oil	
Notes/Conditions: West Facing
