PDC Energy, Inc. – 69175
Cache 8-13, 24, 34; Cornish 8-53
 NESW, Section 8, Township 6 South, Range 63 West
 Weld County, Colorado

PDC Energy, Inc – 69175
Cache 8-13, 24, 34; Cornish 8-53 Tank Battery
 NESW, Section 8, Township 6 North, Range 63 West
 Weld County, Colorado

TANK BATTERY DECOMMISSIONING FORM

TANK BATTERY DECOMMISSIONING

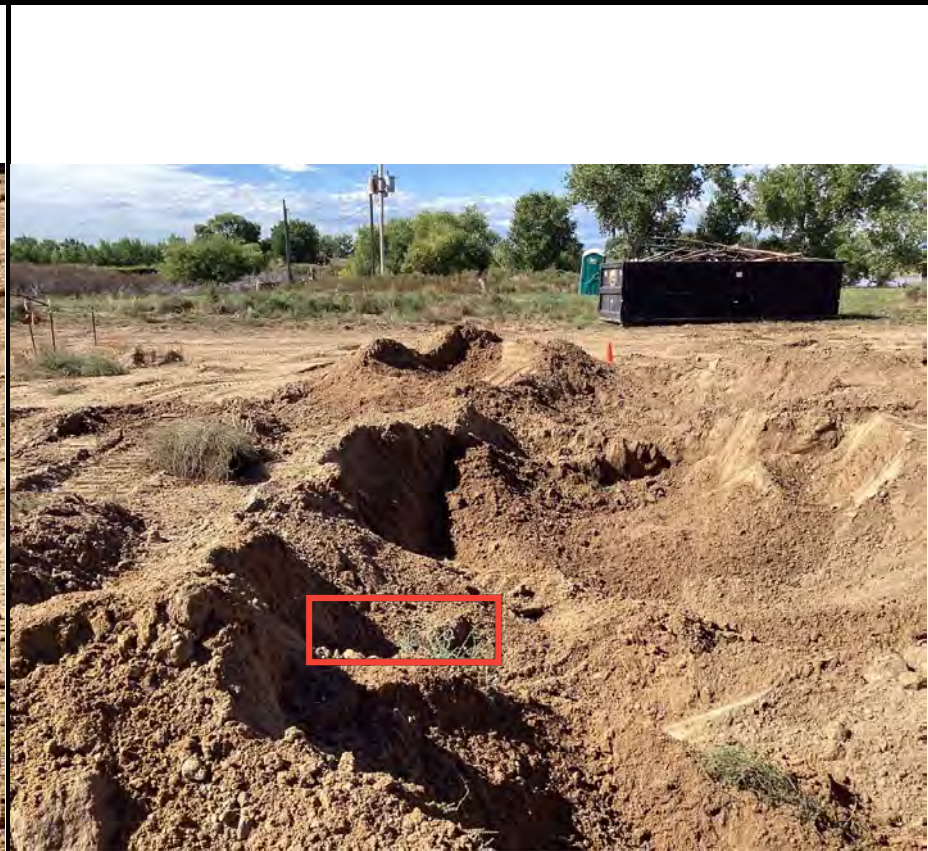
Equipment ID: SEP02-DL@3'		Equipment Type: Dump Line	
Material: Steel	Volume:	Contents: Crude Oil	
Notes/Conditions: West Facing

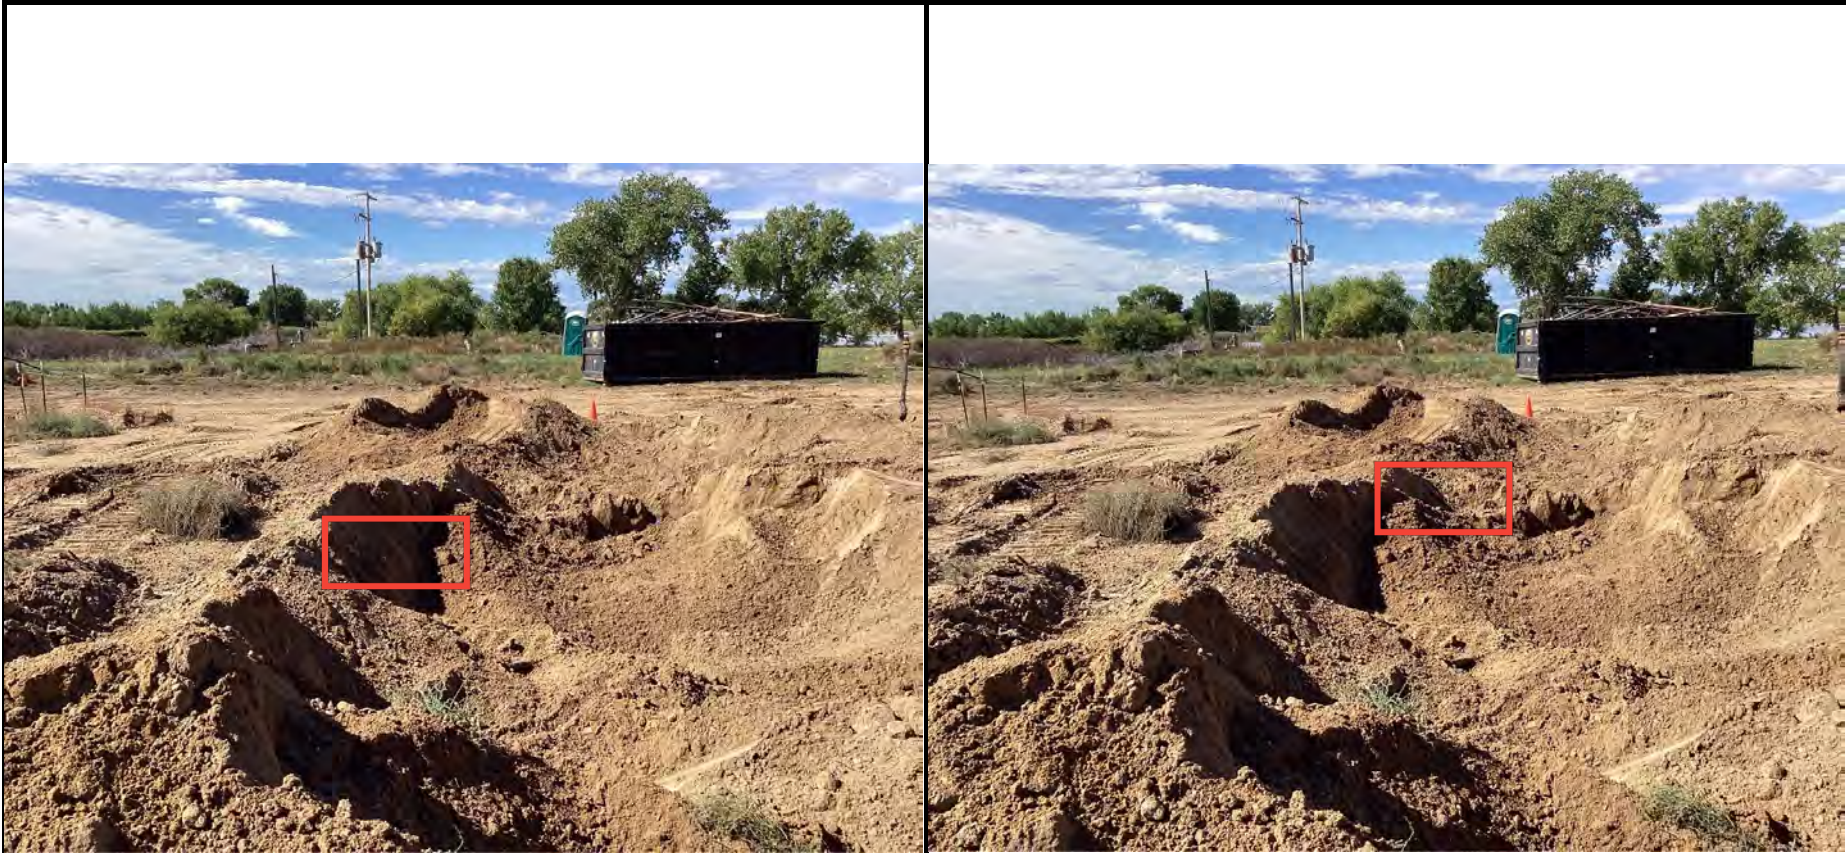
Equipment ID: SEP03-DL@3'		Equipment Type: Dump Line		Equipment ID: SEP04-DL@3'		Equipment Type: Dump Line	
Material: Steel	Volume:	Contents: Crude Oil		Material: Steel	Volume:	Contents: Crude Oil	
Notes/Conditions: West Facing				Notes/Conditions: West Facing
