Inspection Photos

Operator: Noble Energy Inc

Location ID: 306327

Inspection Document #: 714002504

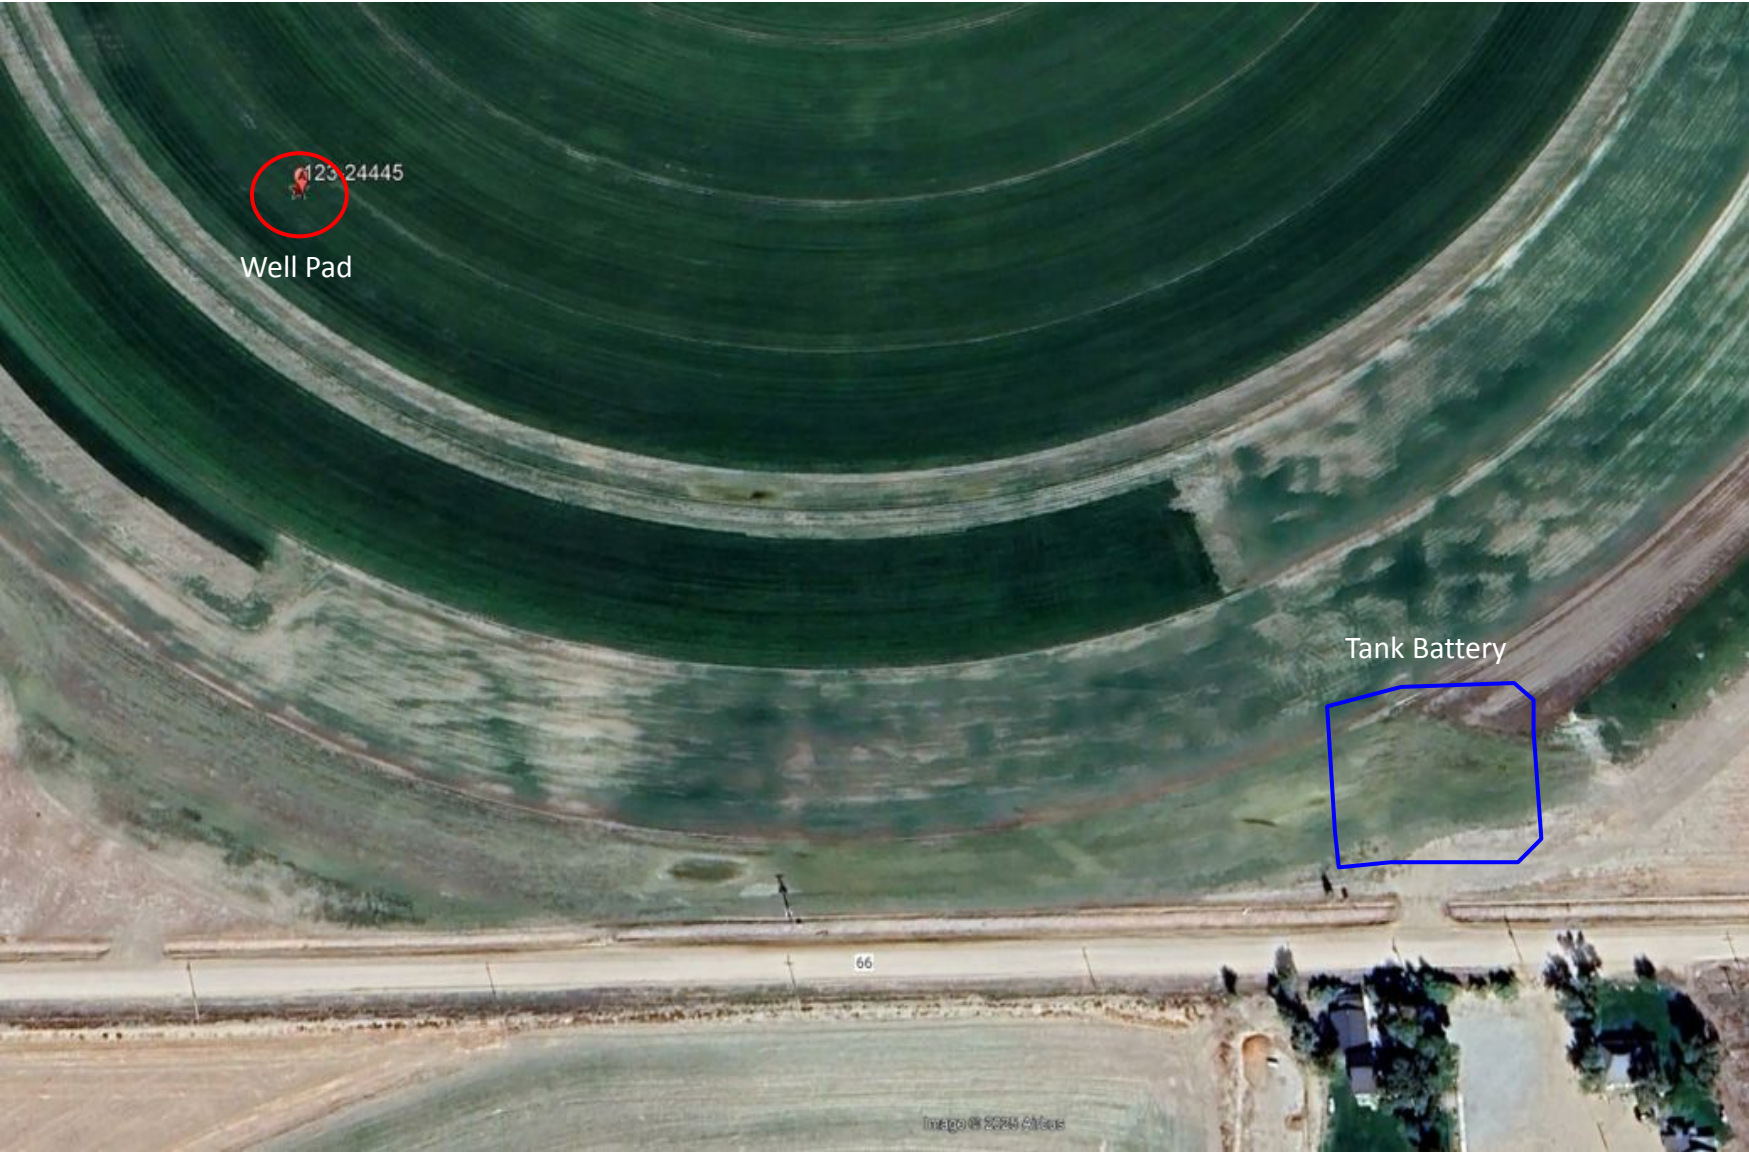
Photo 1. 2025 aerial imagery showing the Tank Battery location (highlighted in blue) and Well Pad (highlighted in Red). Note: Could not determine through historical imagery where the well pad access road existed. Tank battery is associated with its own location ID #461166.

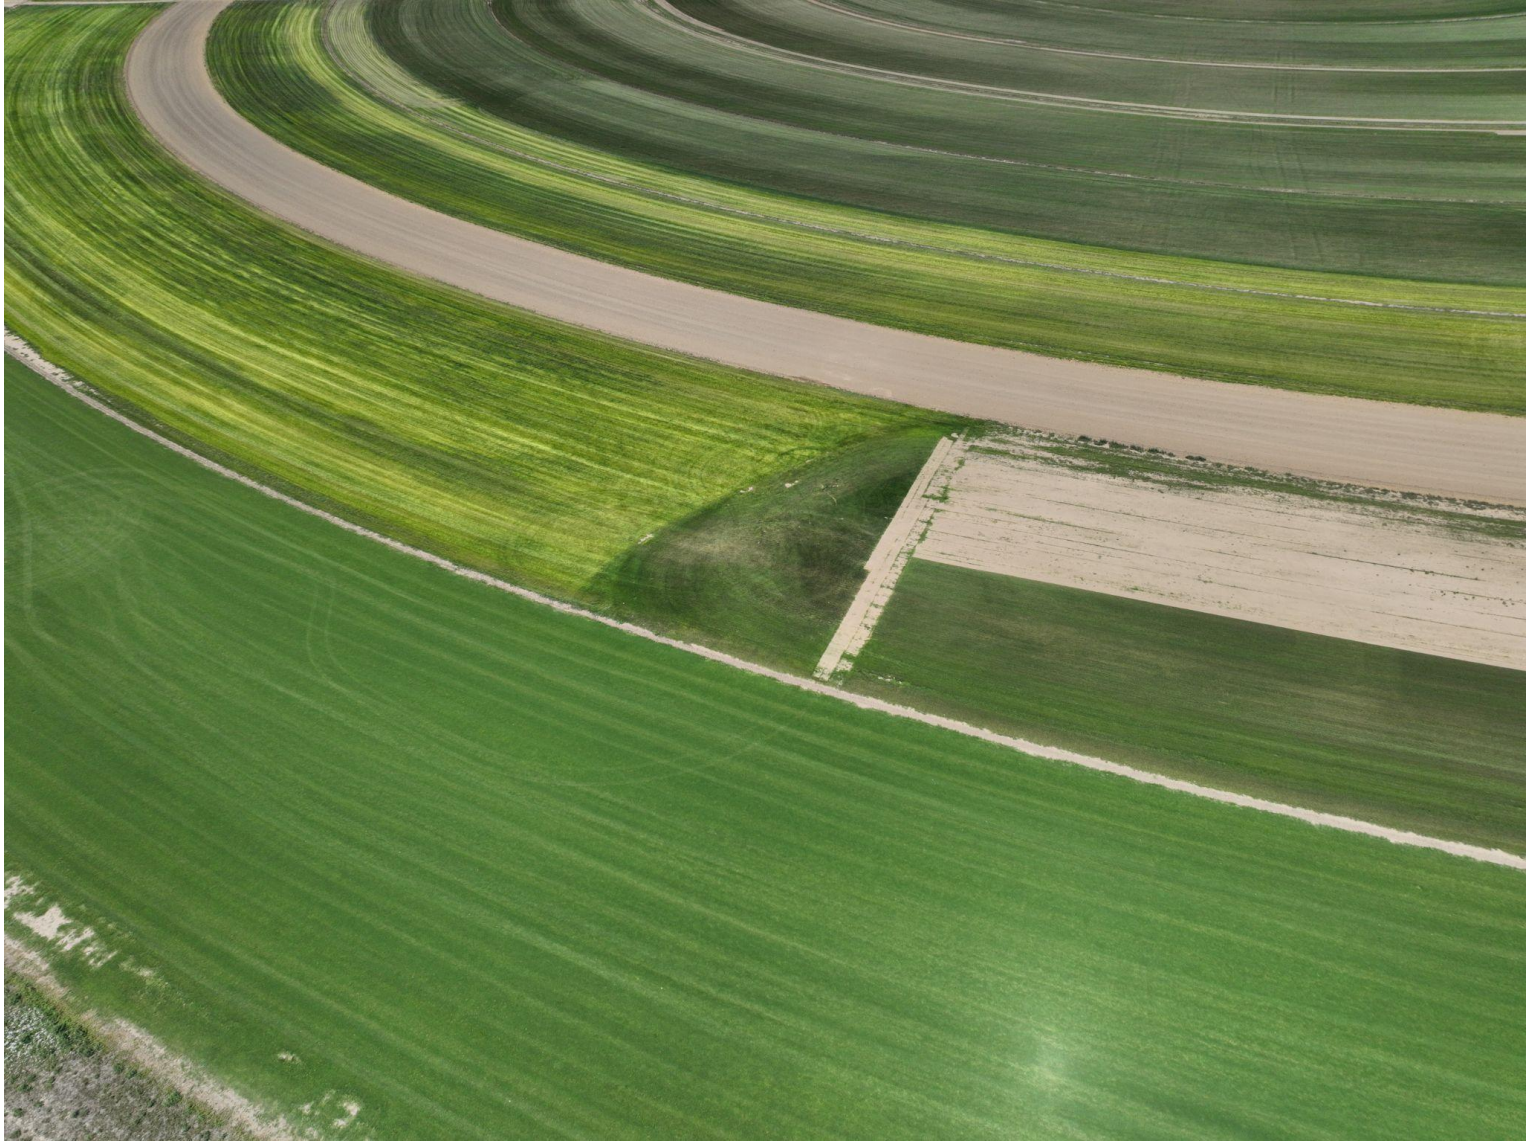
Photo 2. Aerial view of the well pad taken with a drone at the time of the inspection from the southern edge facing north. Note: Sod grass vegetation at the well pad appears consistent with adjacent reference areas.
