**INITIAL DECOMMISSIONING REPORT
WALCKER USX AB01-08P FLOWLINE**

**ECMC SPILL TRACKING # 491267
ECMC REMEDIATION # 41669**

Noble Energy, Inc - 100322 - DJ Basin
Walcker USX AB01-08P
 SENE, Section 1, Township 7 North, Range 64
 West Weld County, Colorado

Noble Energy, Inc - 100322 - DJ Basin
Walcker USX AB01-08P Flowline
 SENE, Section 1, Township 7 North, Range 64 West
 Weld County, Colorado

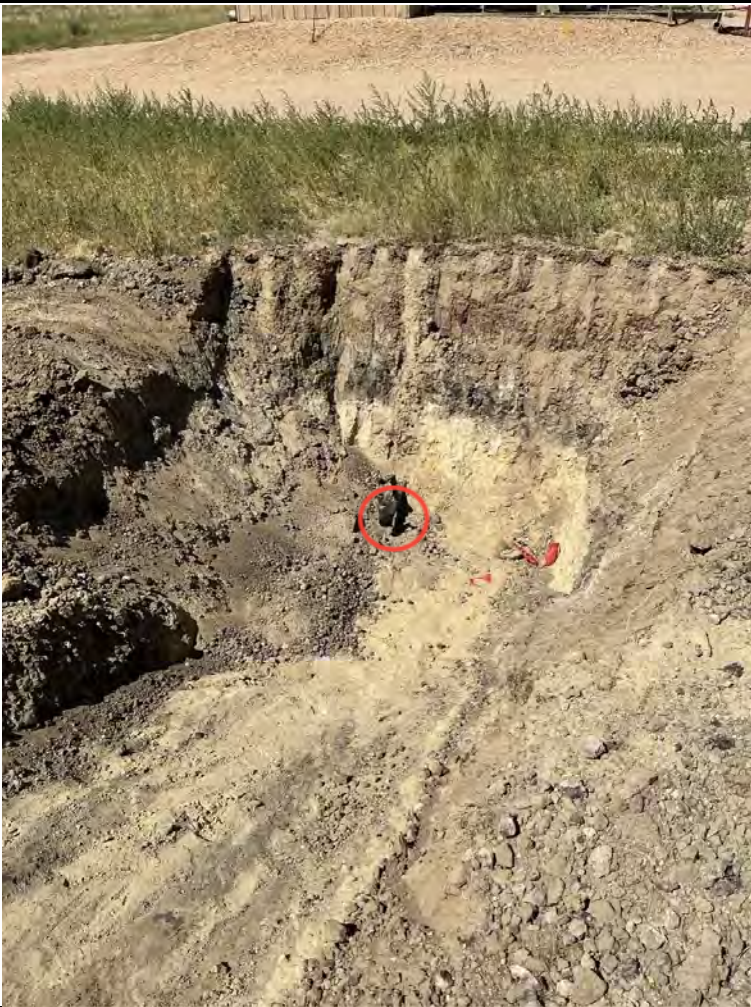
Equipment ID: FL01-01 @ 4'		Equipment Type:		Equipment ID: FL01-02 @ 4'		Equipment Type:	
Material:	Volume:	Contents:		Material:	Volume:	Contents:	
Notes/Conditions: Facing West				Notes/Conditions: Facing West

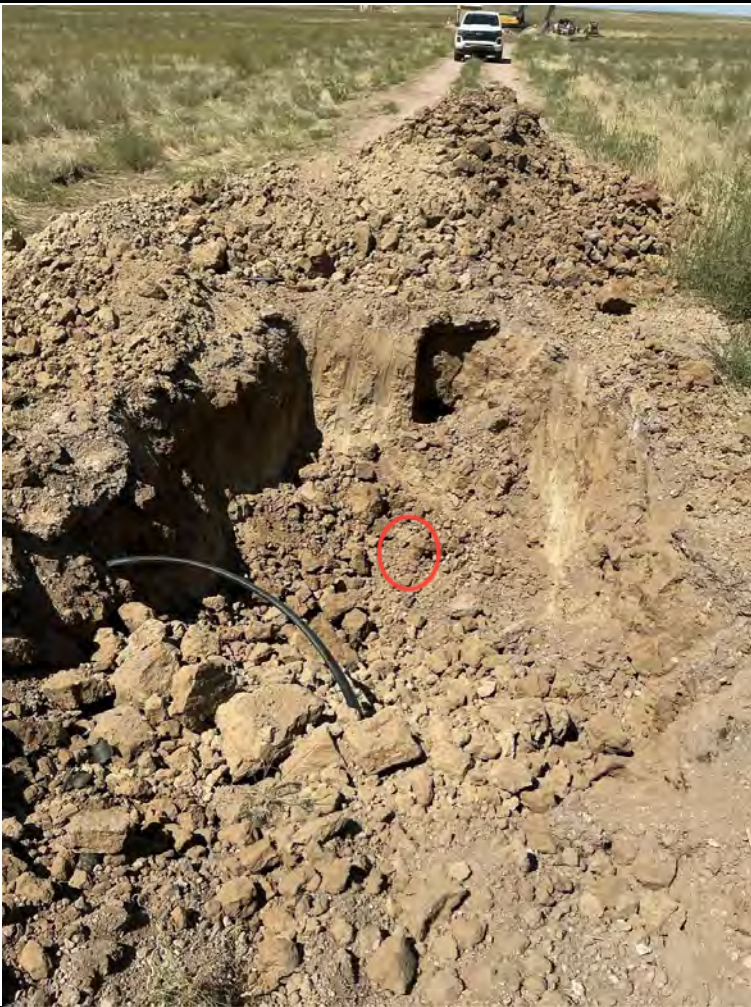
Equipment ID: FL01-03@4'		Equipment Type:		Equipment ID: FL01-04@4'		Equipment Type:	
Material:	Volume:	Contents:		Material:	Volume:	Contents:	
Notes/Conditions: Facing West				Notes/Conditions: Facing West

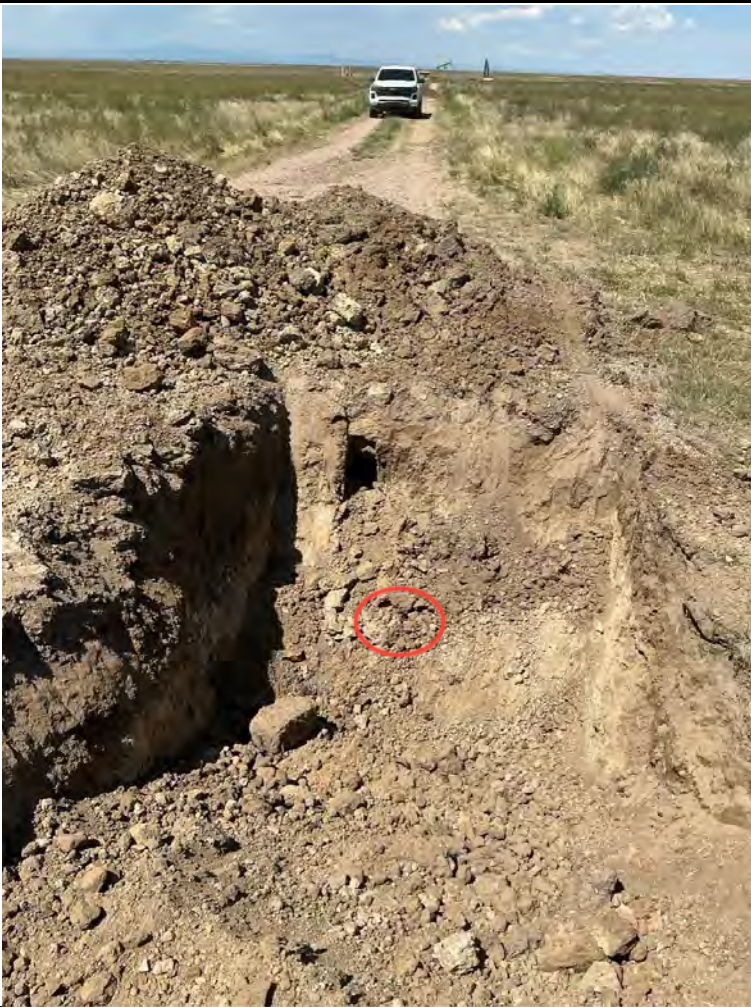
Equipment ID: FL01-05@4'		Equipment Type:		Equipment ID: FL01R-W@4'		Equipment Type:	
Material:	Volume:	Contents:		Material:	Volume:	Contents:	
Notes/Conditions: Facing west				Notes/Conditions: Facing east

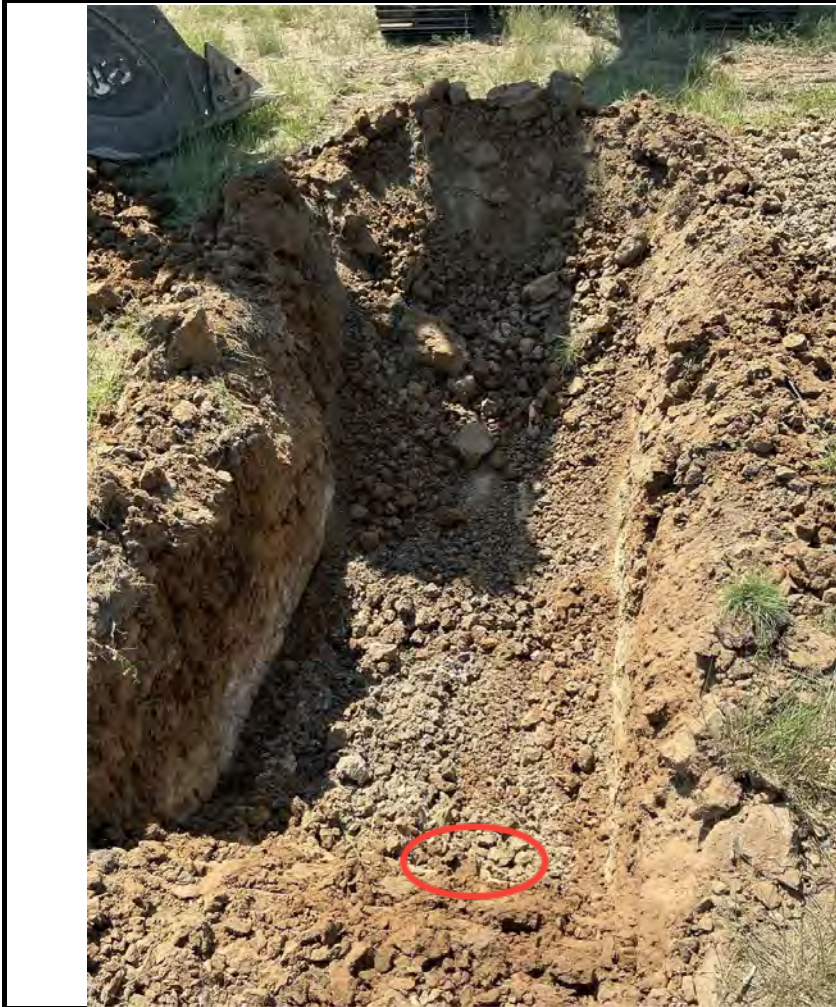
Equipment ID:		Equipment Type:	
Material:	Volume:	Contents:	
Notes/Conditions: SB01 @2', SB01 @3', & SB01 @4' Facing South

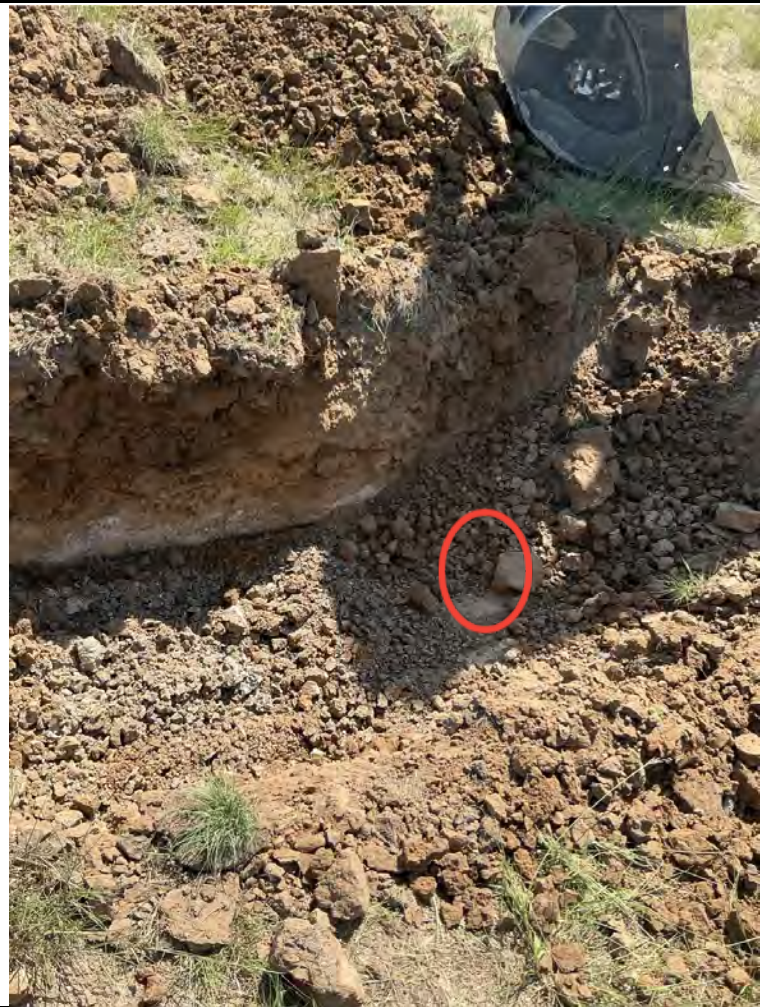
Equipment ID:		Equipment Type:	
Material:	Volume:	Contents:	
Notes/Conditions: SB02 @2', SB02 @3', & SB02 @4' Facing East
