Inspection Photos

API: 017-07232

Operator: **CITATION OIL & GAS CORP**

Inspection Date: 10/21/2025

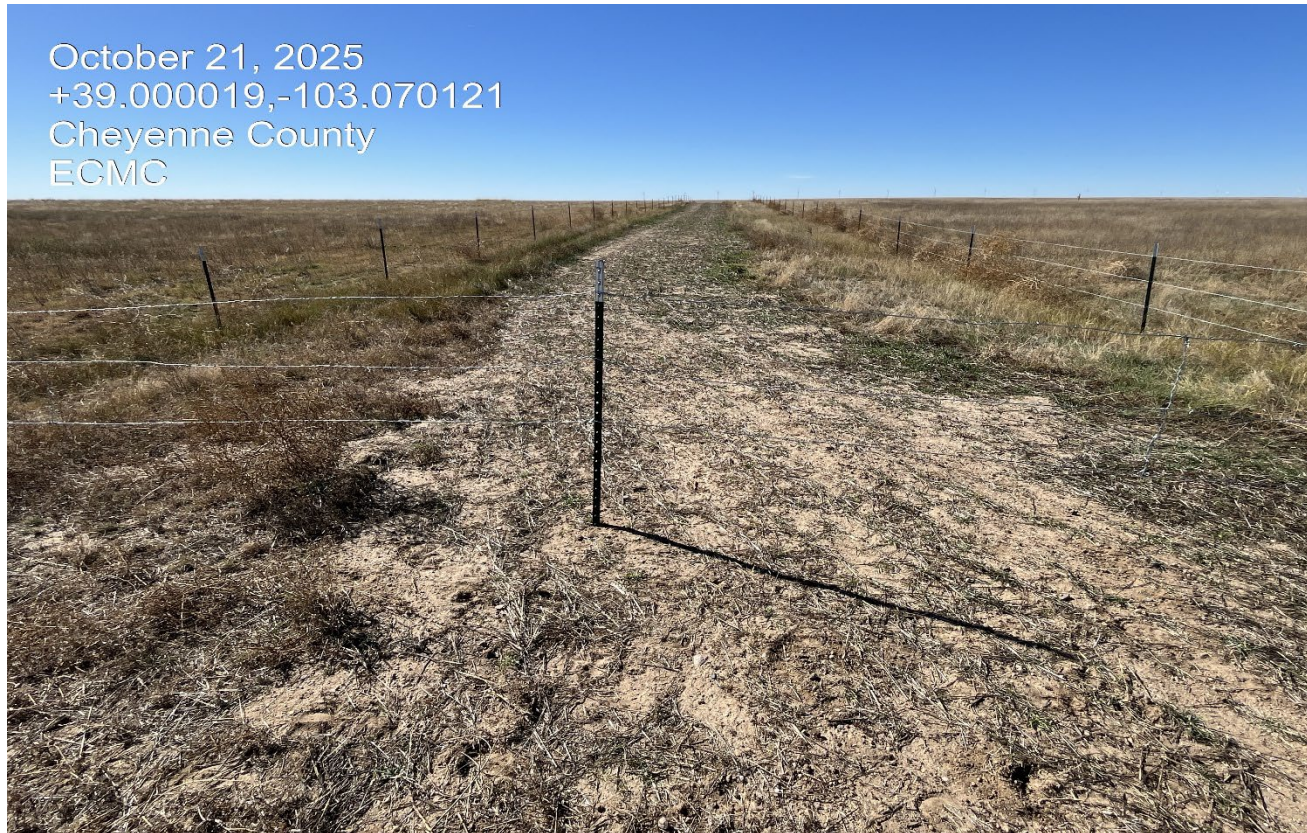
Photo 1. Facing west at the beginning of the access road. Reclamation was performed however no recontouring of the road occurred. The reclaimed area has been fenced off.

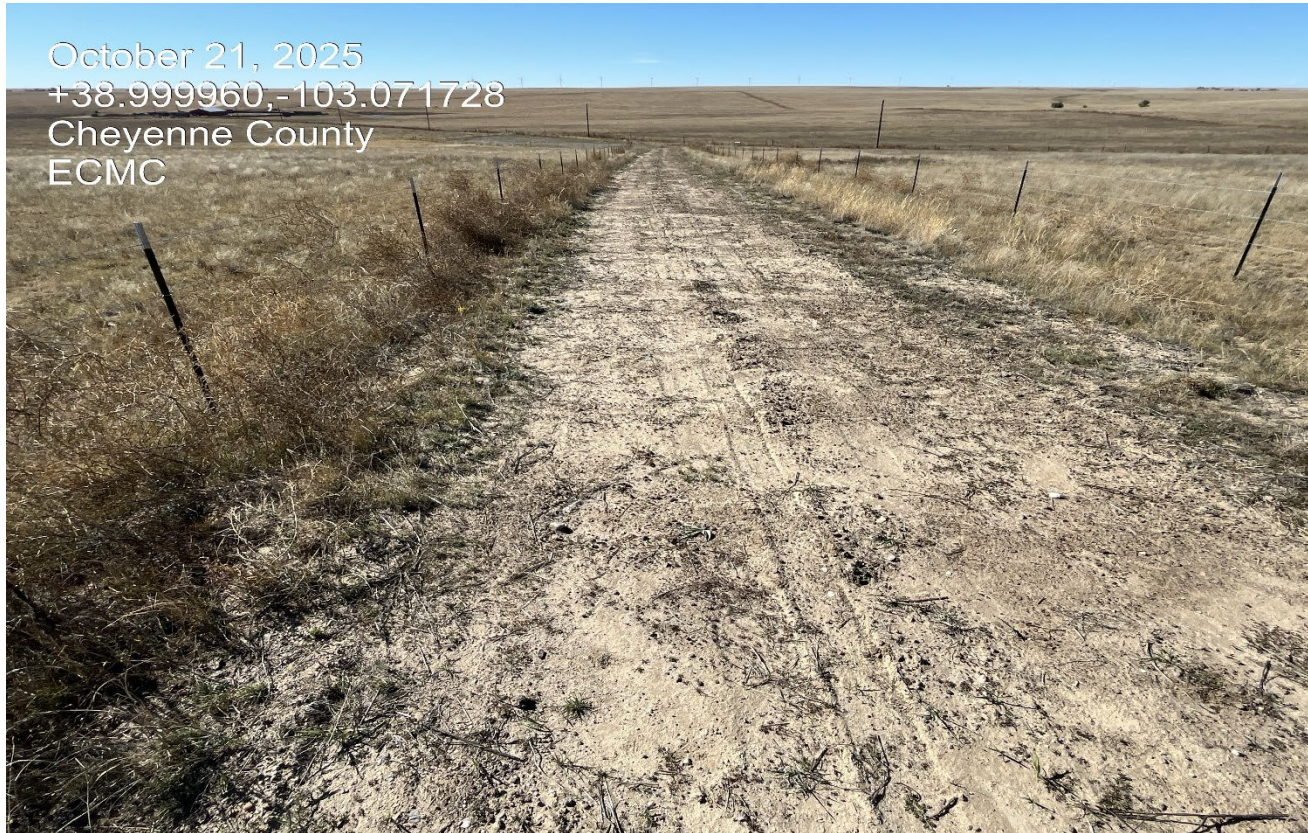
Photo 2. Facing west further along the road. The road was not regraded to match the surrounding contours and remains crowned with road side ditches.

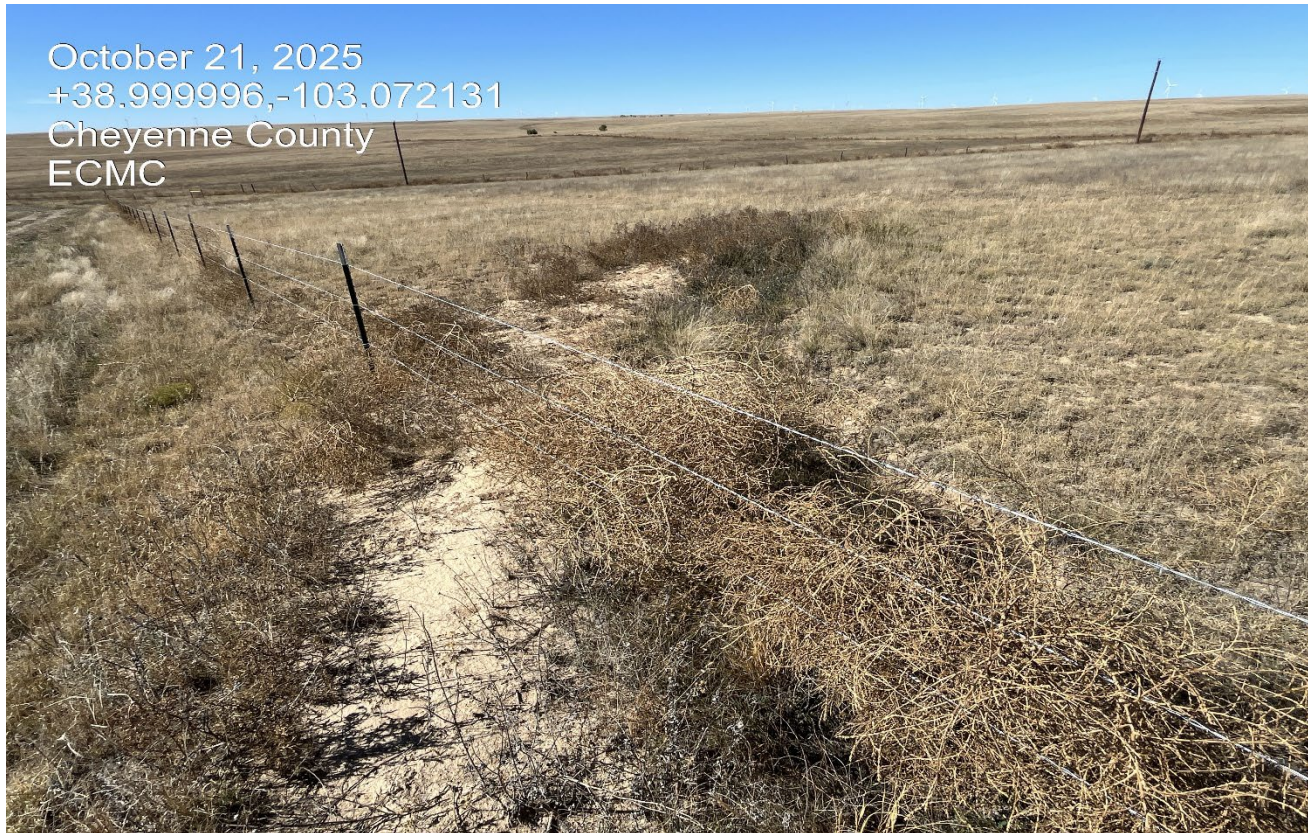
Photo 3. There are road side diversion ditches that were not regraded and reclaimed.

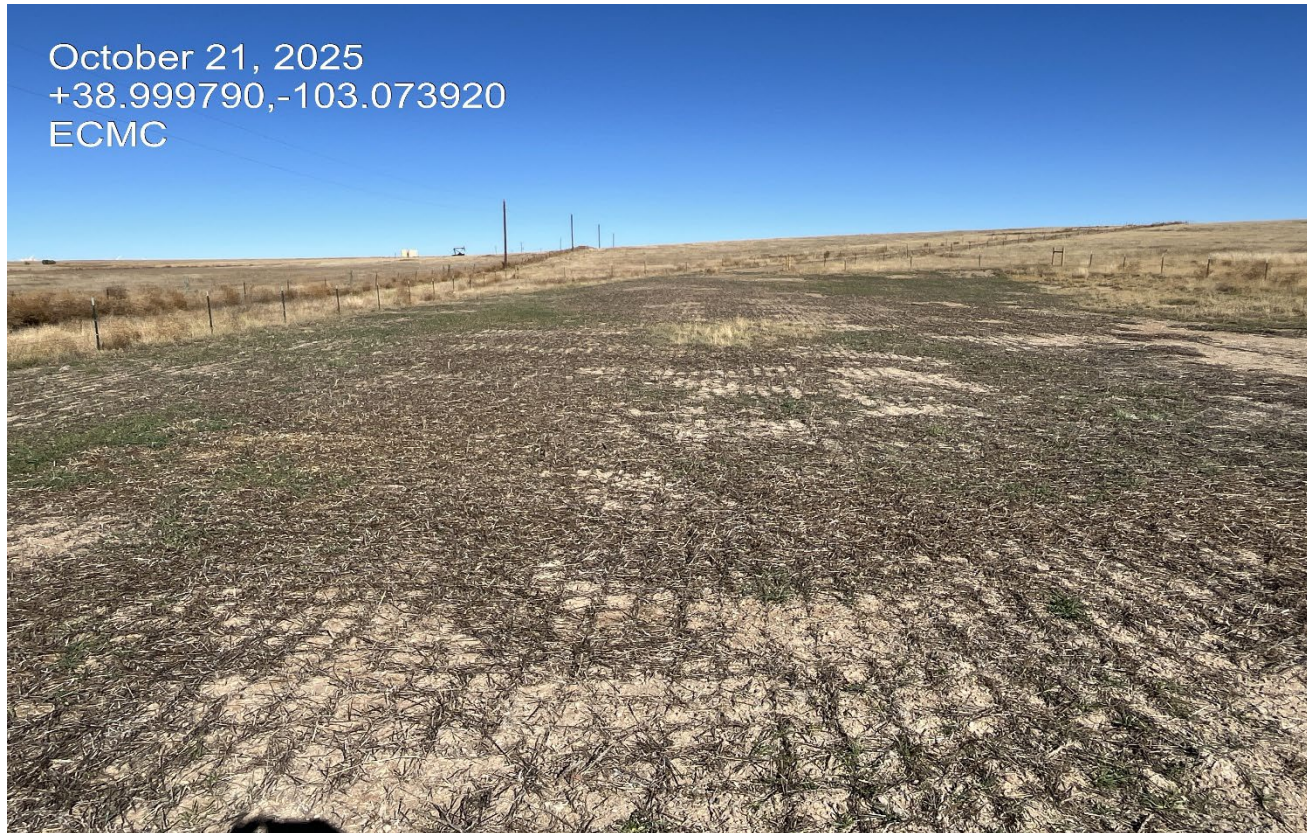
Photo 5. West side of the location facing east. There was some res of unknown vegetation establishing.
