# Inspection Photos

API: 017-07388

Operator: **CITATION OIL & GAS CORP**

Inspection Date: 10/21/2025

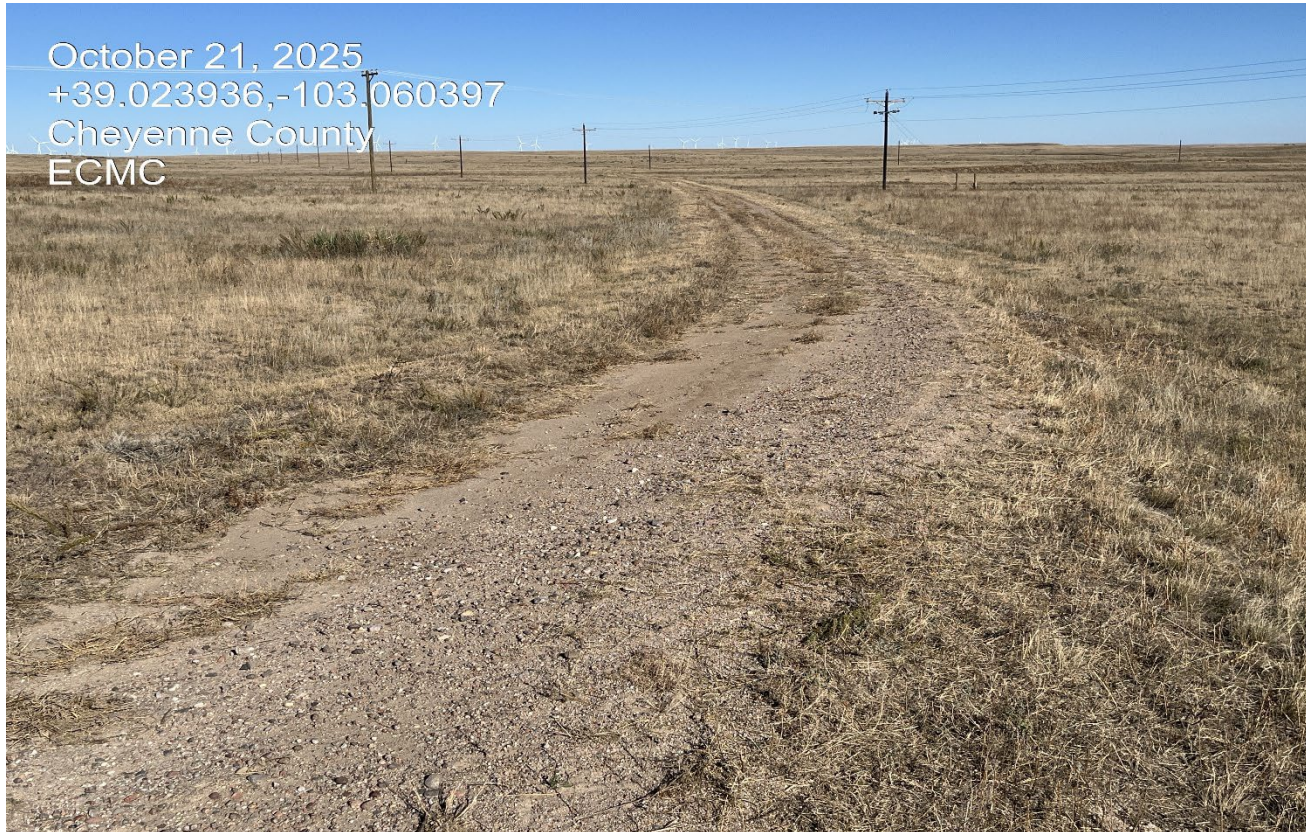
**Photo 1.** Facing east toward the access road. Operator has indicated that a variance will be sought for the road to remain. It does not appear a variance application has been submitted.

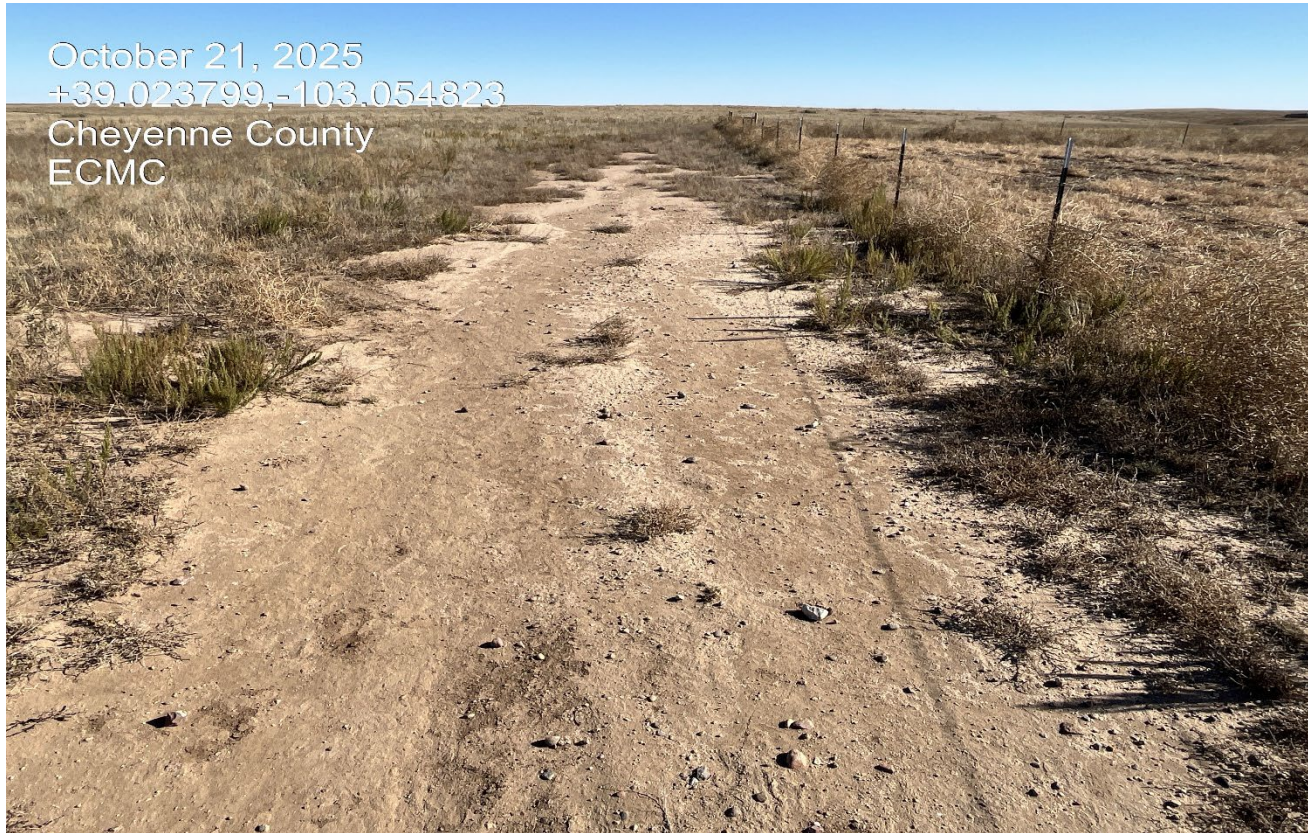
**Photo 2.** Facing south toward the location. The access road continues thru the location however this area should be reclaimed back to a two track road.

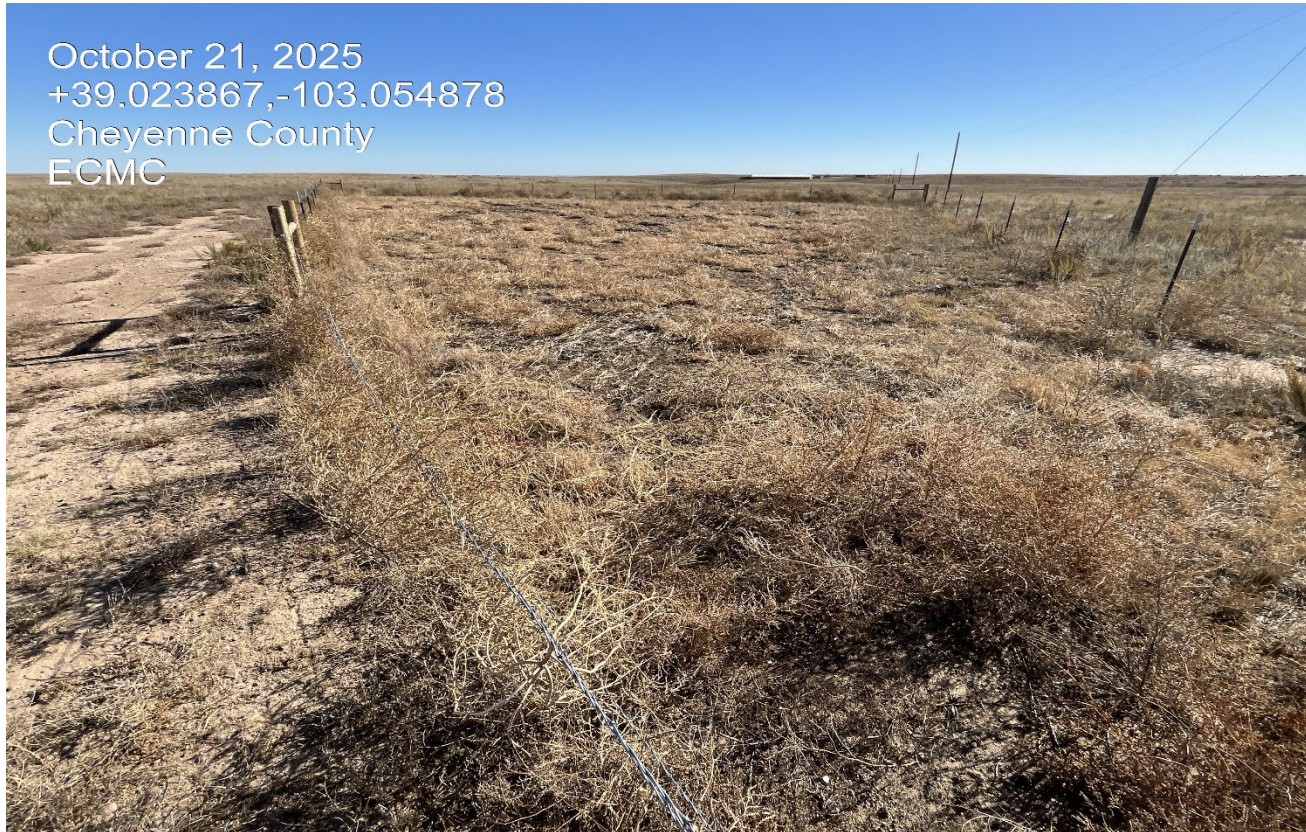
**Photo 3.** Facing south at the location. The reclaimed area consists mostly of undesirable weeds. It appears the weeds have been mowed but weed debris should also be removed from the fence.

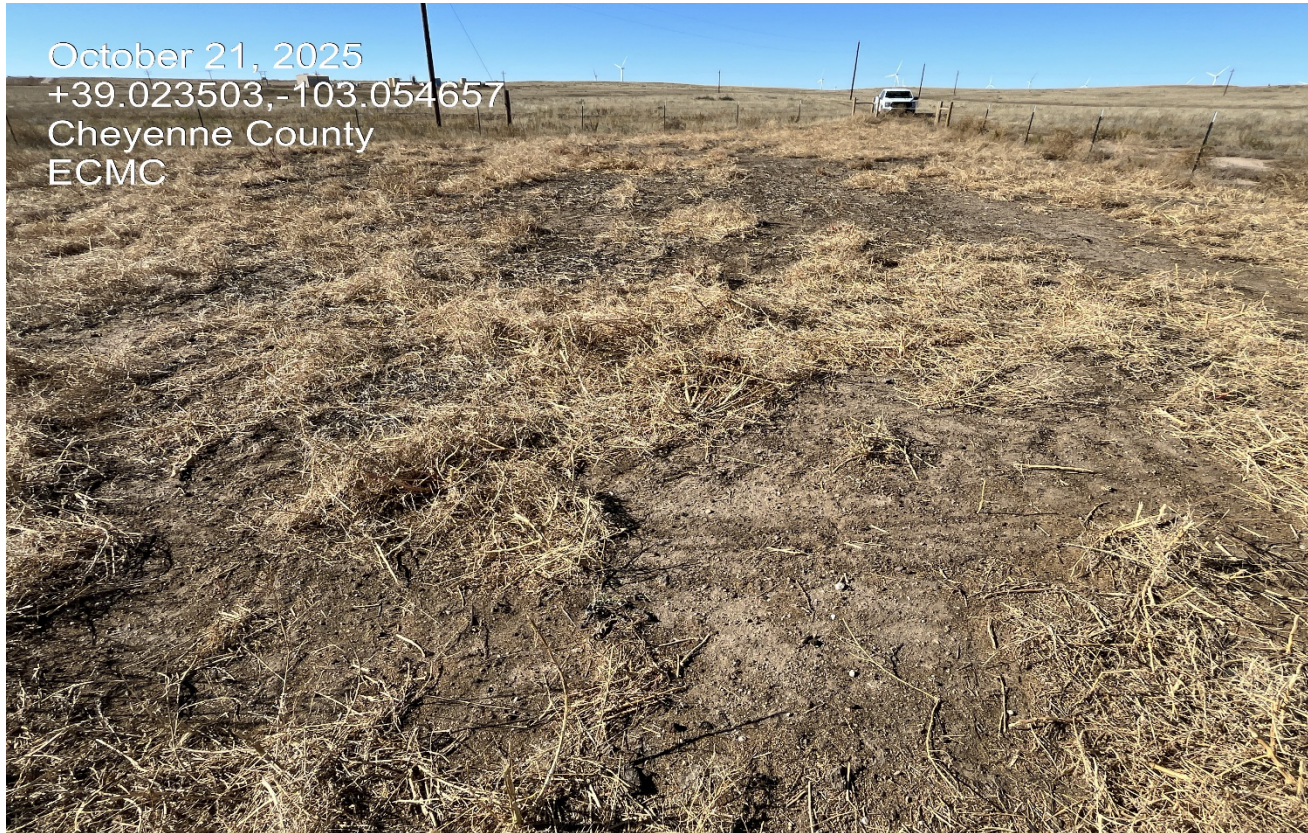
**Photo 4.** Facing north at the location. The reclaimed area consists mostly of undesirable weeds and will need reseeding.

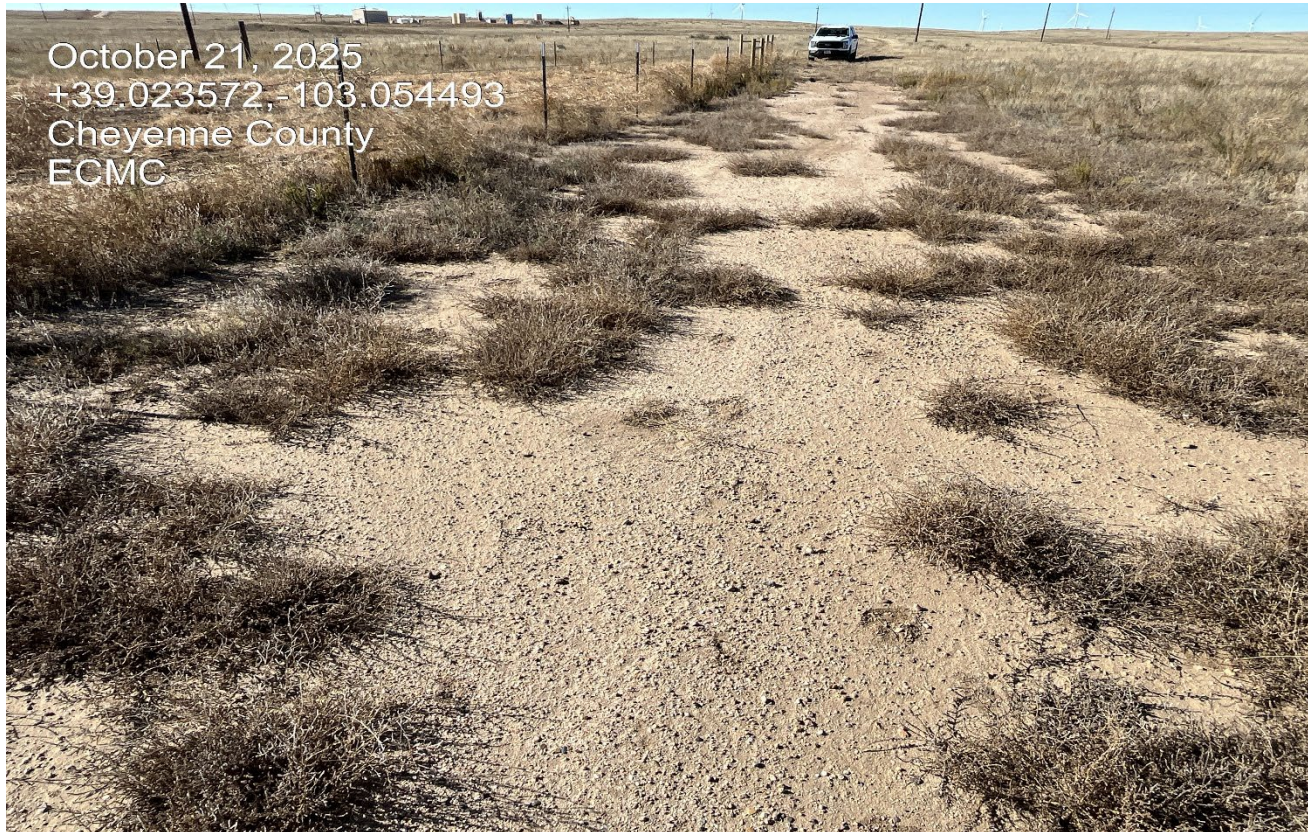
**Photo 5.** Facing north at the location. The access road continues thru the location however this area should be reclaimed back to a two track road.
