# Inspection Photos

**Operator:** SWN Production Company LLC

**Location ID:** 313329

**Inspection Doc:** 719200360

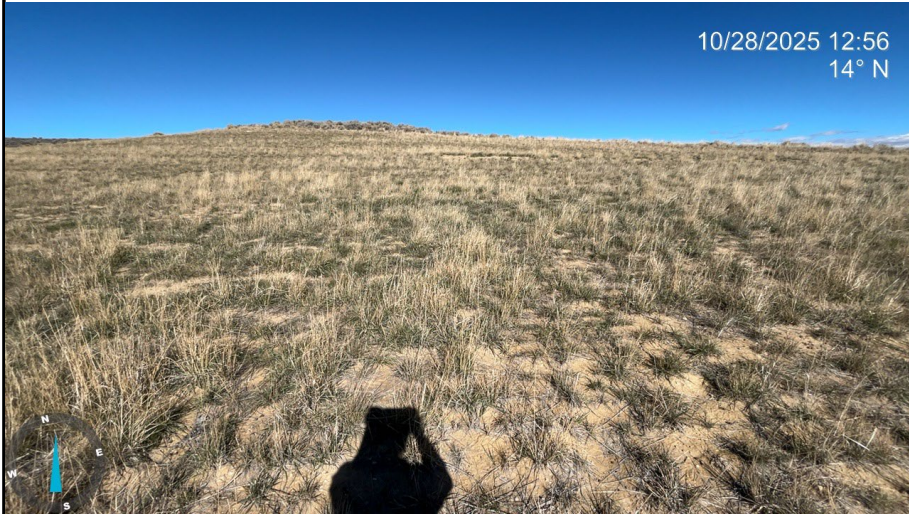
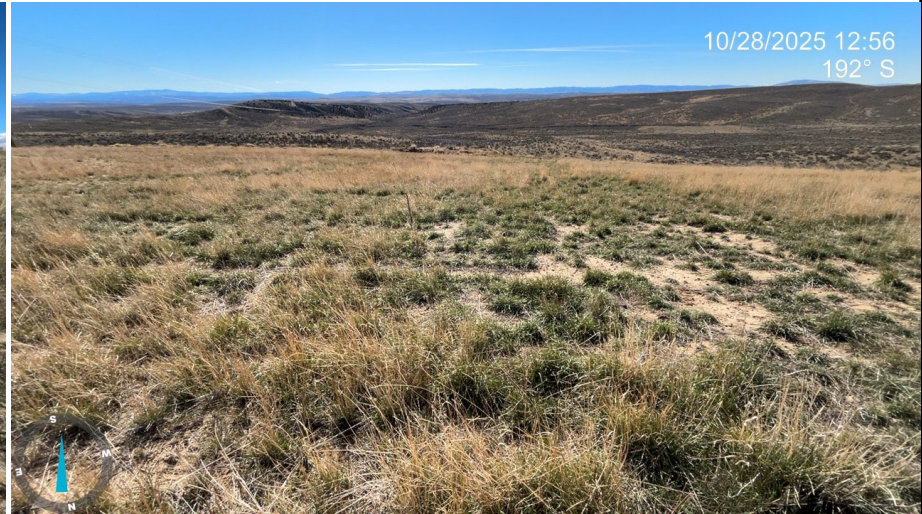
**Photo 1:** Photos showing an overview of the location looking north and south, respectively.

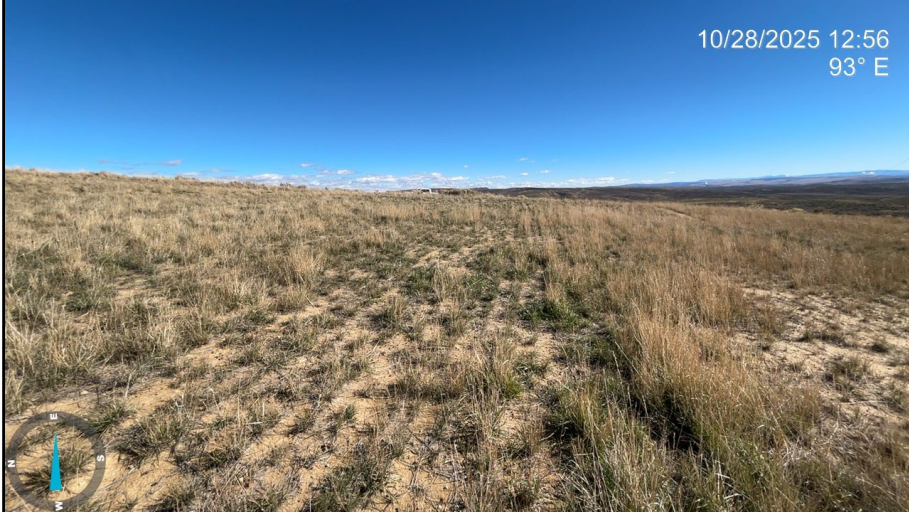
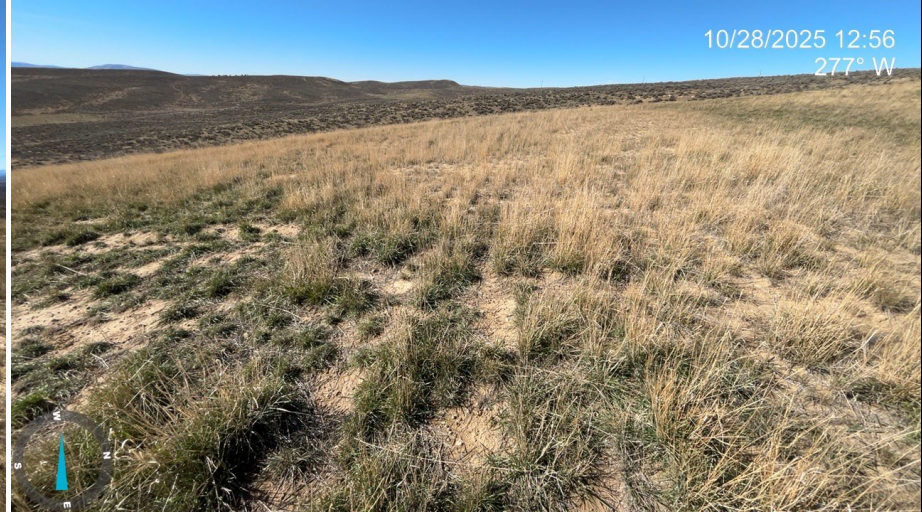
**Photo 2:** Photos showing an overview of the location looking east and west, respectively.

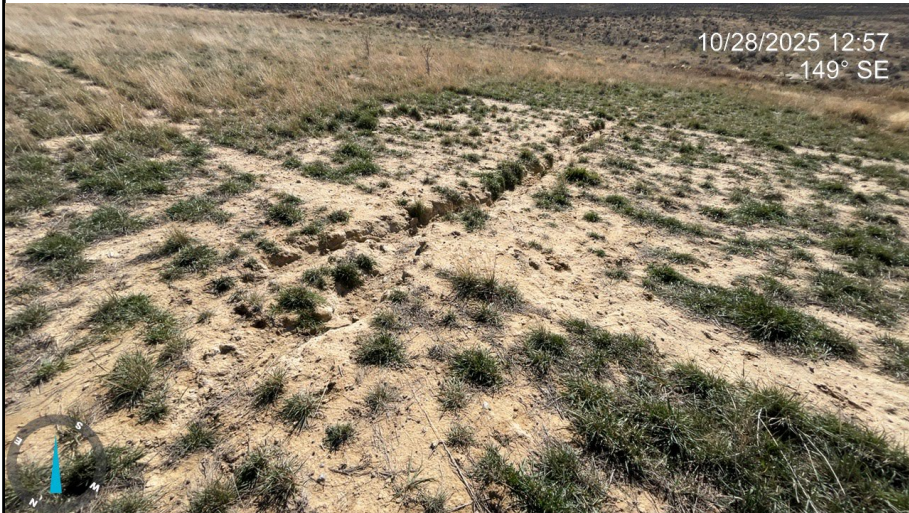
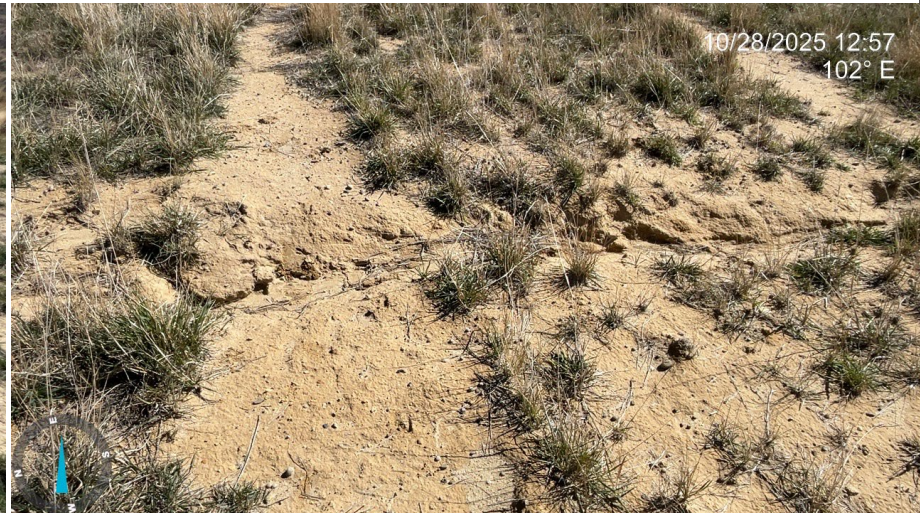
**Photo 3:** Photos showing portions of the location that are not progressing towards 1004 requirements; erosion and rilling is evident. Ongoing stormwater management is required until Final Reclamation has passed.

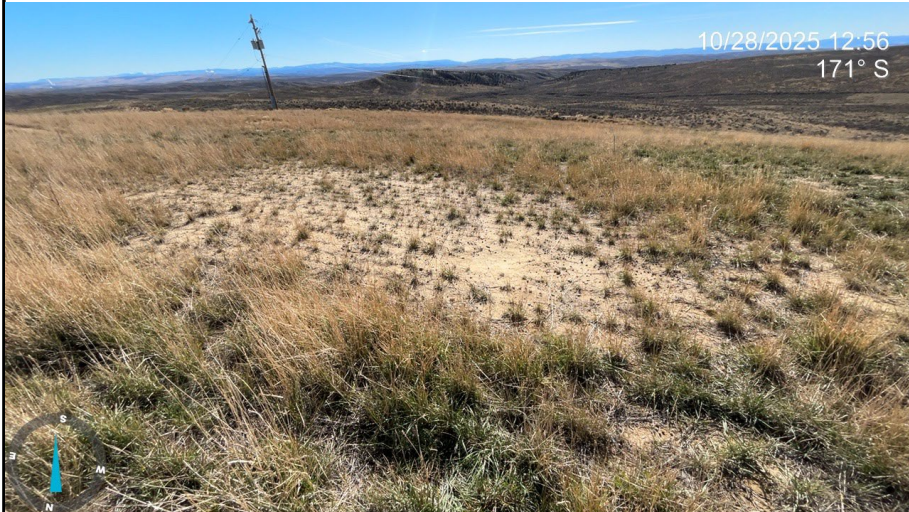
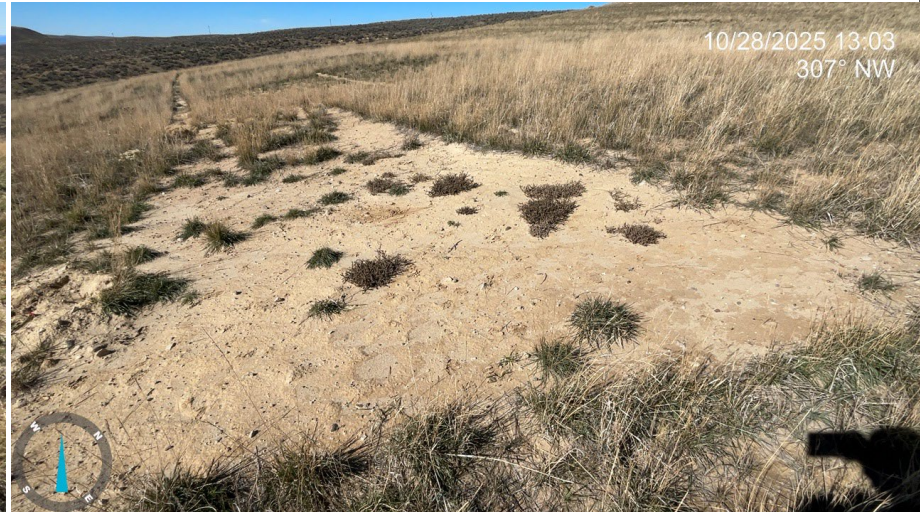
**Photo 4:** Photos showing examples of portions of the location that are not progressing towards 1004 requirements; uniformity is not evident and undesirable plant species, such as prickly Russian thistle, has established in some areas.

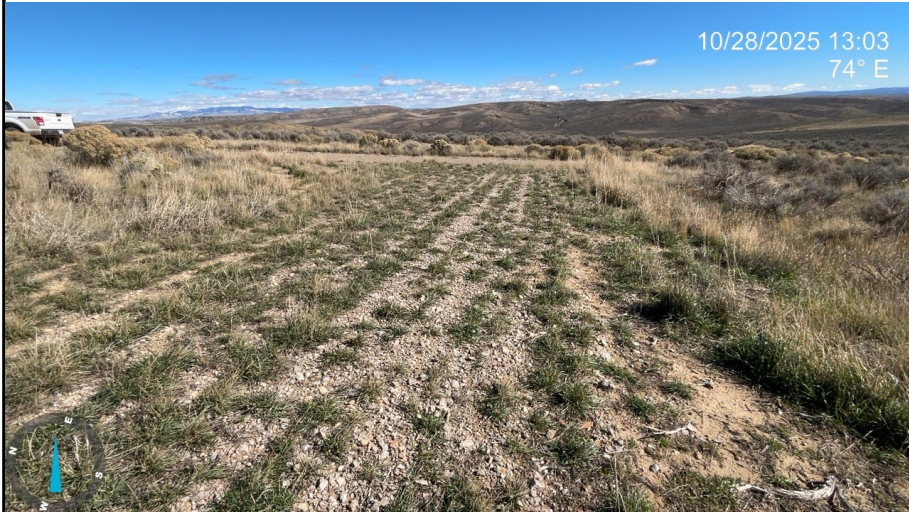
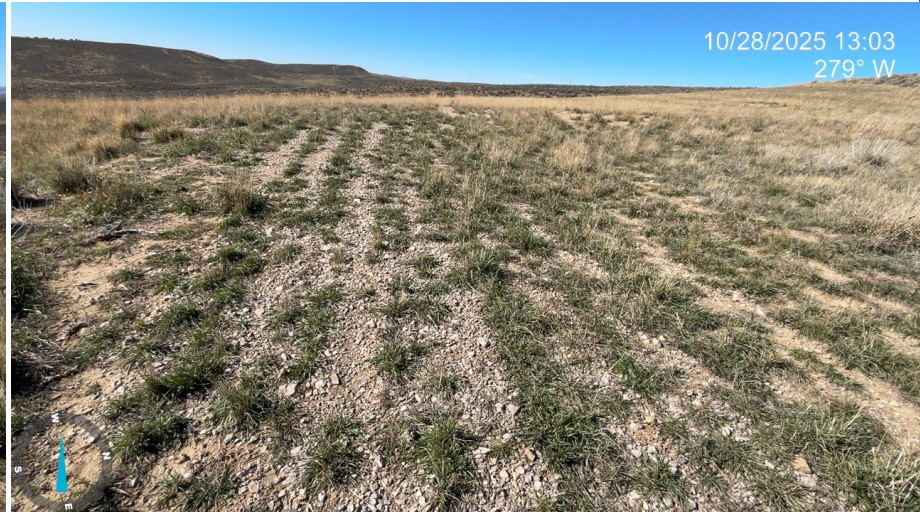
**Photo 5:** Photos showing the access road leading to the location has not been reclaimed per 1004 Rules. Operator appears to have seeded directly onto the road; gravel/compaction is evident.

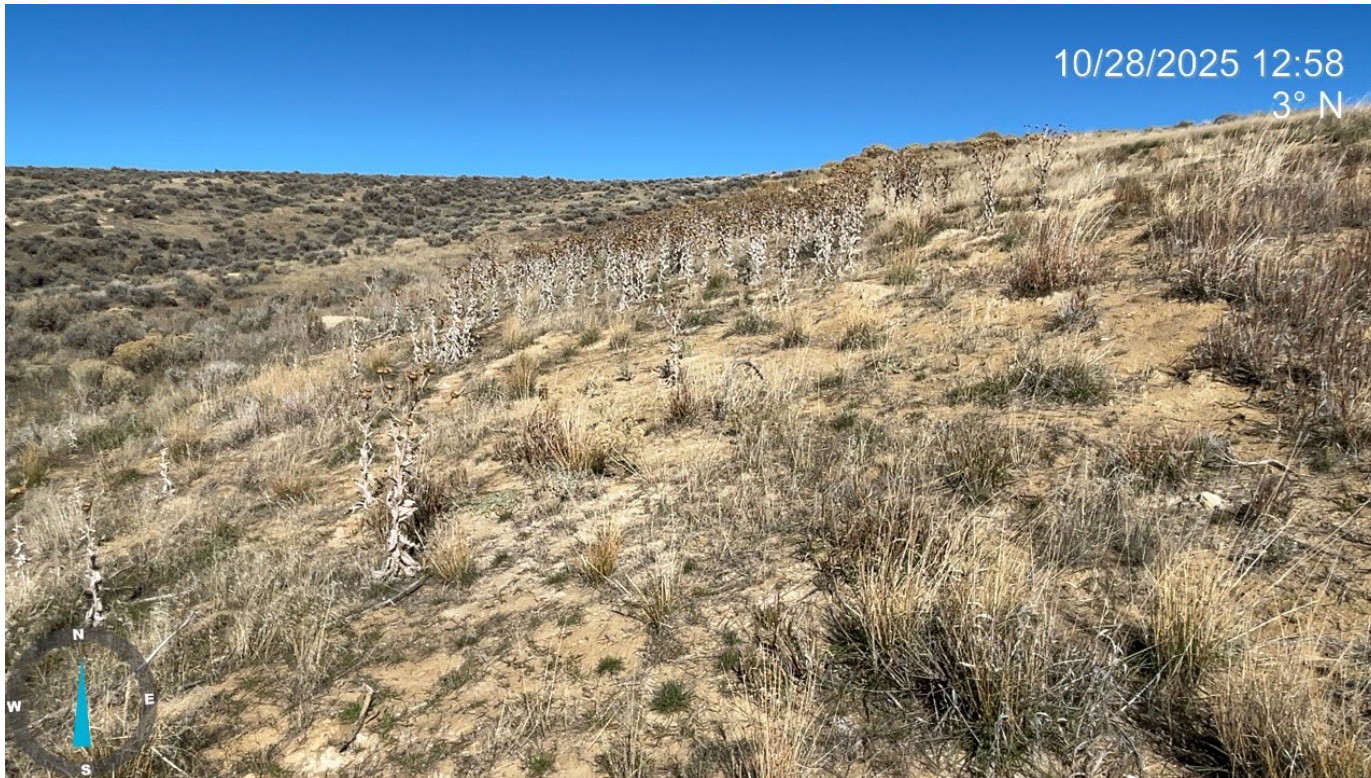
**Photo 6:** Photo showing the western portion of the location looking north; Scotch thistle, a List B noxious weed, has infested the hillside. It does not appear as though weed control has been performed in 2025.

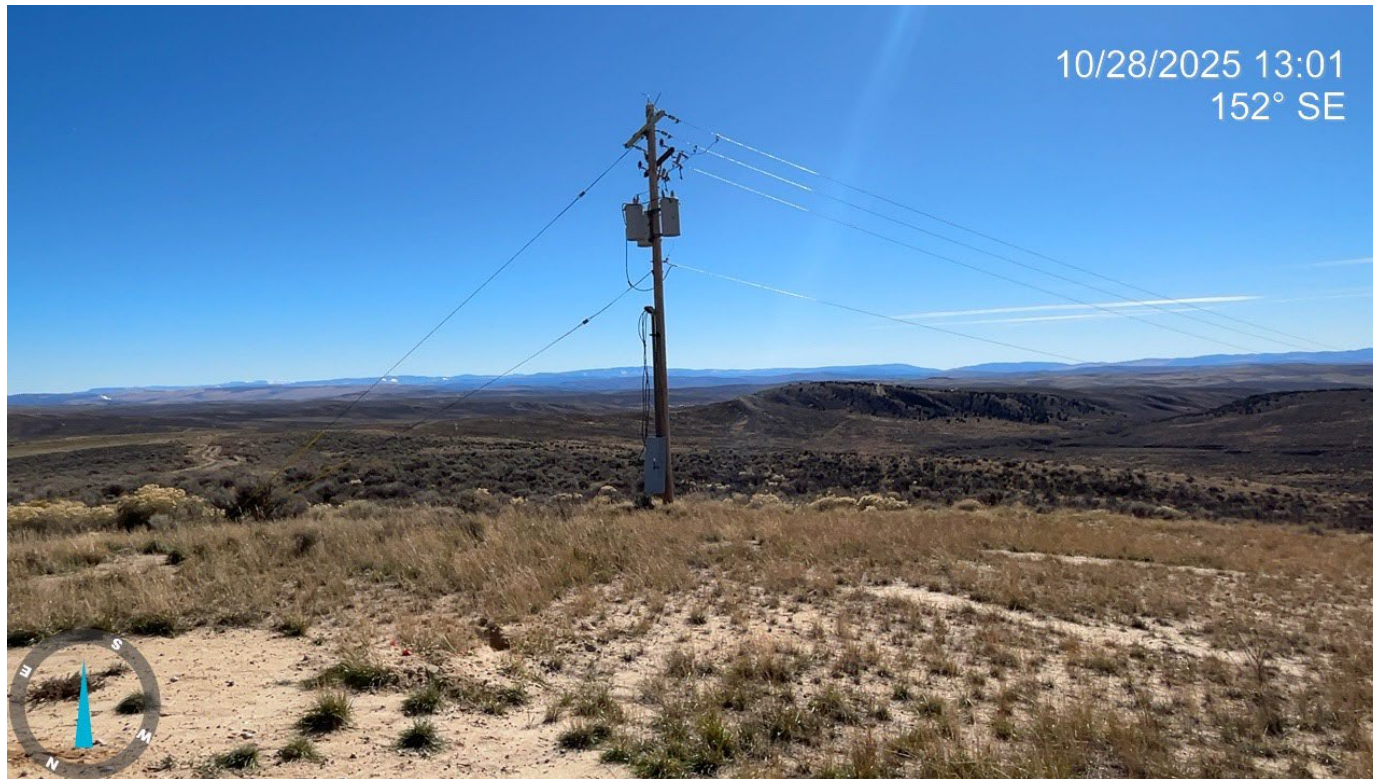
**Photo 7:** Utility equipment that is no longer in use remains at the location and requires removal.

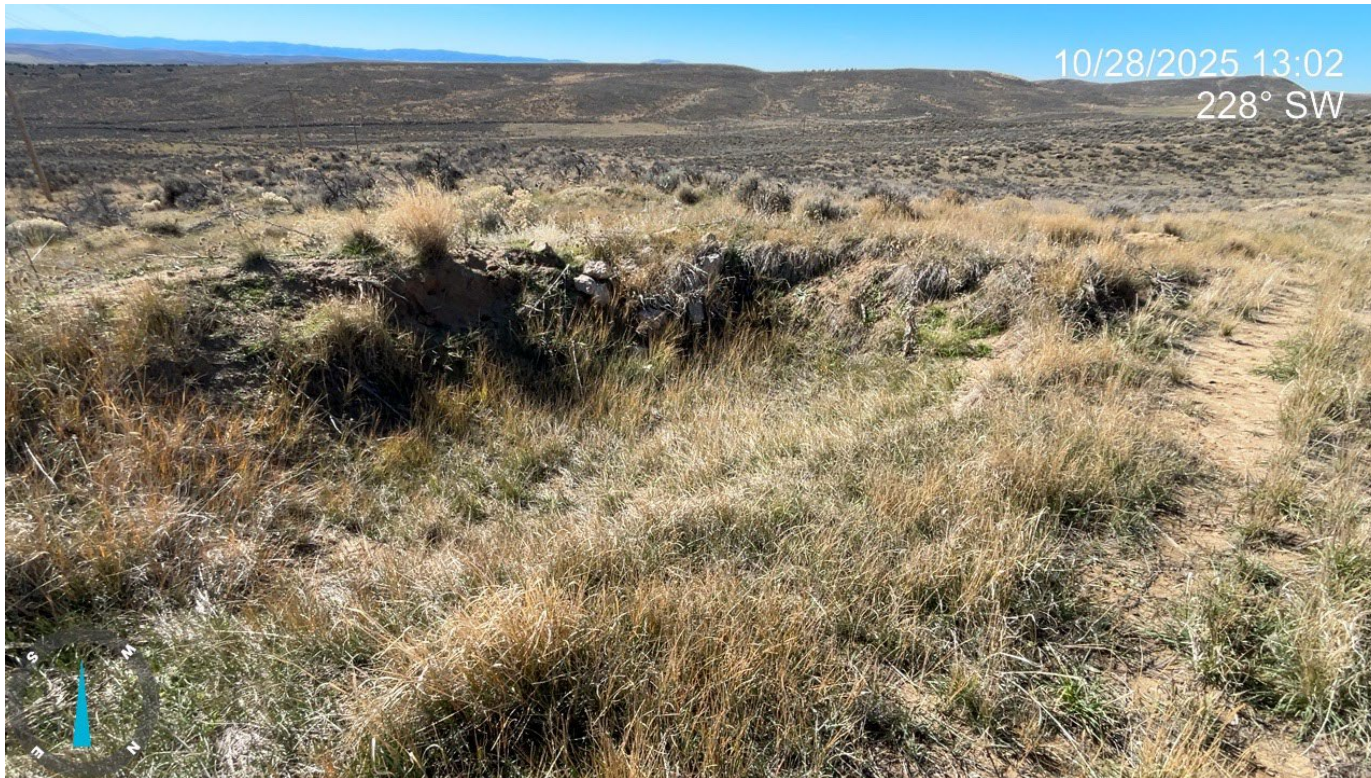
**Photo 8:** Photo showing an example of stormwater controls that remain on the southern end of the location. The location has not been reclaimed per 1004 Rules.

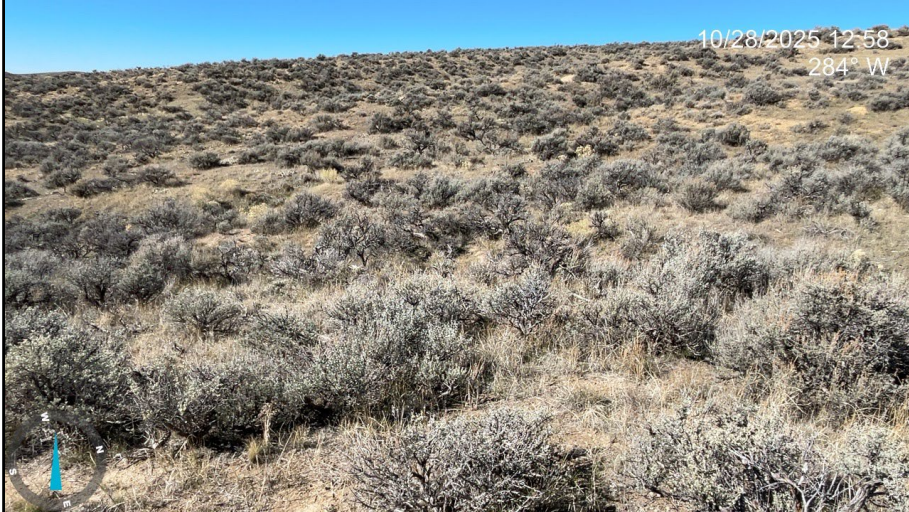
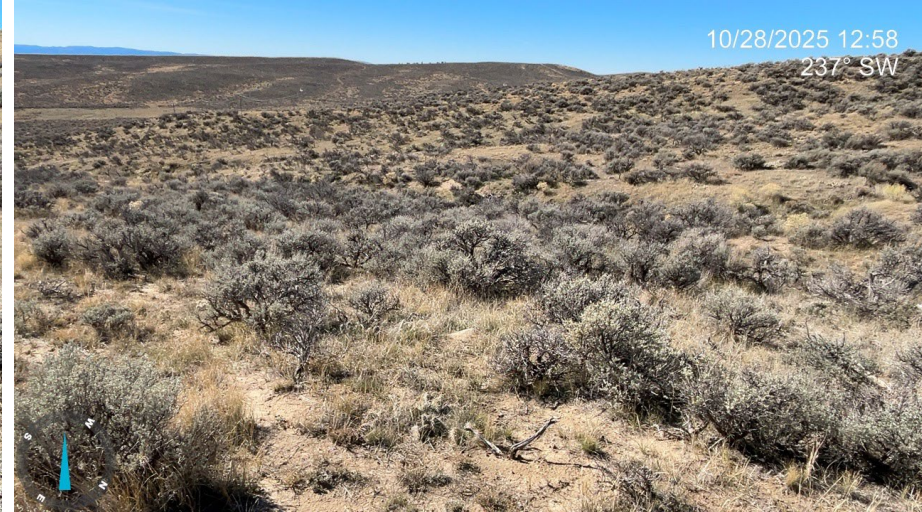
**Photo 9:** Photos showing an example of the reference area, located to the west of the location, characterized by big sagebrush shrublands. Big sagebrush is dominant.
