Inspection Photos

Operator: SWN Production Company LLC

Location ID: 313328

Inspection Doc: 719200362

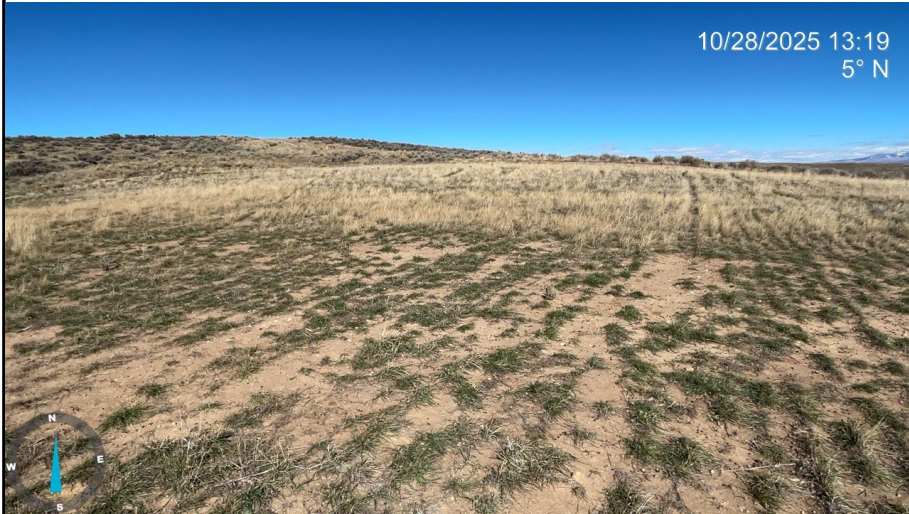
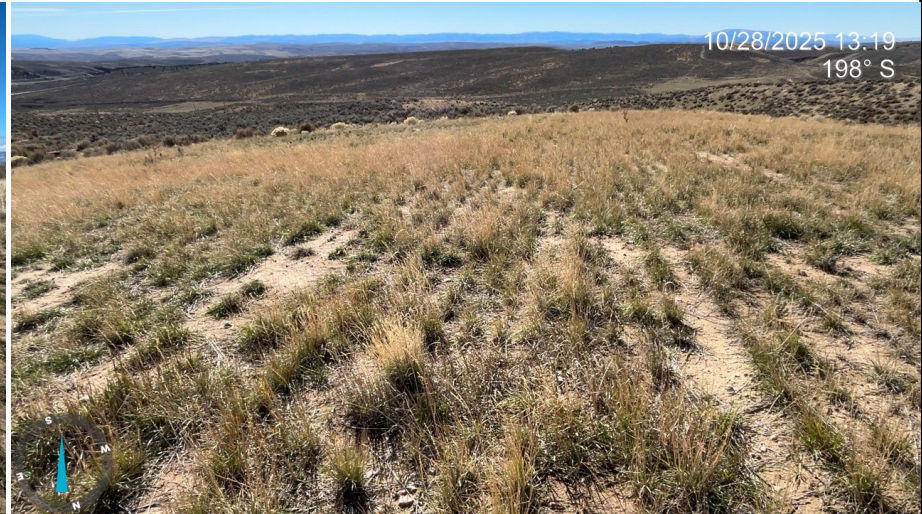
Photo 1: Photos showing an overview of the location looking north and south, respectively. Vegetation is not uniform throughout the location.

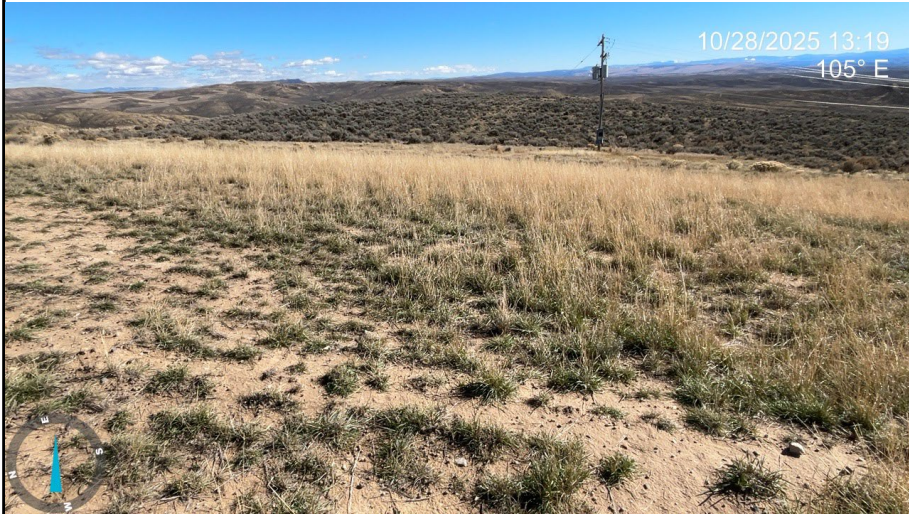
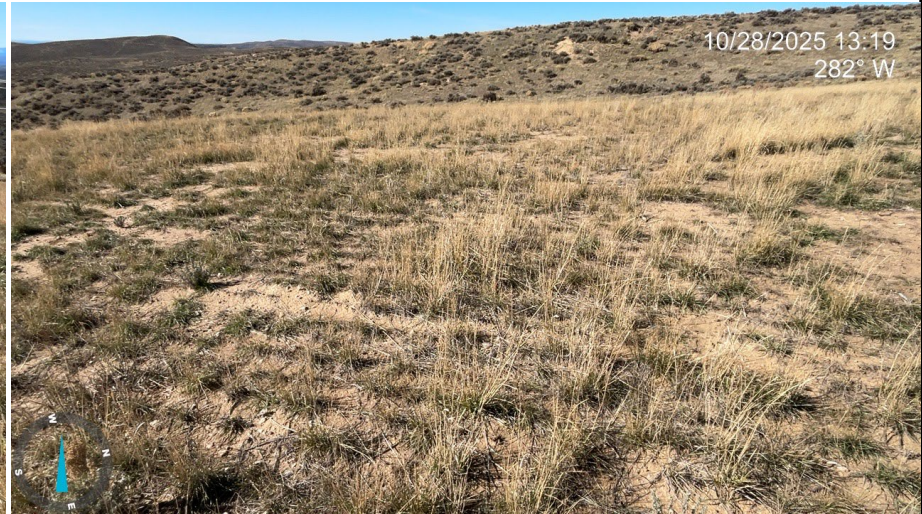
Photo 2: Photos showing an overview of the location looking east and west, respectively. Vegetation is not uniform throughout the location.

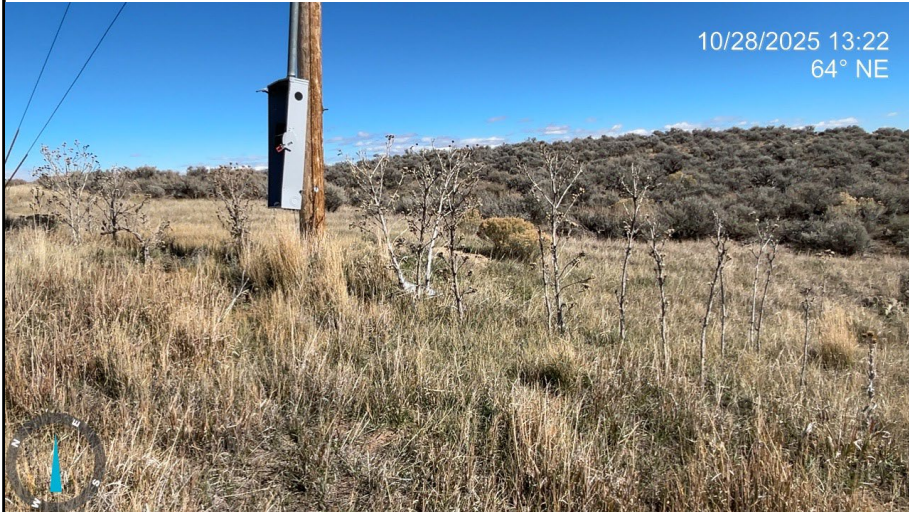
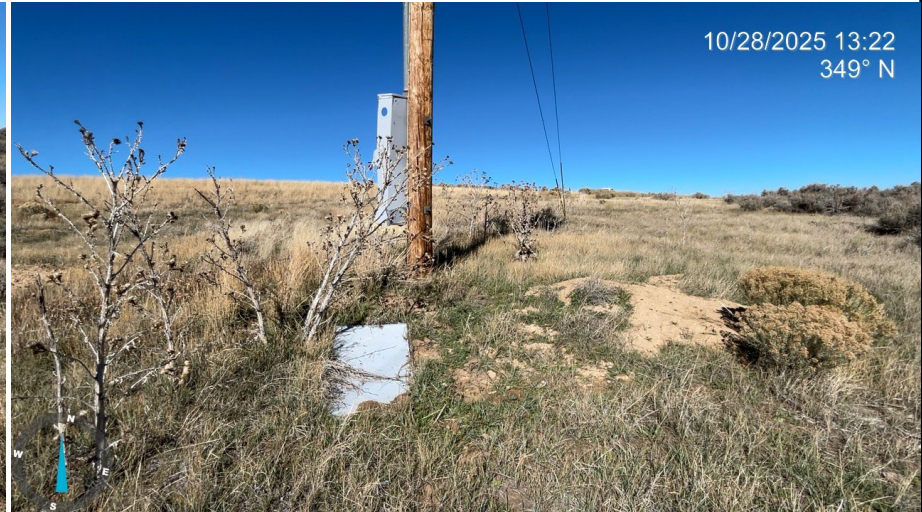
Photo 3: Photo left showing an example of Scotch thistle, a List B noxious weed, is present throughout the location. Photo right shows location signage remains at the location and requires removal.

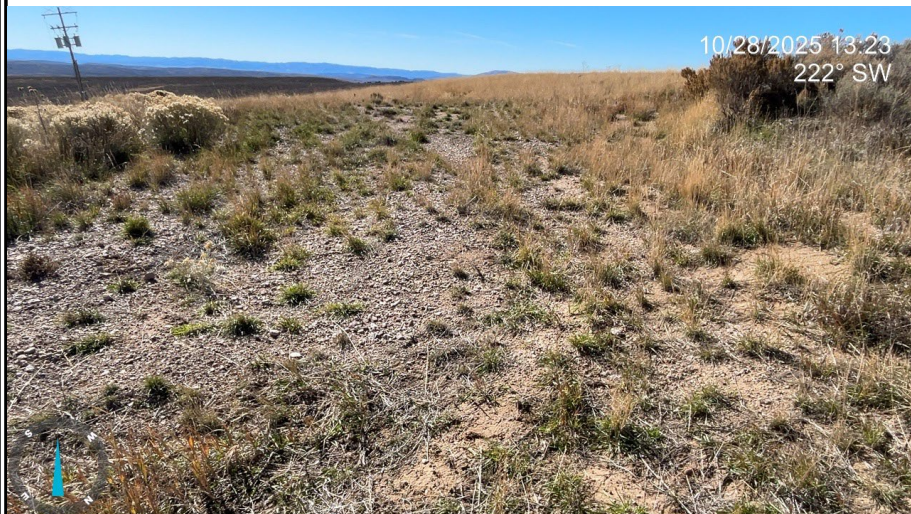
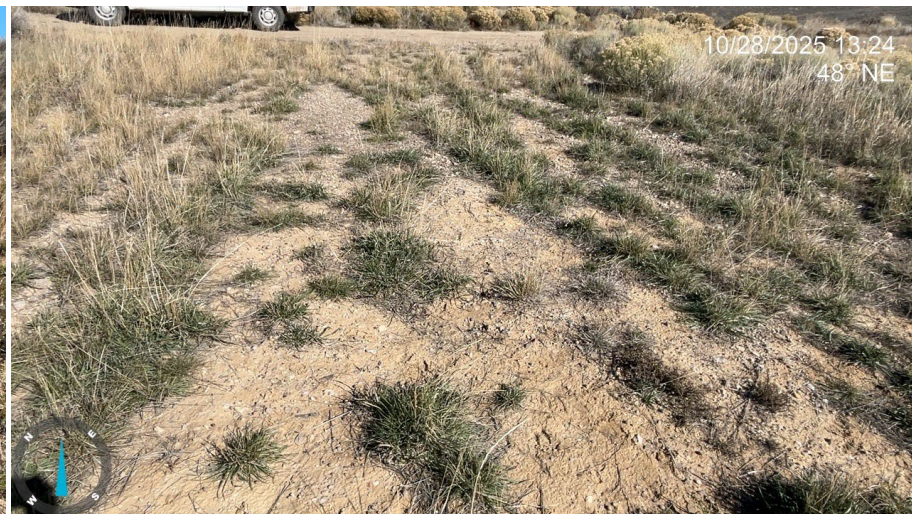
Photo 4: Photos showing the access road leading to location has not been reclaimed per 1004 Rules. Operator appears to have seeded directly onto the road; gravel/compaction is evident.

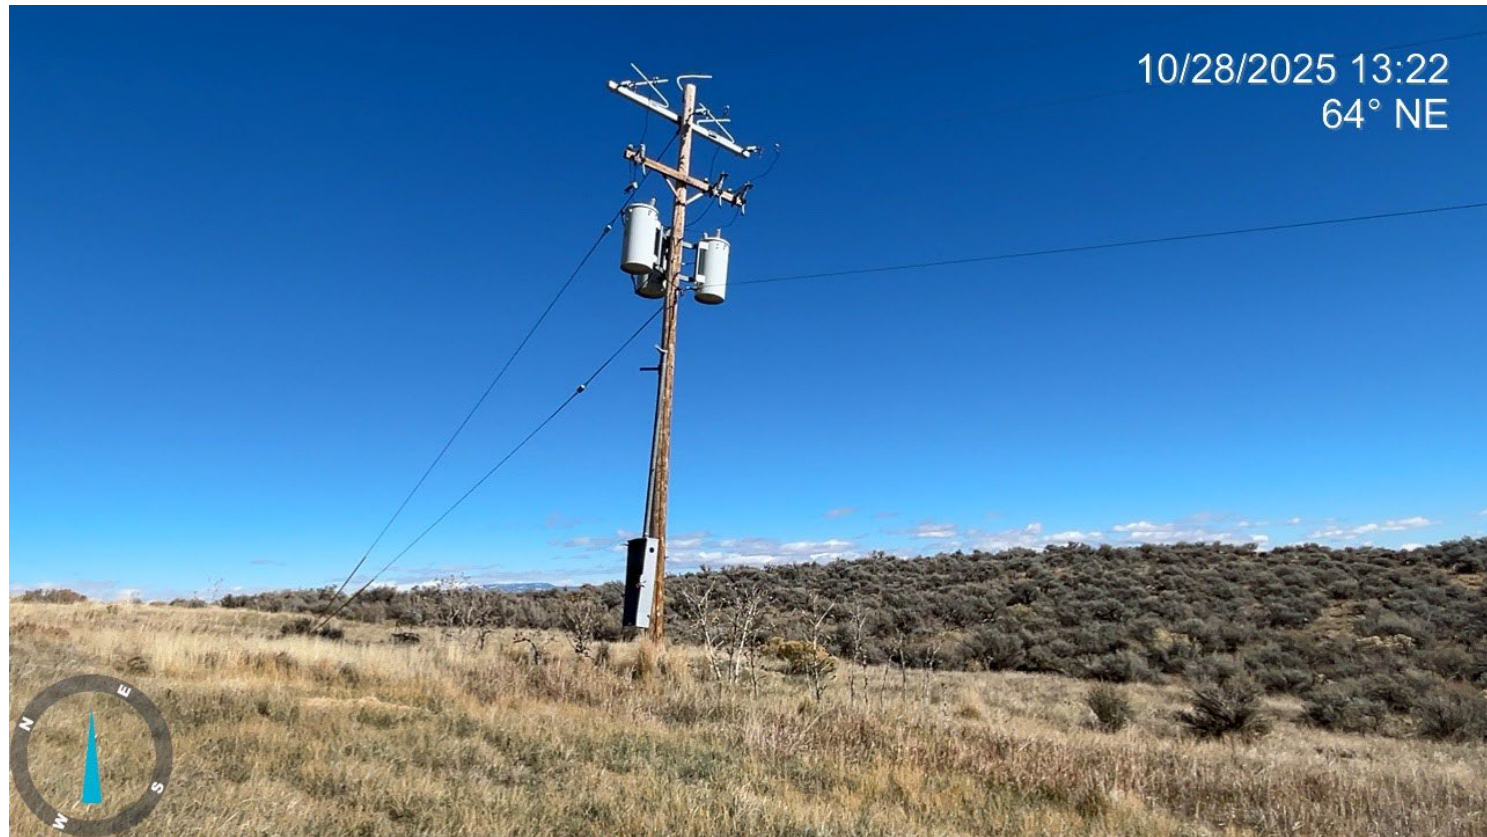
Photo 5: Photo showing an example of utility equipment that remains at the location and requires removal.

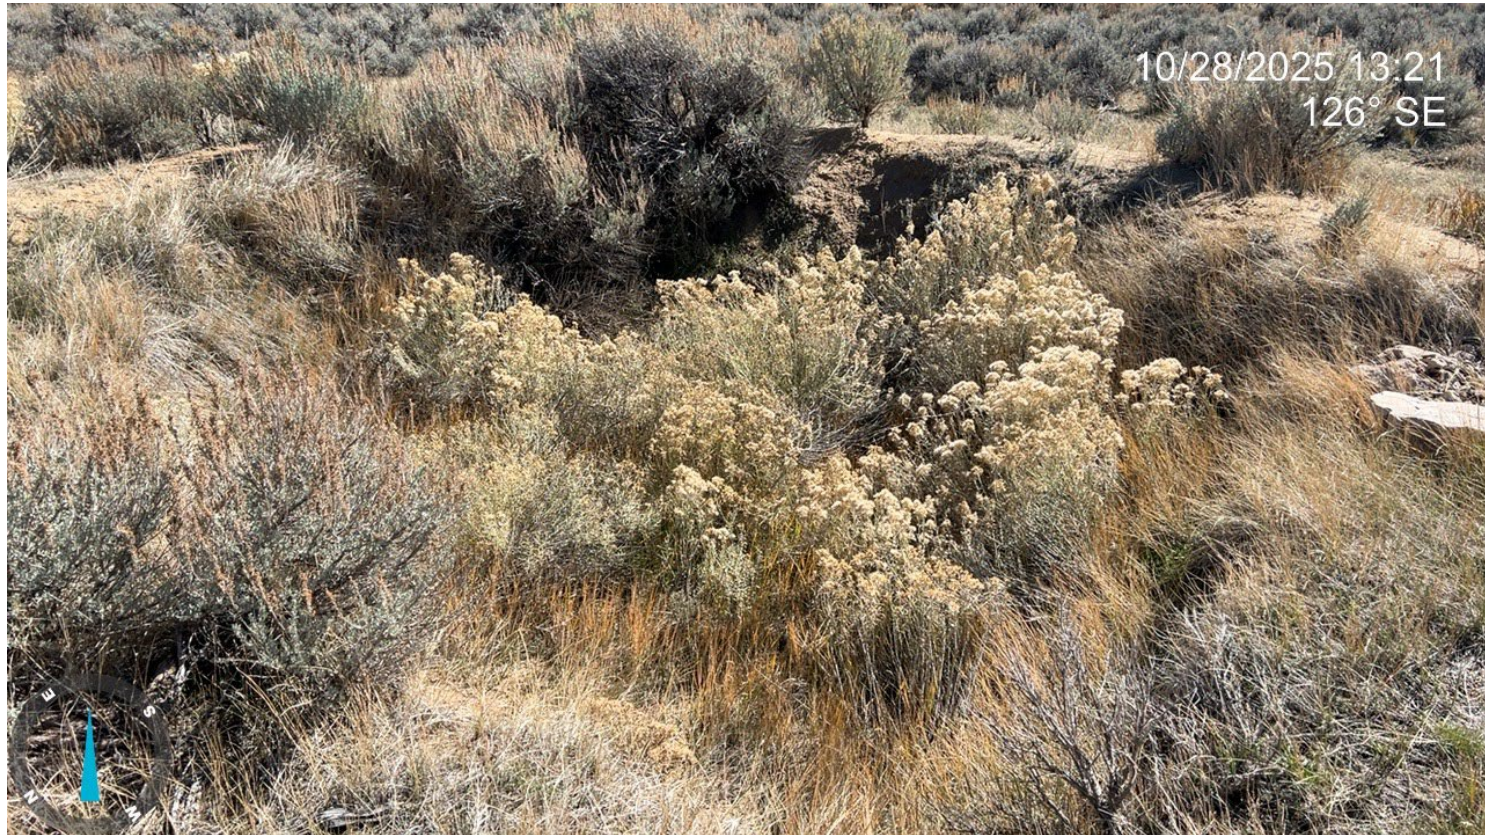
Photo 6: Photo showing stormwater controls are present at the southern end of the location.

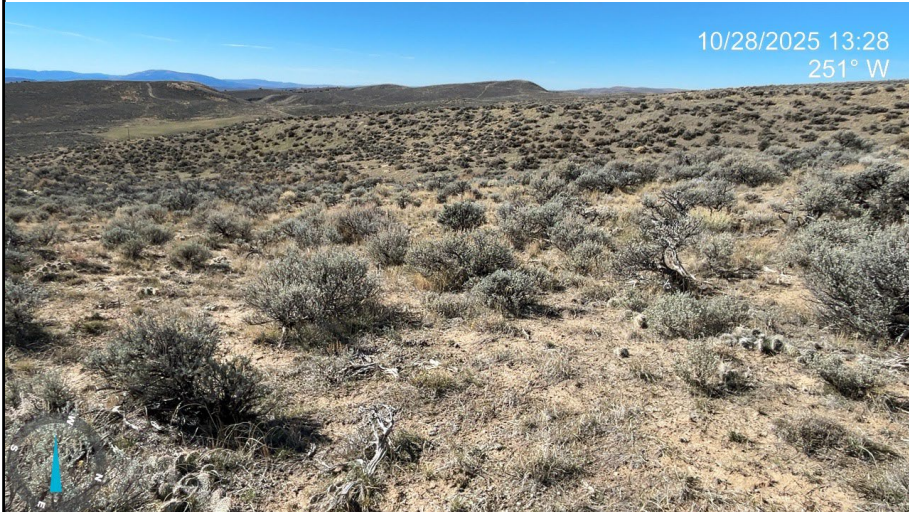
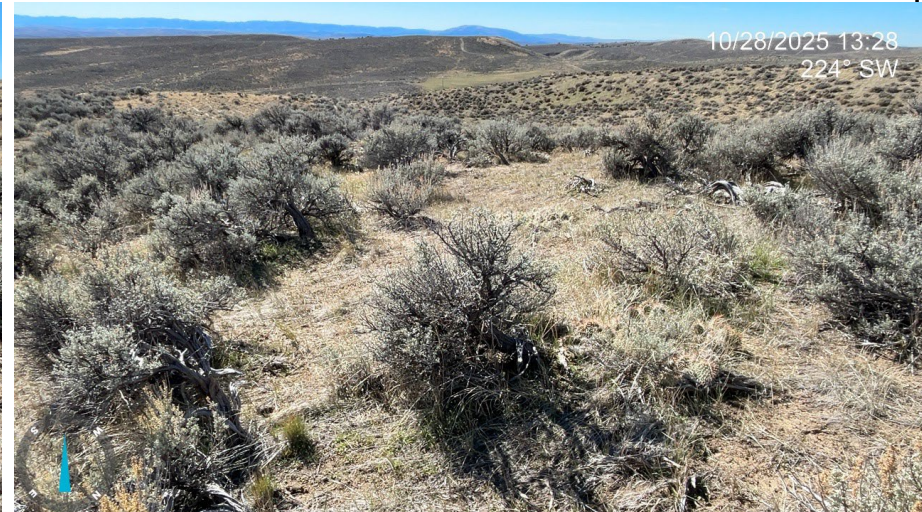
Photo 7: Photos showing an example of the reference area, located to the west of the location, characterized by big sagebrush shrublands. Big sagebrush is dominant.
