# Inspection Photos

**Operator:** SWN Production Company LLC

**Location ID:** 313331

**Inspection Doc:** 719200364

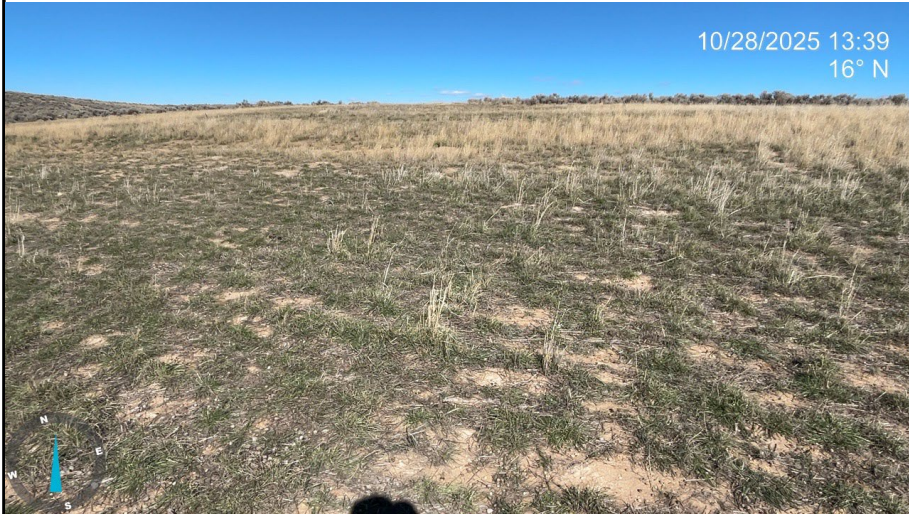
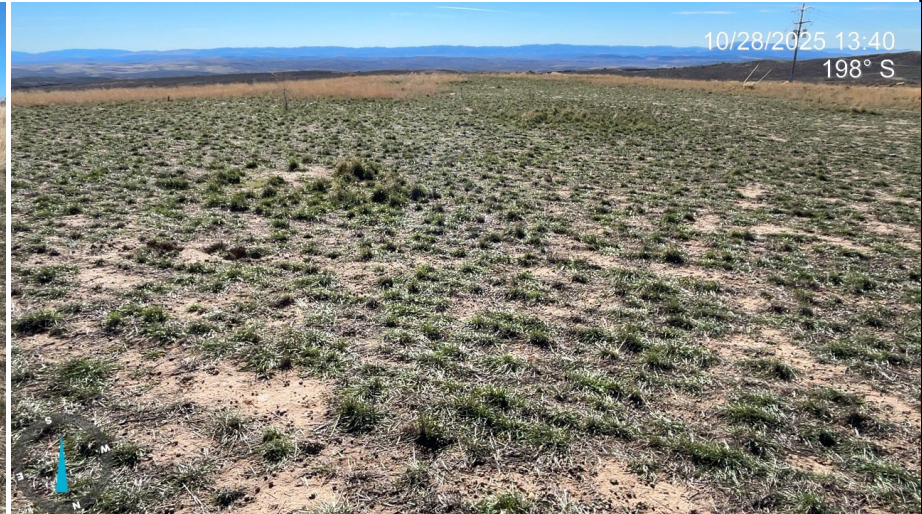
**Photo 1:** Photos showing an overview of the location looking north and south, respectively.

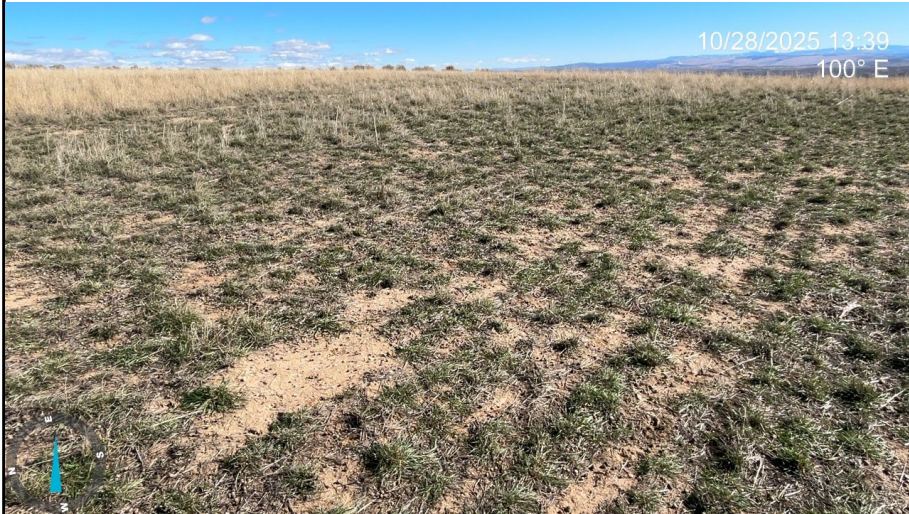
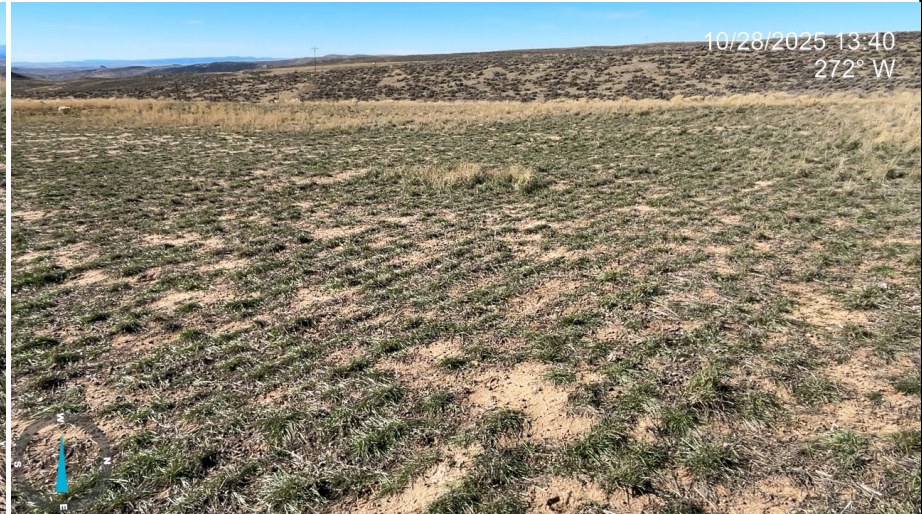
**Photo 2:** Photos showing an overview of the location looking east and west, respectively.

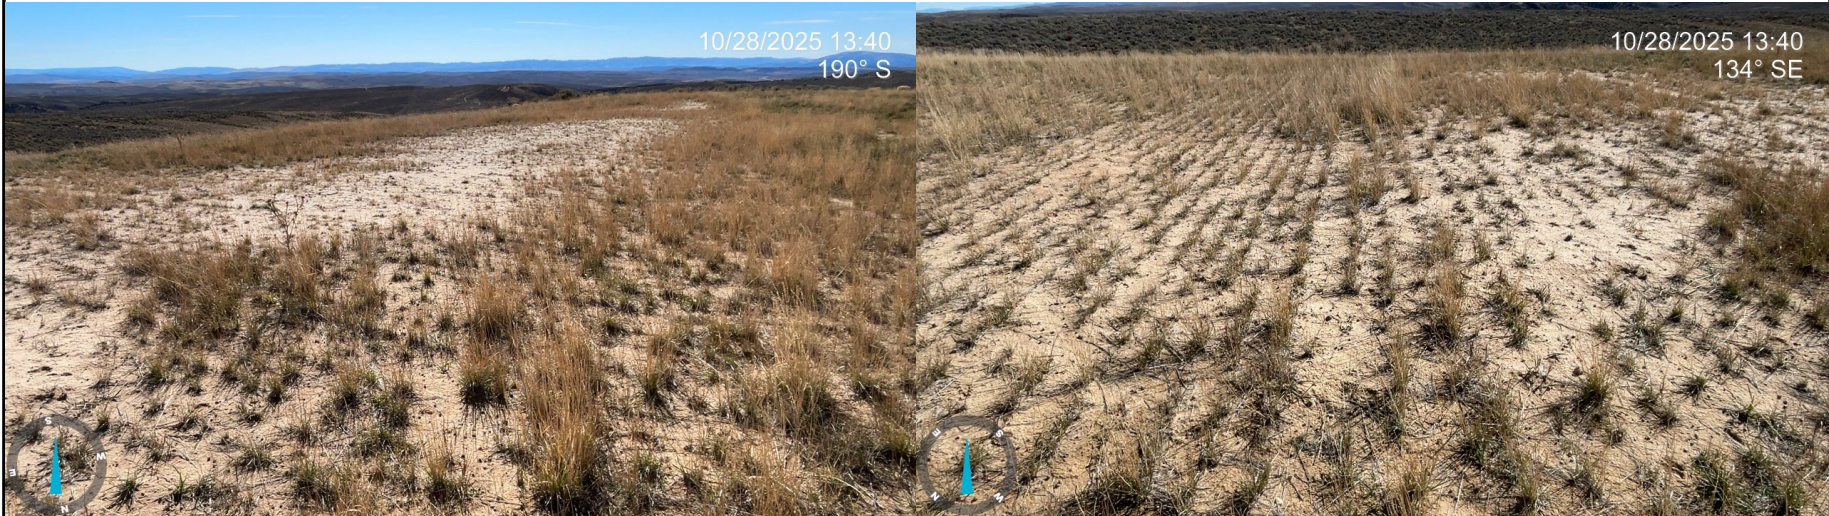
**Photo 3:** Photos showing an overview of the central portion of the location looking south and southeast, respectively. Vegetation is not progressing towards 1004 reclamation requirements; uniformity is not evident. These areas are at risk of erosion.

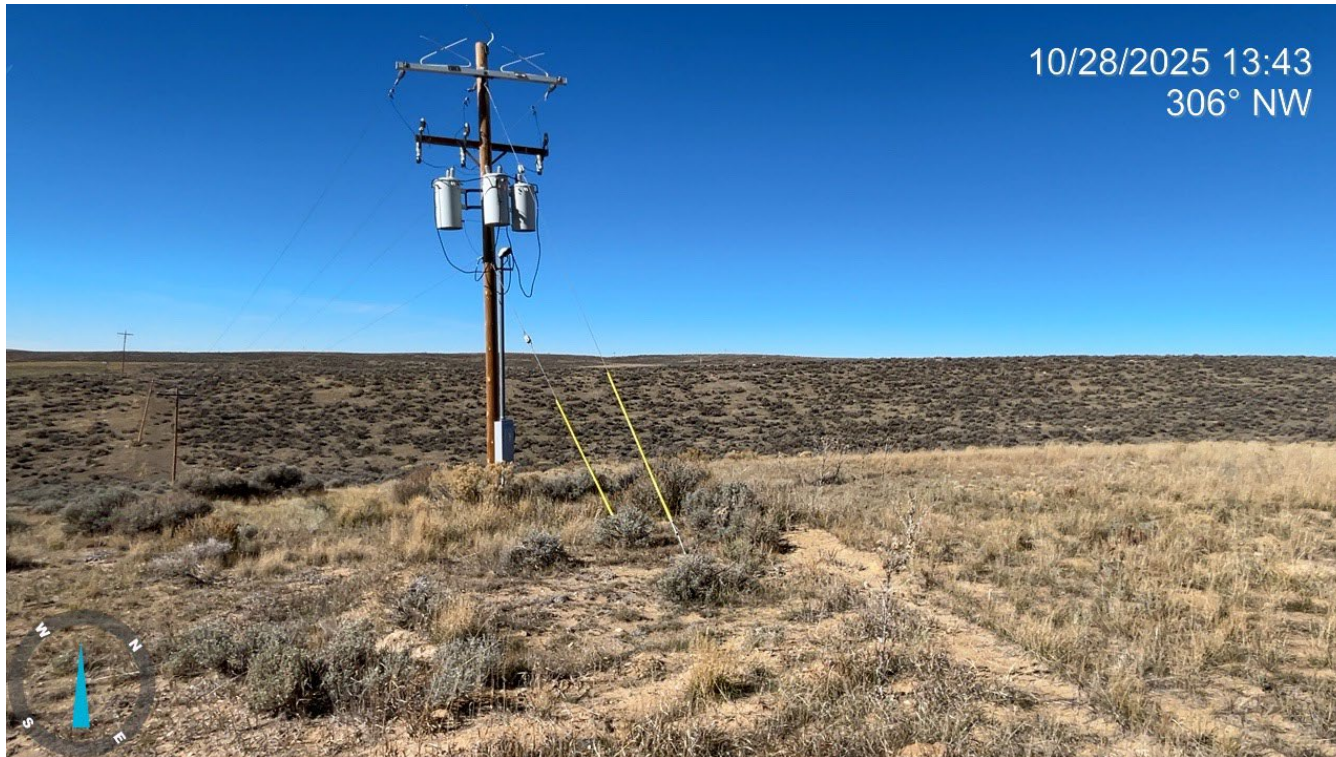
**Photo 4:** Photos showing an example of utility equipment that remains at the site and requires removal.

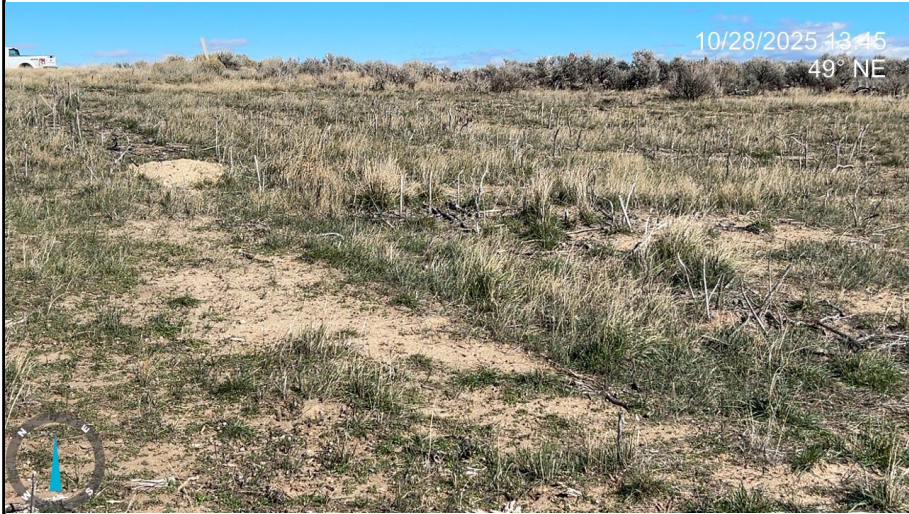
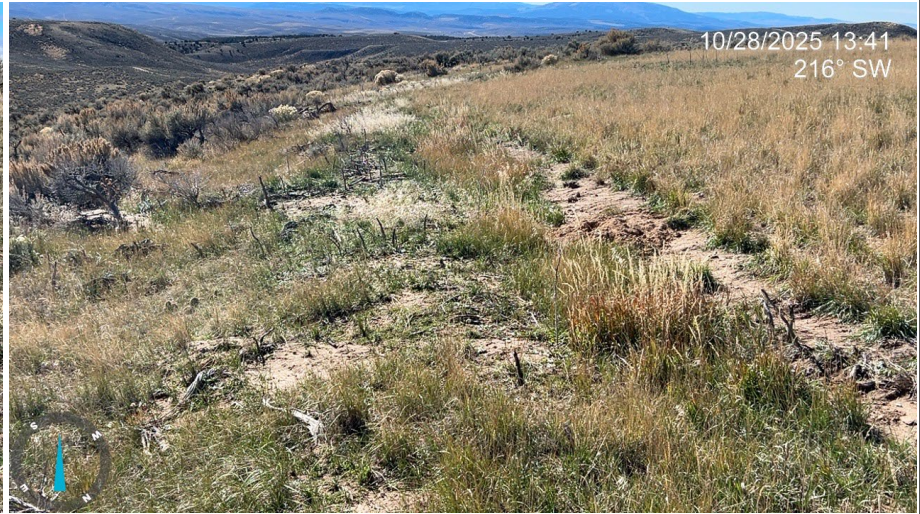
**Photo 5:** Photos showing an example of Scotch thistle, a List B noxious weed species, that is present throughout the location. Comply with Rules 1004.e. and 606.c.

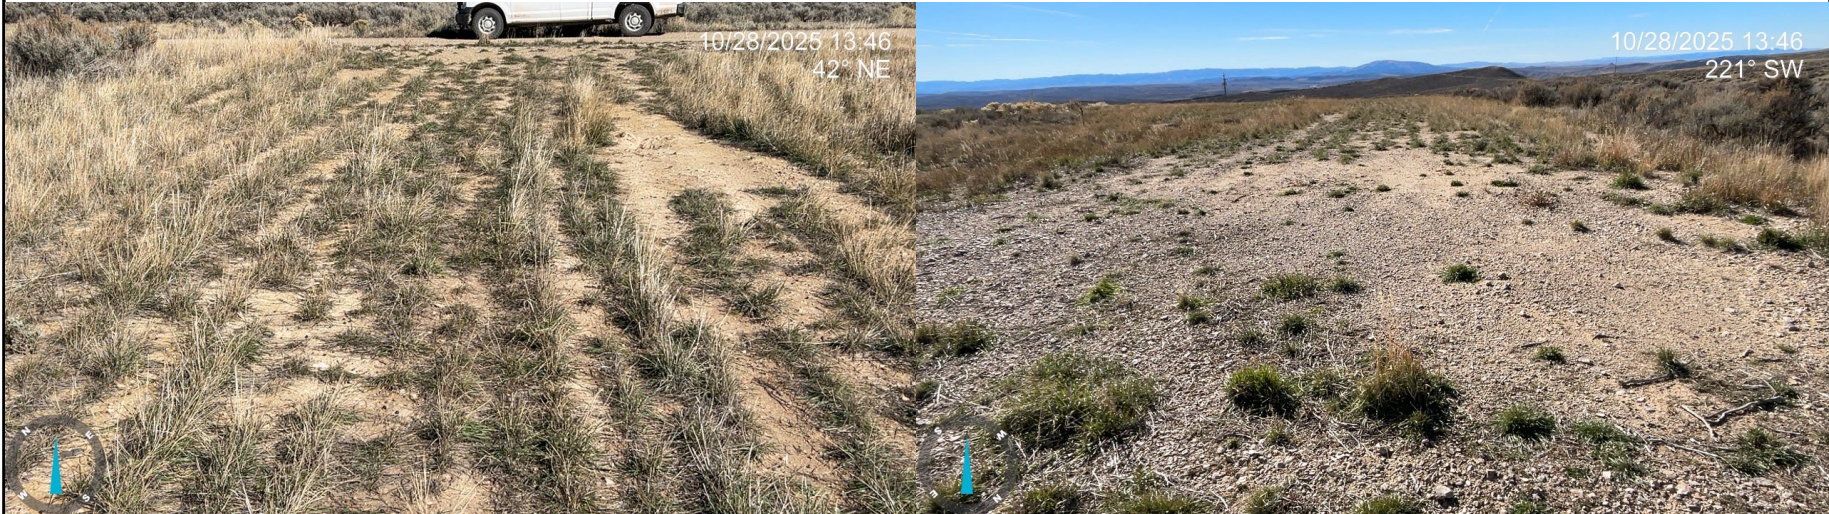
**Photo 6:** Photos showing the access road leading to the location. Operator appears to have seeded directly onto the road; gravel/compaction is evident.

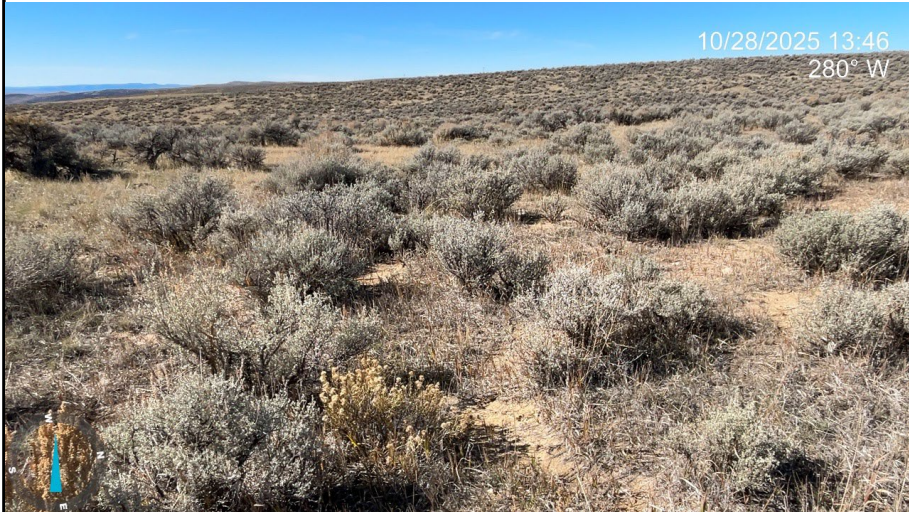
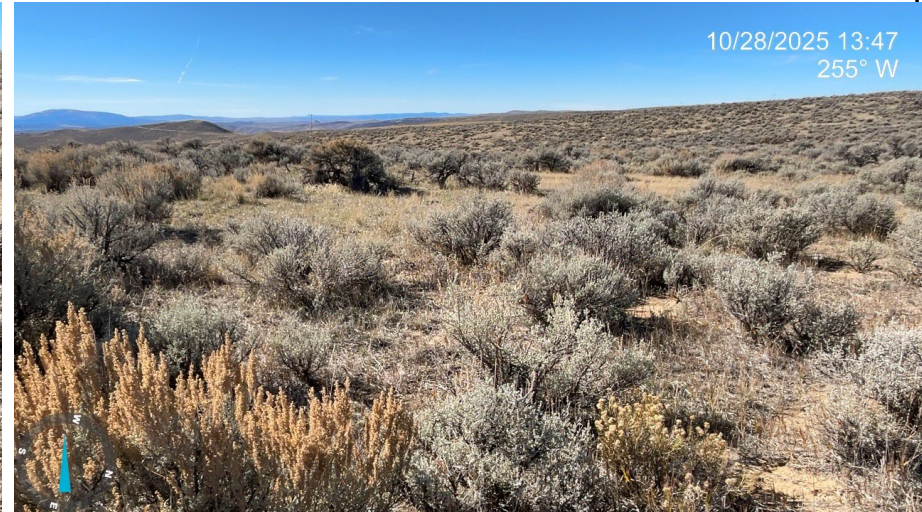
**Photo 7:** Photos showing an example of the reference area, located to the northwest of the location, characterized by big sagebrush shrublands. Big sagebrush is dominant.
