# Inspection Photos

Operator: Noble Energy Inc

Location ID: 302655

Inspection Photos  
Location Name: Dinnel C 26-18  
Location ID: 302655

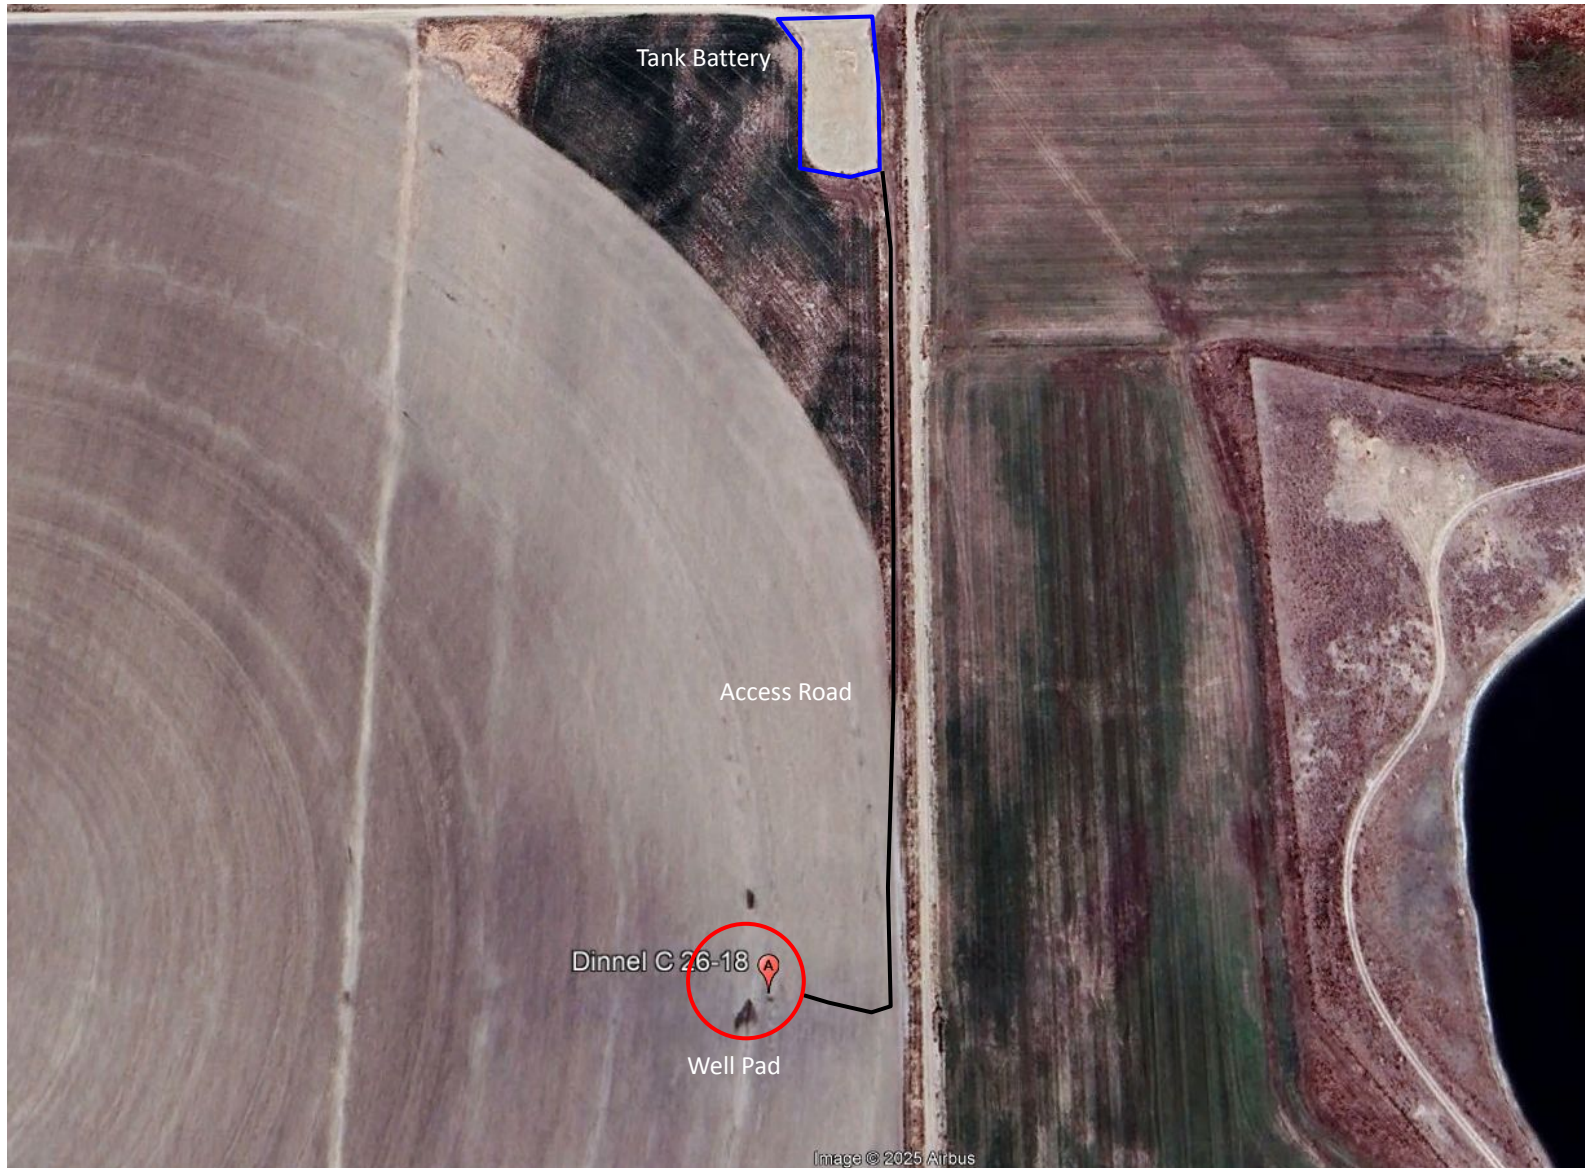
**Photo 1.** Aerial imagery showing the Tank Battery location (highlighted in blue), Access Road (highlighted in black) and Well Pad (highlighted in red). Note: tank battery is associated with its own location ID #447063.

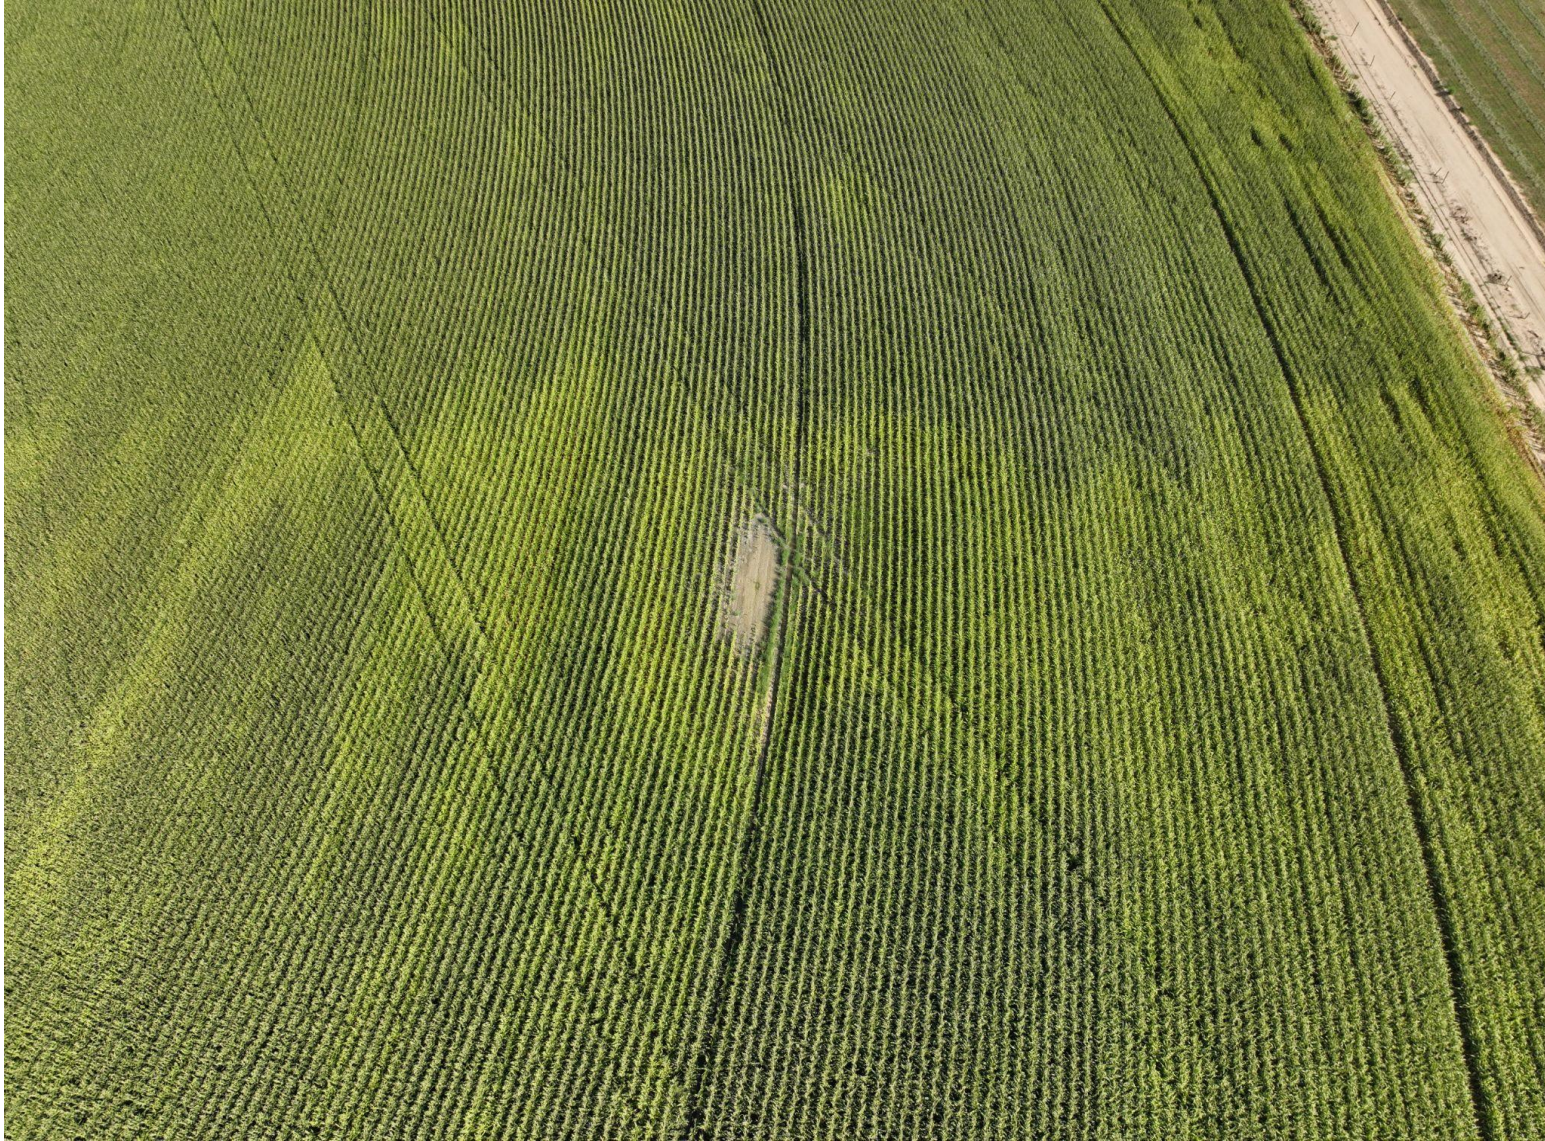
**Photo 2.** Aerial view of the well pad and access road taken during the time of the inspection with a drone from the southern edge facing north. Note: obvious stunting and lack of crop establishment issues were observed. Area does not appear consistent with adjacent reference areas.
