Inspection Photos

Operator: SWN Production Company LLC

Location ID: 313182

Inspection Doc: 719200369

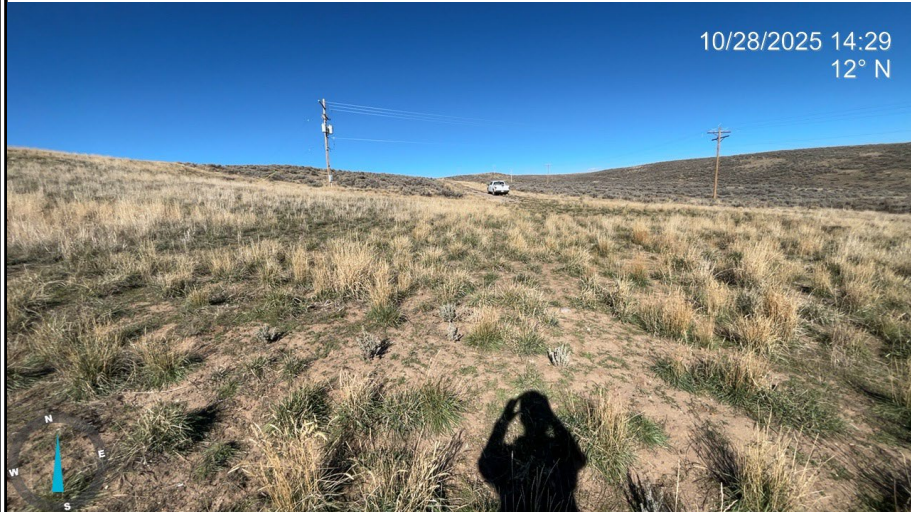
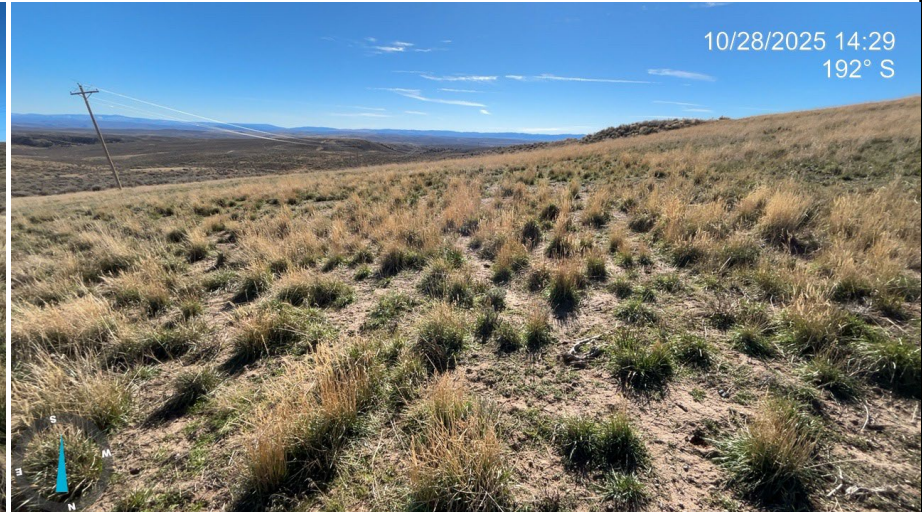
Photo 1: Photos showing an overview of the location looking north and south, respectively.

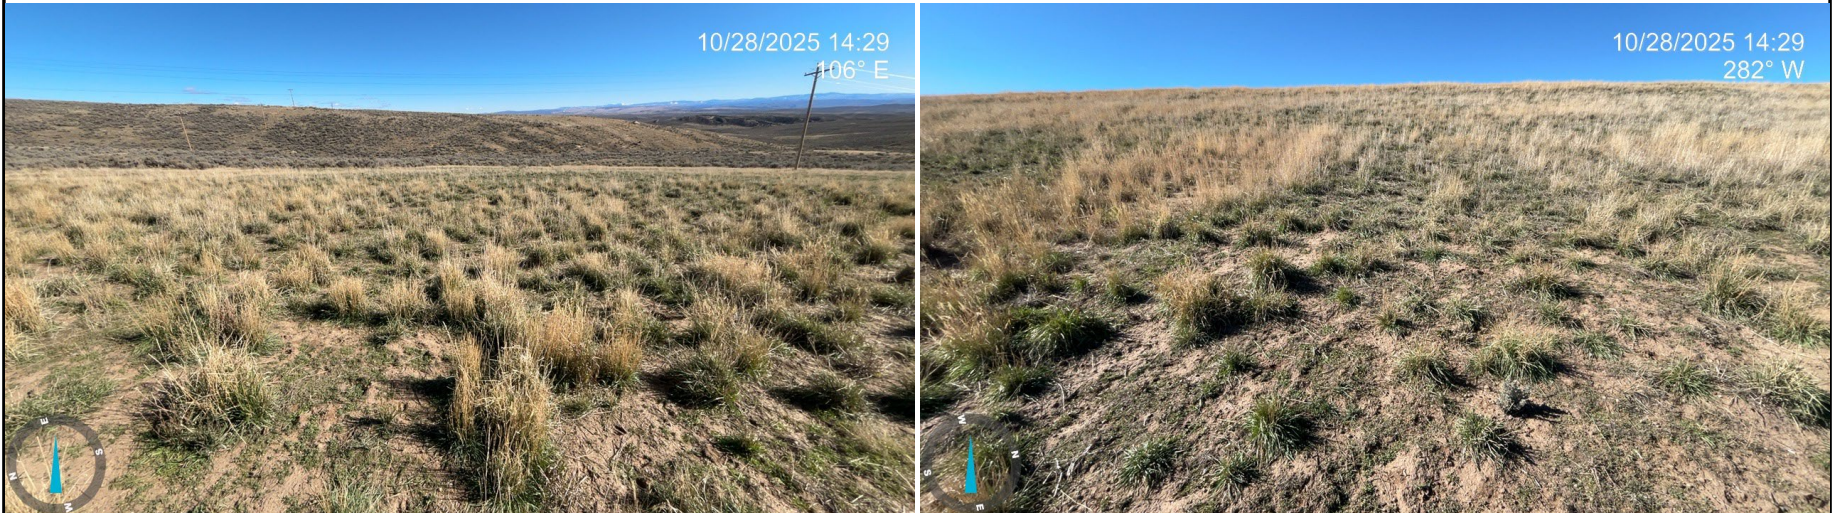
Photo 2: Photos showing an overview of the location looking east and west, respectively.

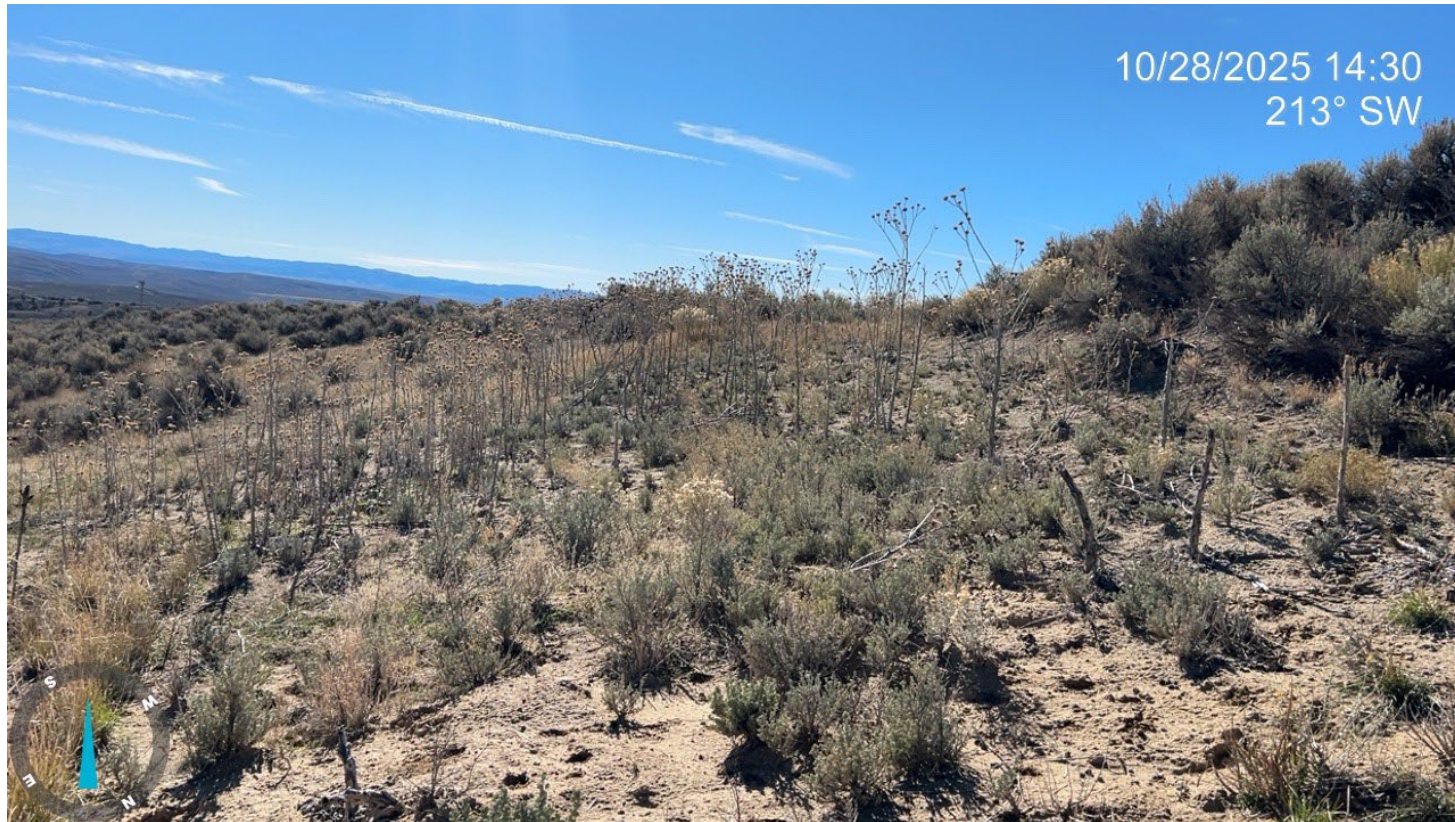
Photo 3: Photos showing a dense patch of Scotch thistle, a List B noxious weed species, that is present on the southwestern hillside of the location.

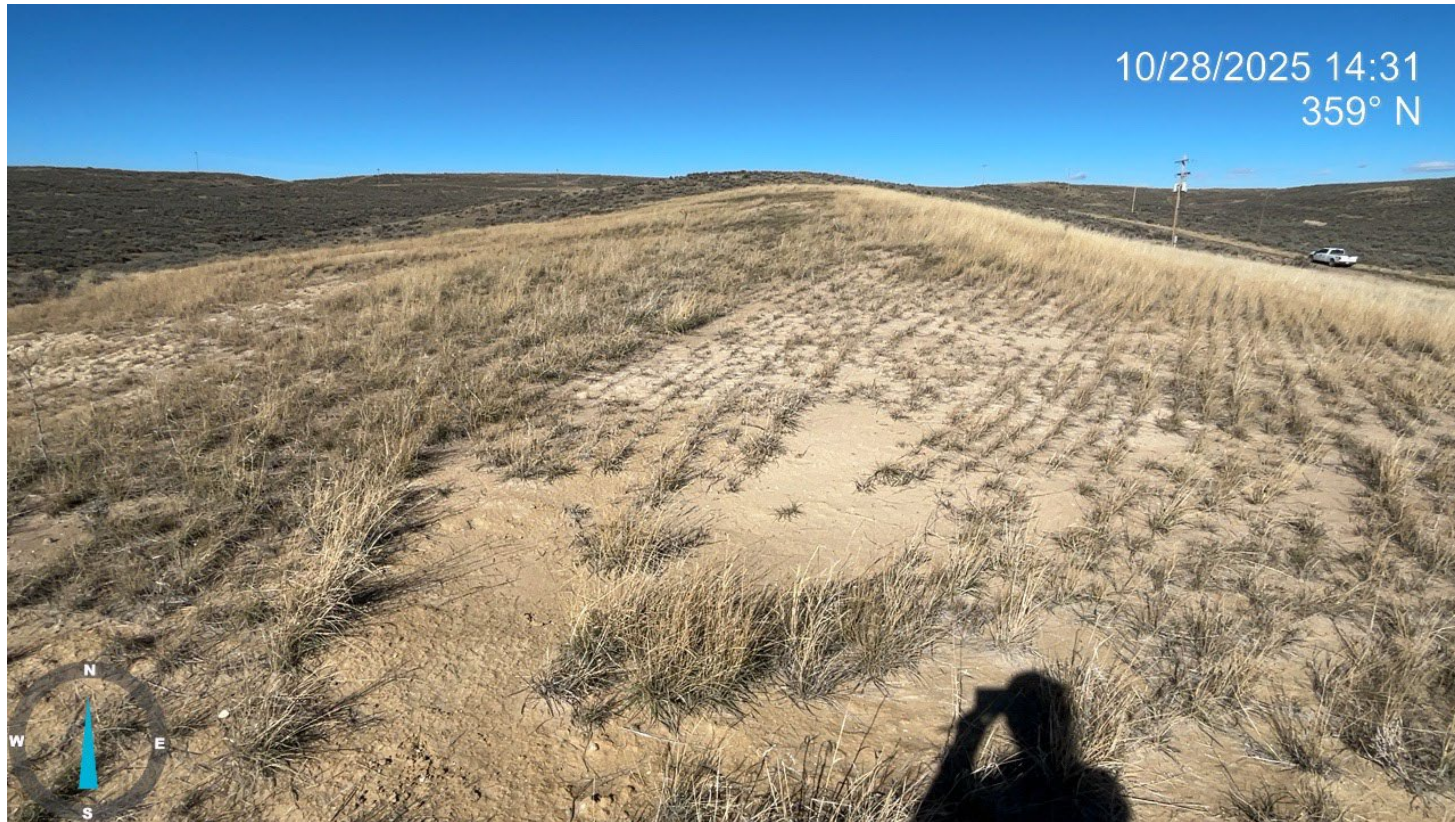
Photo 4: Photos showing the western hillside of the location that is not progressing towards 1004 reclamation requirements; uniformity is not evident.

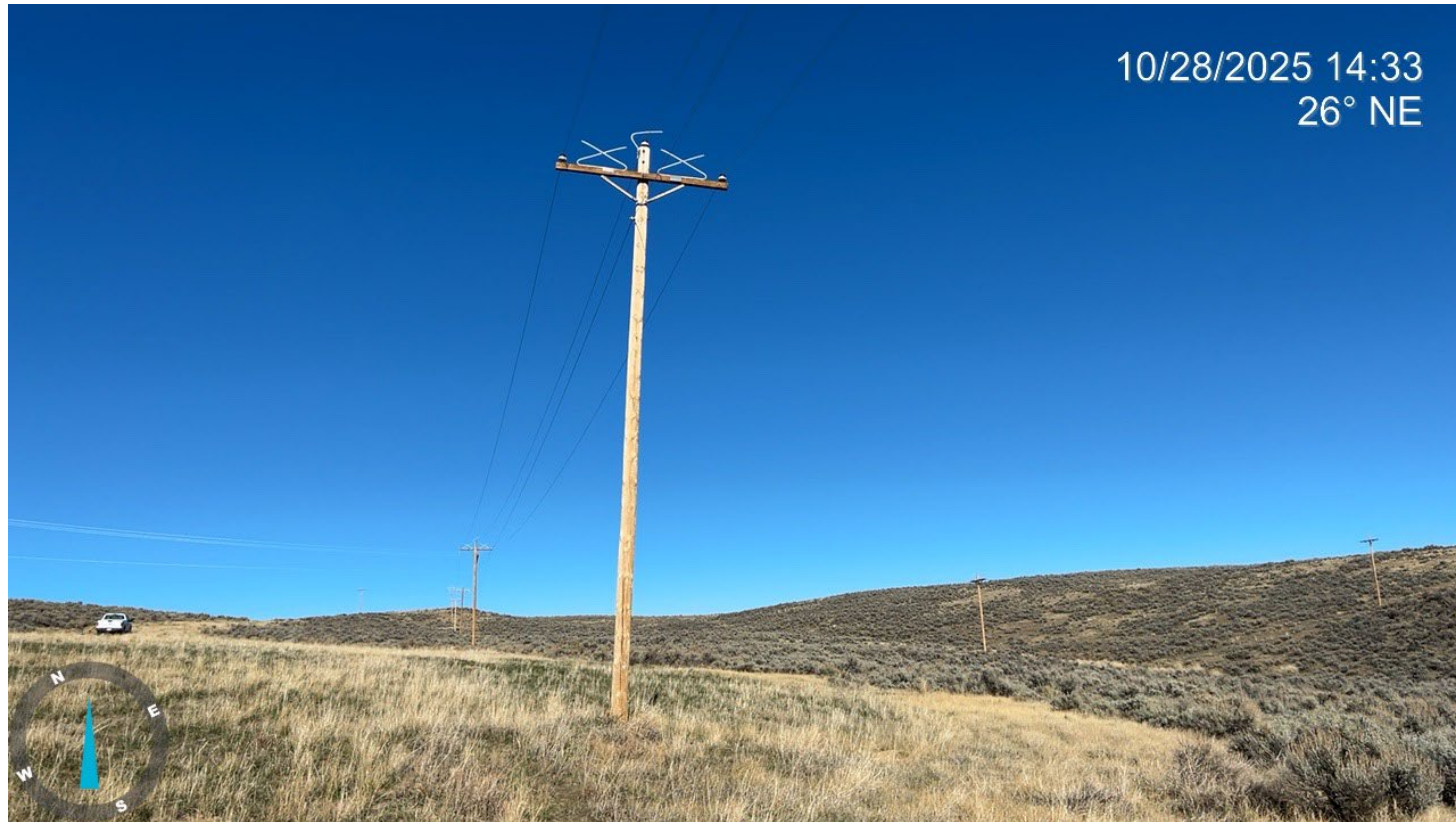
Photo 5: Photos showing an example of utility equipment that remains at the location and requires removal.

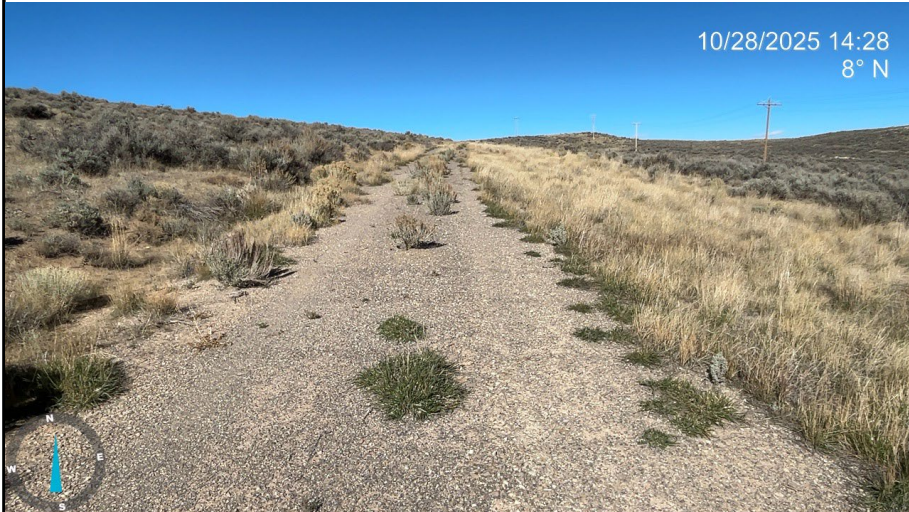
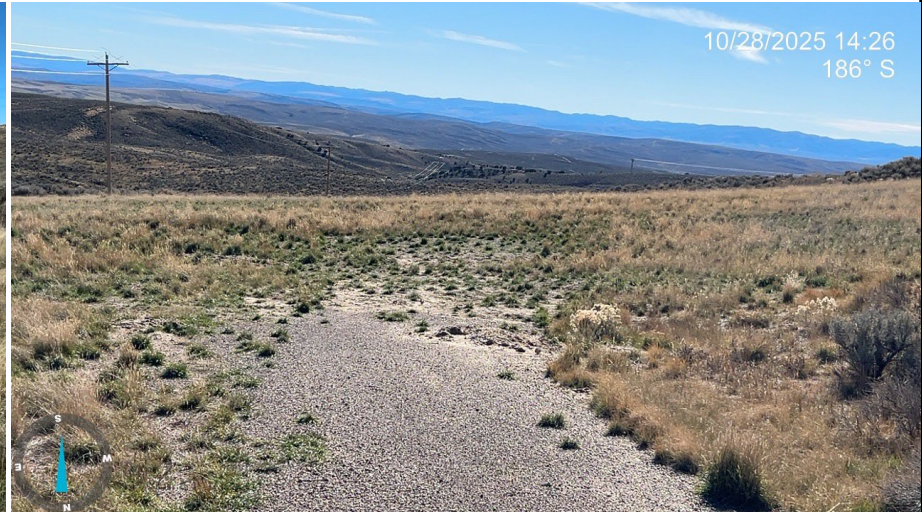
Photo 6: Photos showing the northern access road leading to location has not been reclaimed; gravel and compaction is evident.

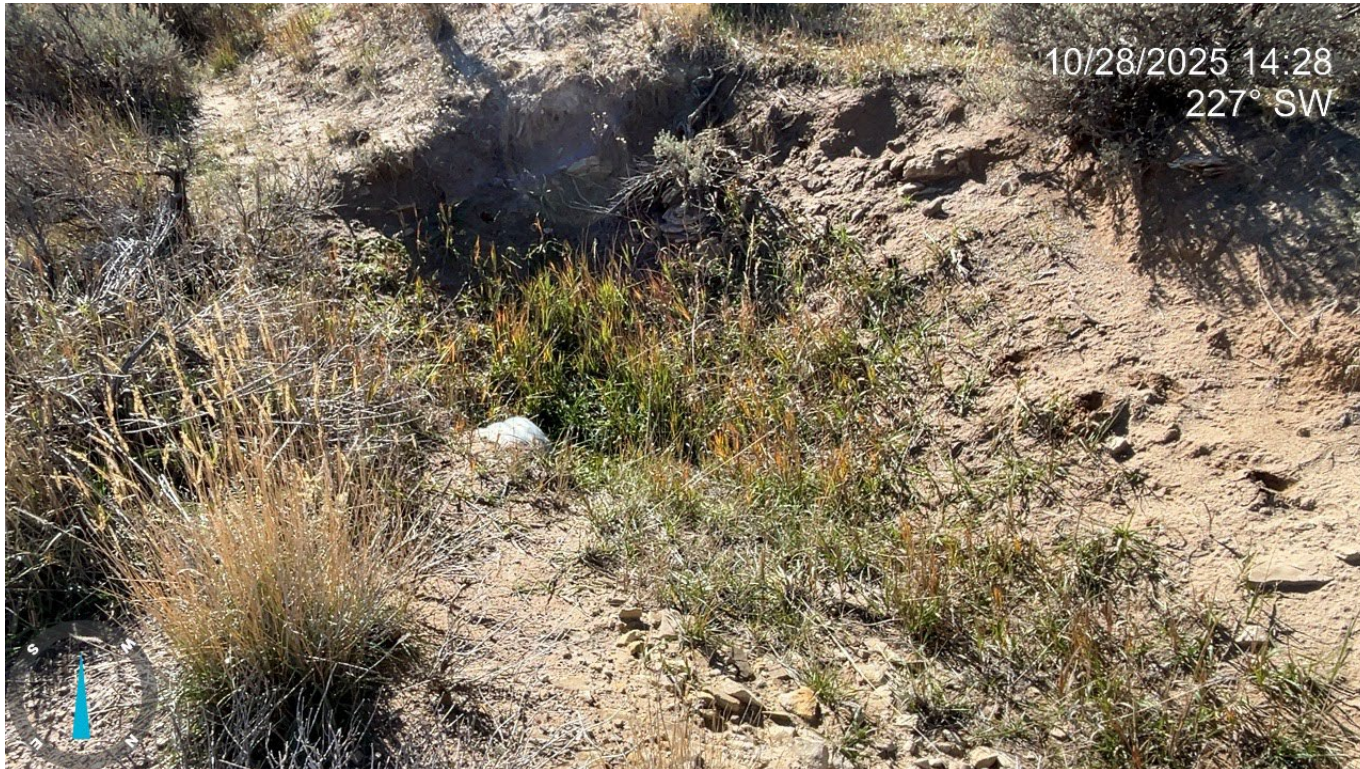
Photo 7: Photo showing an example of a culvert that remains along the unreclaimed northern access road.

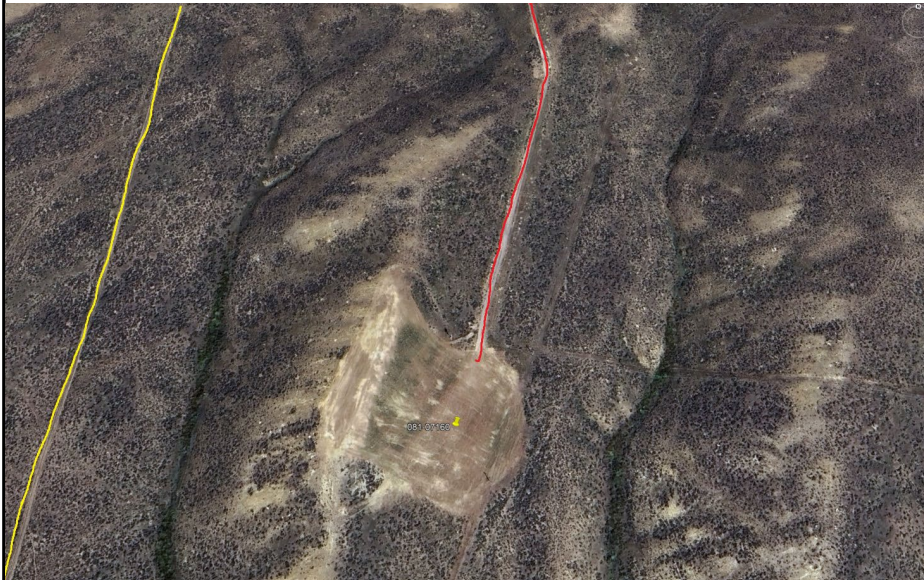
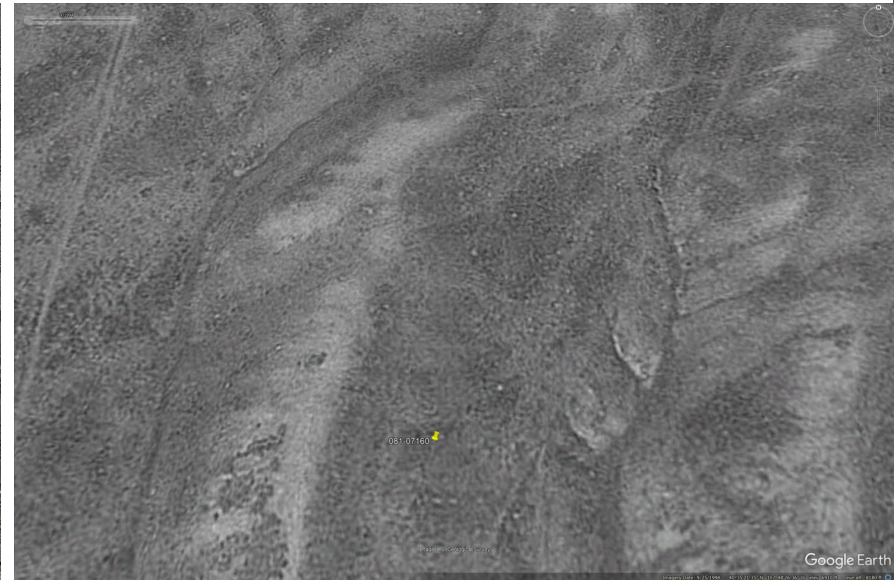
Photo 8: Google earth aerial imagery. Left photo dated 2023; right 1994. Yellow lines represent access roads that existed prior to Oil and Gas disturbances. Red lines represent access roads constructed to Oil and Gas Locations subject to 1004 final reclamation requirements. Access road to the location did not pre-exist Oil & Gas activities.

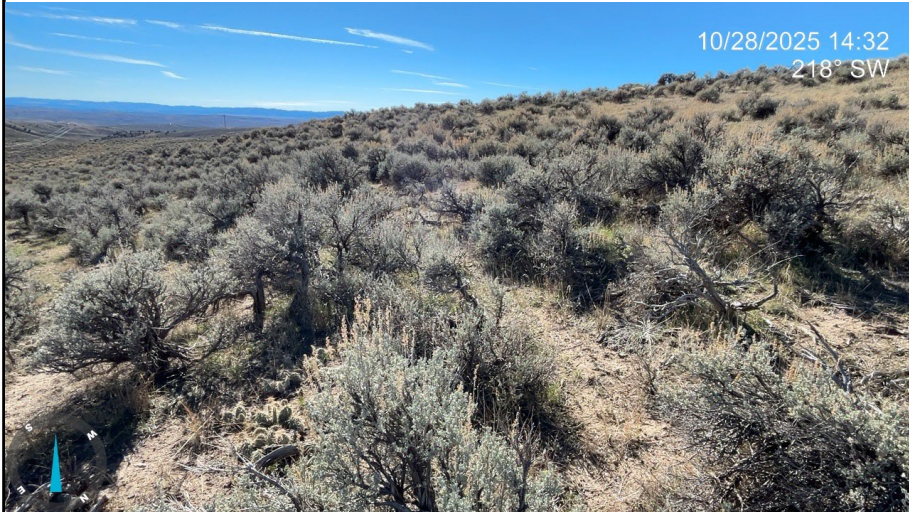
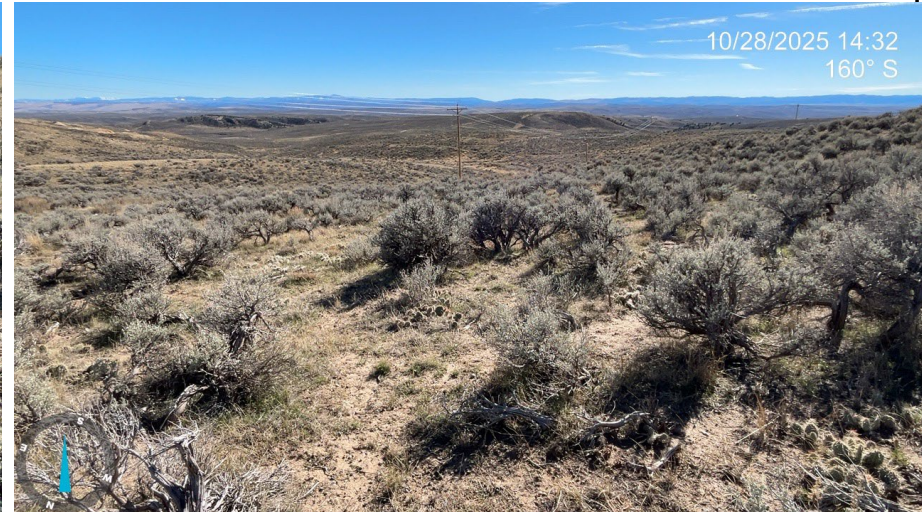
Photo 9: Photos showing an example of the reference area, located to the south of the location. Reference areas are characterized by big sagebrush shrublands, and big sagebrush is dominant.
