Inspection Photos

Operator: SWN Production Company LLC

Location ID: 313155

Inspection Doc: 719200375

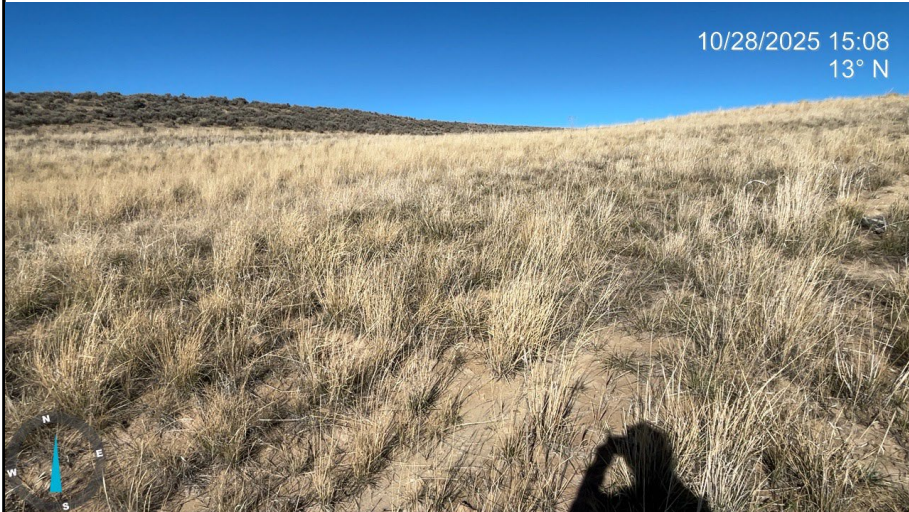
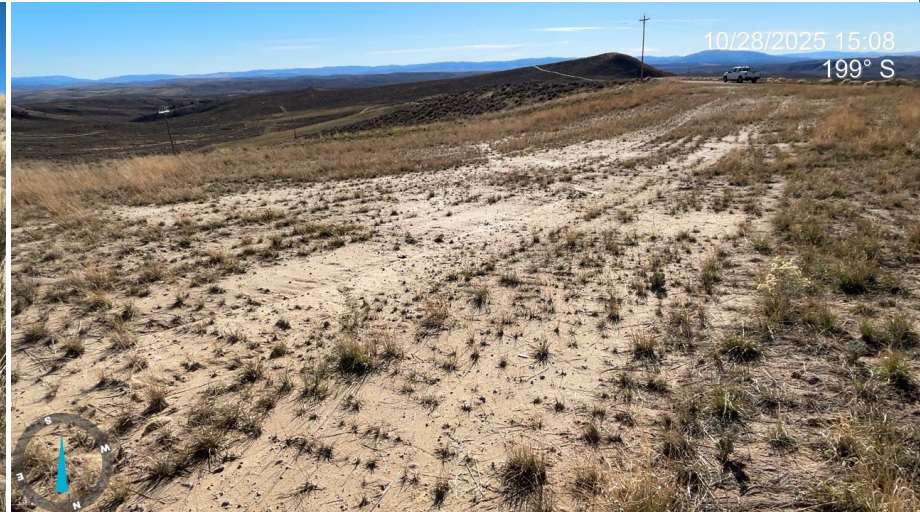
Photo 1: Photos showing an overview of the location looking north and south, respectively. Vegetation is not progressing towards 1004 reclamation requirements in some areas; uniformity is not evident.

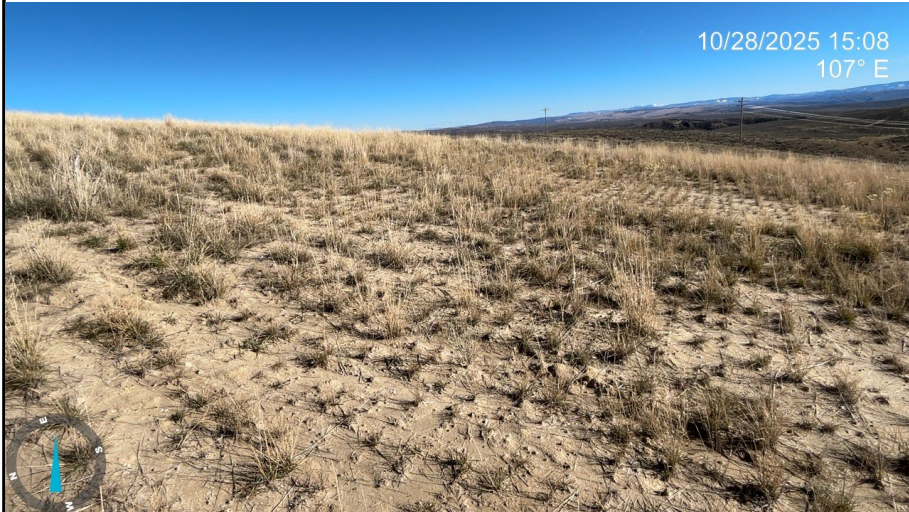
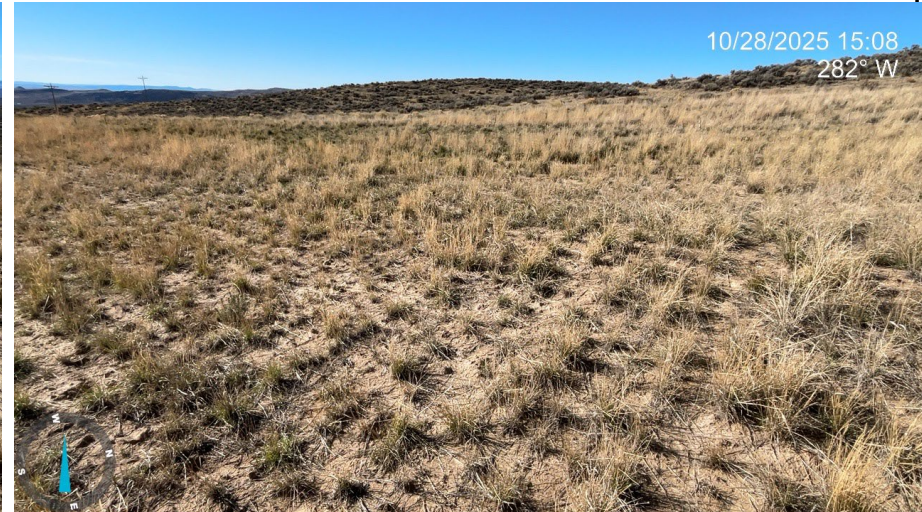
Photo 2: Photos showing an overview of the location looking east and west, respectively.

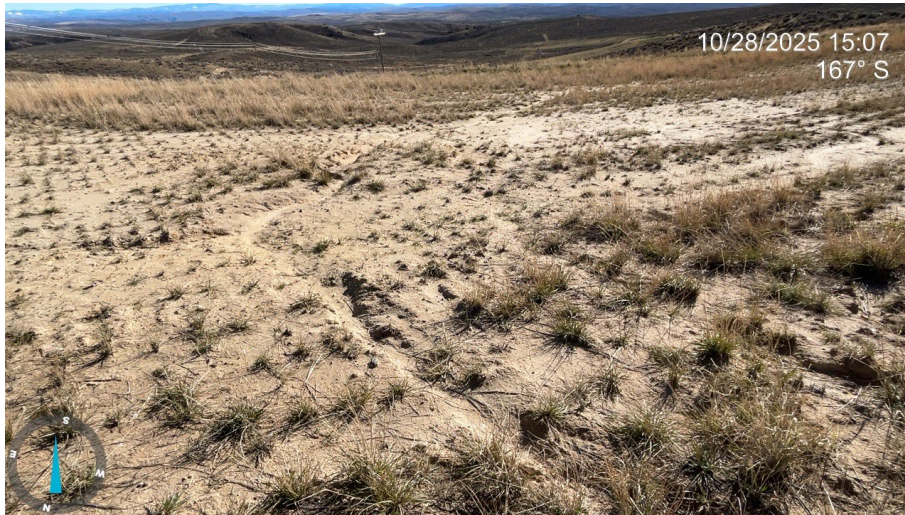
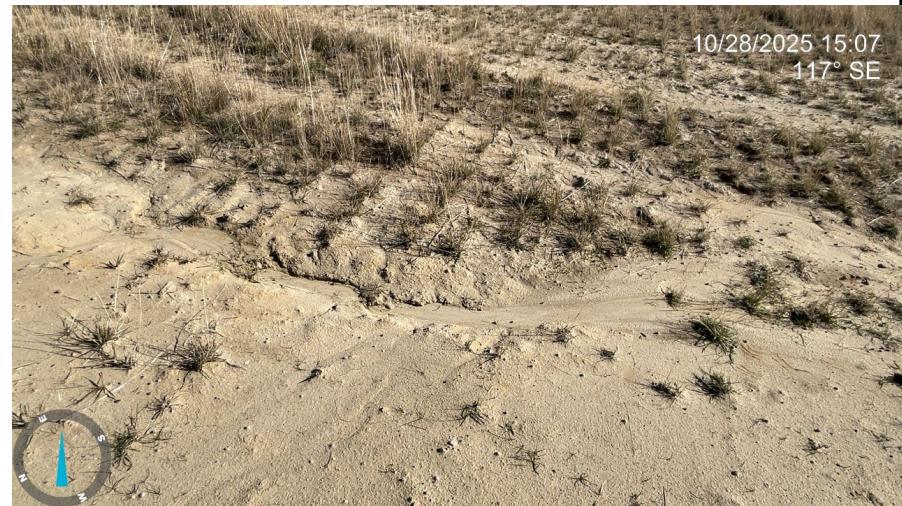
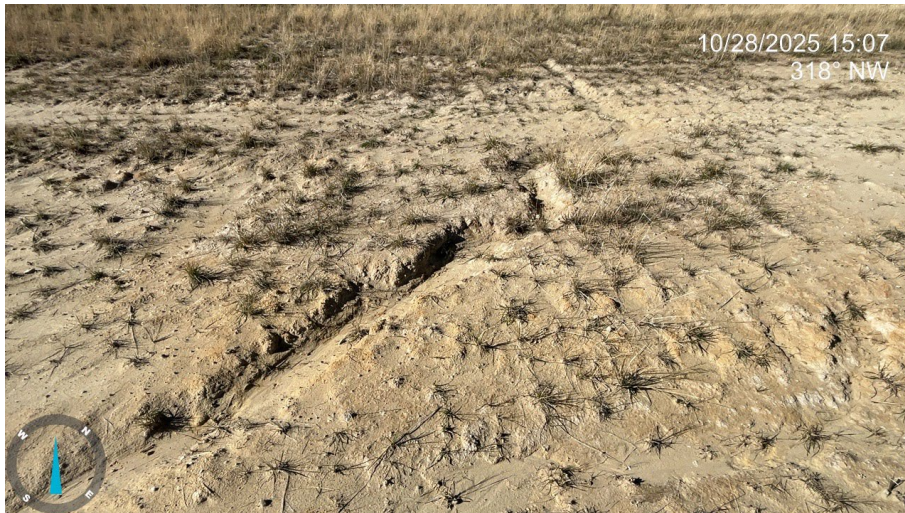
Photo 3: Photos showing example of rilling and erosion that is occurring in portions of the location that are predominantly bare and are not progressing towards 1004 reclamation requirements.

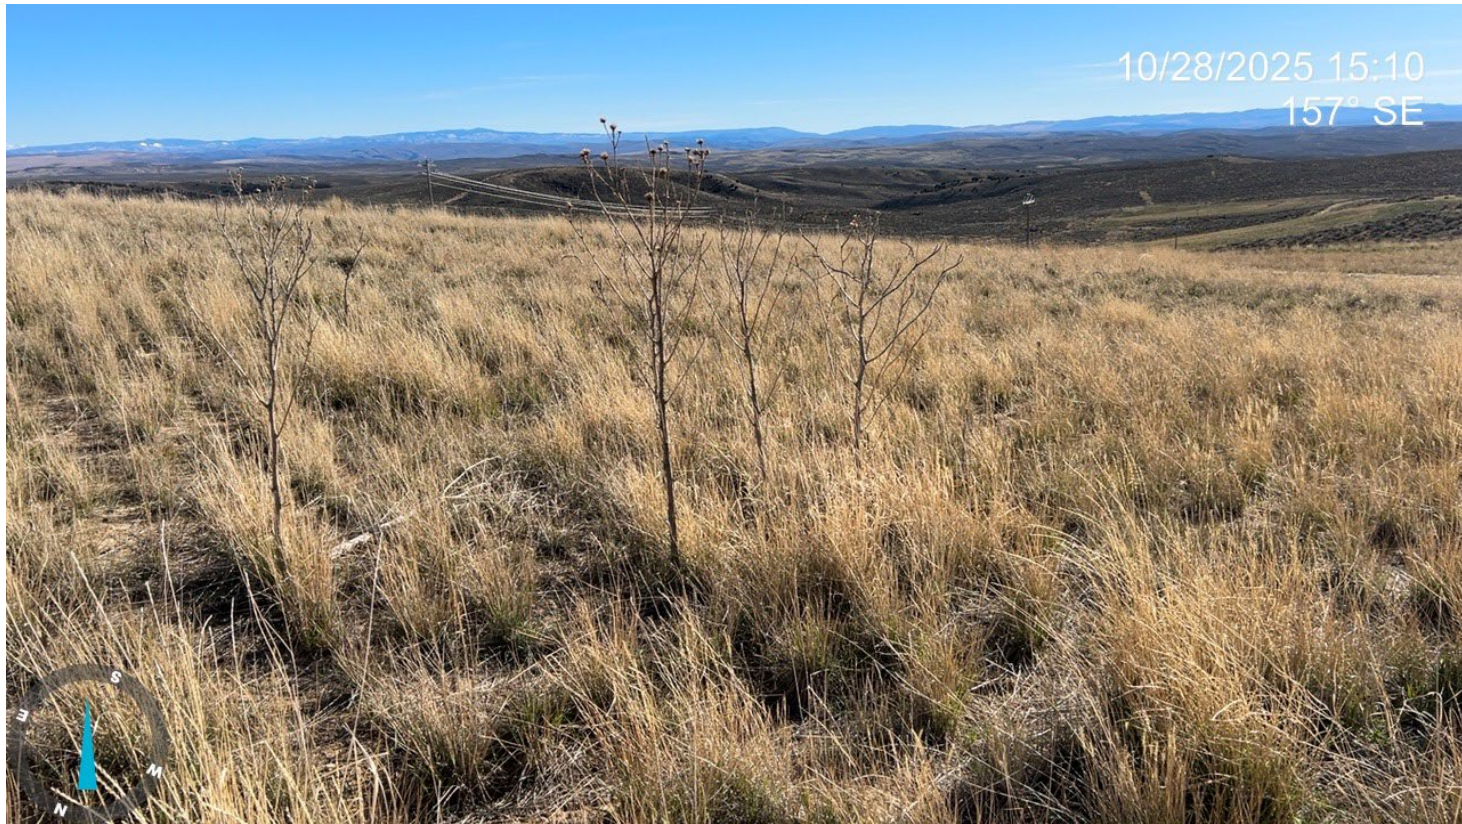
Photo 4: Photo left showing an example of Scotch thistle, a List B noxious weed, that is scattered throughout the location. Weeds do not appear to have been managed in 2025.

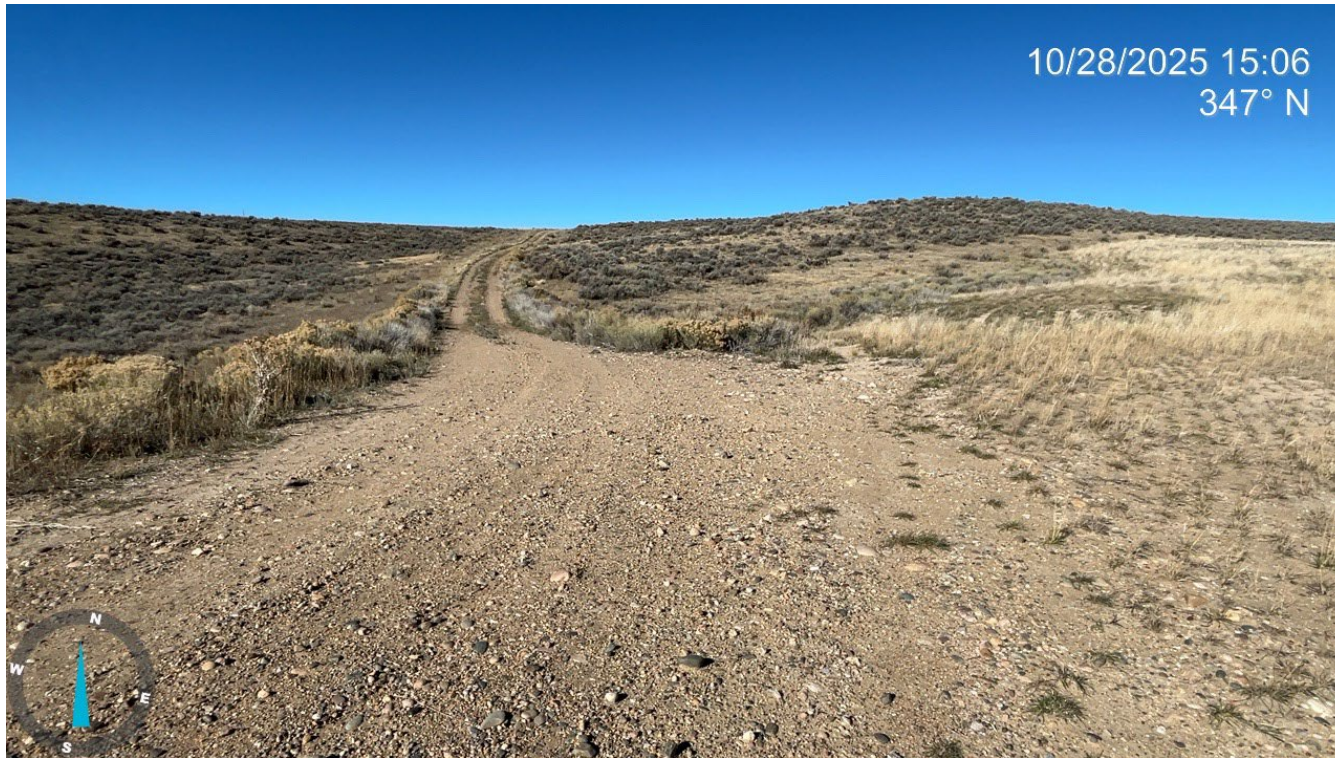
Photo 5: Photo showing the access road on the western portion of the location looking north. The access road remains has not been reclaimed; gravel and compaction is evident.

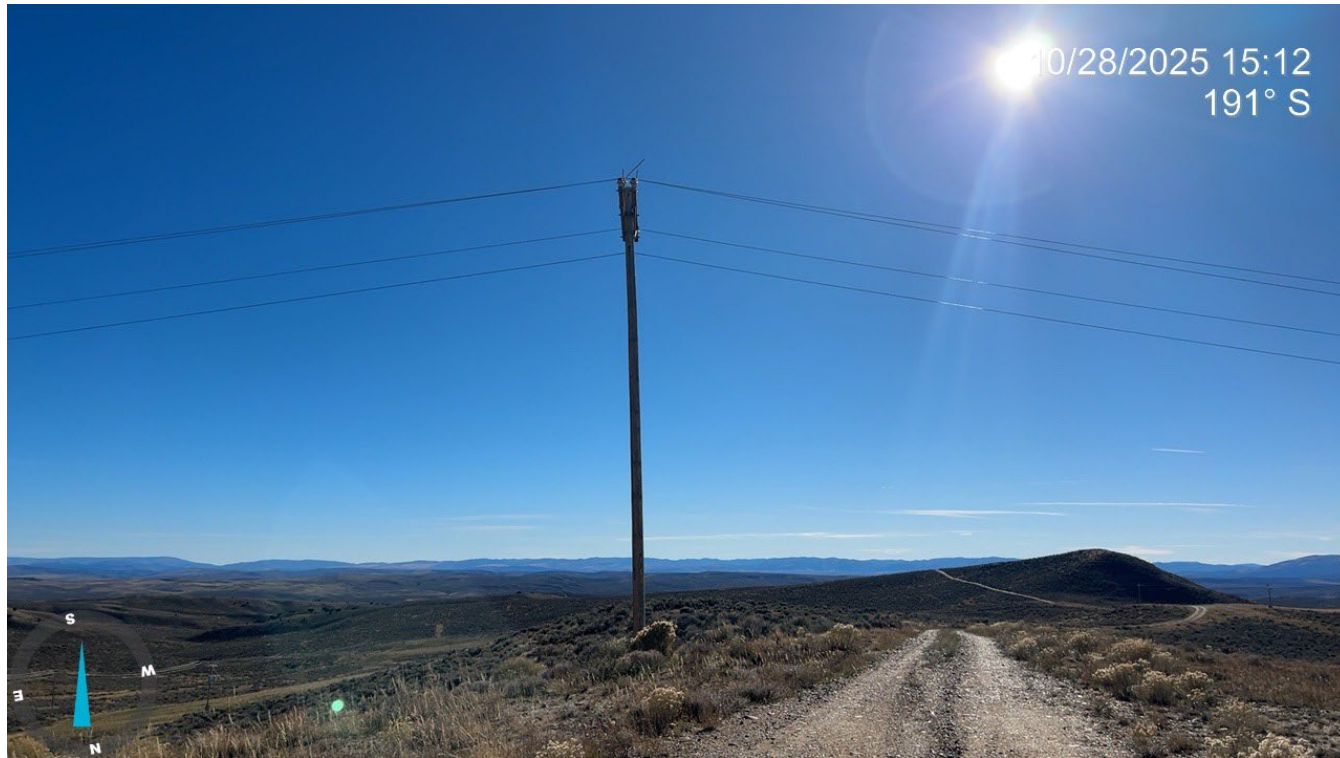
Photo 6: Photo showing utility equipment associated with the location that requires removal and the access road on the western portion of the location looking south. The access road remains unreclaimed; gravel and compaction is evident.

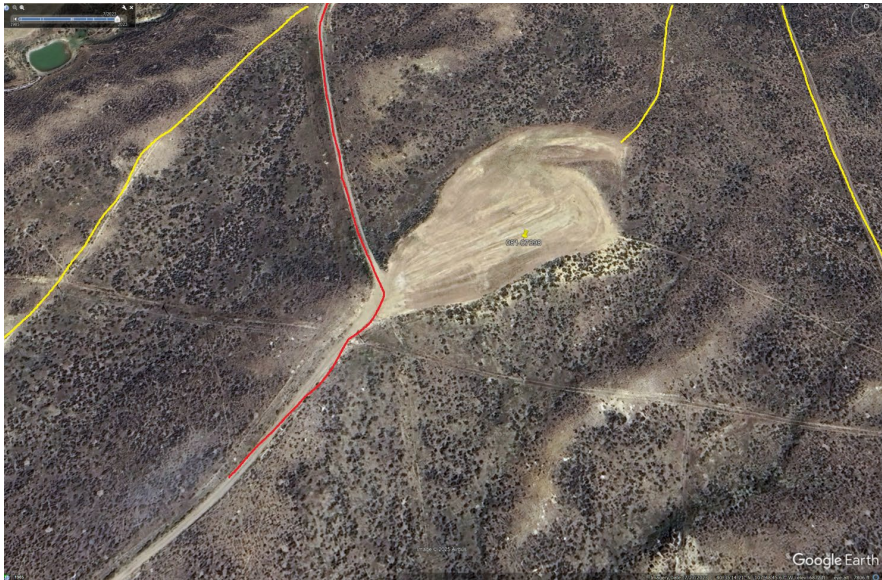
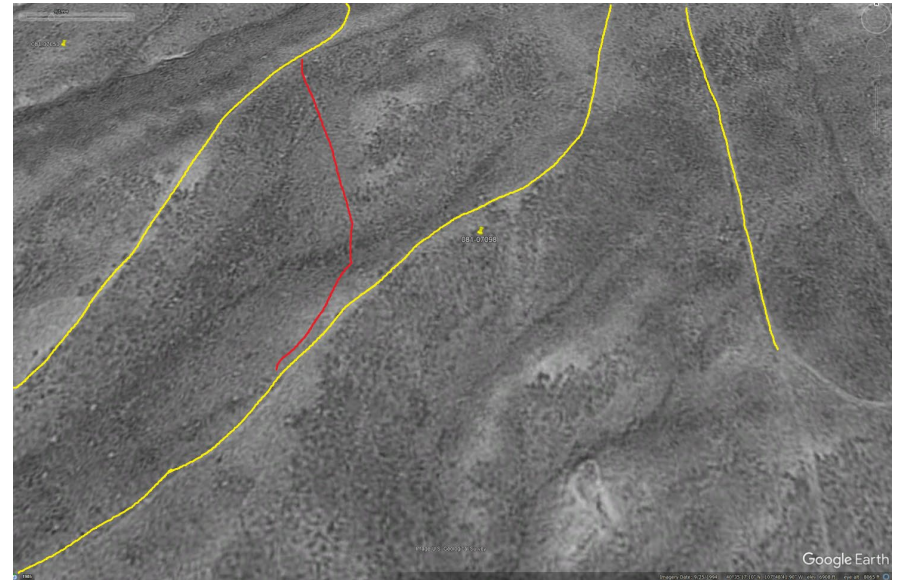
Photo 8: Google earth aerial imagery. Left photo dated 2023; right 1994. Yellow lines represent access roads that existed prior to Oil and Gas disturbances. Red lines represent access roads constructed to Oil and Gas Locations subject to 1004 final reclamation requirements. Access road to the Walker 7-93-3/Pad 4 did not pre-exist the location.

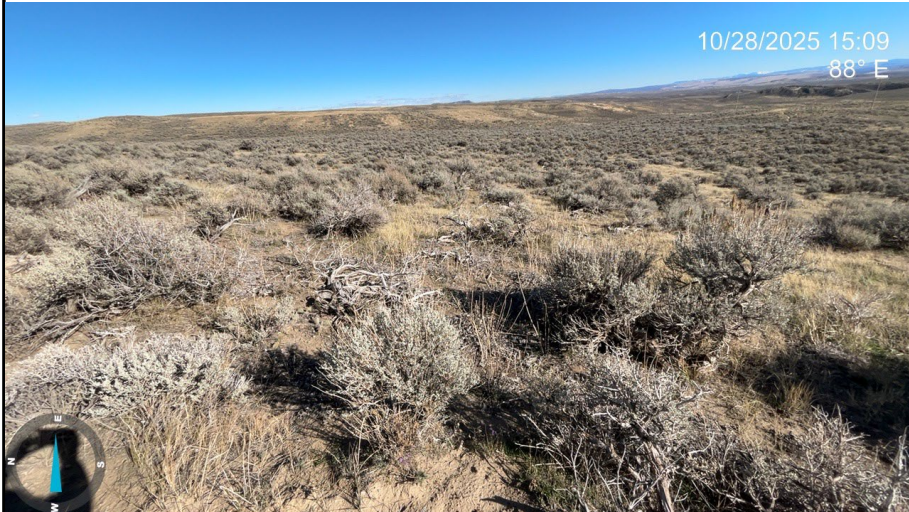
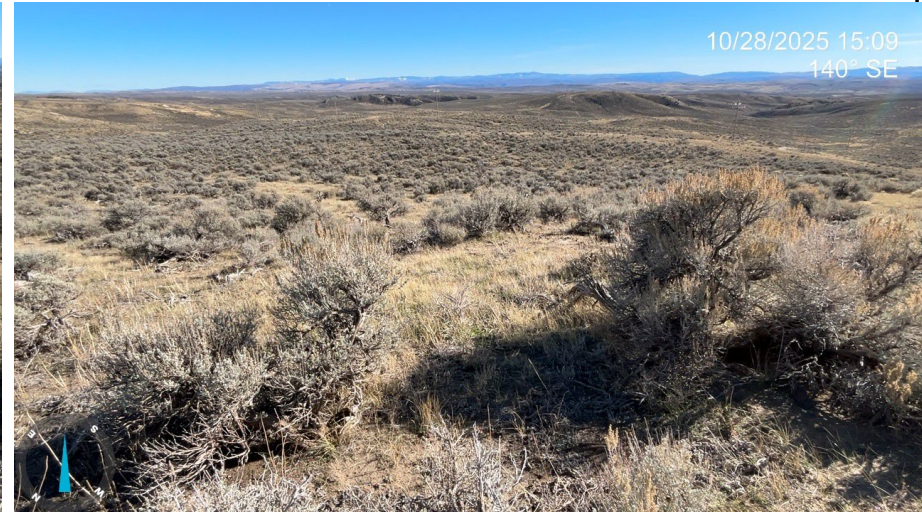
Photo 9: Photos showing an example of the reference area, located to the east of the location. Reference areas are characterized by big sagebrush shrublands; big sagebrush is dominant.
