# Inspection Photos

**Operator:** SWN Production Company LLC

**Location ID:** 313180

**Inspection Doc:** 719200377

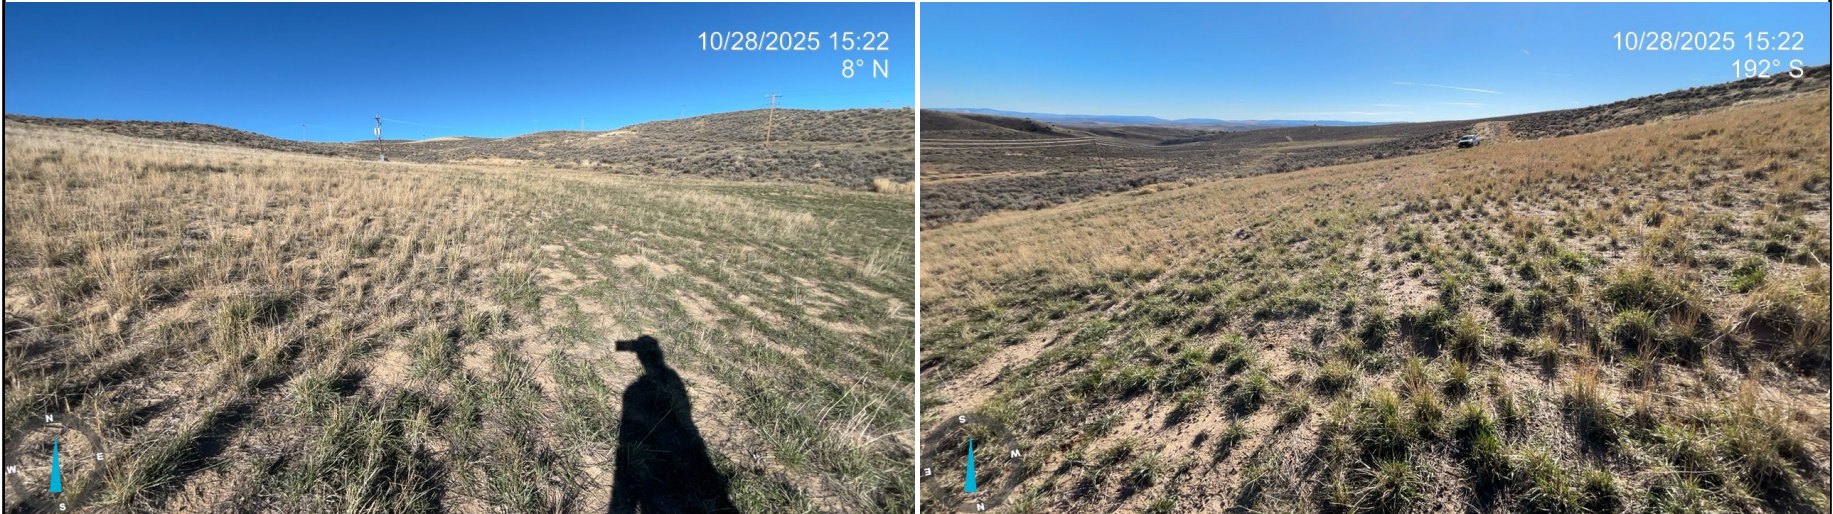
**Photo 1:** Photos showing an overview of the location looking north and south, respectively.

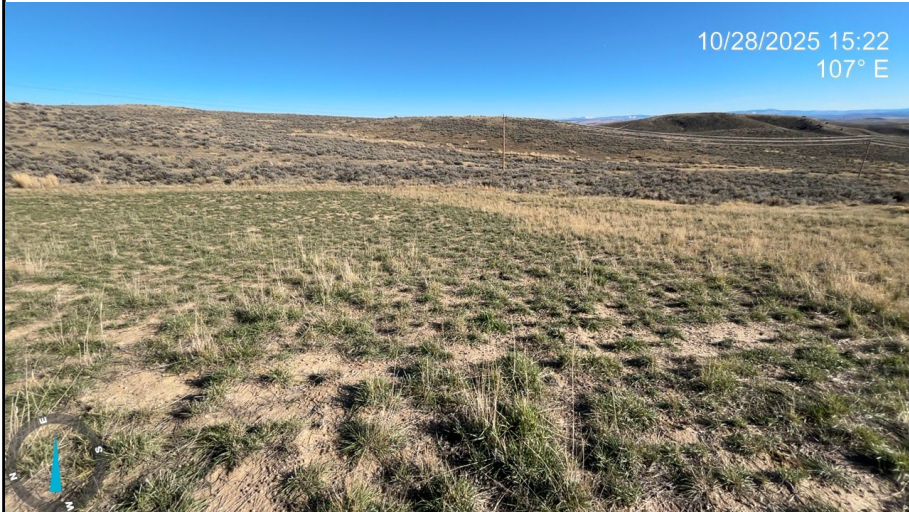
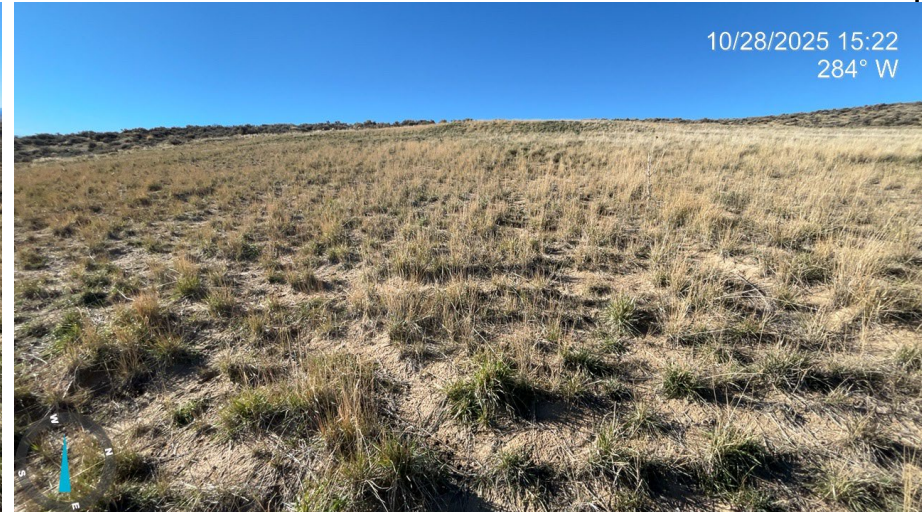
**Photo 2:** Photos showing an overview of the location looking east and west, respectively.

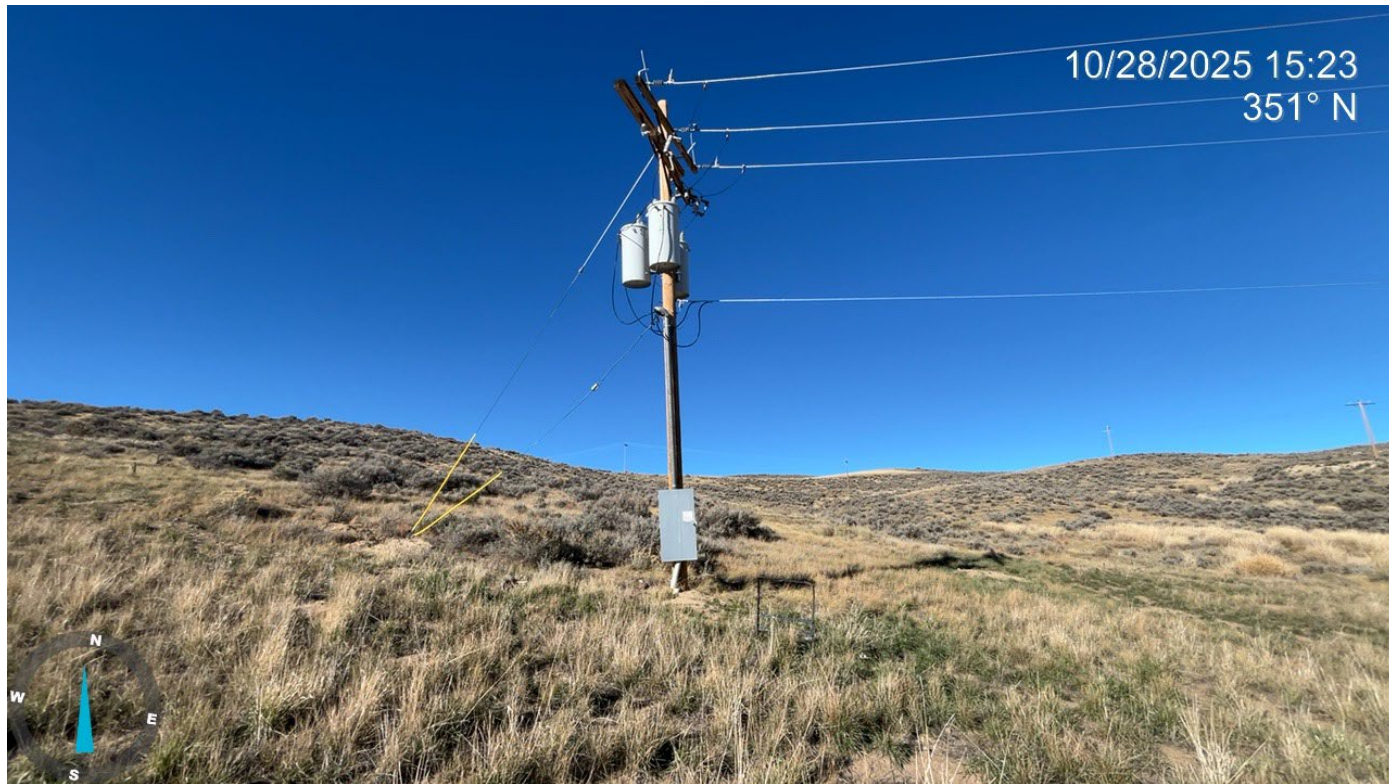
**Photo 3:** Photo showing an example of utility equipment that remains at the location and requires removal.

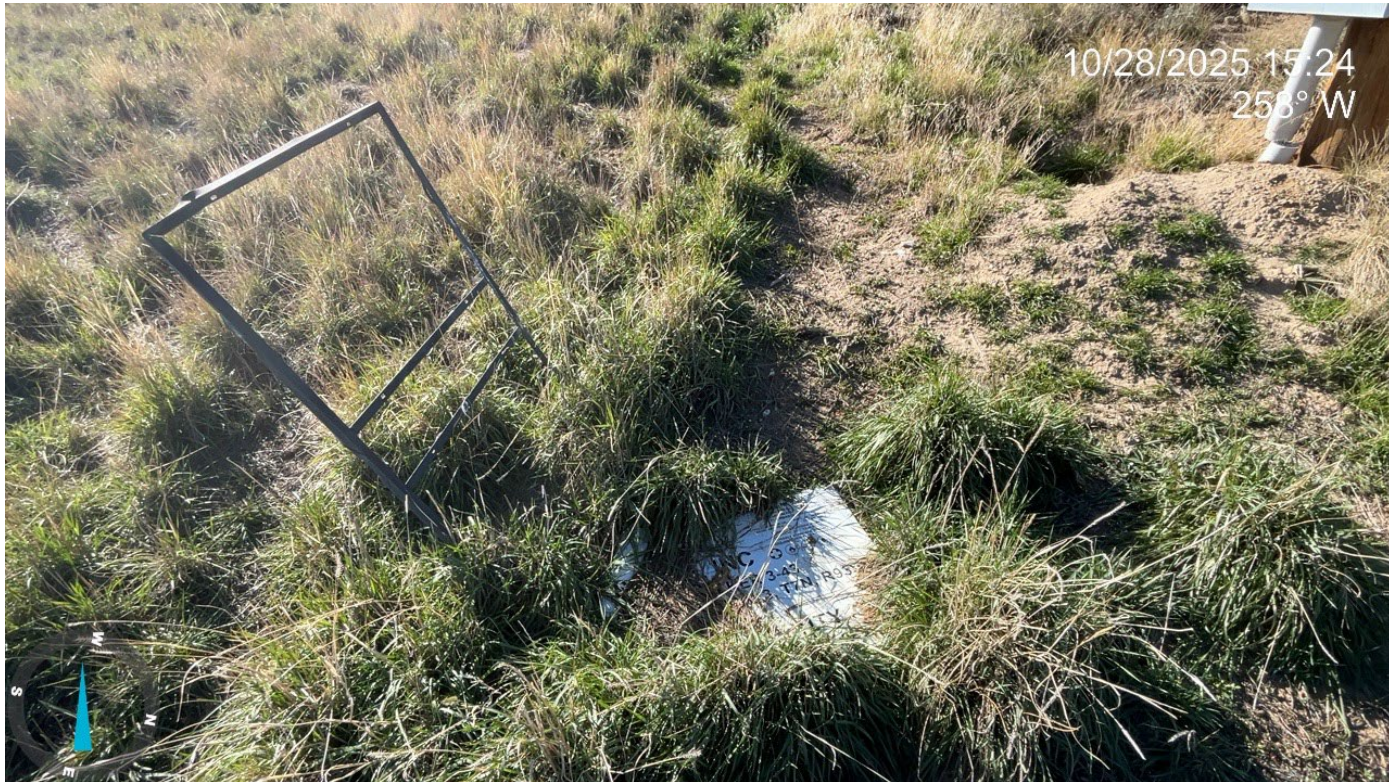
**Photo 4:** Photo showing signage debris that remains at the location and requires removal.

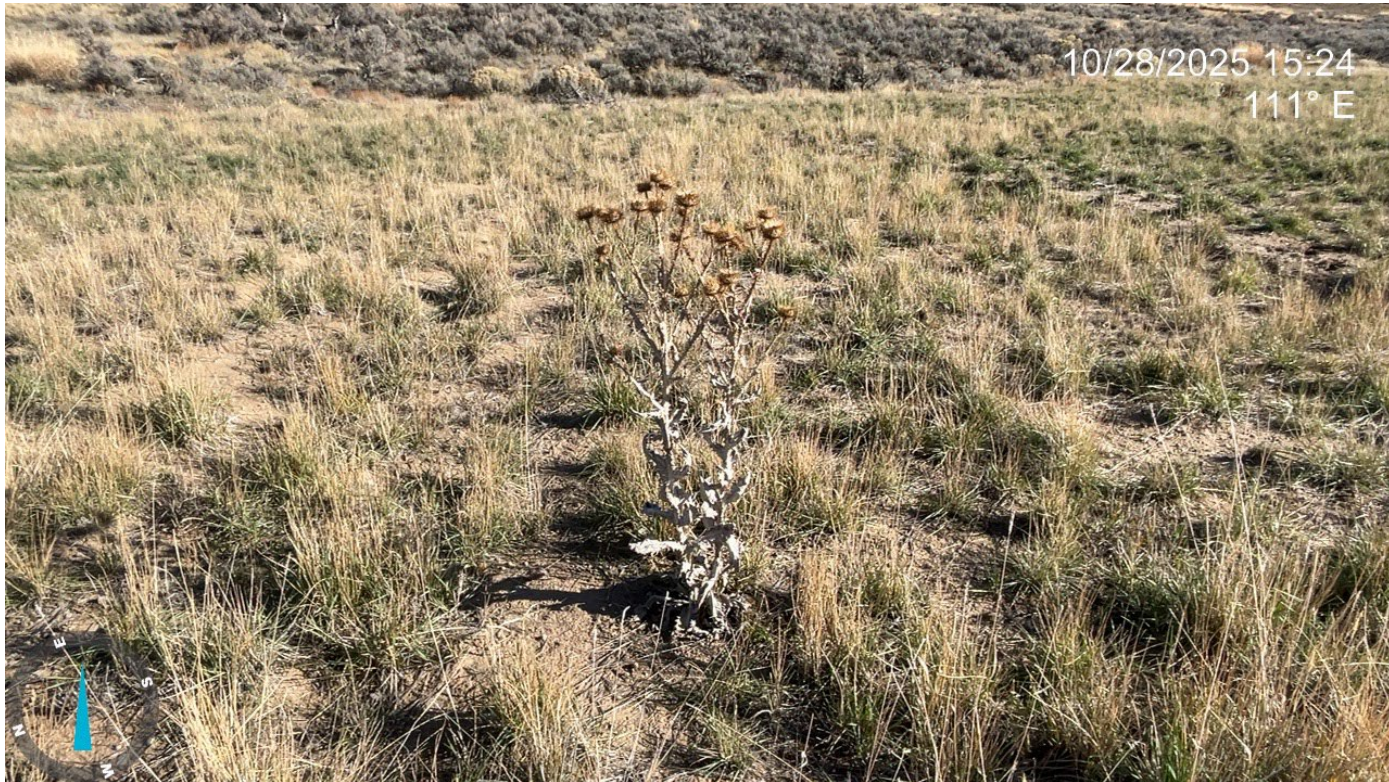
**Photo 5:** Photo showing an example of Scotch thistle, a List B noxious weed, that is present throughout the location. It does not appear as though weeds have been managed in 2025.

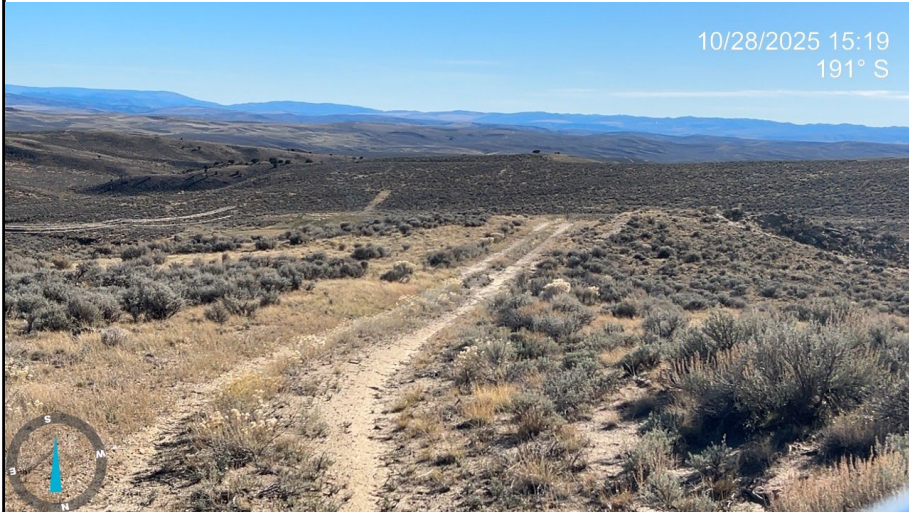
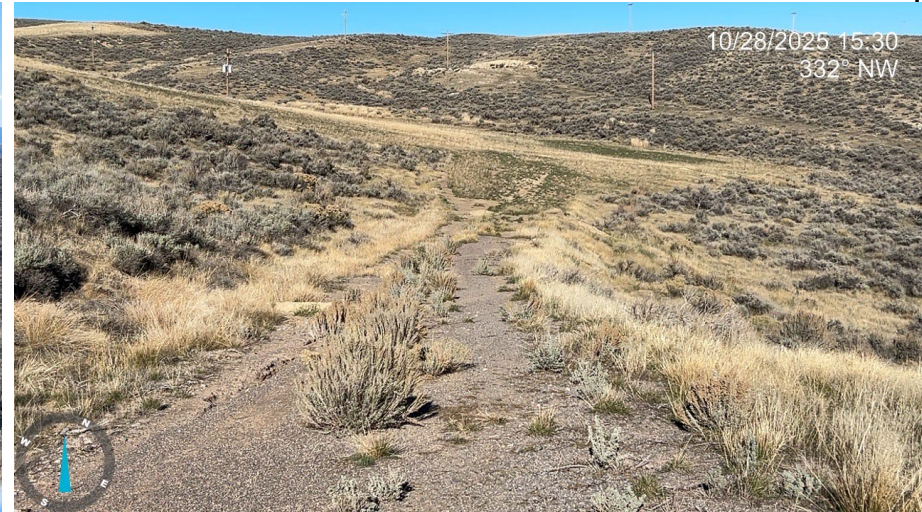
**Photo 6:** Photos showing the access road leading to the location. The access road has not been reclaimed; gravel/compaction evident.

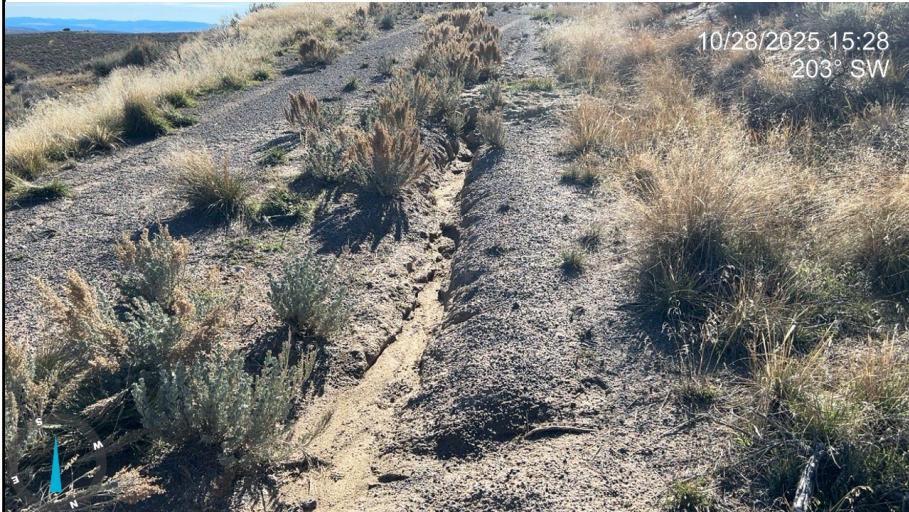
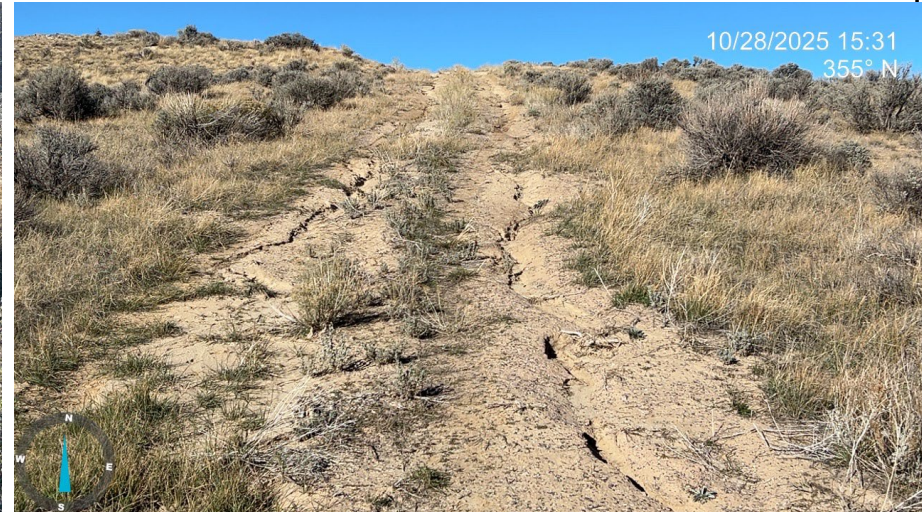
**Photo 7:** Photos showing the access road leading to the location. Erosion, rilling and sediment migration is occurring on the road. Ongoing stormwater control maintenance is required until the location receives a passing final inspection.

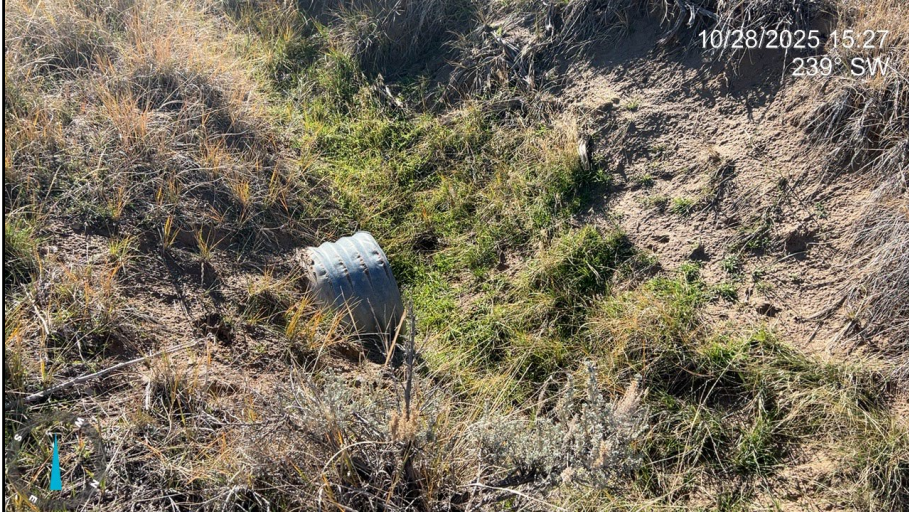
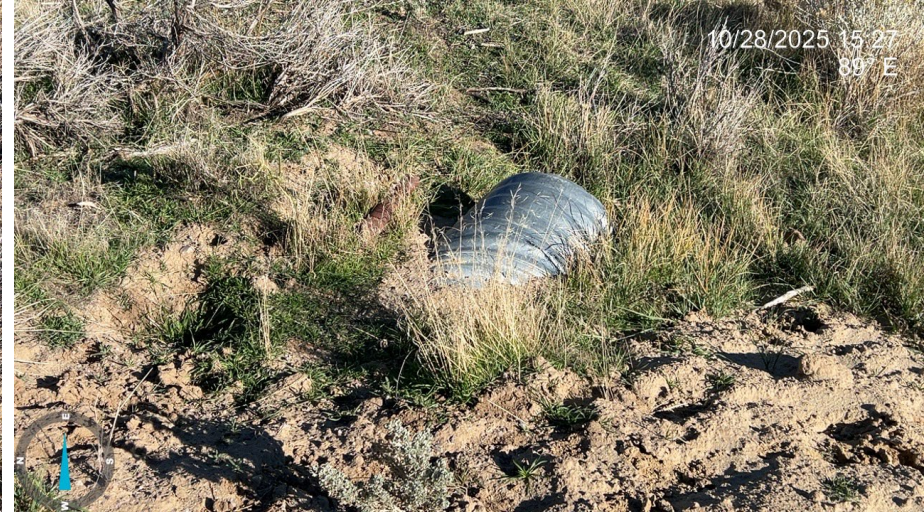
**Photo 8:** Photos showing an example of culverts remaining along the access road.

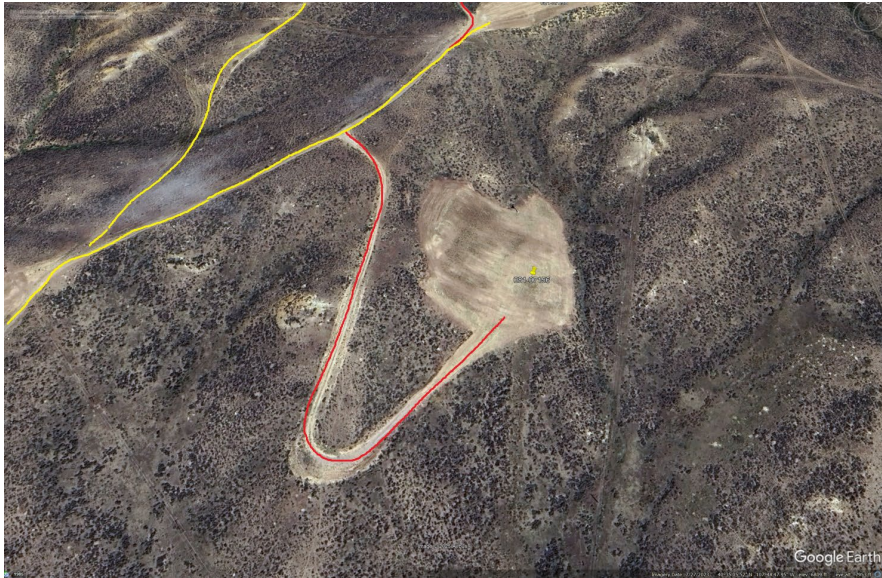
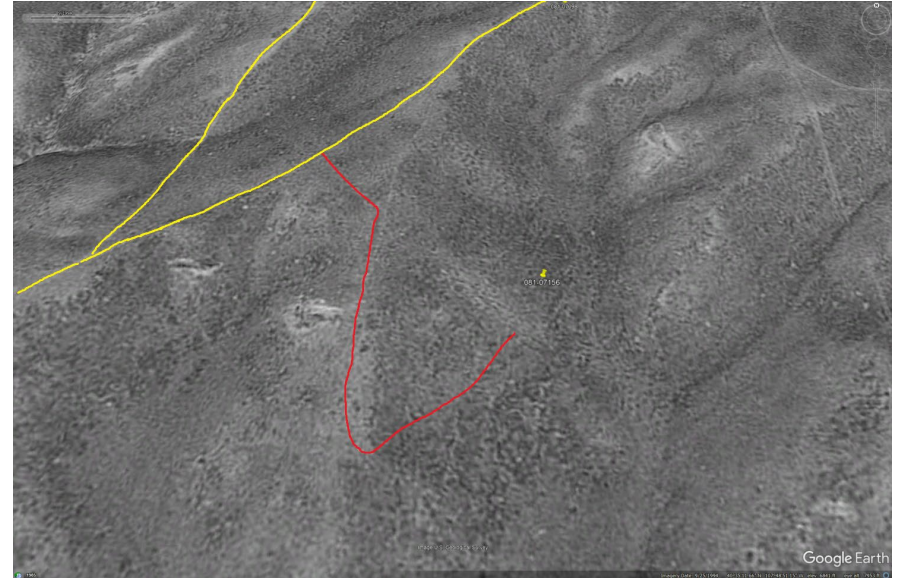
**Photo 9:** Google earth aerial imagery. Left photo dated 2023; right 1994. Yellow lines represent access roads that existed prior to Oil and Gas disturbances. Red lines represent access roads constructed to Oil and Gas Locations subject to 1004 final reclamation requirements. Access road to the Walker 7-93-3/Pad 6 did not pre-exist the location.

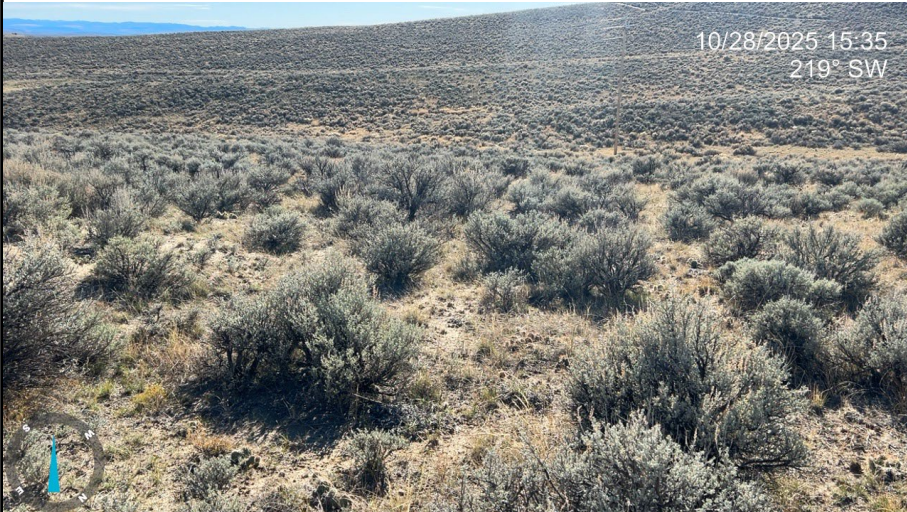
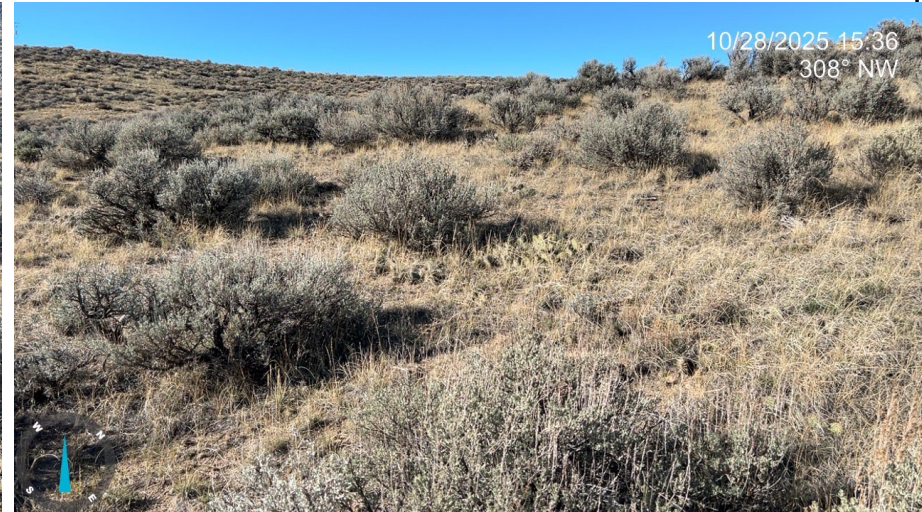
**Photo 10:** Photos showing an example of the reference area, located to the southwest of the location. Reference areas are characterized by big sagebrush shrublands; big sagebrush is dominant.
