Inspection Photos

Operator: SWN Production Company LLC

Location ID: 313152

Inspection Doc: 719200380

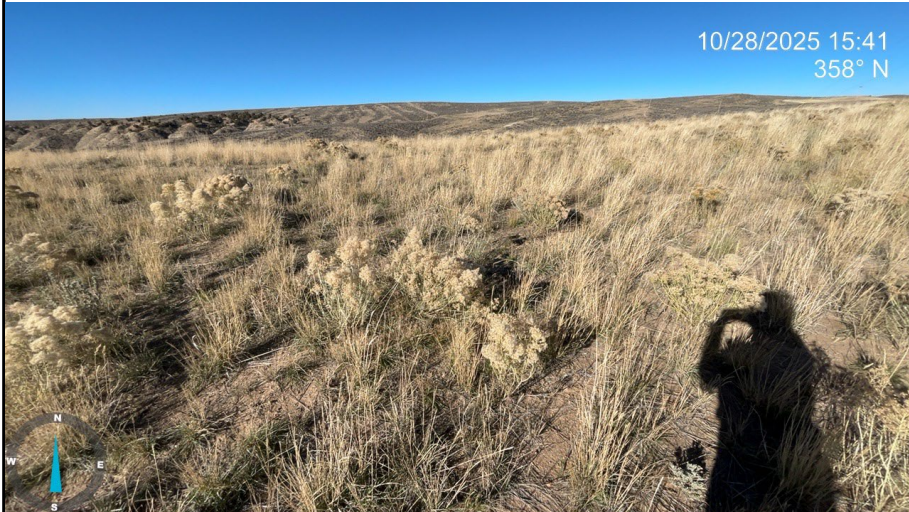
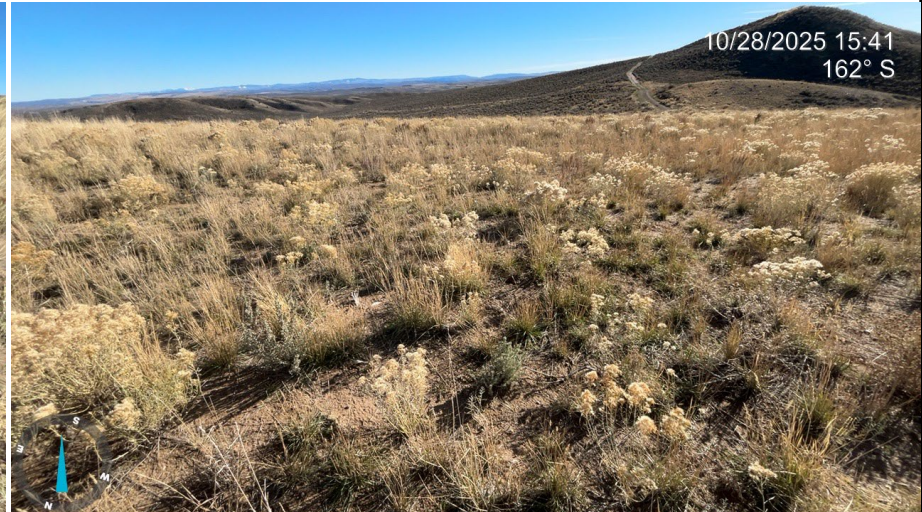
Photo 1: Photos showing an overview of the location looking north and south, respectively.

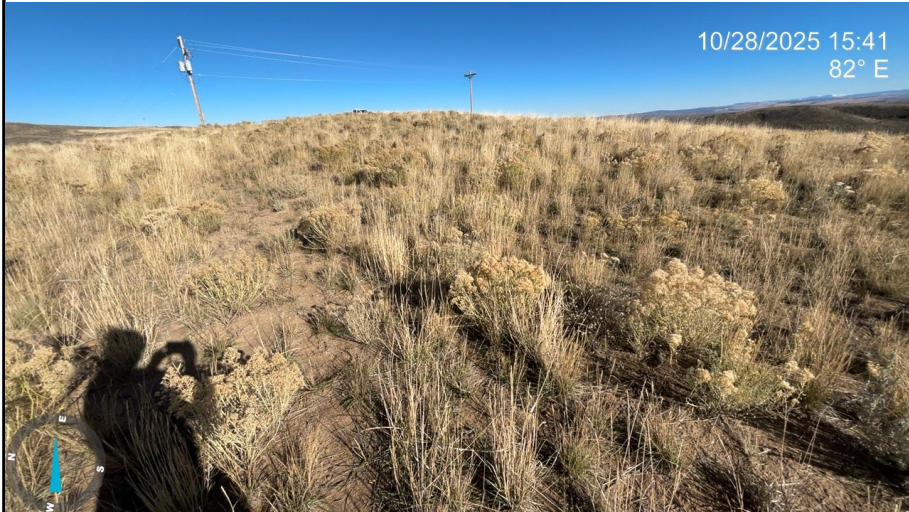
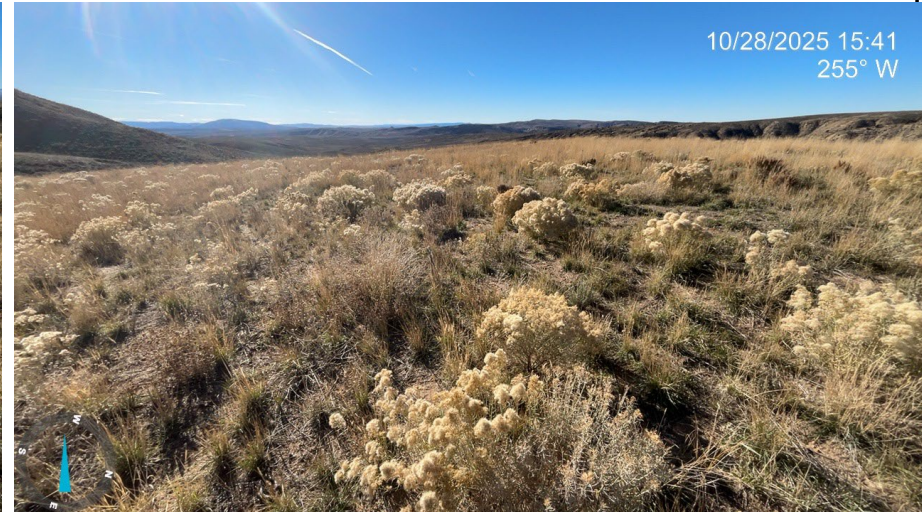
Photo 2: Photos showing an overview of the location looking east and west, respectively.

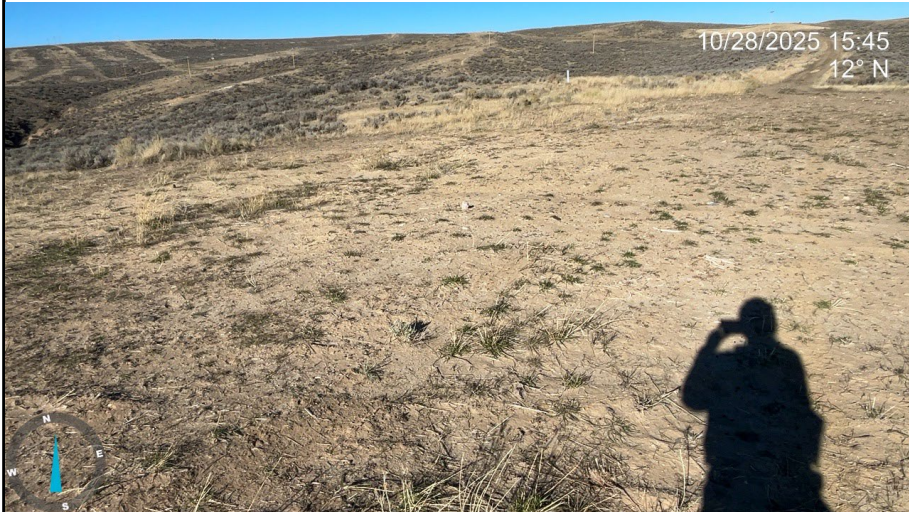
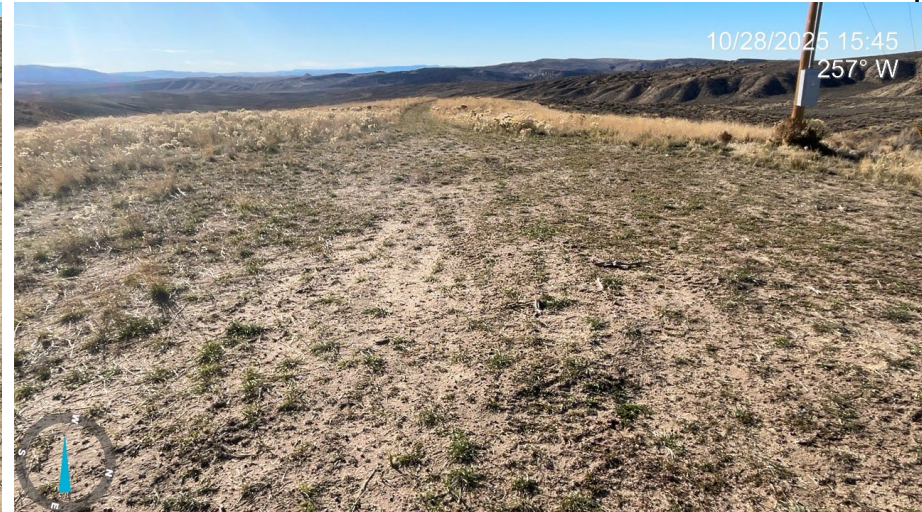
Photo 3: Photos showing an example of the eastern portion of the location. Vegetation is not progressing towards 1004 reclamation requirements; some areas remain predominantly bare and uniformity is not evident. Additional seeding may be required to meet 1004 standards.

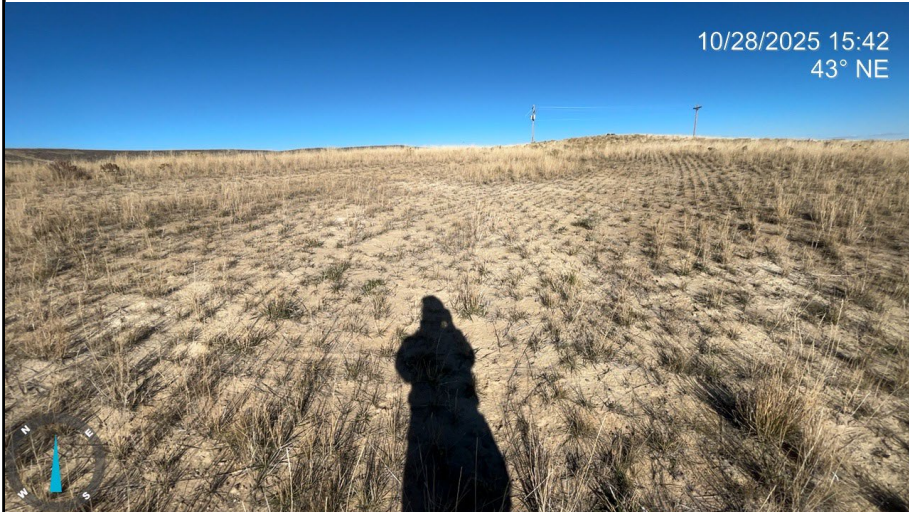
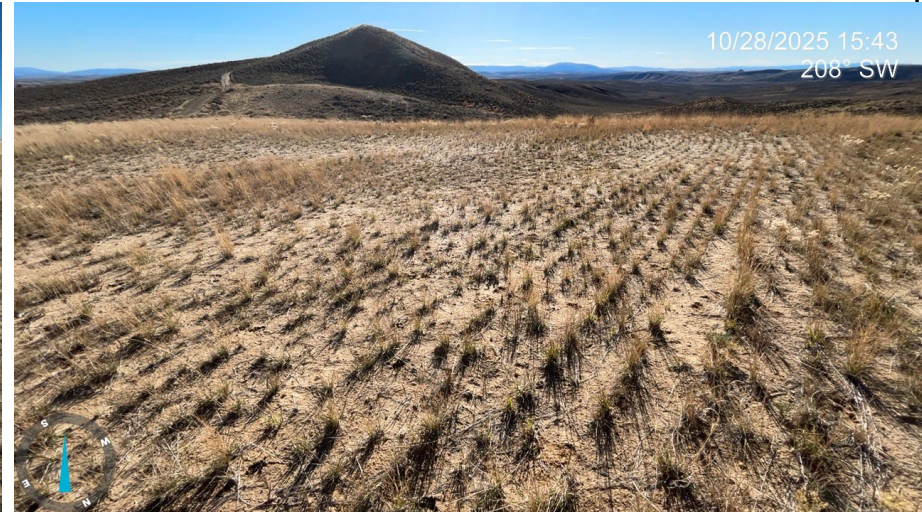
Photo 4: Photos showing an example of the north-central portion of the location. Vegetation is not progressing towards 1004 reclamation requirements; uniformity is not evident. Additional may be required to meet 1004 standards.

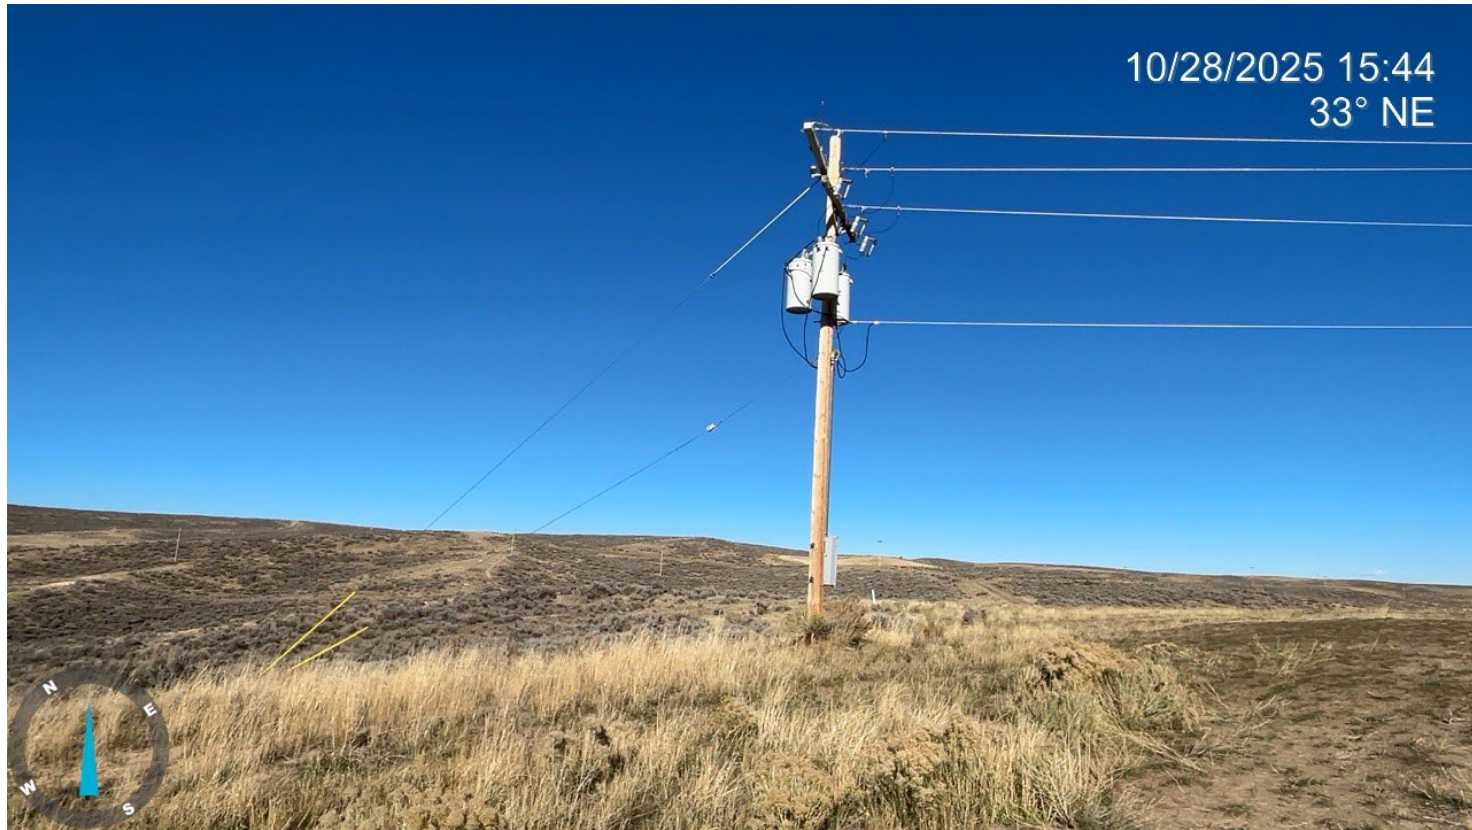
Photo 5: Photo showing an example of utility equipment that remains at the location and requires removal.

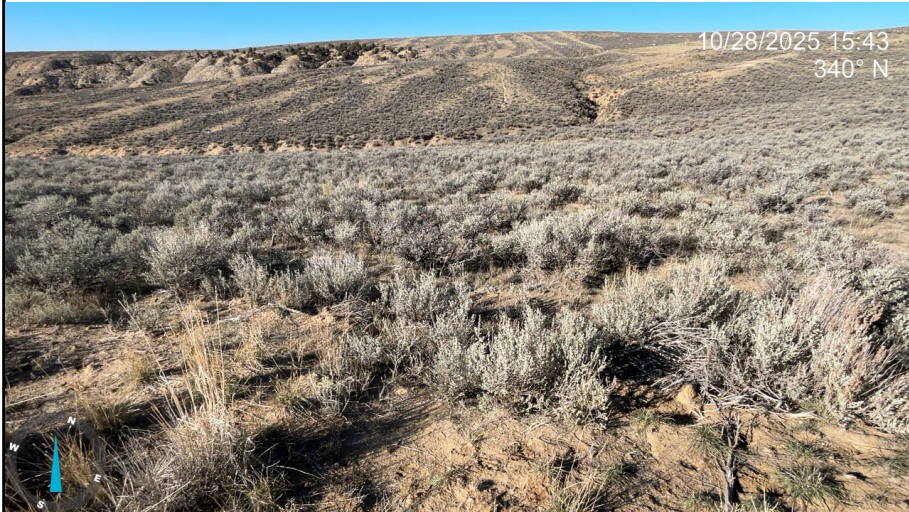
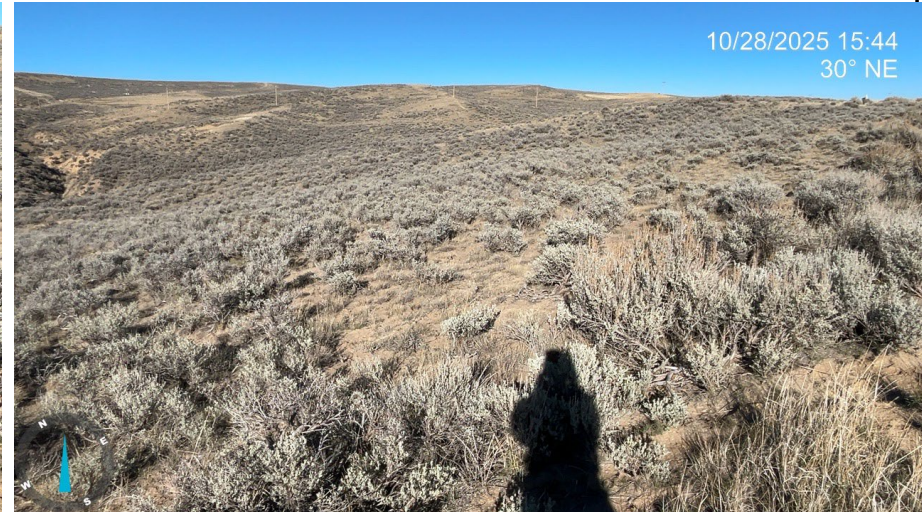
Photo 6: Photos showing an example of the reference area, located to the north of the location. Reference areas are characterized by big sagebrush shrublands; big sagebrush is dominant.
