DECOMMISSIONING REPORT
ALEXANDER FEDERAL H4-2JI FLOWLINE

ECMC REMEDIATION # 29328

Noble Energy, Inc - 100322
Alexander Federal H4-2JI
 NWNE Sec. 4-T3N-R65W
 Weld County, Colorado

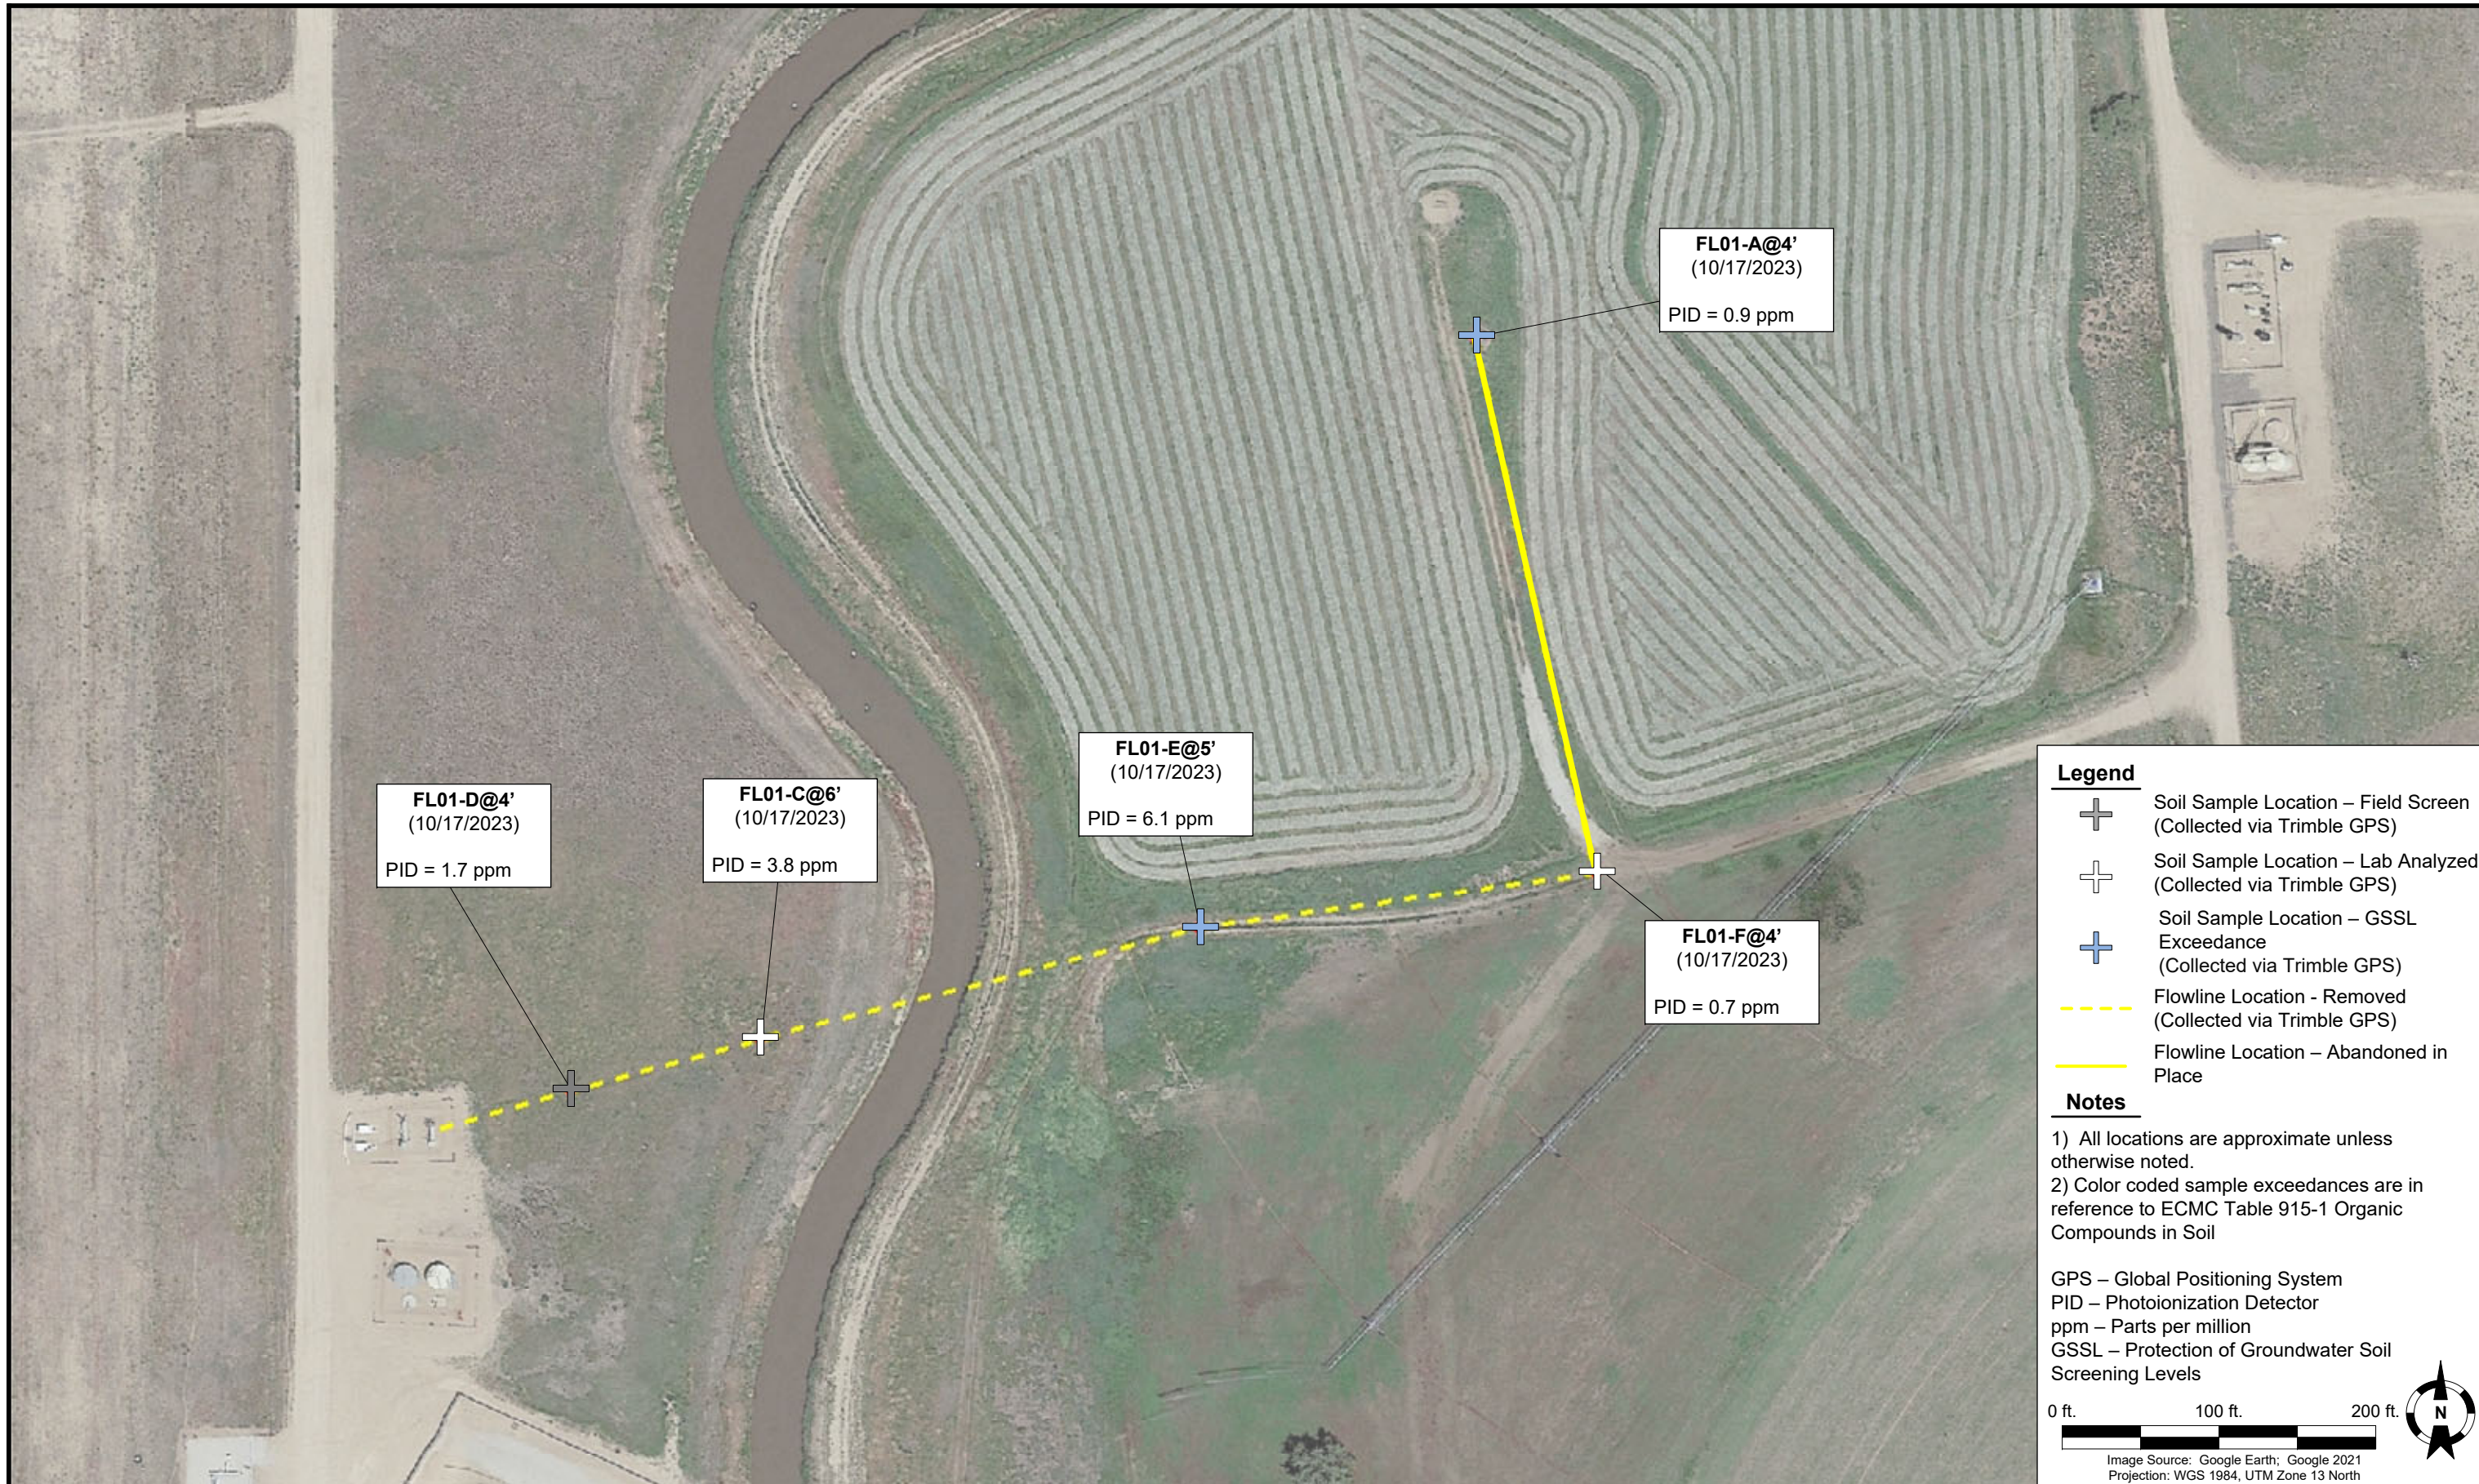
**FIGURE
 2**

- 1) All locations are approximate unless otherwise noted.
- 2) Color coded sample exceedances are in reference to ECMC Table 915-1 Organic Compounds in Soil

**SOIL SAMPLE
 LOCATION MAP
 (10/17/2023)**

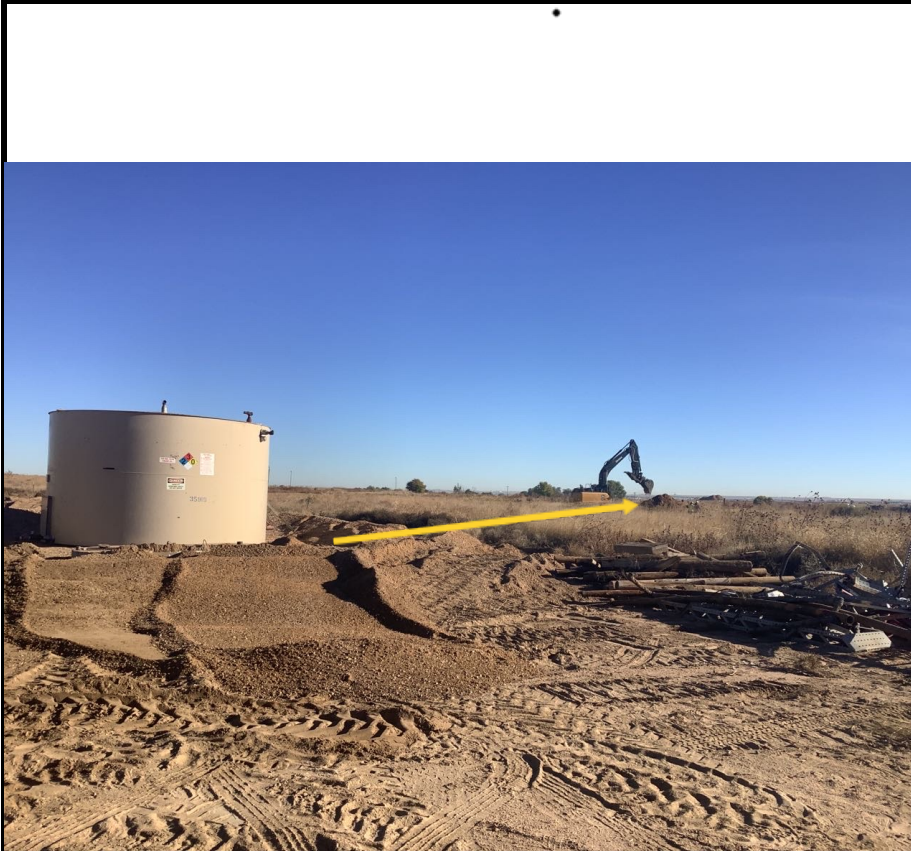
Equipment ID:		Equipment Type:	
Material:	Volume:	Contents:	
Notes/Conditions: Site photo - Facing NE Arrow points from facility to FL01-C, indicates flowline direction

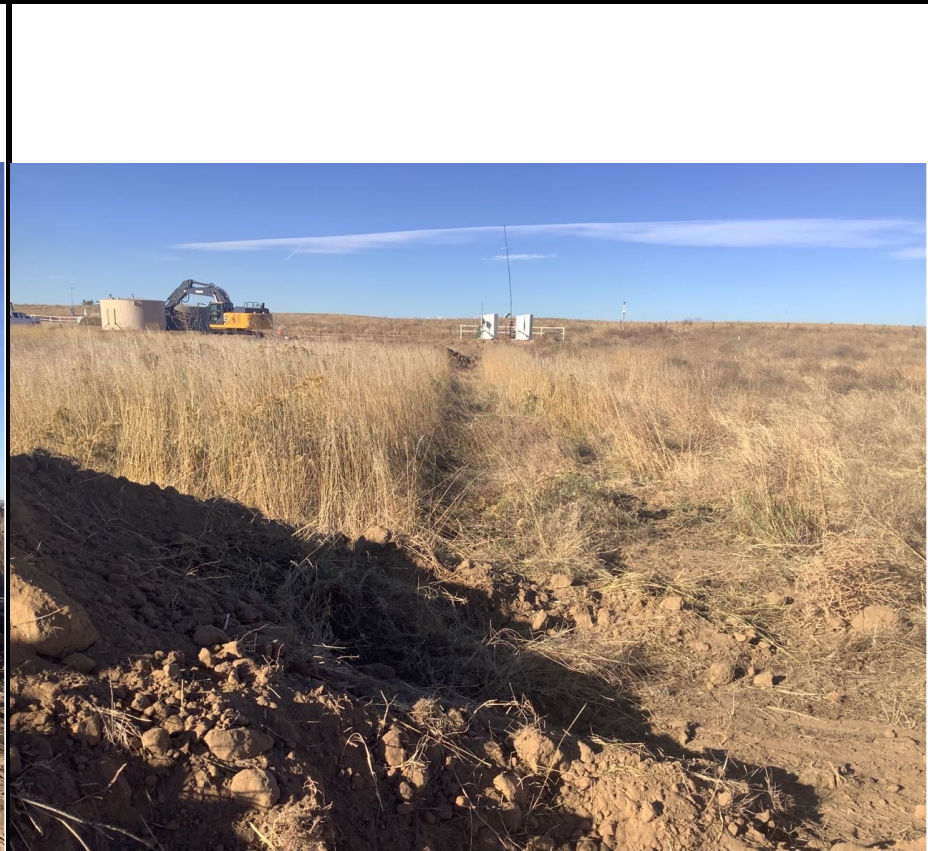
Equipment ID:		Equipment Type:	
Material:	Volume:	Contents:	
Notes/Conditions: Site photo From C point towards facility

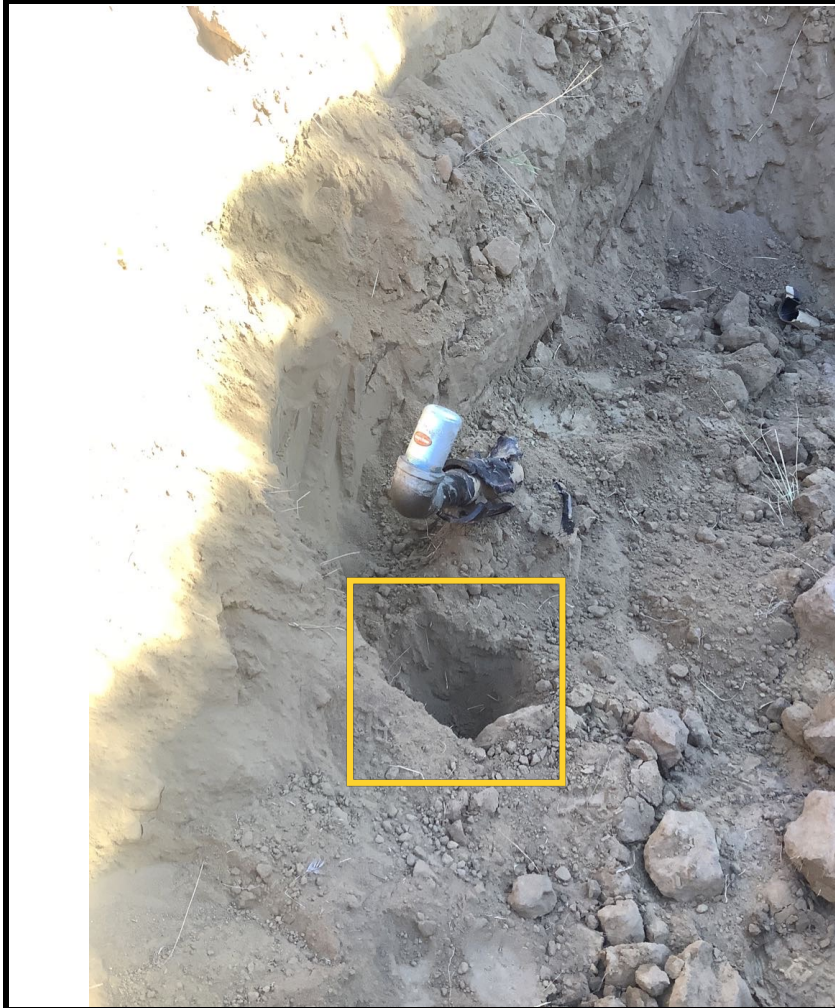
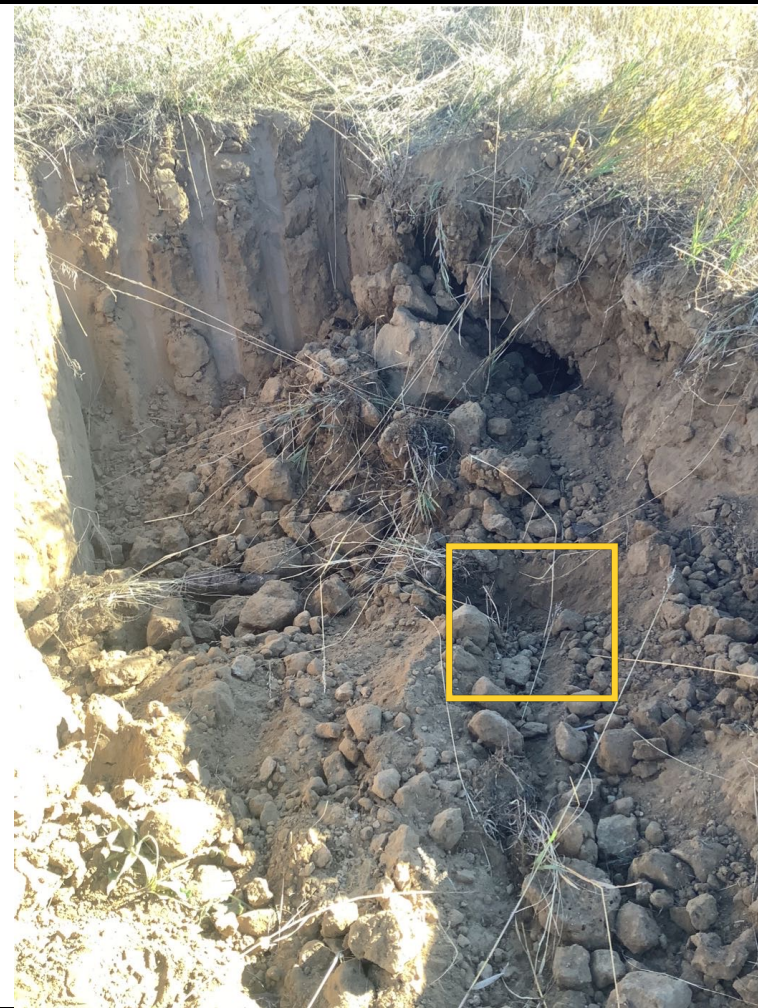
Flowline type	Oil / Gas / Water			
Depth	5'			
Age				
Length	1071'			
Construction Material	steel			
Were flowlines pulled?	yes, partially ABIP			
Visual Integrity of lines	good			
Visual impacts if trenched	none observed			
PID Readings if trenched	0.7 - 6.1			
Sample taken? Location/Sample ID#	yes, see below			
Photo Number(s)	3 - 7

Equipment ID: FL01-C@6'		Equipment Type:		Equipment ID: FL01-D@4'		Equipment Type:	
Material:	Volume:	Contents:		Material:	Volume:	Contents:	
Notes/Conditions: Facing NE				Notes/Conditions: Facing SW

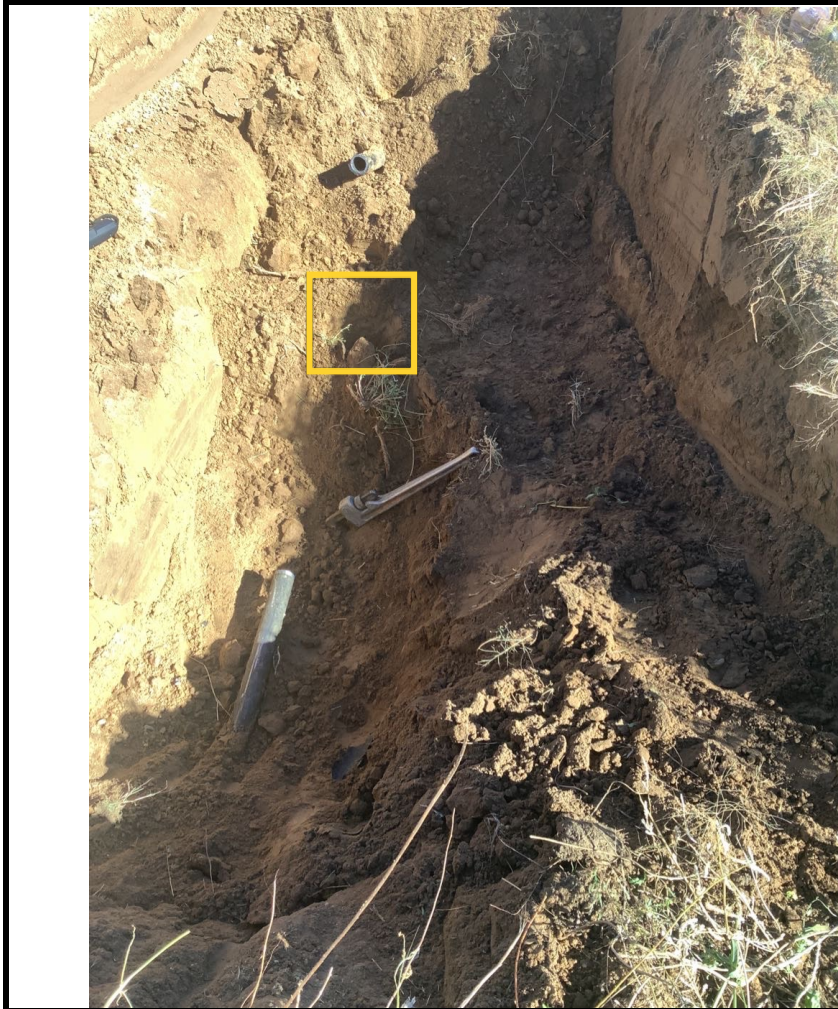
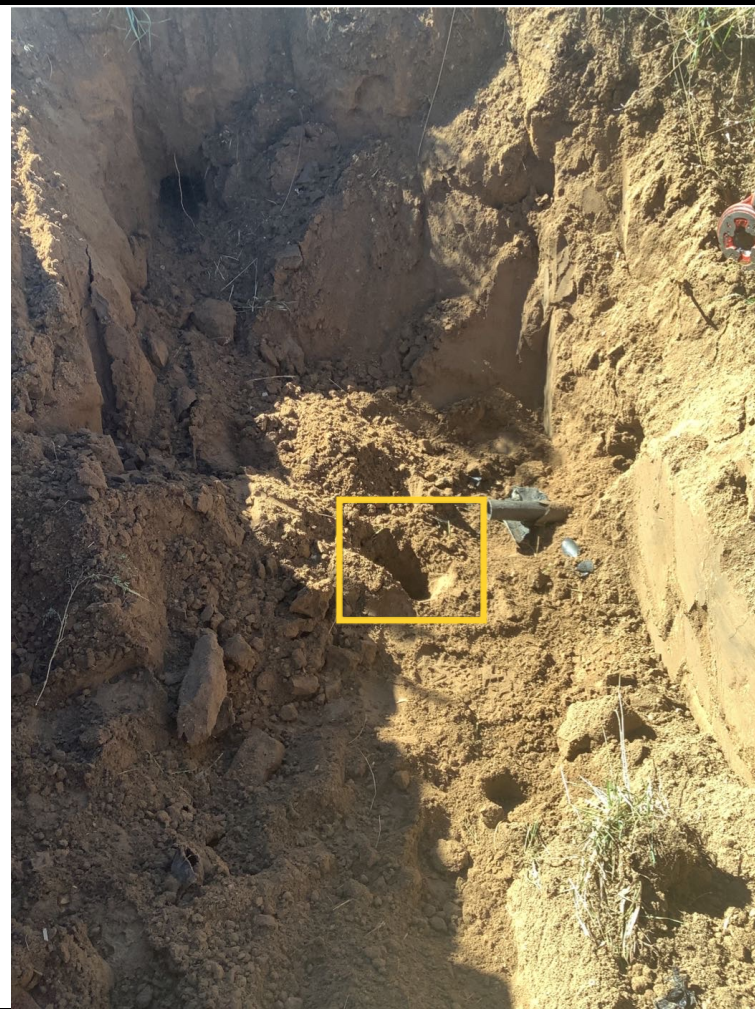
Other observations regarding on location flowlines:
Samples were taken at the wellhead (FL01-A@4') and along the flowline path (FL01-C@6' - FL01-F@4').
A direction change was observed at FL01-F@4', samples were also taken at the bell holes on either side of the Platte Valley Ditch.

Equipment ID: FL01-E@5'		Equipment Type:		Equipment ID: FL01-F@4'		Equipment Type:	
Material:	Volume:	Contents:		Material:	Volume:	Contents:	
Notes/Conditions:				Notes/Conditions: Direction change
