Inspection Photos

Operator: SWN Production Company LLC

Location ID: 313327

Inspection Doc: 719200386

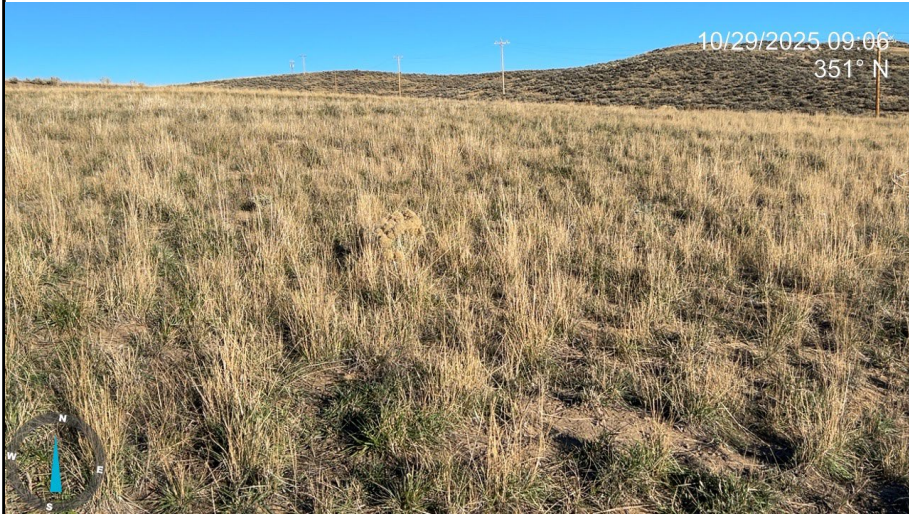
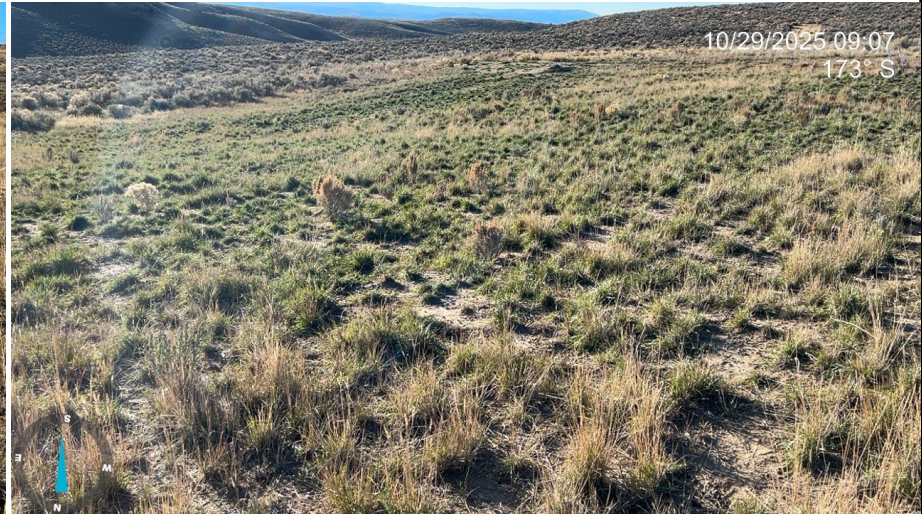
Photo 1: Photos showing an overview of the location looking north and south, respectively.

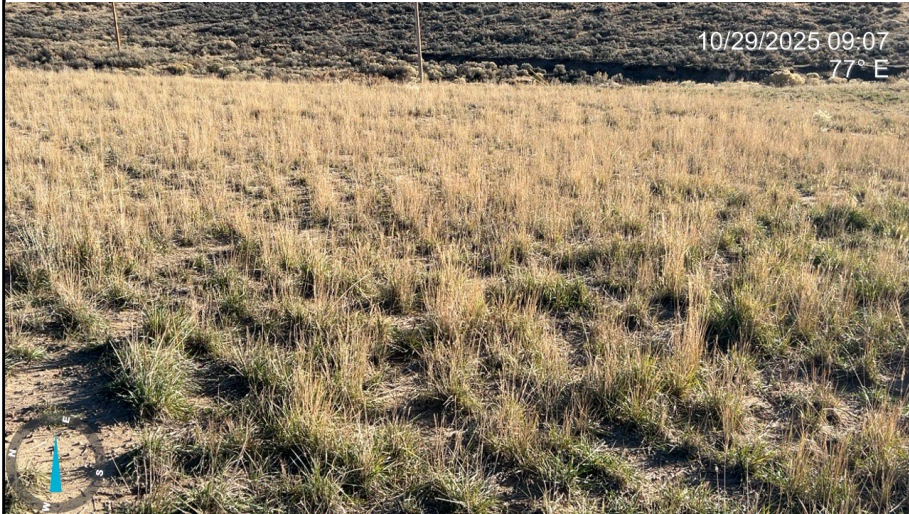
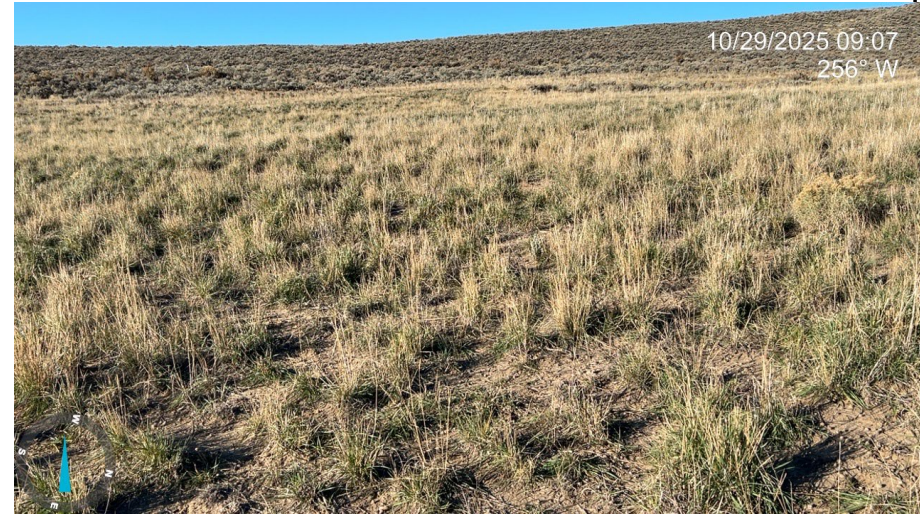
Photo 2: Photos showing an overview of the location looking east and west, respectively.

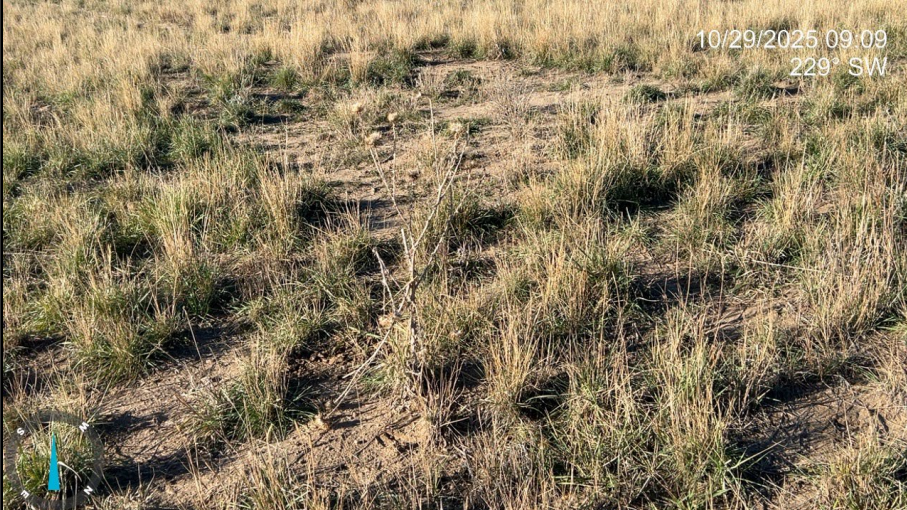
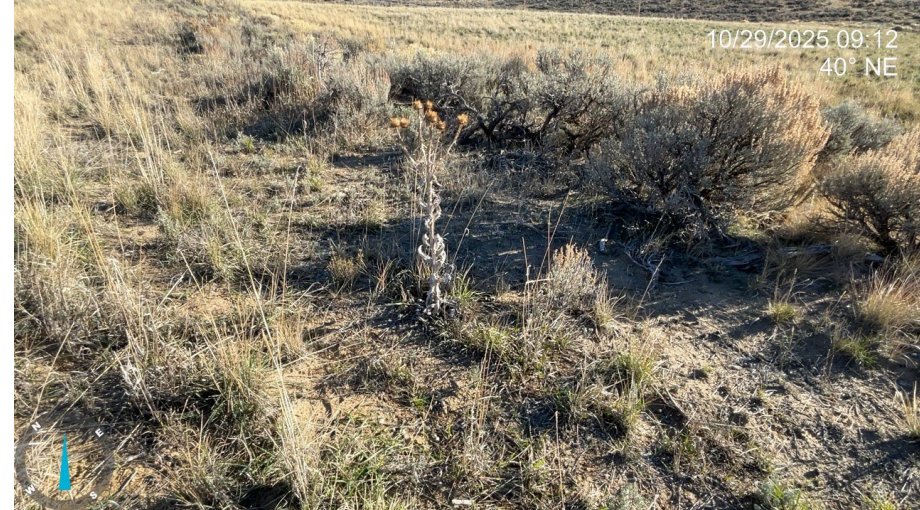
Photo 3: Photos showing an example of Scotch thistle, a List B noxious weed, that is present in tertiary amounts throughout the site. It does not appear as though weeds have been managed in 2025.

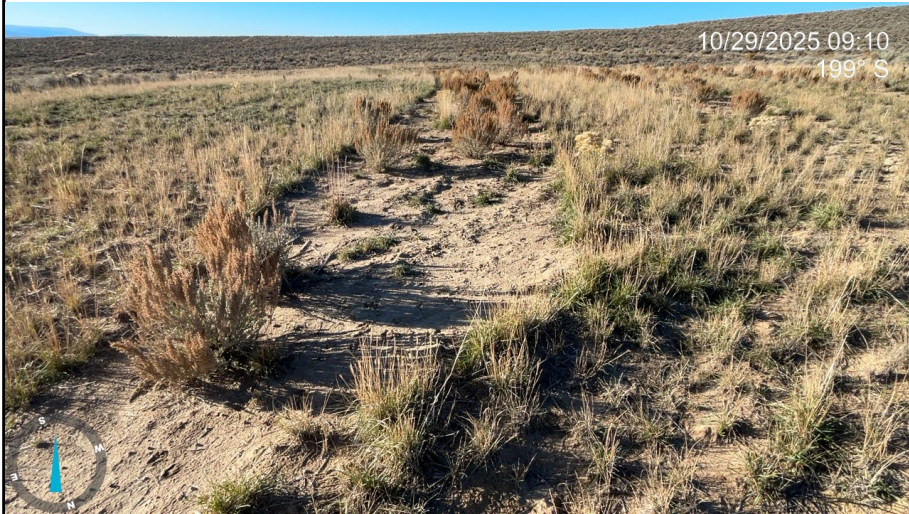
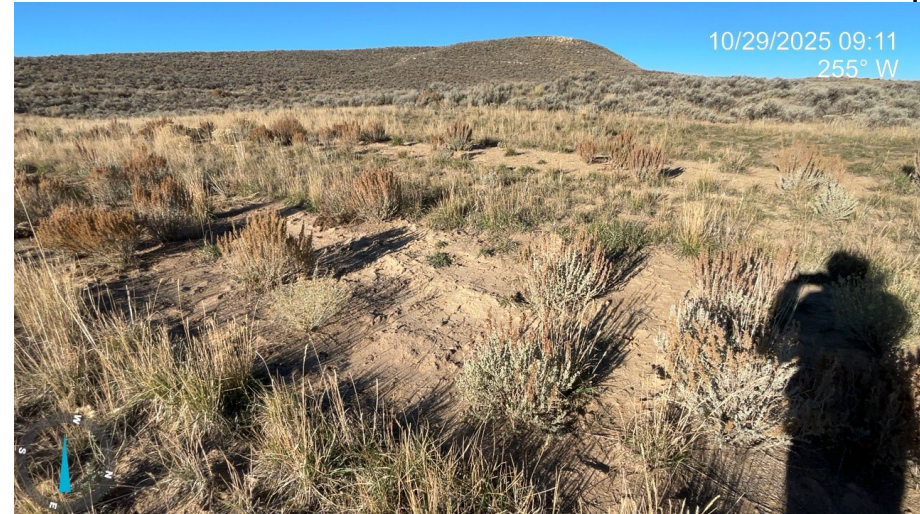
Photo 4: Photos showing an example of western portions of the site that were not reclaimed. Some native vegetation has established; however, the areas appear to have compaction issues and additional seeding may be necessary in some areas.

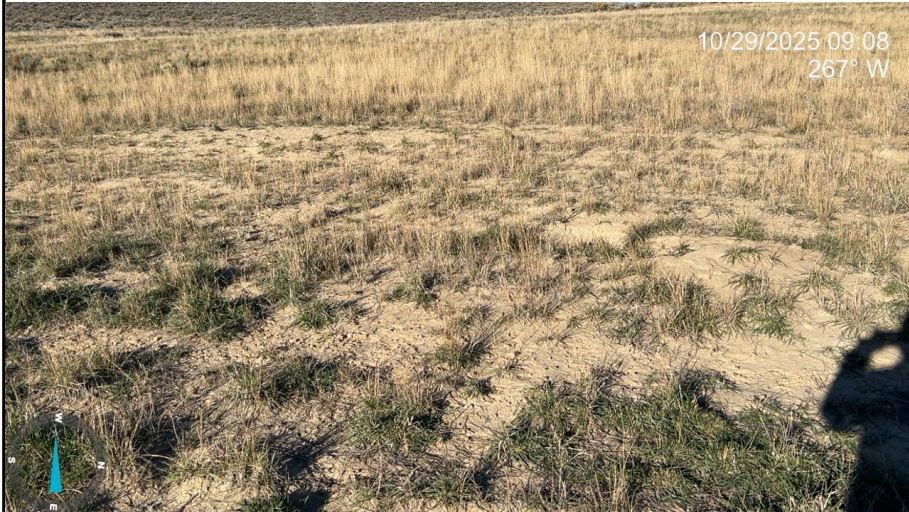
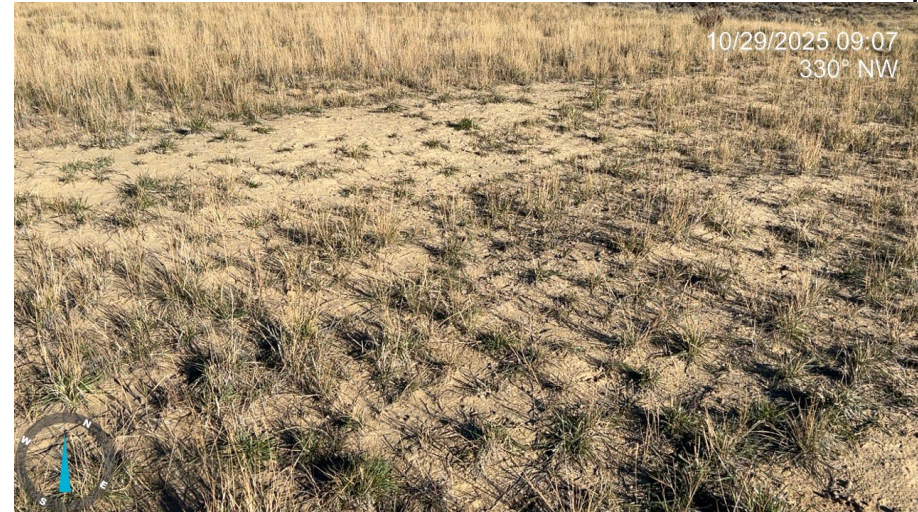
Photo 5: Photos showing an example of areas on the eastern end of the location that were predominantly bare during the 2024 inspection. Desirable, perennial vegetation has established; however, uniformity has not yet been achieved. Vegetation needs more time to develop.

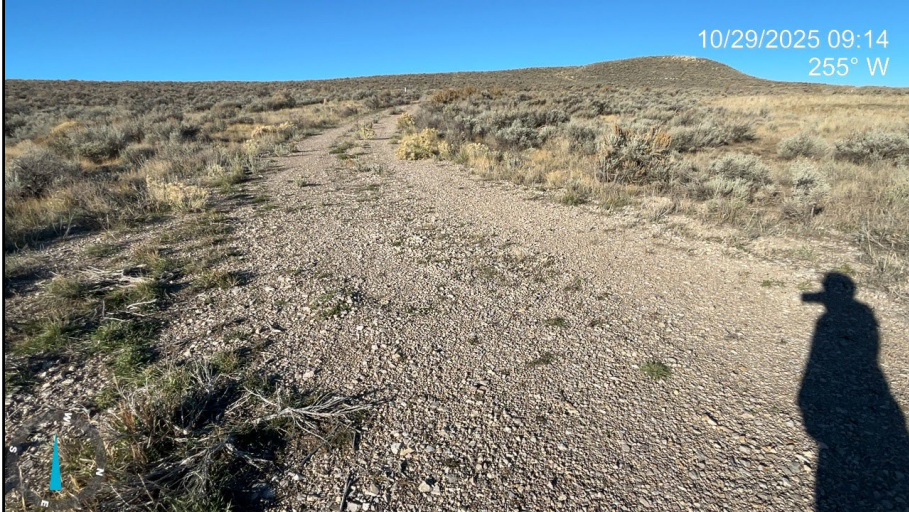
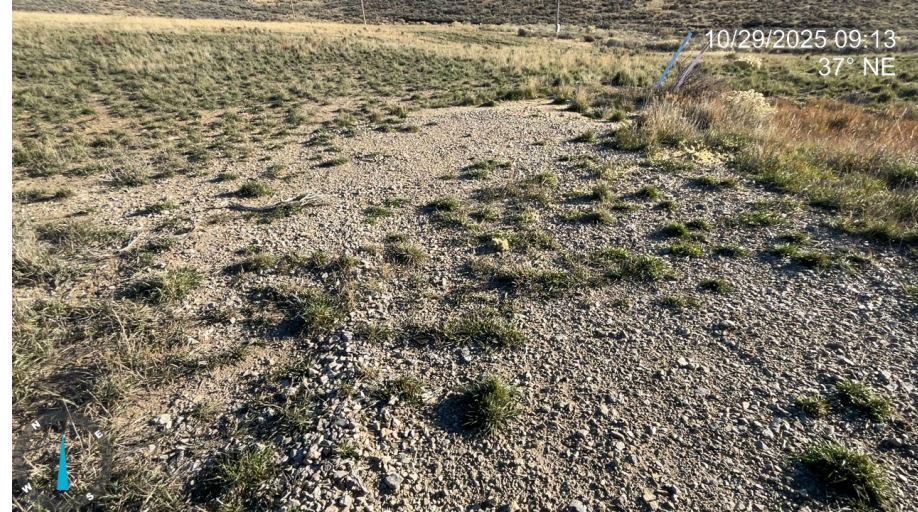
Photo 6: Photos showing the access road leading to the location has not been reclaimed; gravel and compaction is evident.

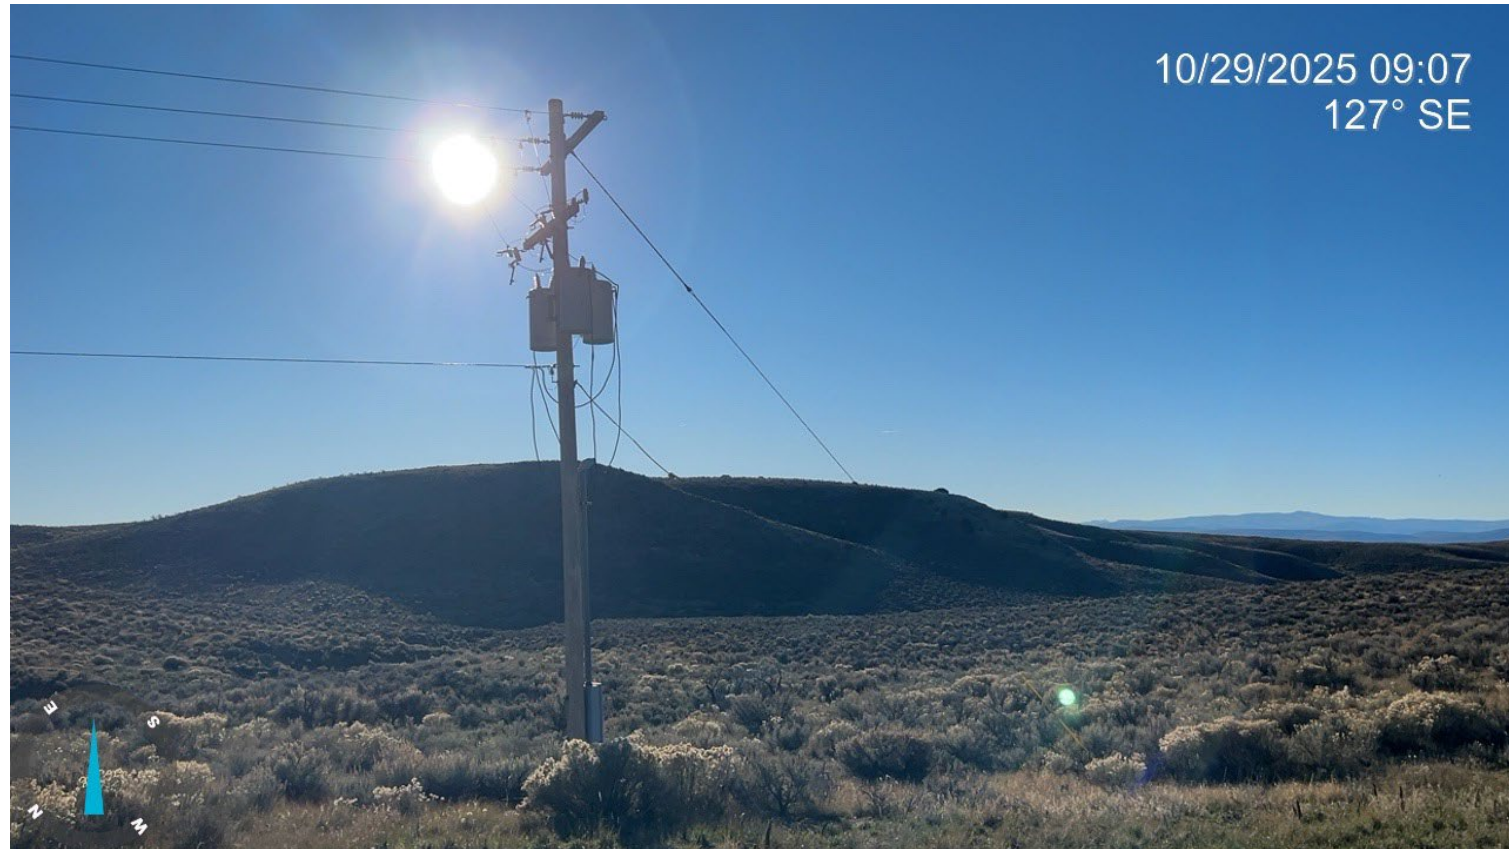
Photo 7: Photos showing an example of utility equipment that remains at the location and requires removal.

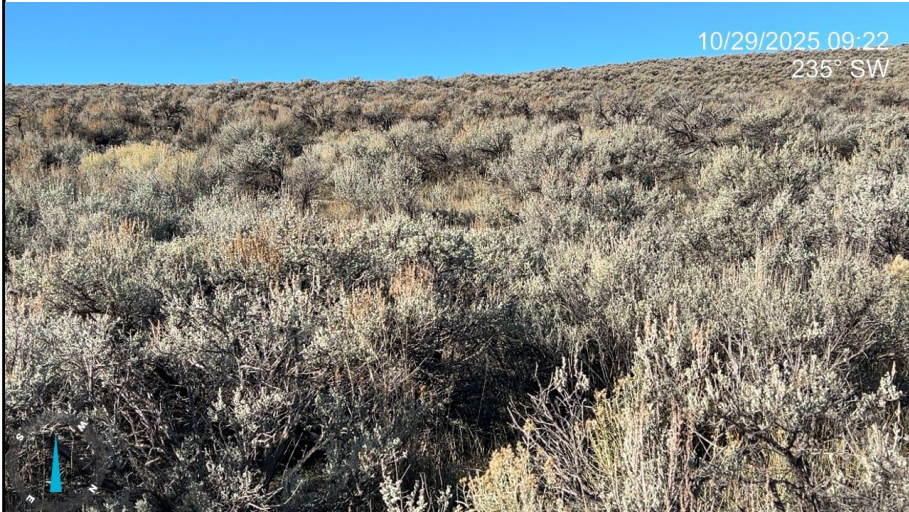
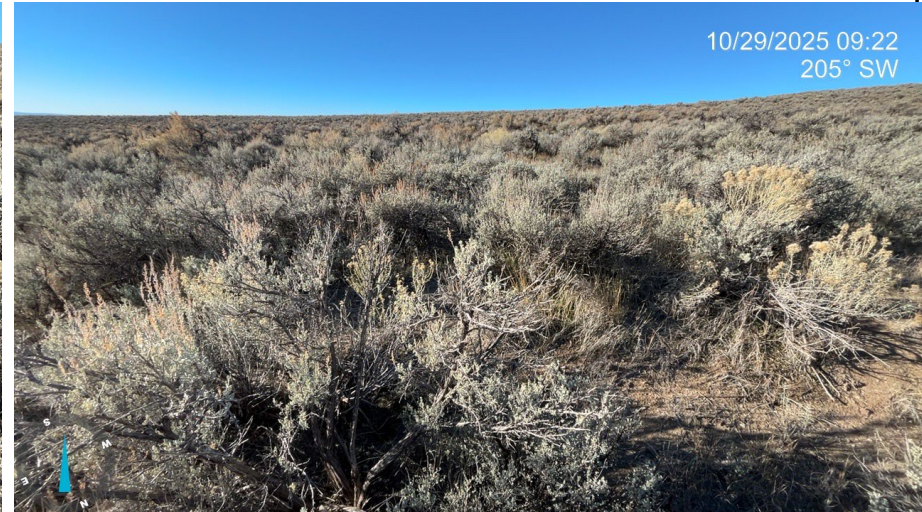
Photo 8: Photos showing an example of the reference area, located to the south of the location. Reference areas are characterized by big sagebrush shrublands, and big sagebrush is dominant.
