Inspection Photos

Operator: Quicksilver Resources Inc #10255

Location ID: 313181

Inspection Doc: 719200391

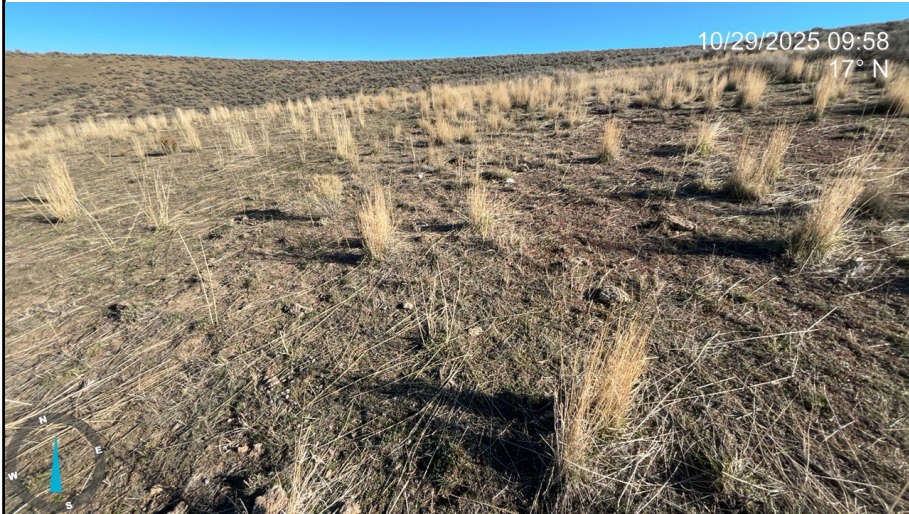
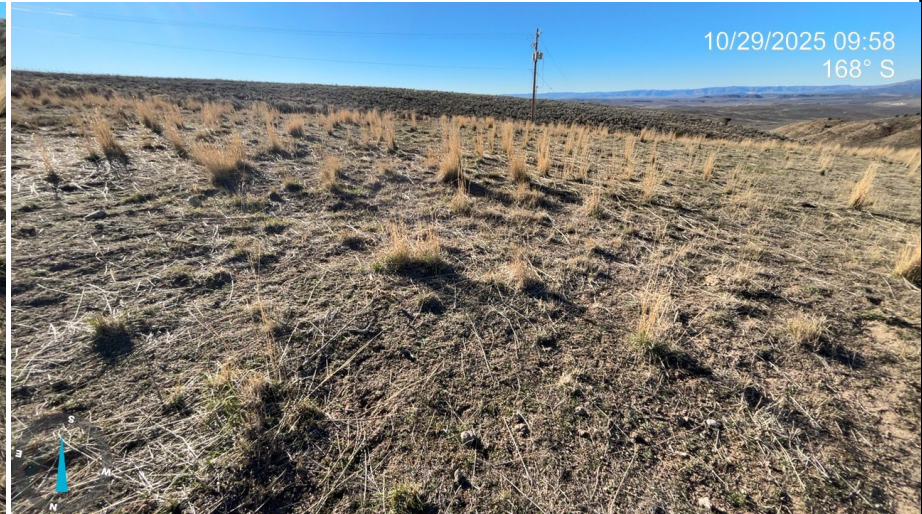
Photo 1: Photos showing an overview of the location looking north and south, respectively.

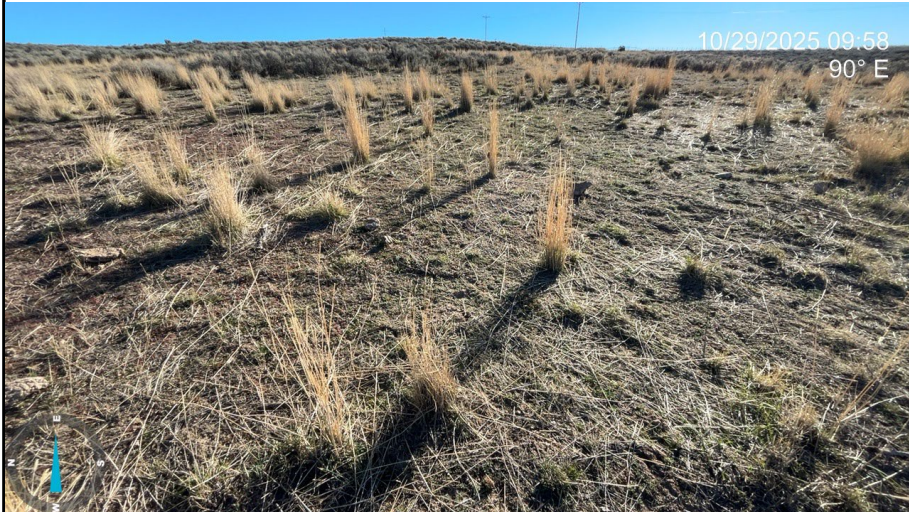
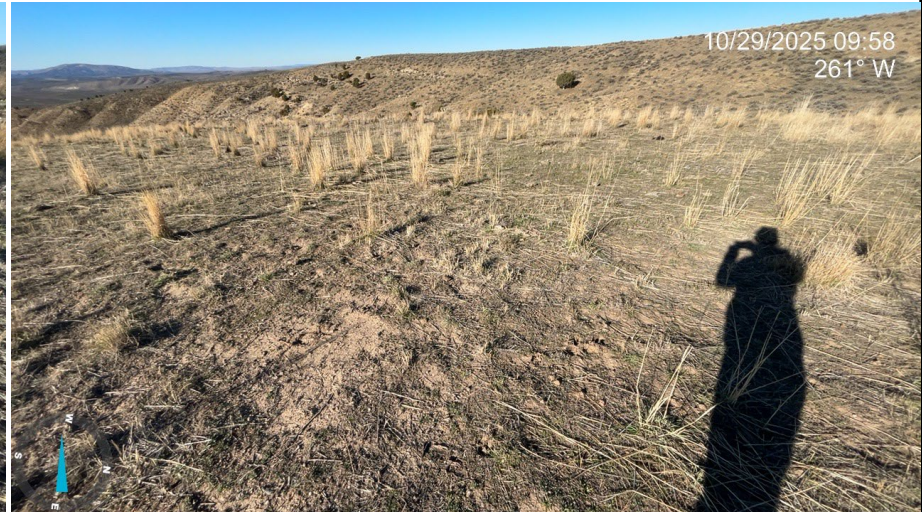
Photo 2: Photos showing an overview of the location looking east and west, respectively.

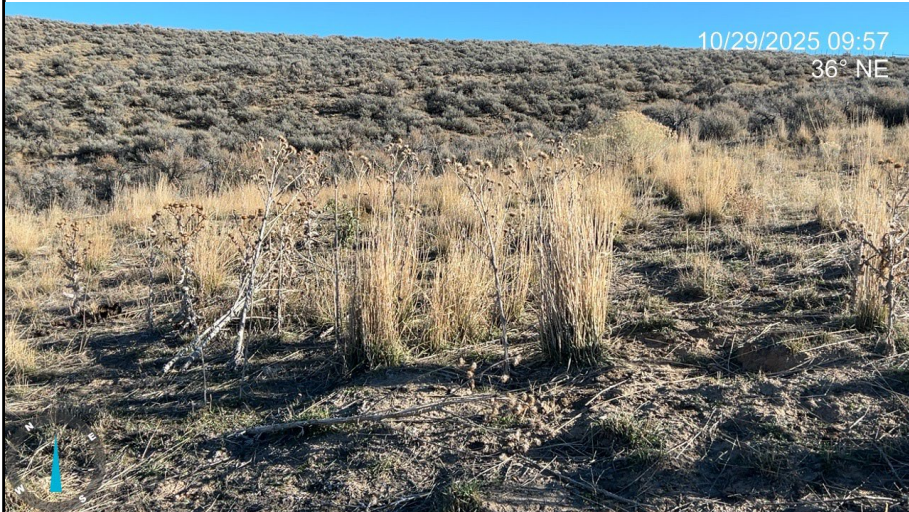
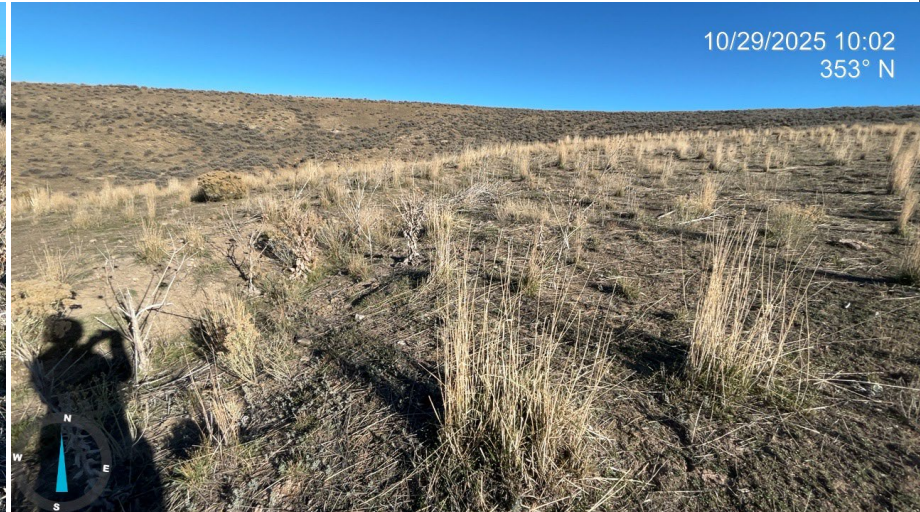
Photo 3: Photos showing an example of Scotch thistle, a List B noxious weed, is present throughout the site. It does not appear as though weeds have been managed in 2025.

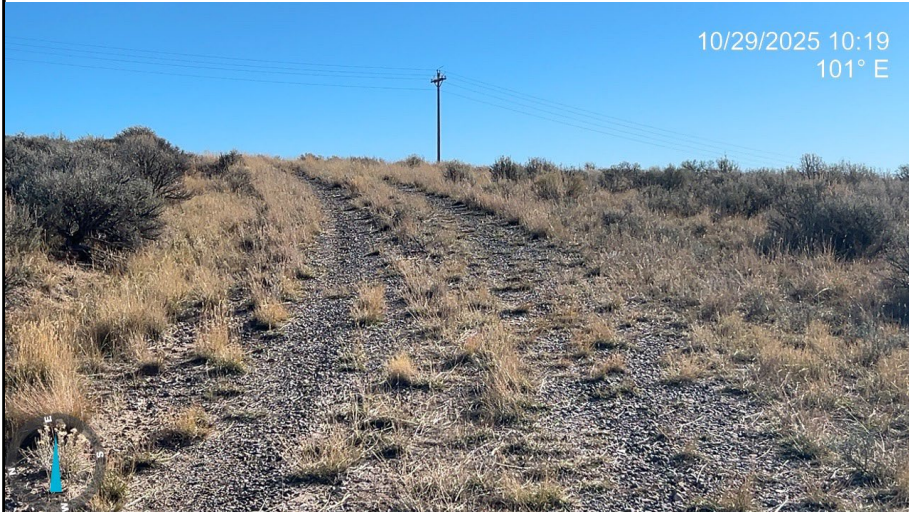
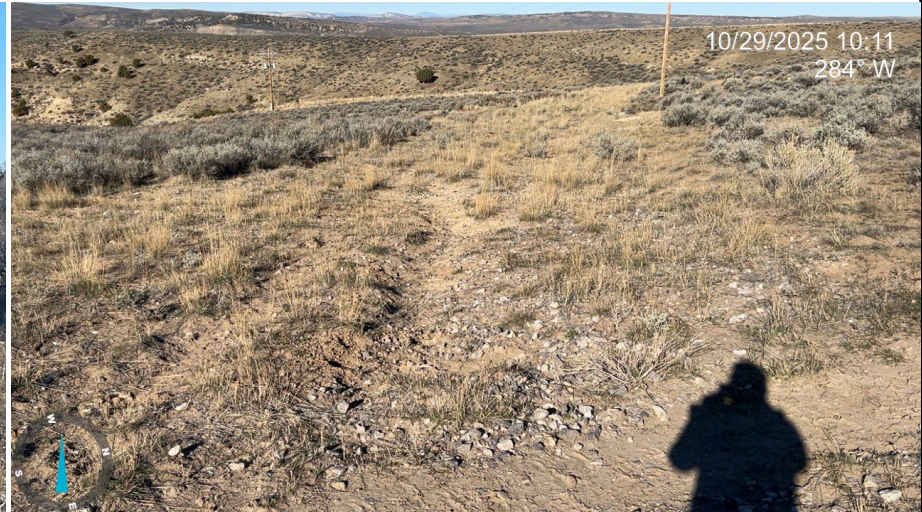
Photo 4: Photos the show access road has not been reclaimed in accordance with 1004 Rules- culverts remaining. Gravel has not been removed; road has not been decompacted, recontoured/regraded and/or reclaimed.

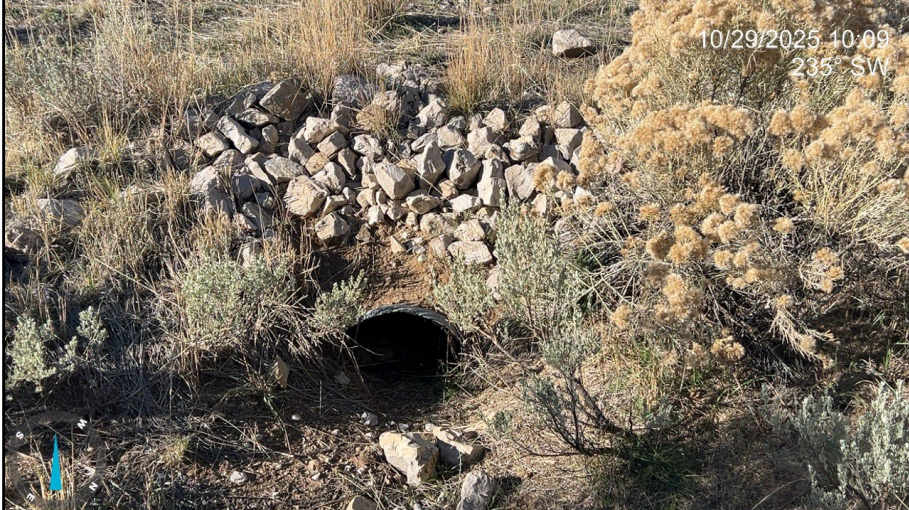
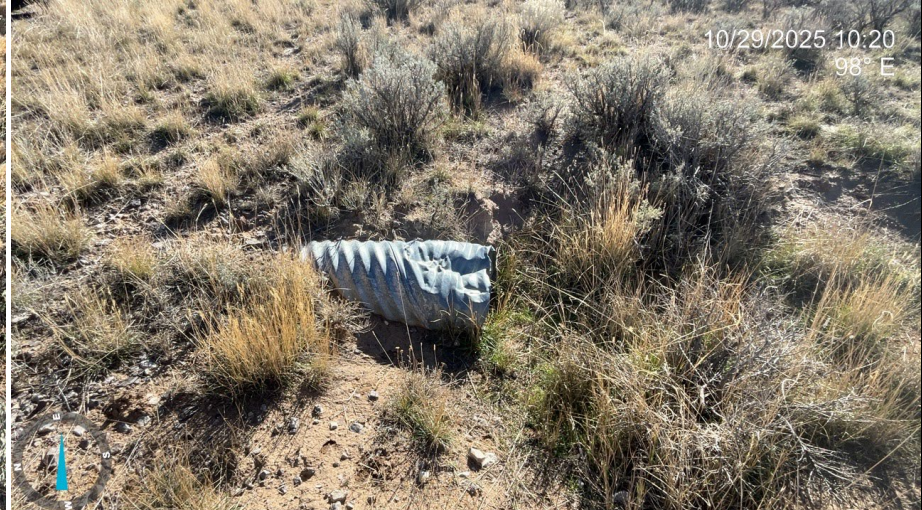
Photo 5: Photos the show access road has not been reclaimed in accordance with 1004 Rules- culverts remaining. Gravel has not been removed; road has not been decompacted, recontoured/regraded and reclaimed.

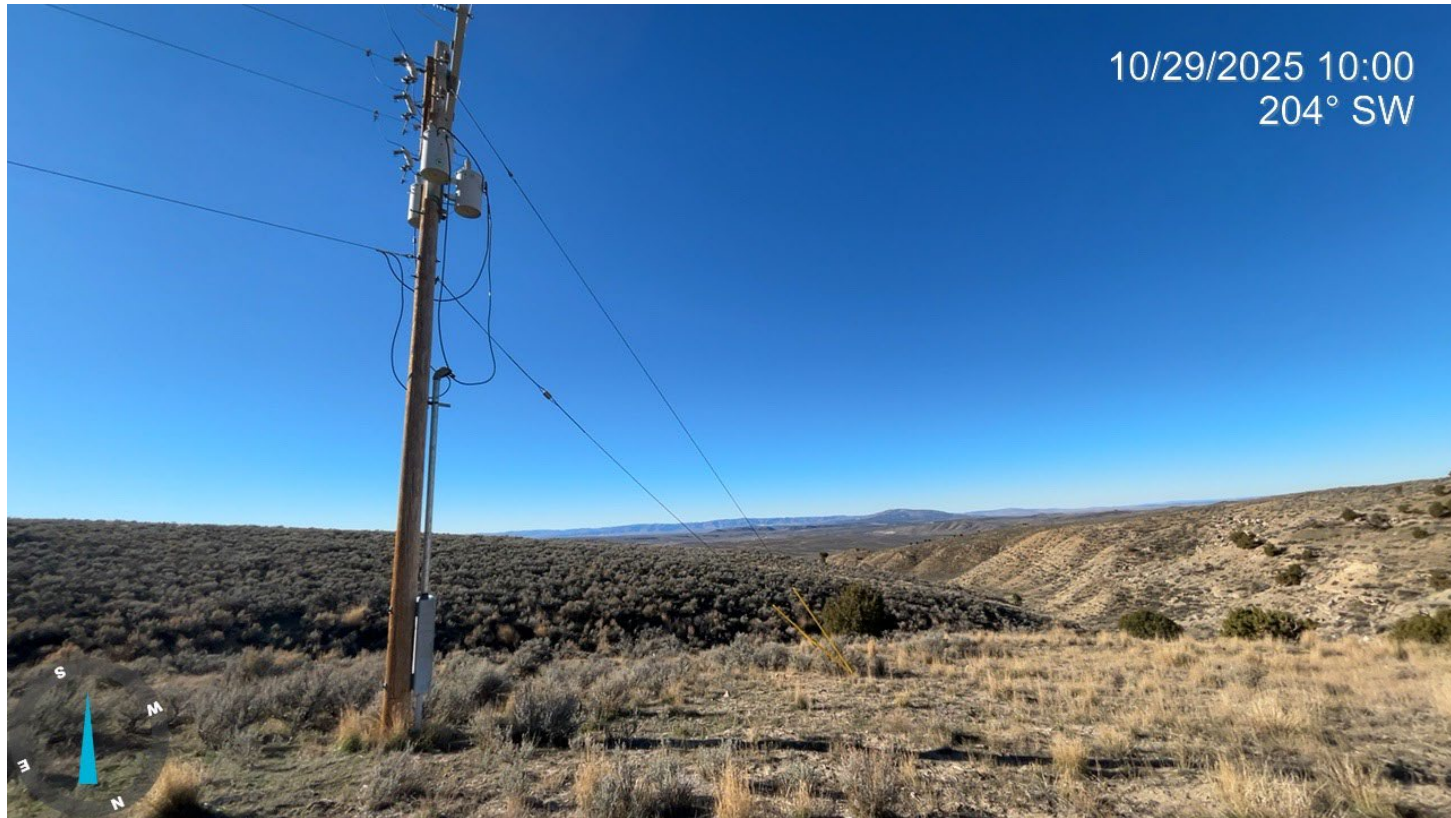
Photo 6: Photo showing an example of utility equipment on and leading to the location that has not been removed.

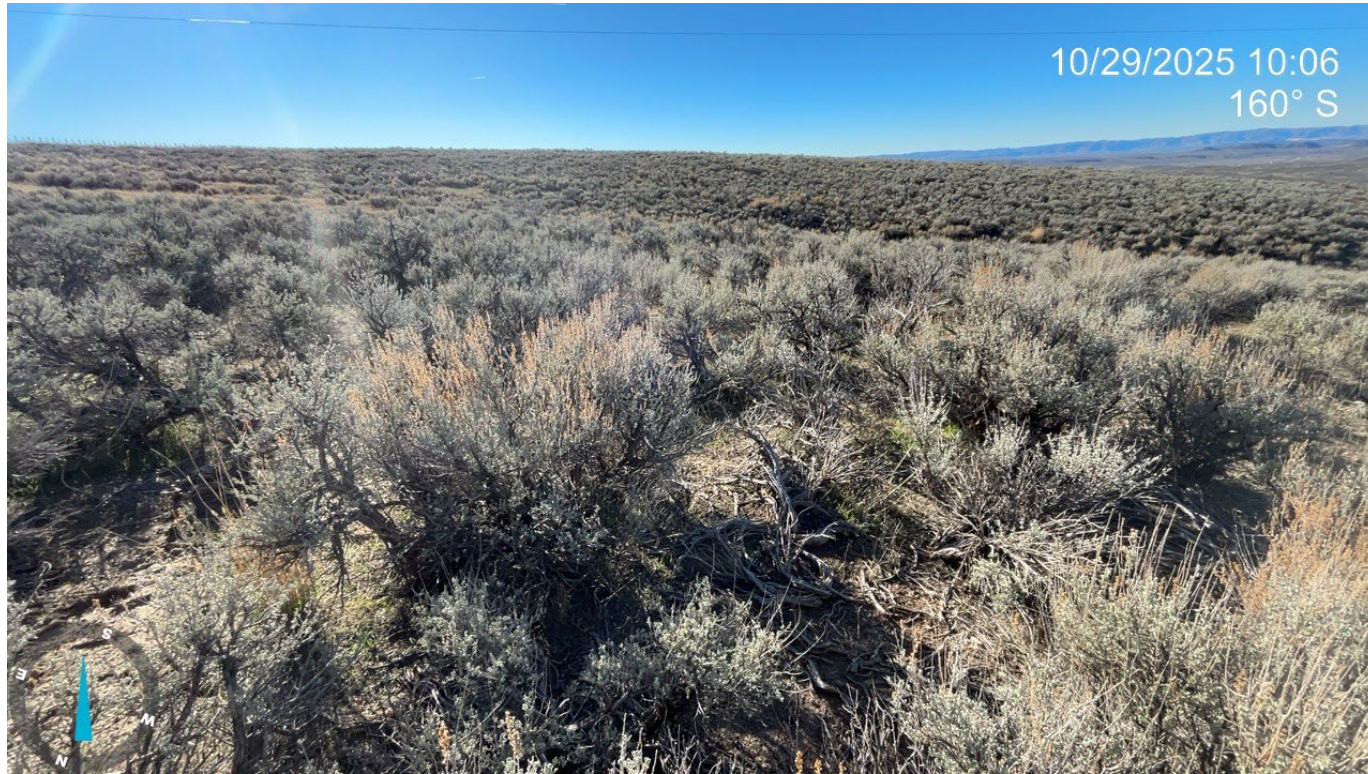
Photo 7: Photos showing an example of the reference area, located to the east of the location looking south. Reference areas are characterized by big sagebrush shrublands, and big sagebrush is dominant.
