Inspection Photos

Operator: SWN Production Company LLC

Location ID: 313350

Inspection Doc: 719200393

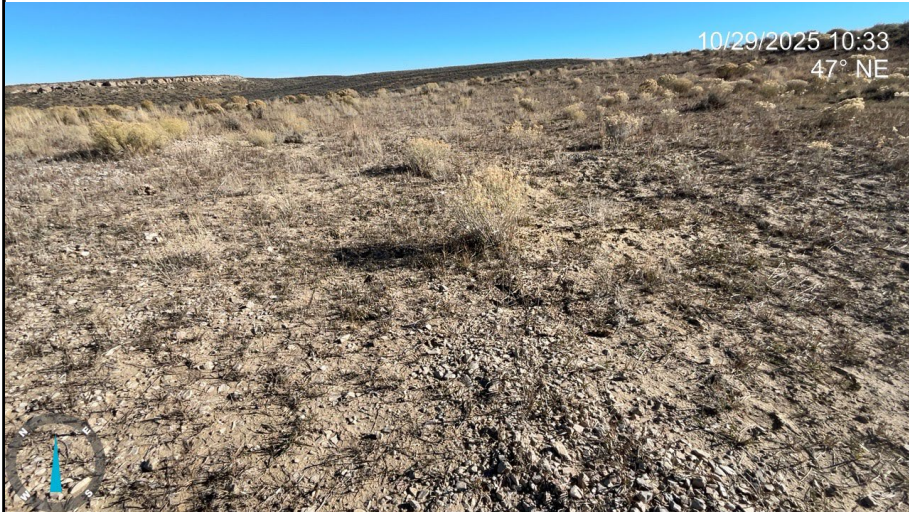
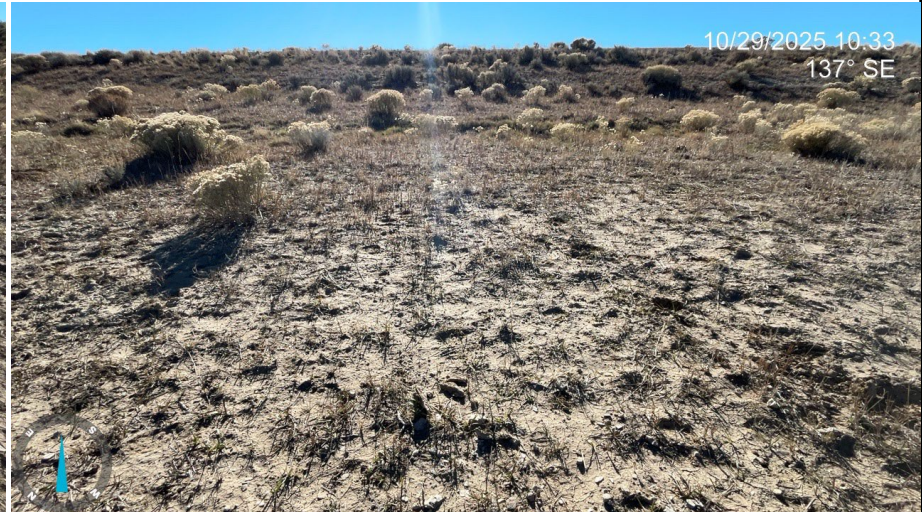
Photo 1: Photos showing an overview of the location looking northeast and southeast, respectively.

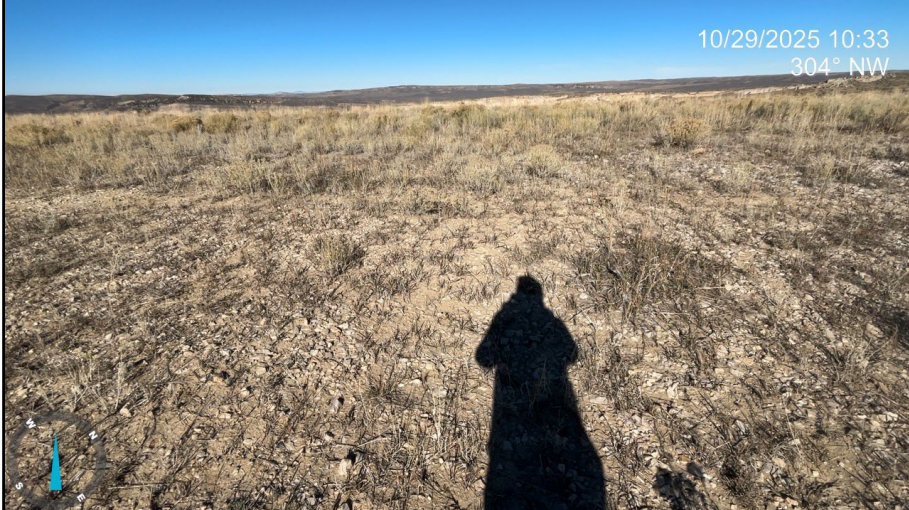
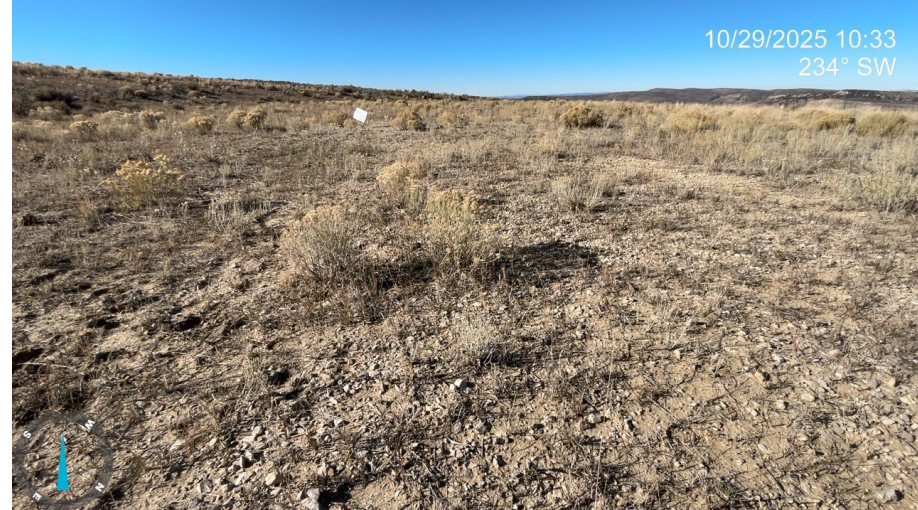
Photo 2: Photos showing an overview of the location looking northwest and southwest, respectively.

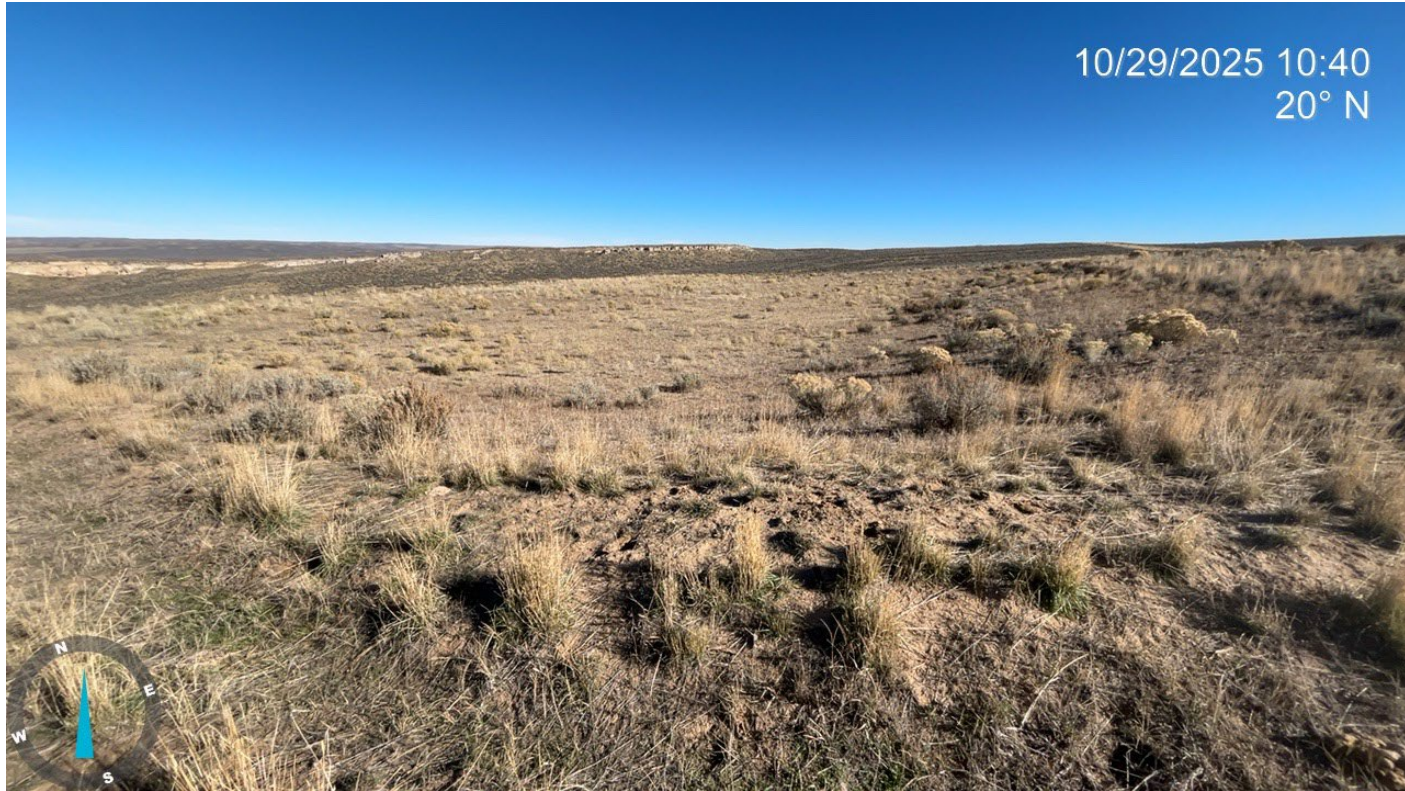
Photo 3: Photo showing an overview from the southwestern end of the location; the location has not been reclaimed per 1004 reclamation requirements. A variance to waive reclamation of the location and access road is pending Commission decision.

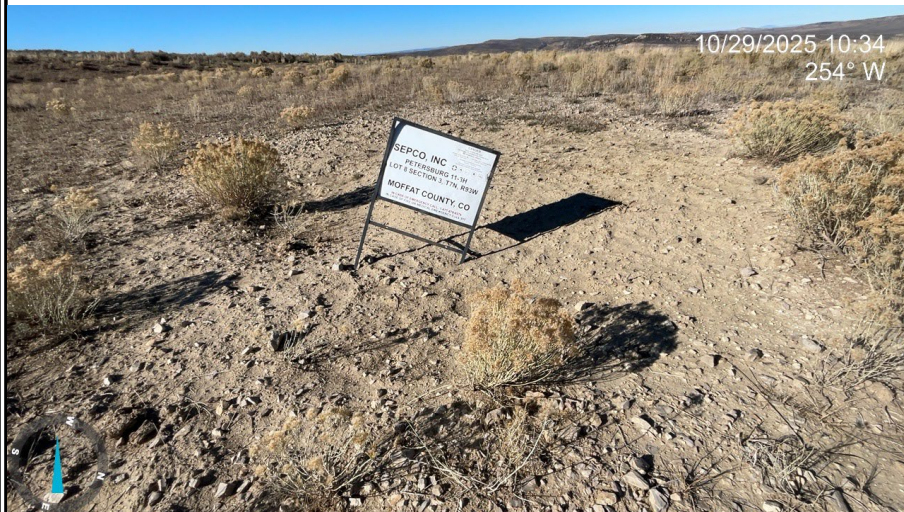
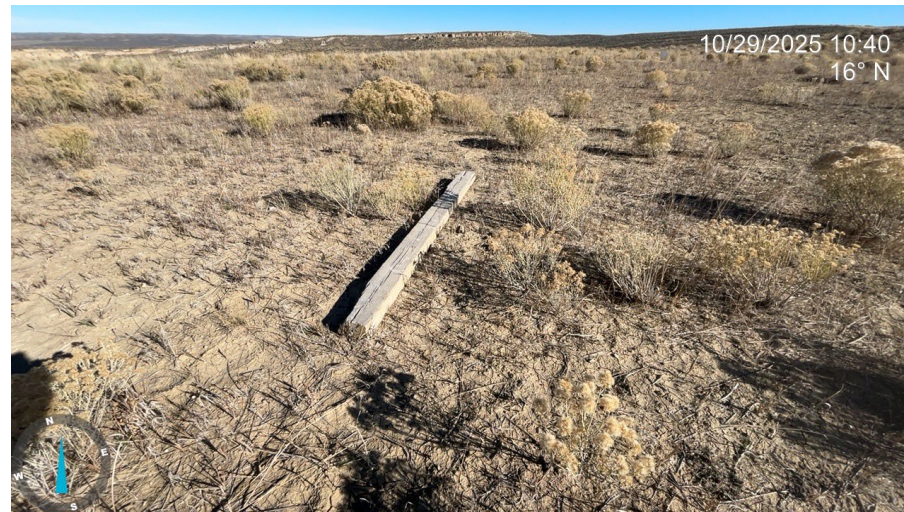
Photo 4: Photos showing a sign with incorrect Operator information and some debris is present at the location. Comply with Rules 606.a. and 1004.a. Removal is required.

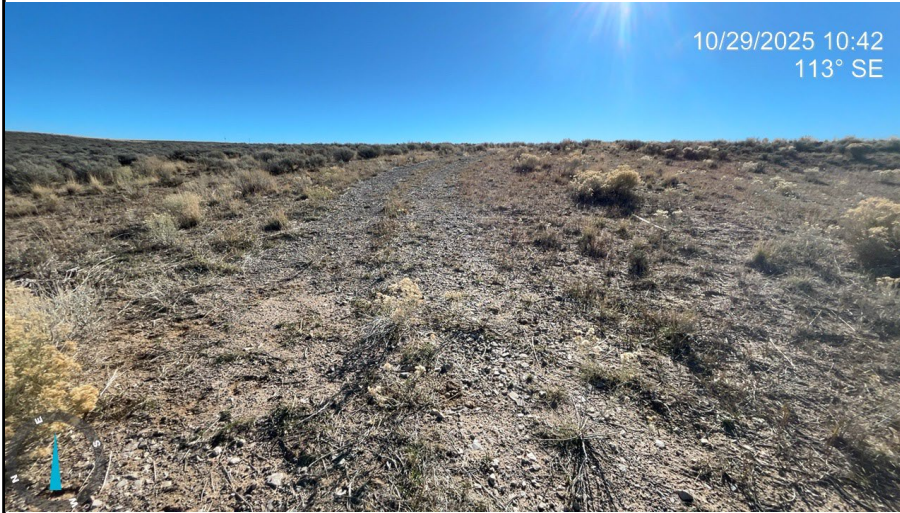
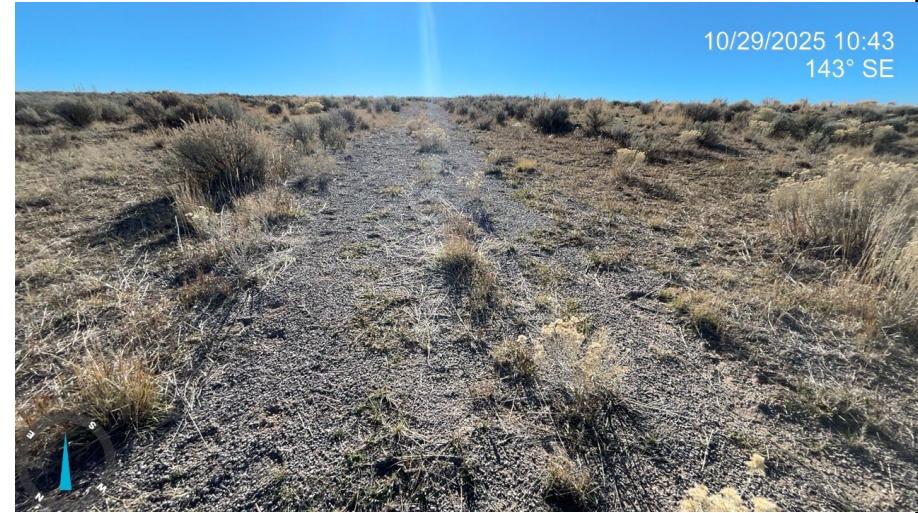
Photo 5: Photos showing the access road leading to the location. The access road has not been reclaimed per 1004 reclamation requirements; gravel and compaction is evident. A variance to waive reclamation of the location and access road is pending Commission decision.

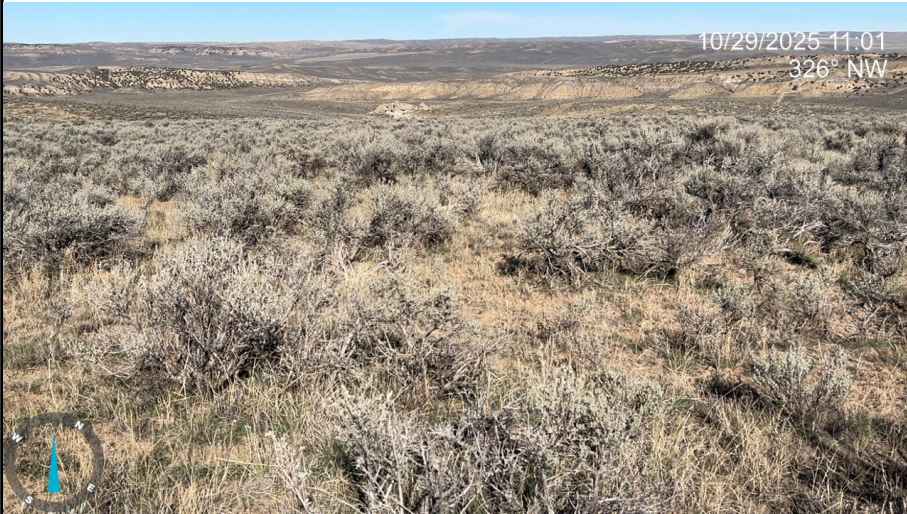
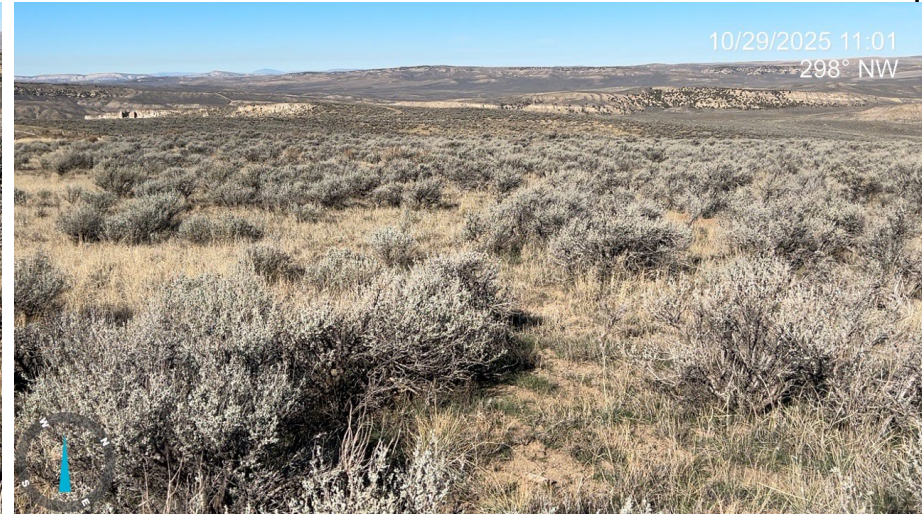
Photo 6: Photos showing an example of the reference area, located to the northeast of the location. Reference areas are characterized by big sagebrush shrublands, and big sagebrush is dominant.
