Inspection Photos

Operator: SWN Production Company LLC

Location ID: 313339

Inspection Doc: 719200397

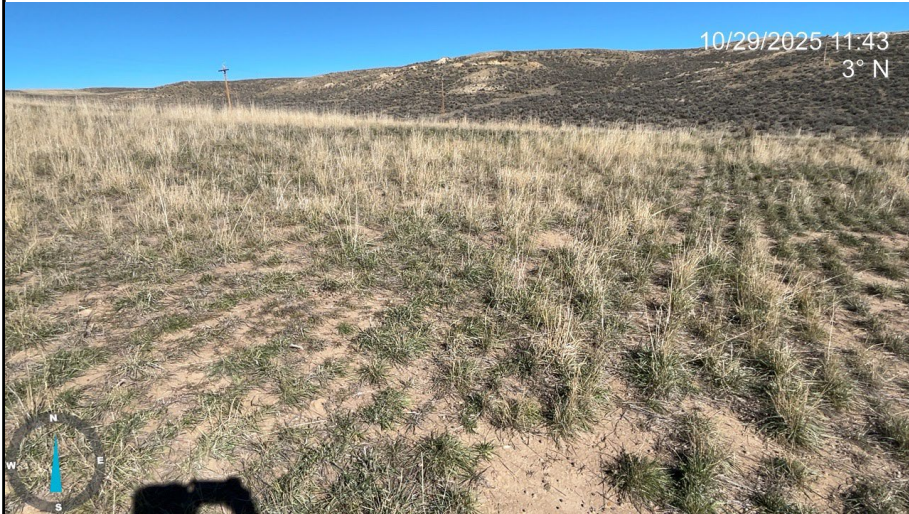
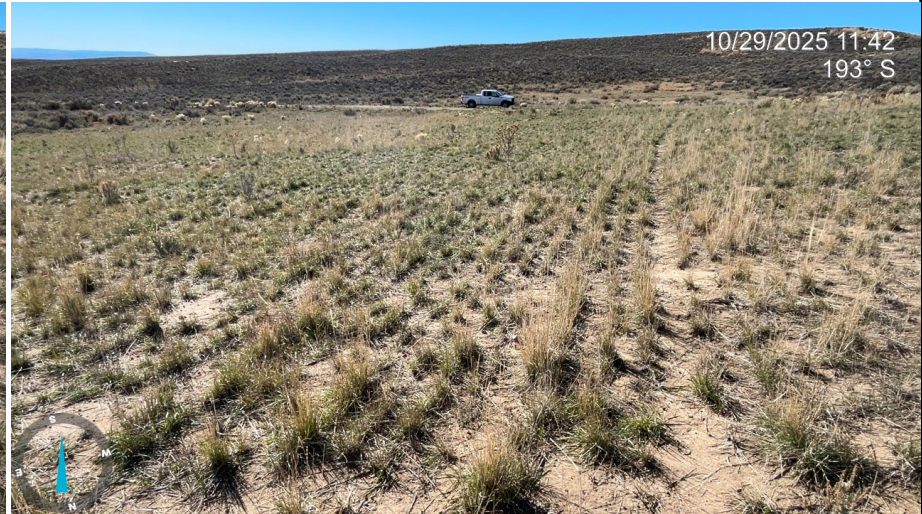
Photo 1: Photos showing an overview of the location looking north and south, respectively.

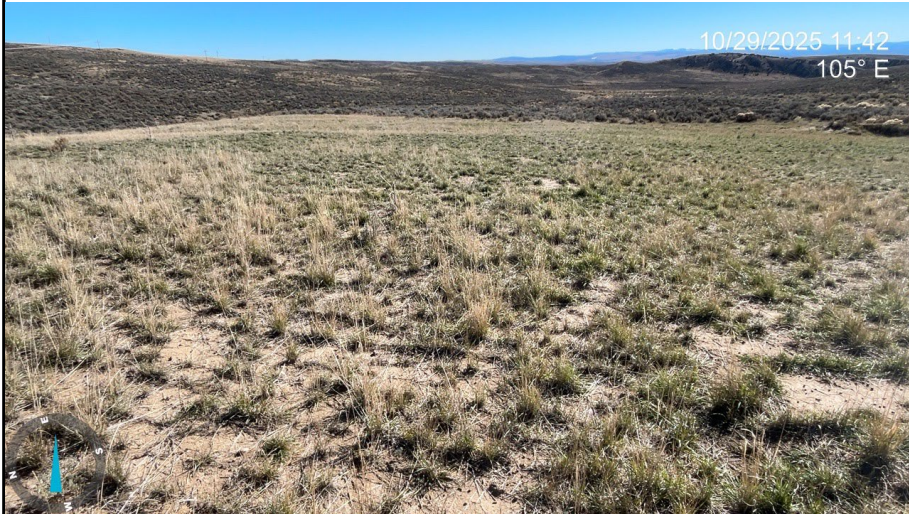
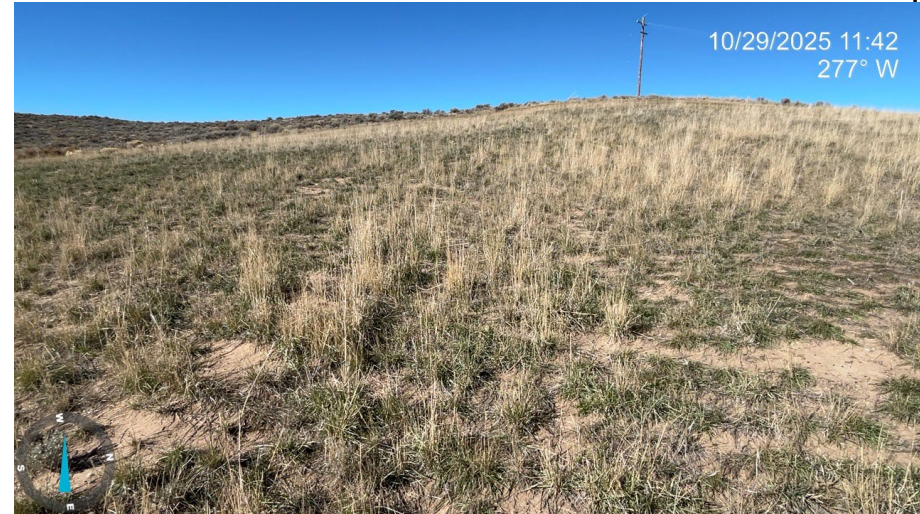
Photo 2: Photos showing an overview of the location looking east and west, respectively.

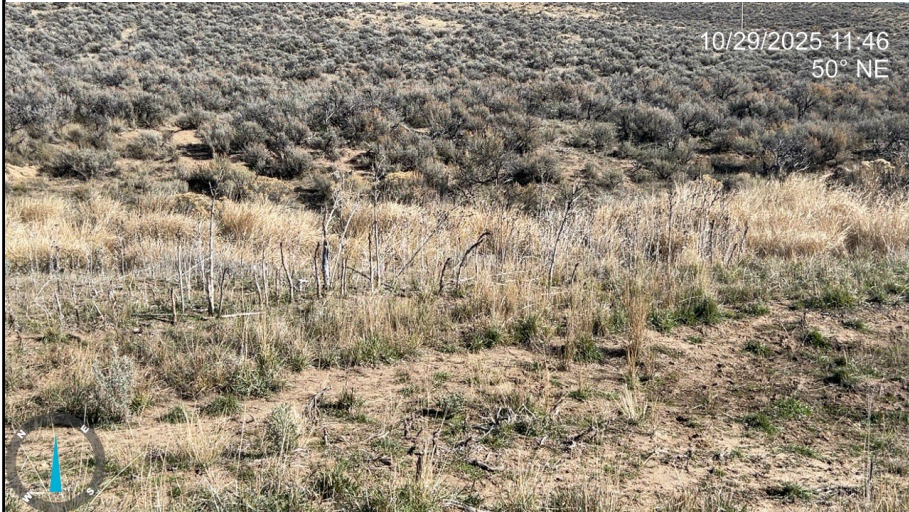
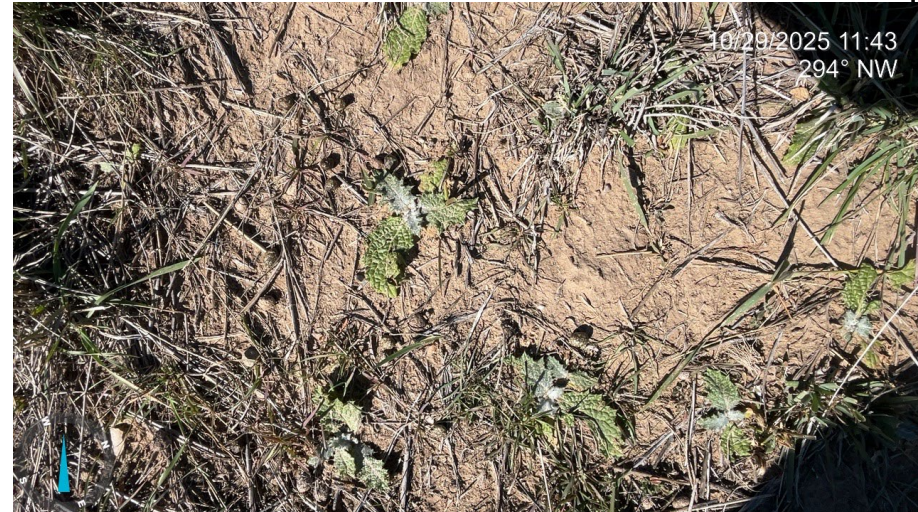
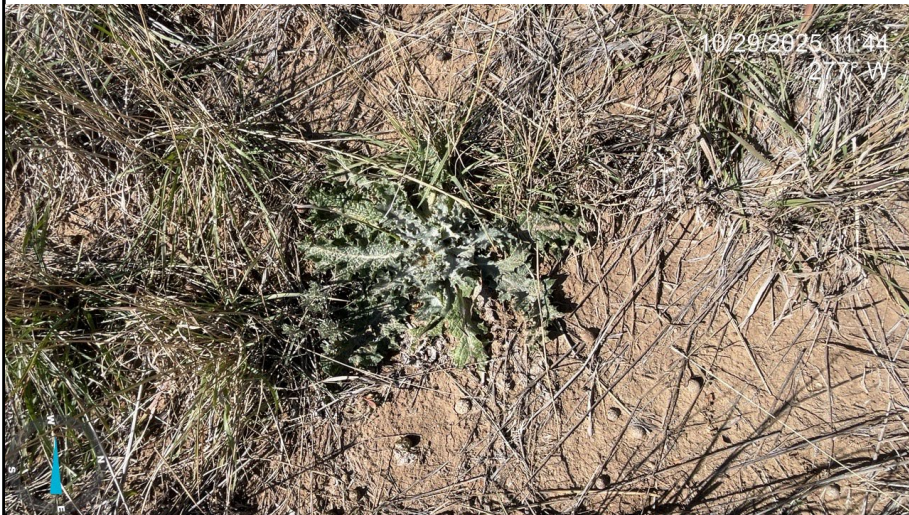
Photo 3: Photos showing an example of Scotch thistle, a List B noxious weed, that is present throughout the site. Basal rosettes and new growth is present. Weeds do not appear to have been managed in 2025.

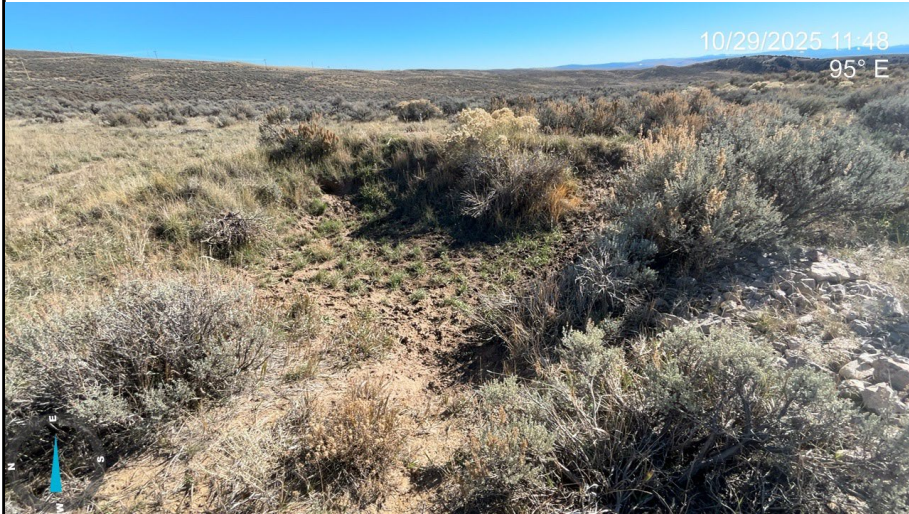
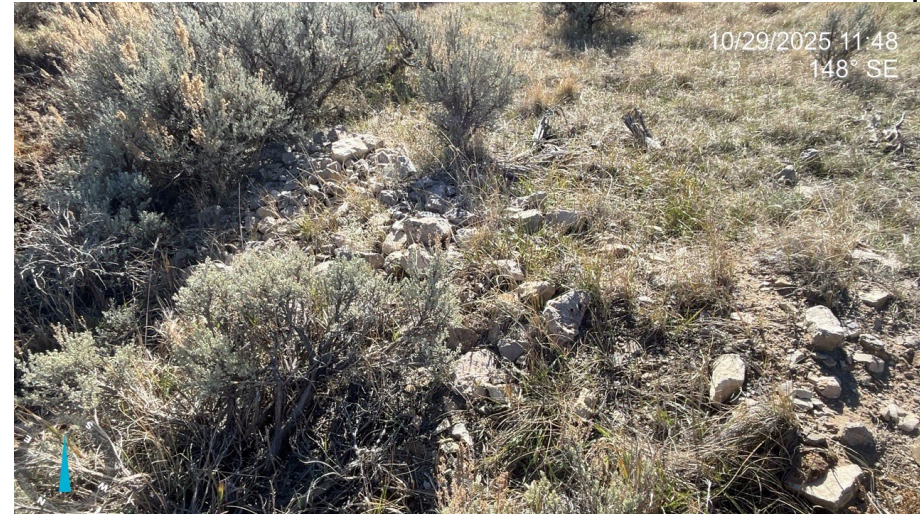
Photo 4: Photos showing a sediment trap that is present on the southeast corner of the location. The location has not been reclaimed pursuant to 1004 reclamation requirements.

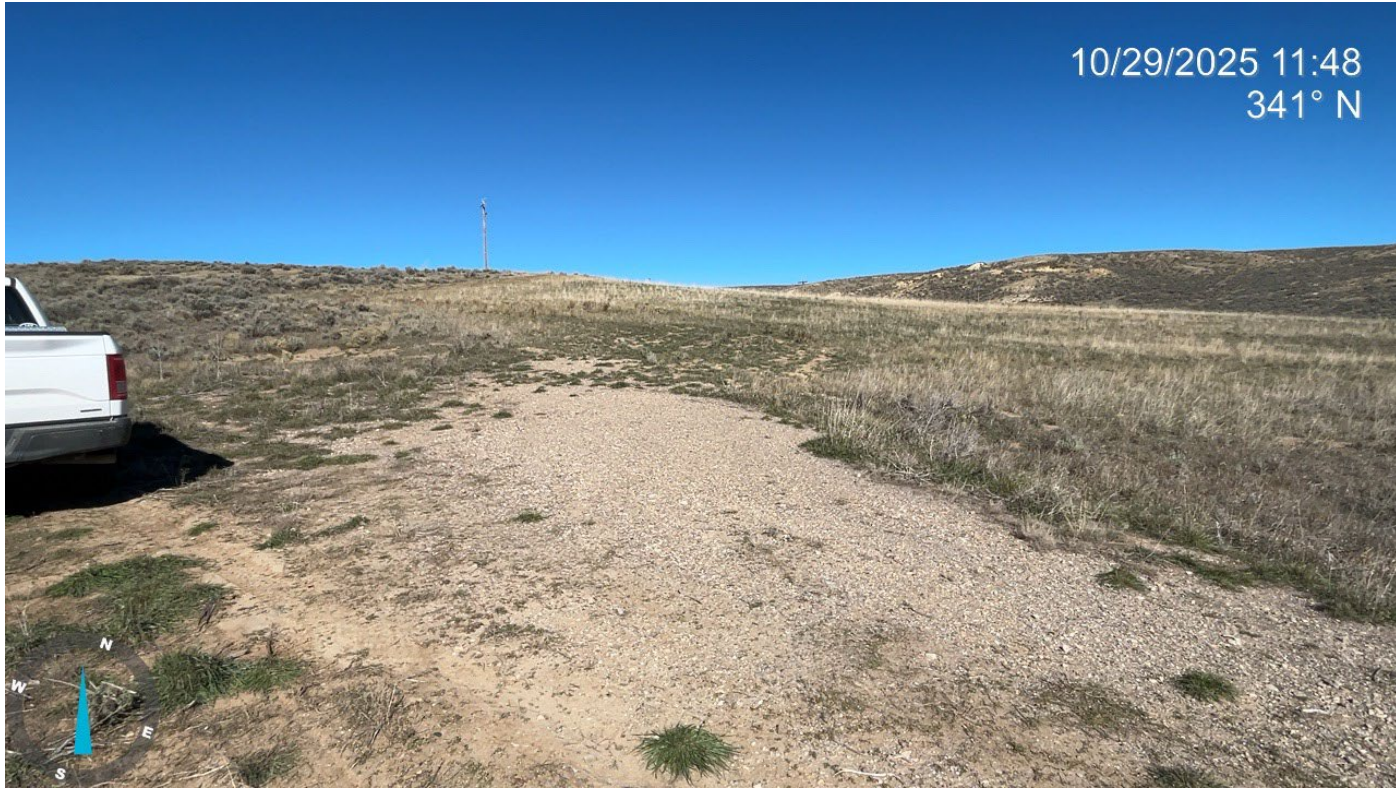
Photo 5: Photos taken from the Location entrance at the south end of the Location. Photo shows areas of the Location that has not been reclaimed in accordance with 1004 requirements; areas have not achieved a uniform vegetative establishment; gravel and compaction remains evident.

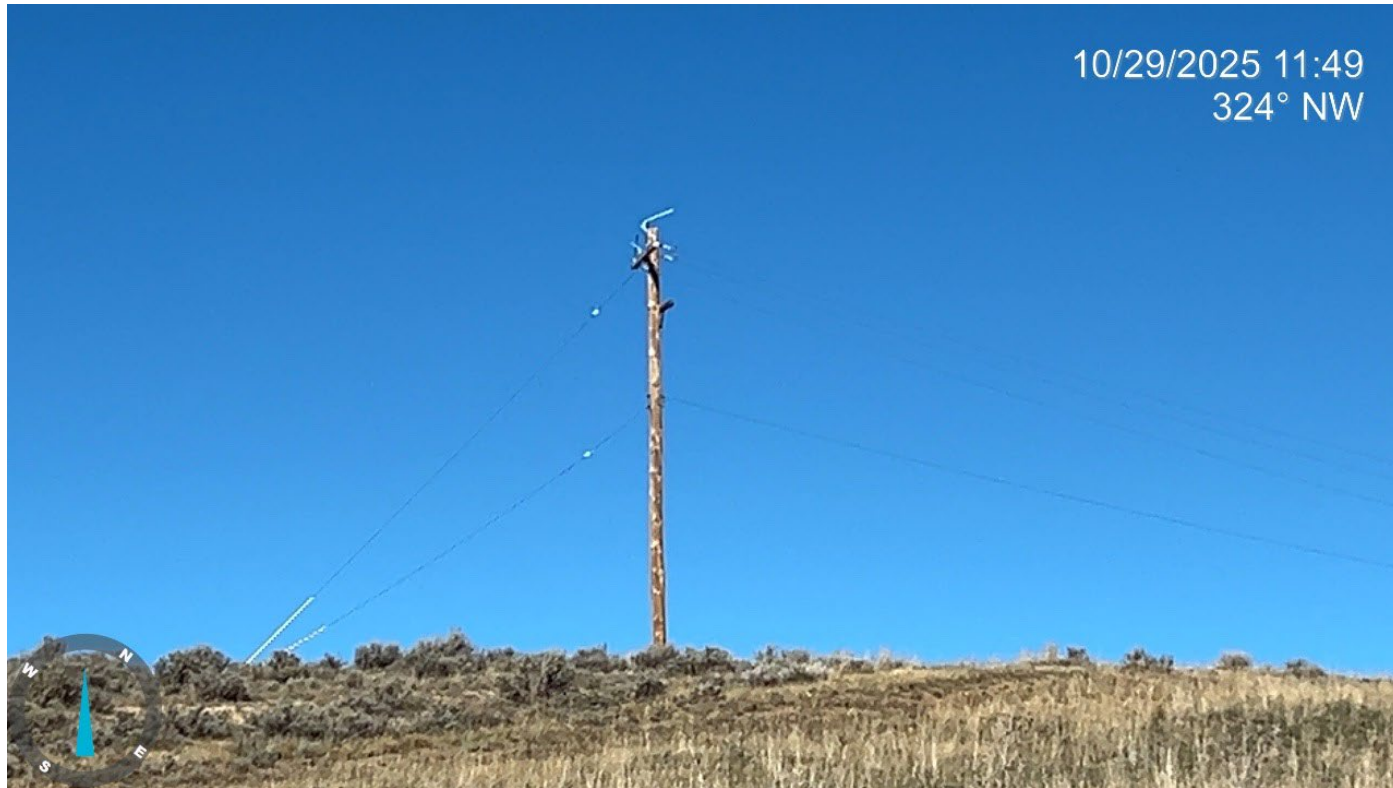
Photo 6: Photo taken on the west end of the location showing an example of utility equipment on and leading to the location remains and requires removal.

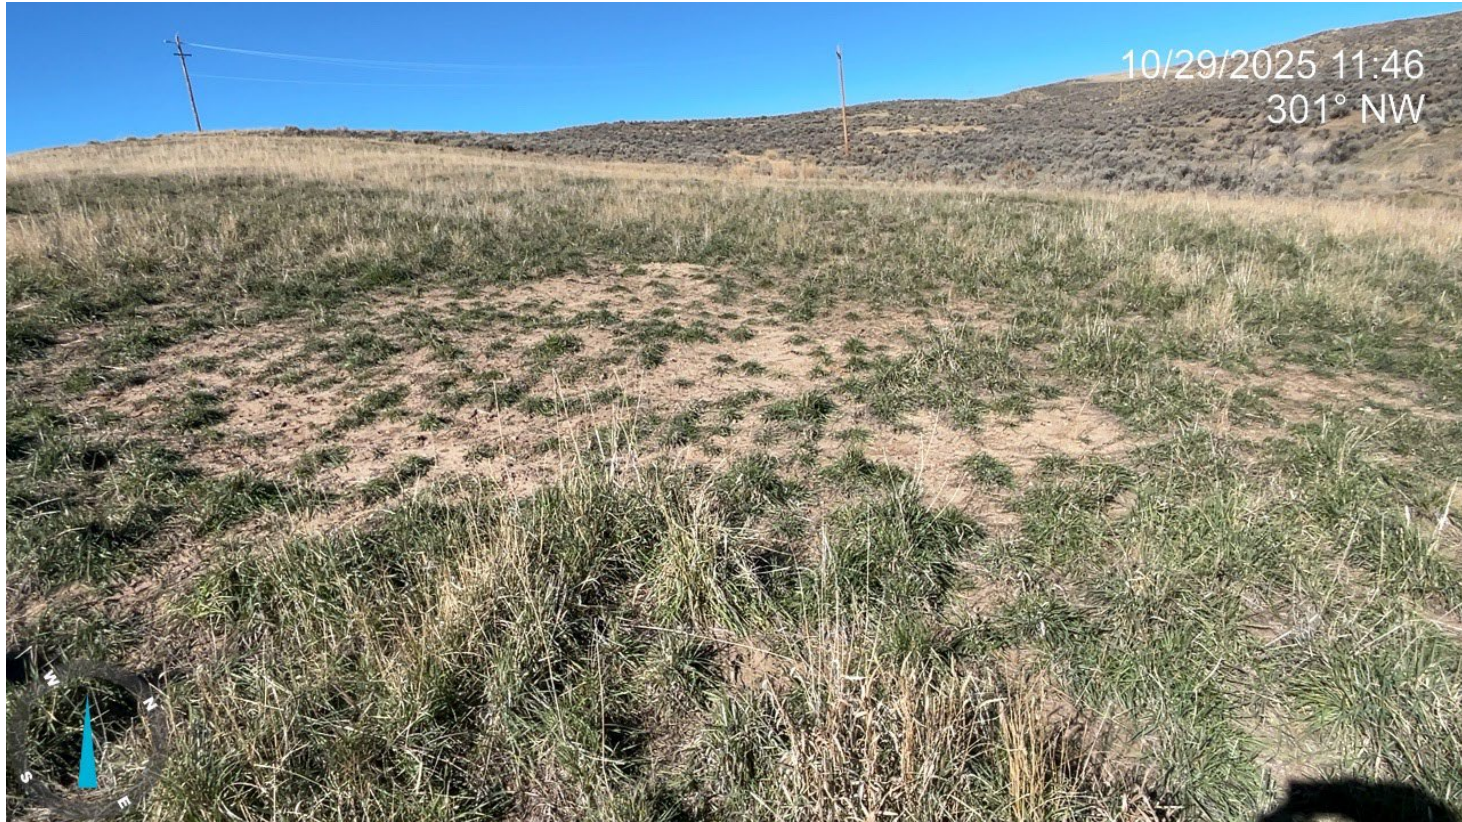
Photo 7: Photo showing some areas throughout the location are patchy and have not achieved uniformity; however, plant establishment is evident and these areas may need more time to develop.

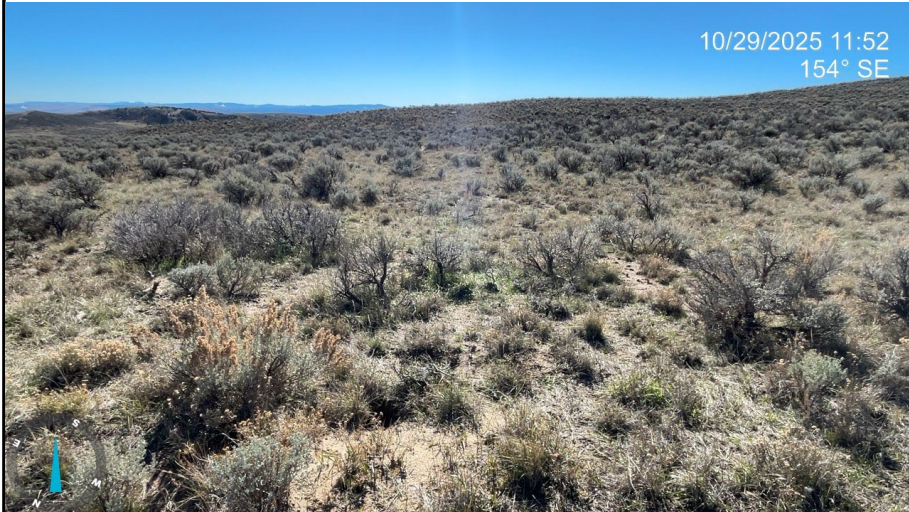
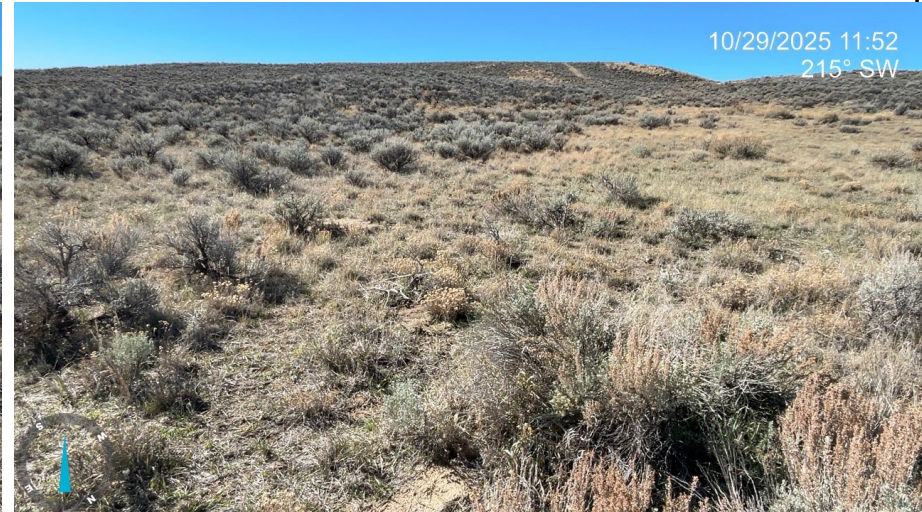
Photo 8: Photos showing an example of the reference area, located to the south of the location. Reference areas are characterized by big sagebrush shrublands, and big sagebrush is dominant.
