Final Reclamation Inspection

Operator: GRIZZLY OPERATING LLC- #443741

Location ID: 443741

Inspection Photos
Location Name: Goza Beneficial Reuse Area
Location ID: 443741

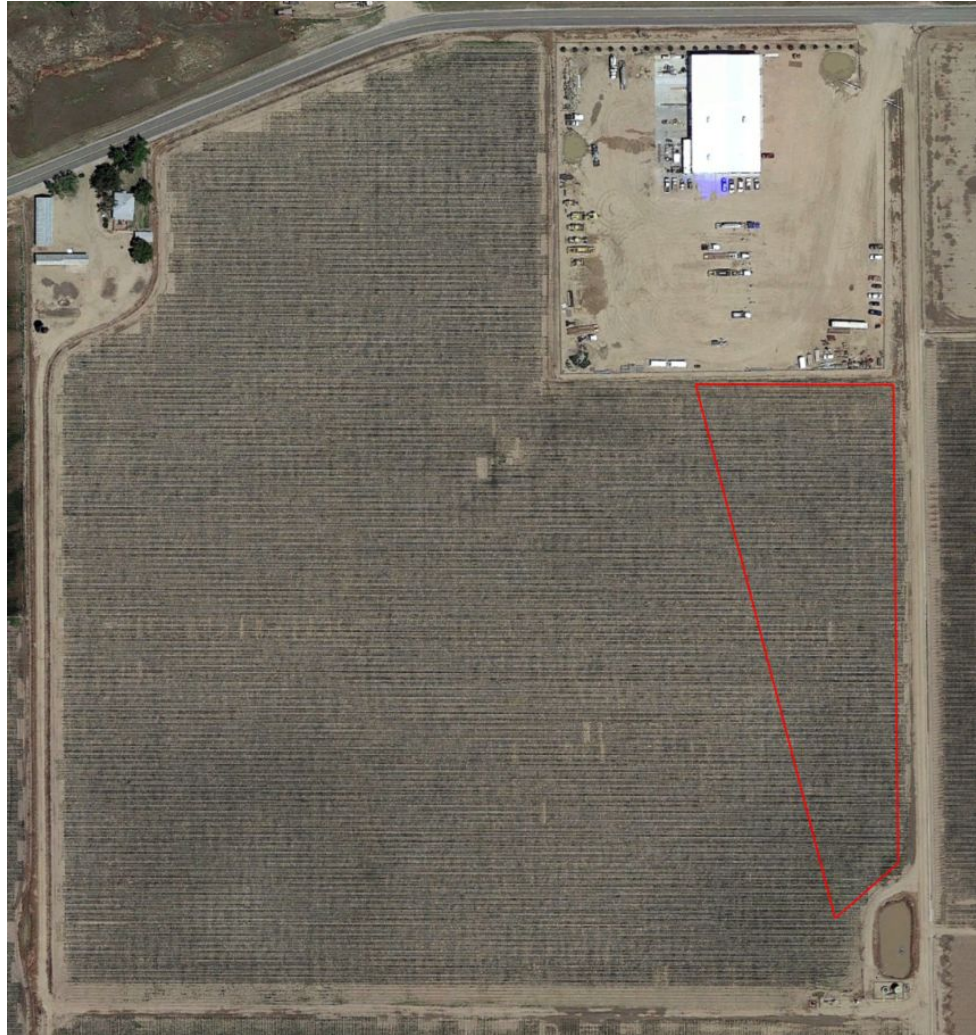
Photo 1. Google Earth aerial imagery from 6/19/2014 prior to the use of the Land Application Site. The red polygon is the planned area for the Goza Beneficial Reuse Area.

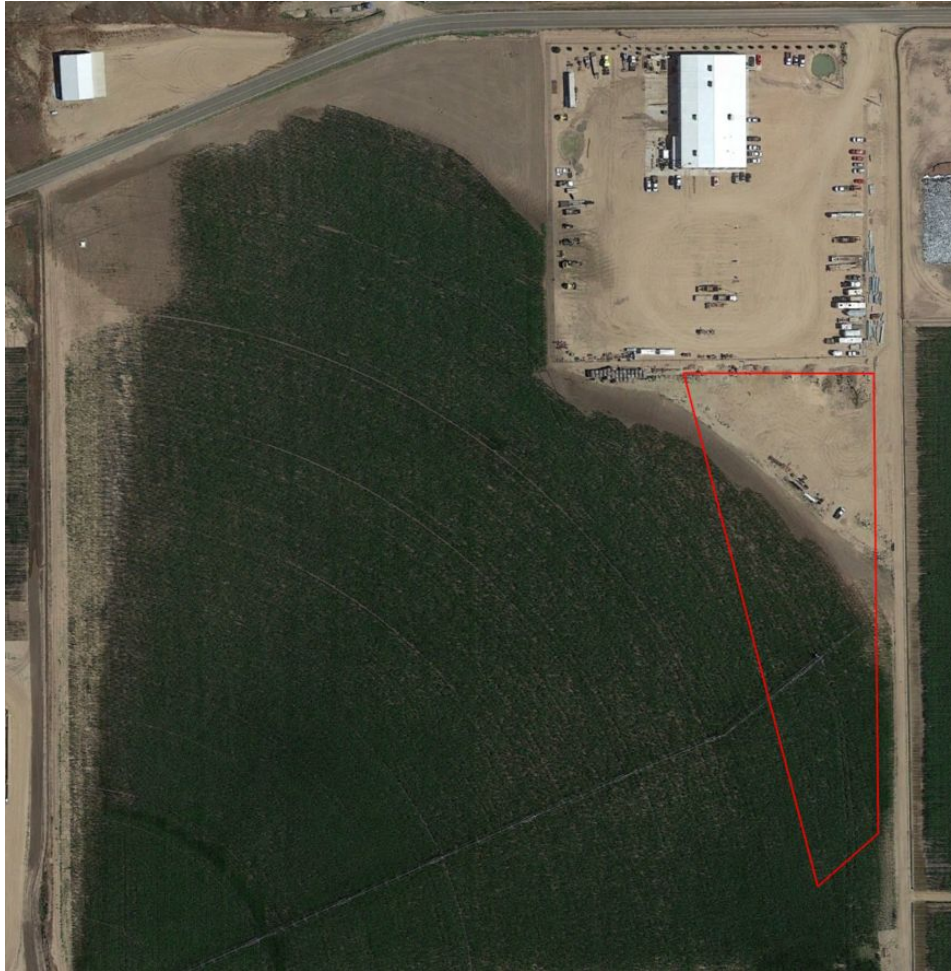
Photo 2. Google Earth aerial imagery from 7/17/2019 after the use of the Land Application Site (LAS) ended in April 2016. The red polygon is the area for the Goza Beneficial Reuse Area. A portion of the northern LAS no longer is incorporated into crop production and appears to be in an agricultural use. Areas of the LAS appear to be uniform with the surrounding reference crop areas and do not appear to indicate any unrestored subsidence.

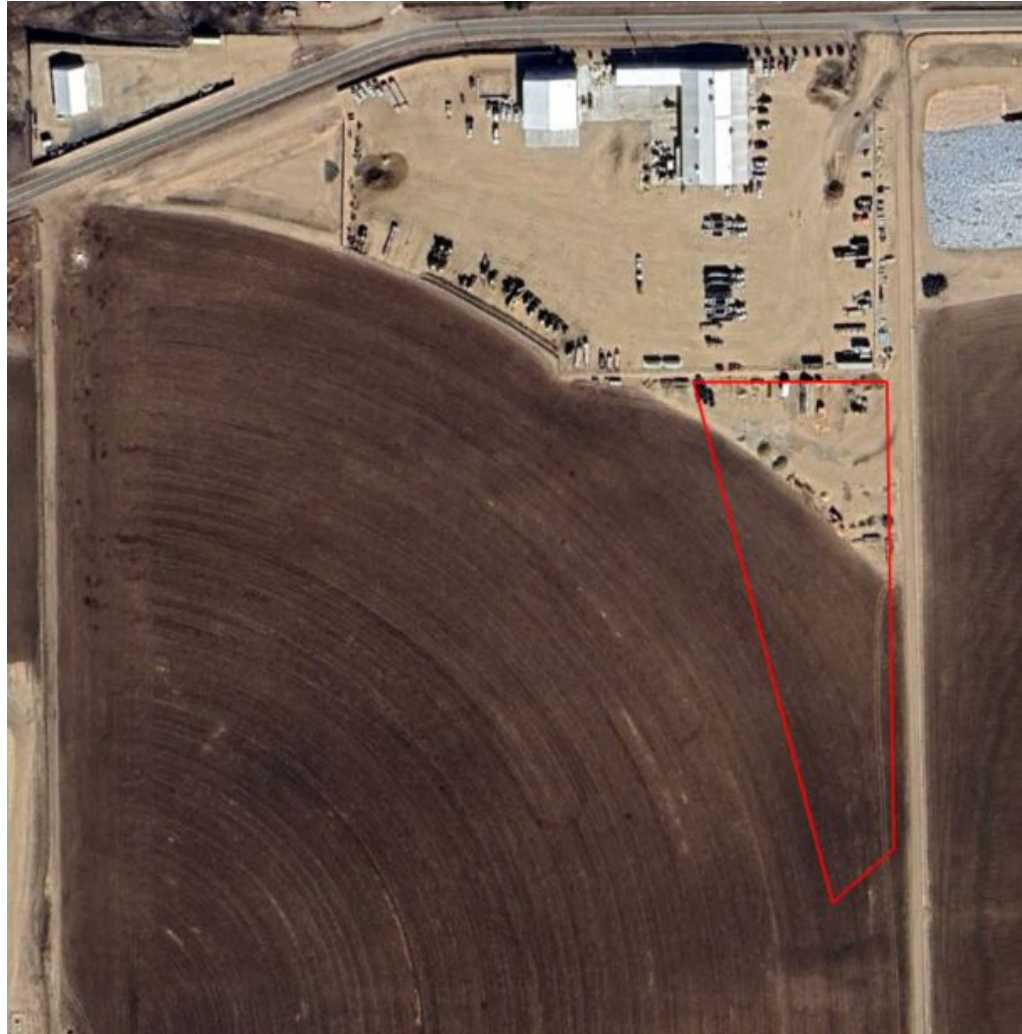
Photo 3. Google Earth aerial imagery from 3/2/2025. See comments under Photo 2.
