Inspection Photos

Operator: SWN Production Company LLC

Location ID: 313257

Inspection Doc: 719200401

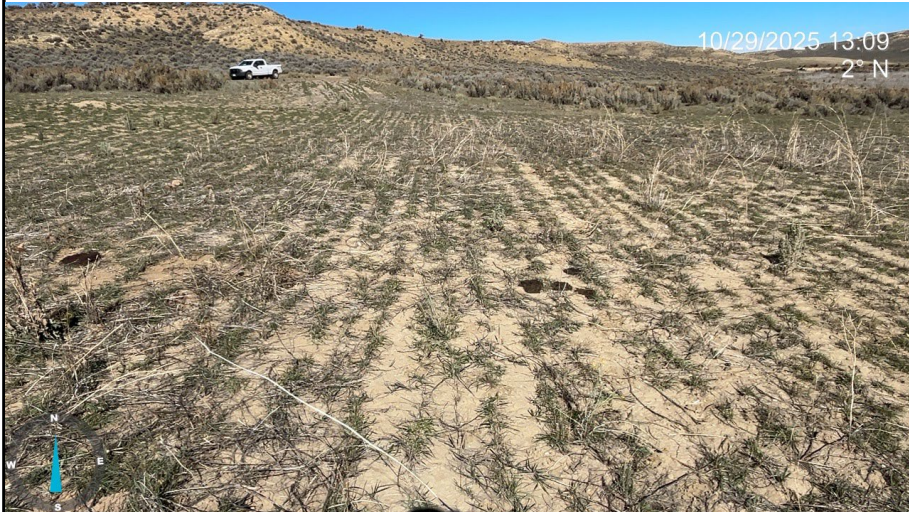
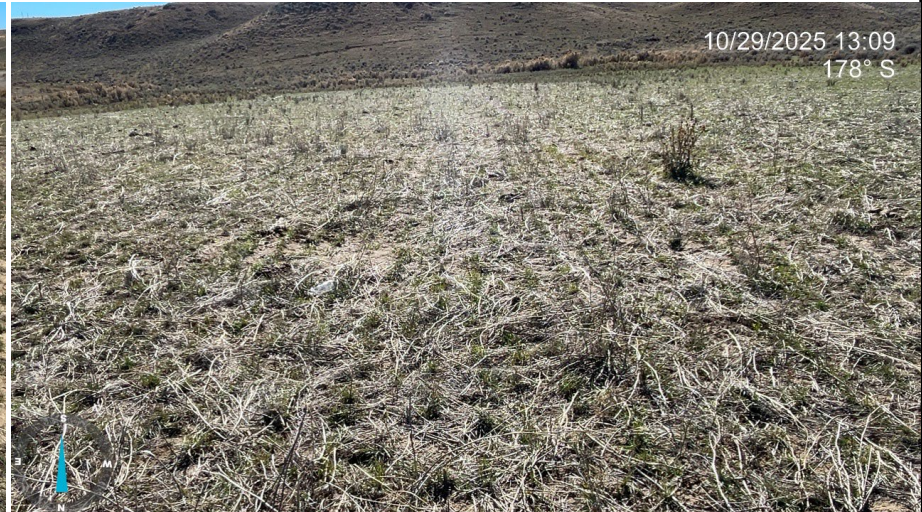
Photo 1: Photos showing an overview of the location looking north and south, respectively.

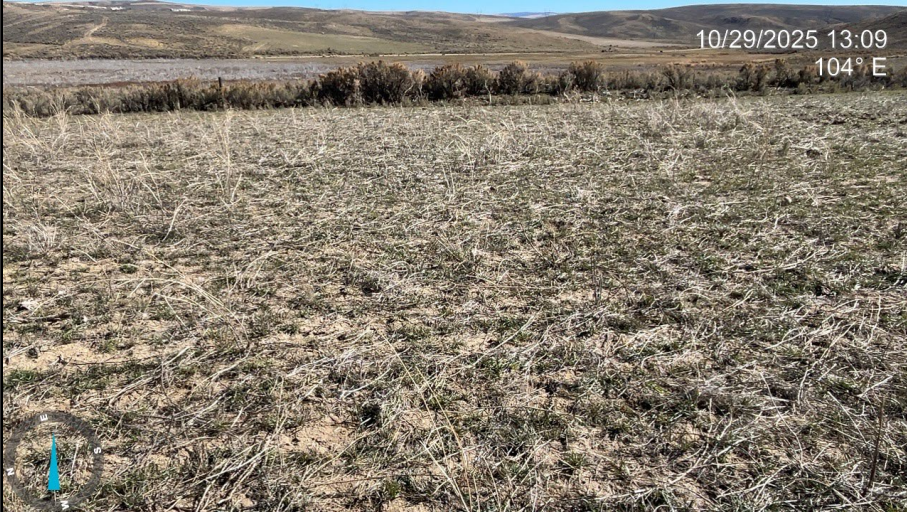
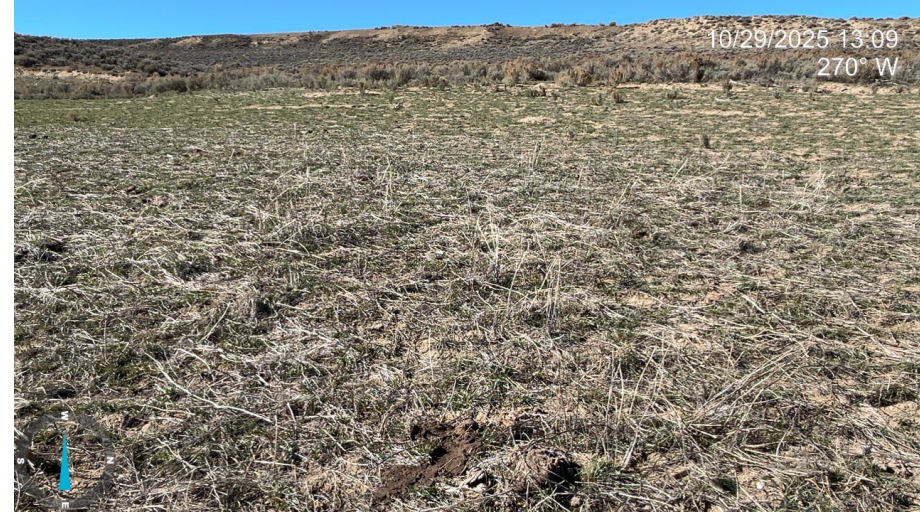
Photo 2: Photos showing an overview of the location looking east and west, respectively.

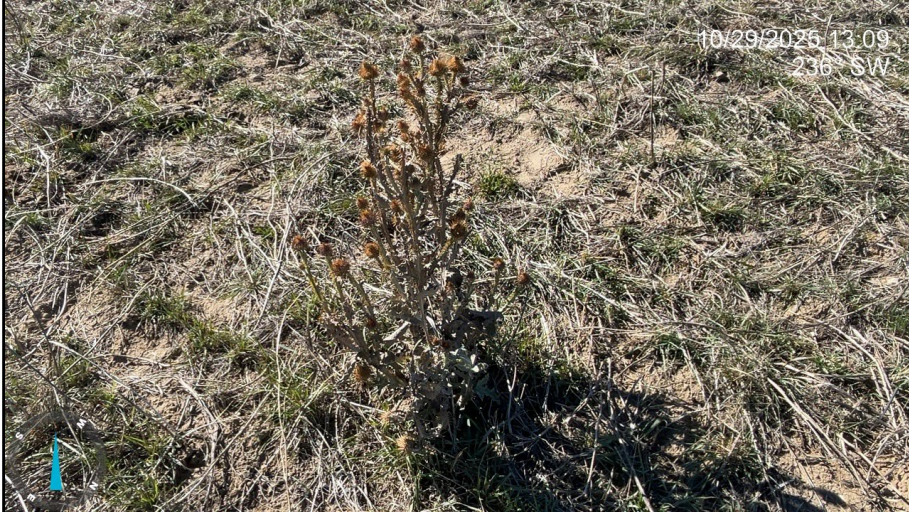
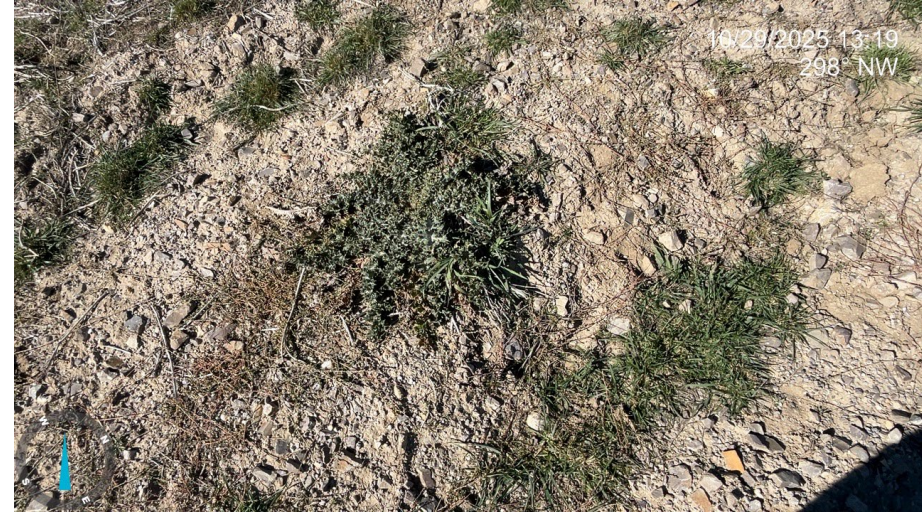
Photo 3: Photos showing an example of Scotch thistle, a List B noxious weed, that is present throughout the site. Basal rosettes are present throughout the location and on the access road.

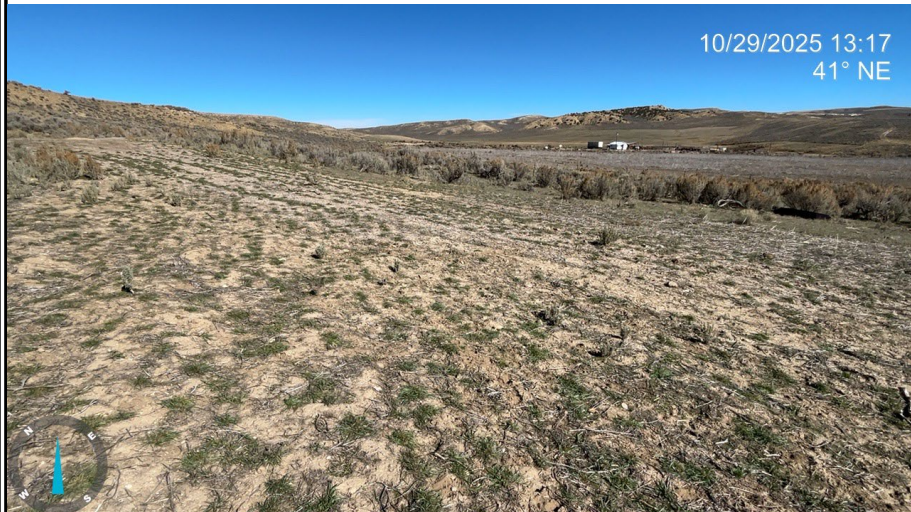
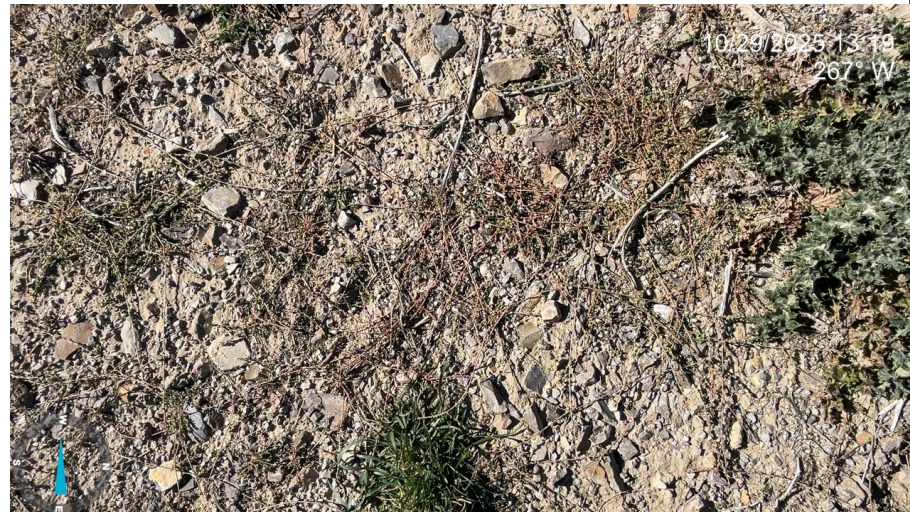
Photo 4: Photos showing the access road leading to the location has not been reclaimed pursuant to 1004 reclamation requirements; gravel and compaction is evident. Knotweed, an undesirable plant species, is present on the road.

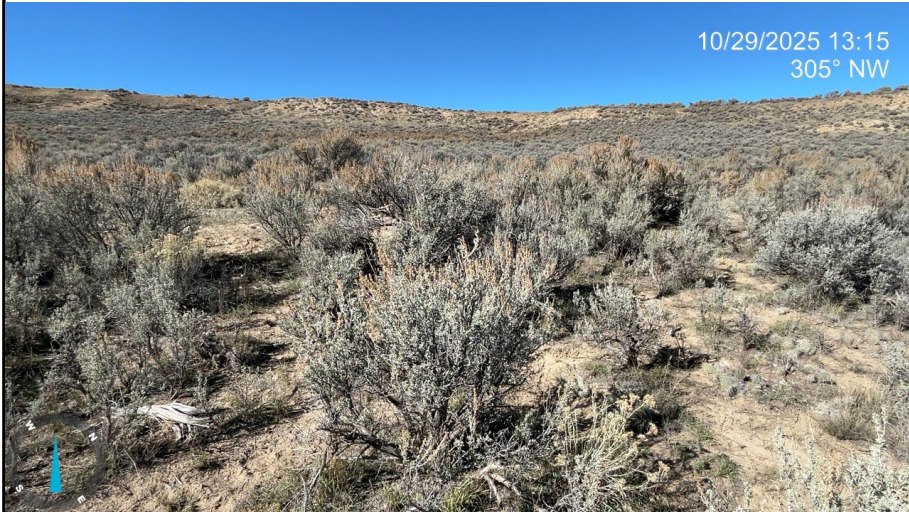
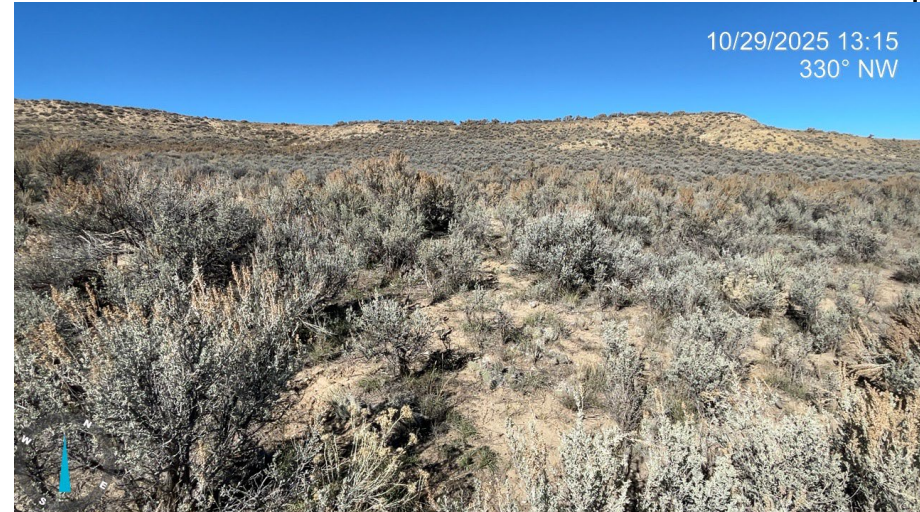
Photo 5: Photos showing an example of the reference area, located to the west of the location. The reference area is characterized by big sagebrush shrublands.
