Final Reclamation Inspection

Operator: KERR MCGEE OIL & GAS ONSHORE LP - 47120

Location ID: 409428

Inspection Photos
Location Name: HSR-LOST CREEK #7-11
Location ID: 409428

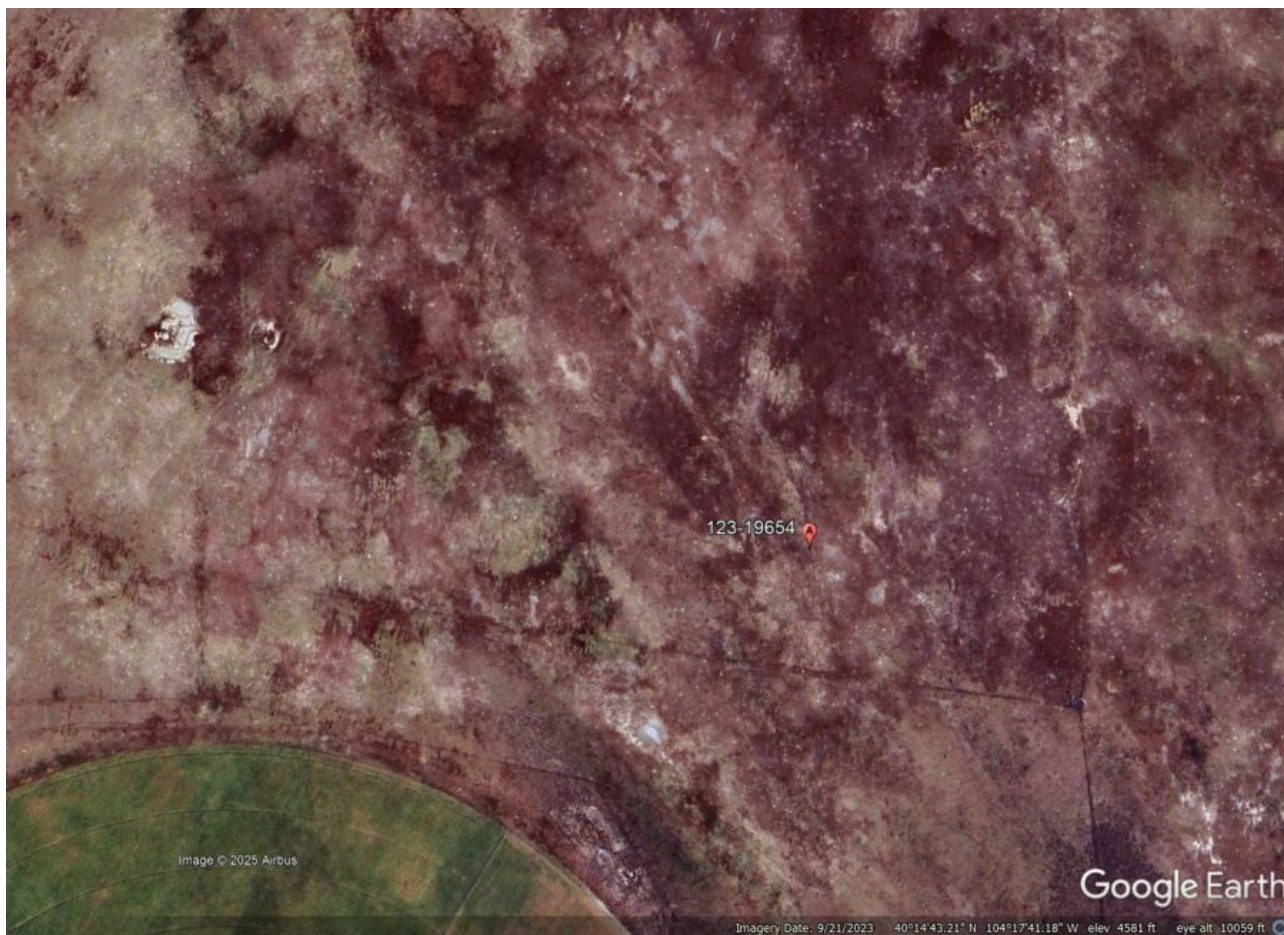
Photo 1. Google Earth Aerial Imagery from September 21, 2023 depicting the well location after plugging operations. Photo illustrates the location and surrounding reference areas are located in degraded prairie dog habitat.

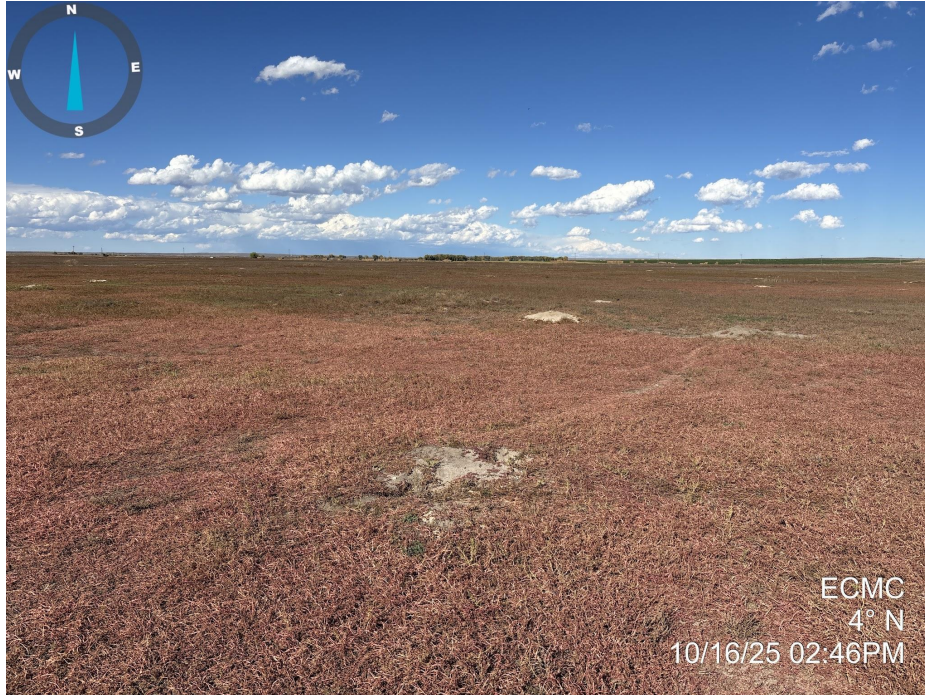
Photo 2. Photo taken of the well location, facing north. Photo illustrates that final reclamation activities have taken place, but the location is dominated by weedy annual vegetation and does not meet Rule 1004 standards.

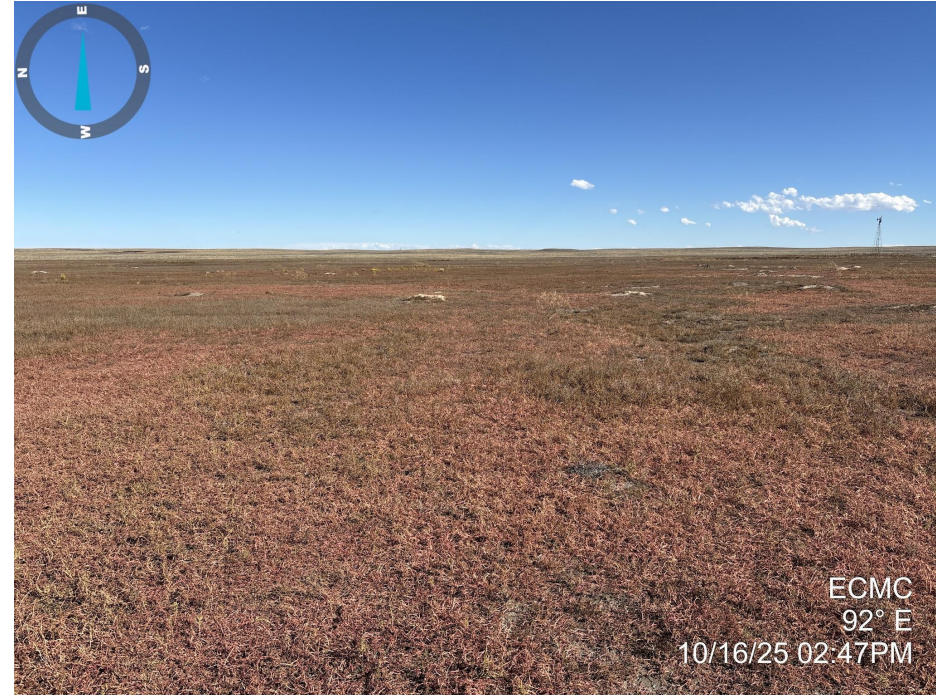
Photo 3. Photo taken of the well location, facing east. See comments under Photo 2.

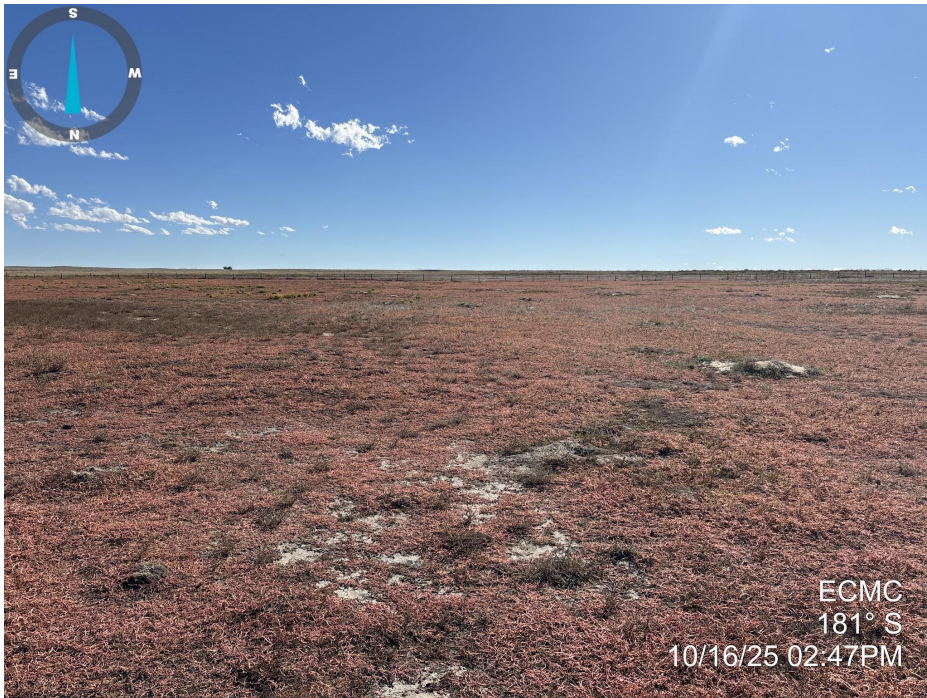
Photo 4. Photo taken of the well location, facing south. See comments under Photo 2.

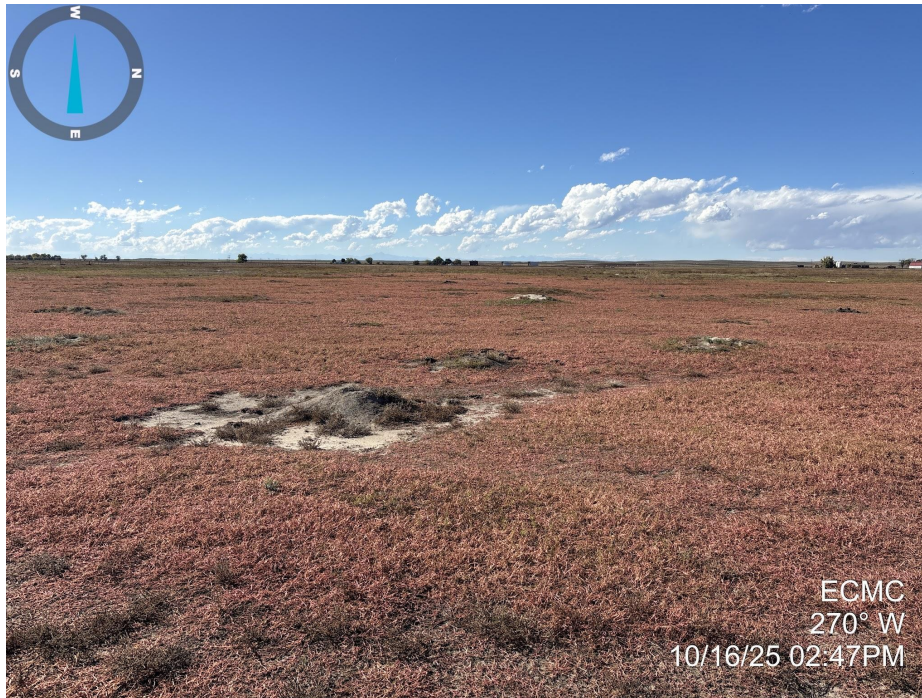
Photo 5. Photo taken of the well location, facing west. See comments under Photo 2.

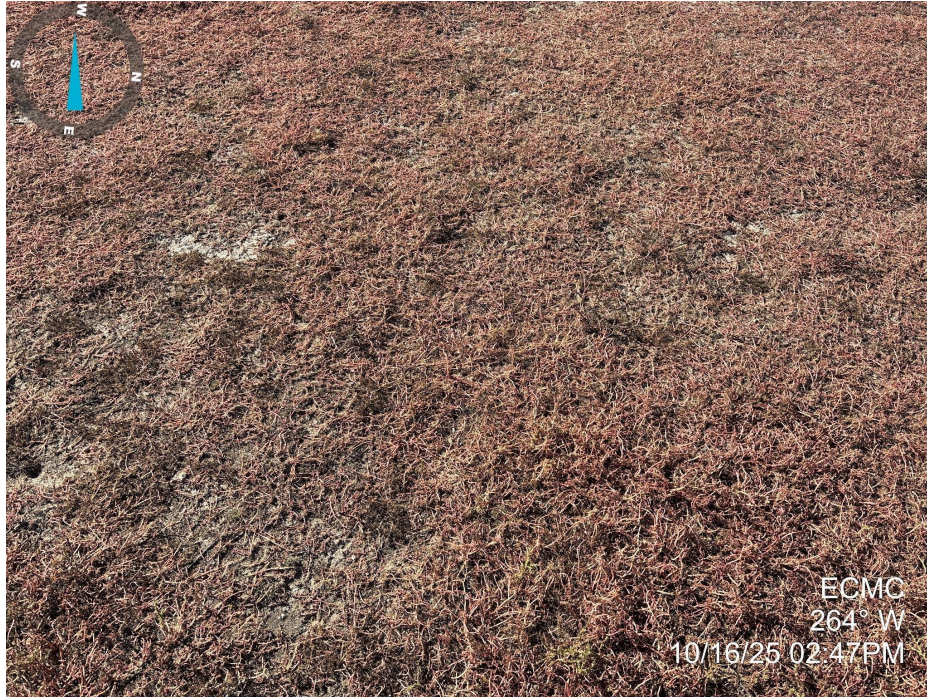
Photo 6. Photo taken of ground cover at the well location. Photo illustrates weedy annual vegetation dominates the location.

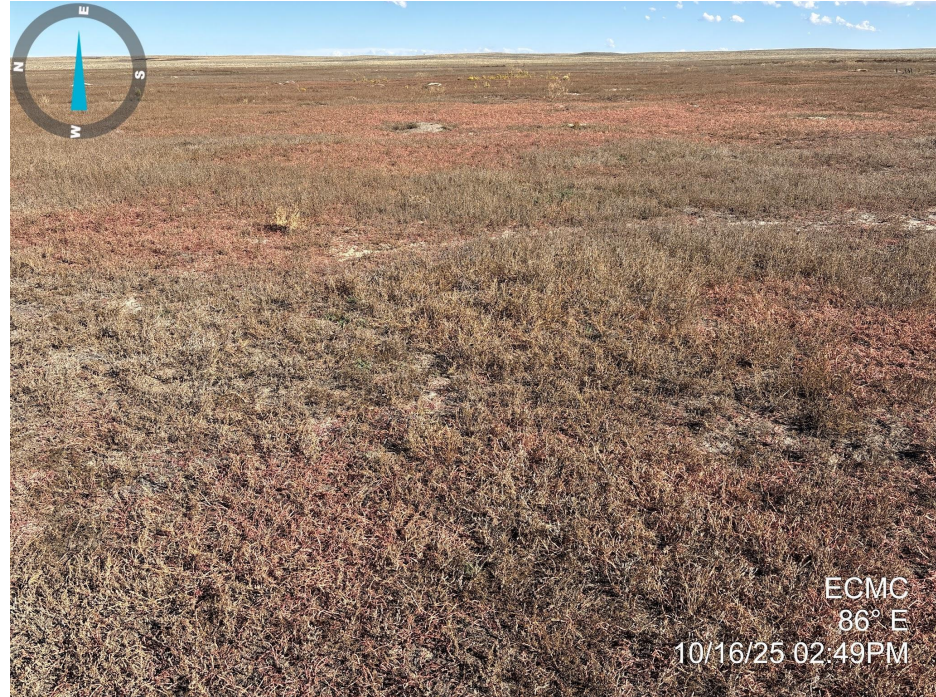
Photo 7. Photo taken of the reference area to the well location, east of the location, facing east. Photo illustrates weedy annual vegetation.
