Final Reclamation Inspection

October 16, 2025

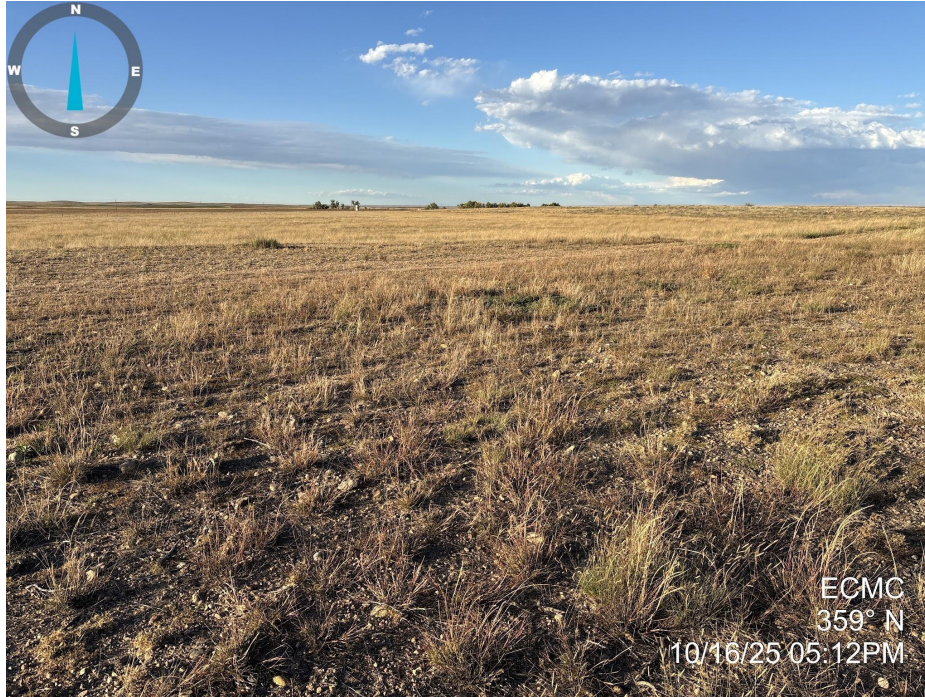
Photo 1. Photo taken of the well location, facing north. Photo illustrates that the location does not meet Rule 1004 standards as gravel, bare ground, and weedy annual vegetation was observed at the location.

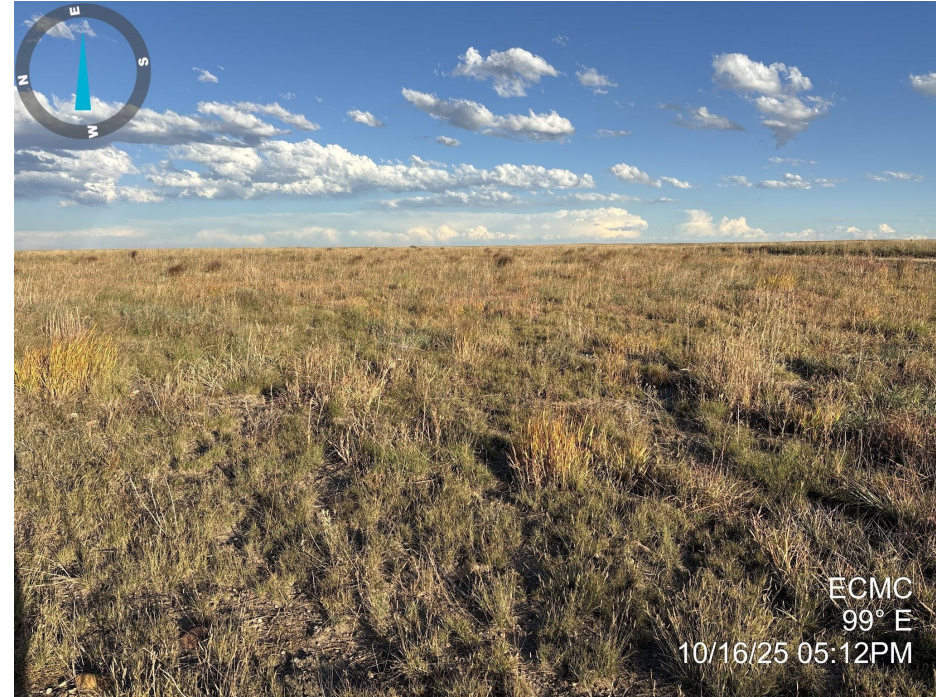
Photo 2. Photo taken of the well location, facing east. See comments under Photo 1.

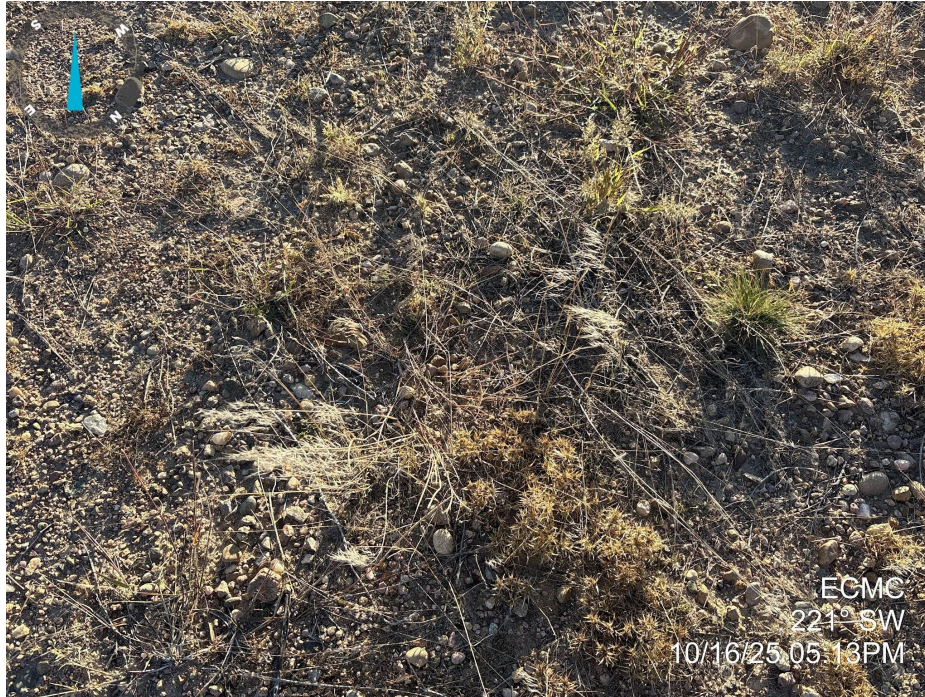
Photo 11. Photo taken of ground cover at the tank battery location. Photo illustrates that gravel and weedy annual vegetation including cheatgrass (*Bromus tectorum*), a List C Noxious Weed species, were observed across the location.

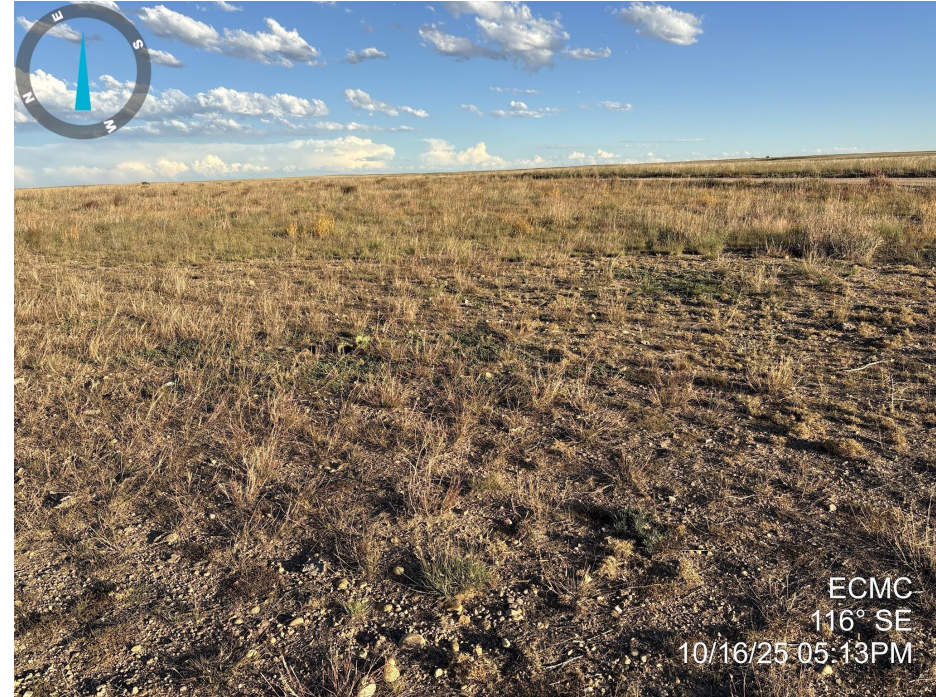
Photo 12. Photo taken of the tank battery location, facing southeast. See comments under Photo 6.
