Final Reclamation Inspection

Operator: NOBLE ENERGY INC - 100322

Location ID: 309727

Inspection Photos
Location Name: COOPER #23-15
Location ID: 309727

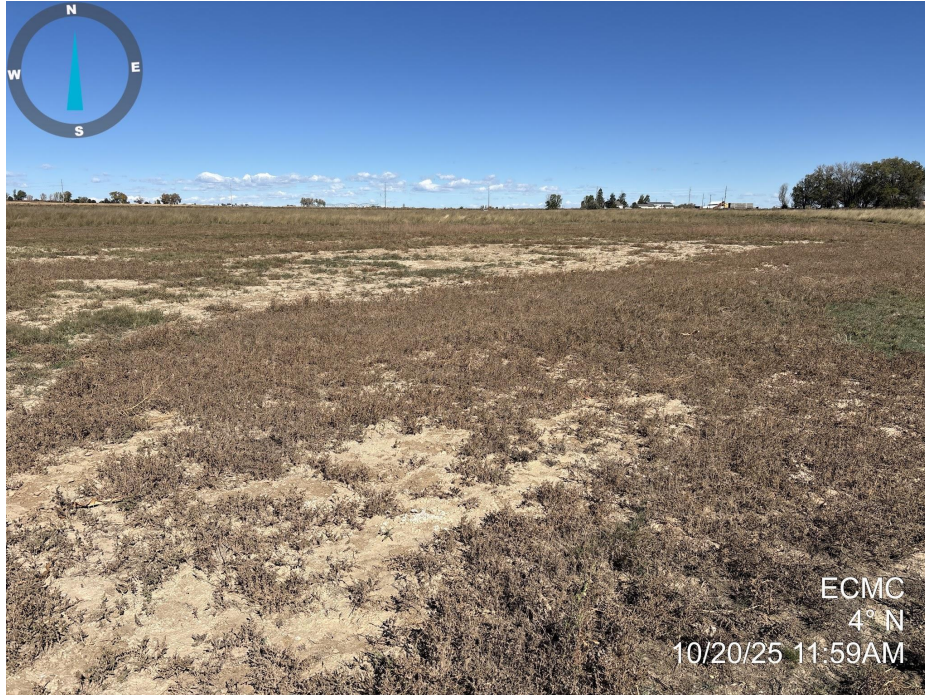
Photo 1. Photo taken of the well location, facing north. Photo illustrates that final reclamation activities have taken place. However, vegetation has not established to Rule 1004 standards at the location. Bare ground and weedy annual vegetation, including kochia (*Bassia scoparia*), were observed across the location.

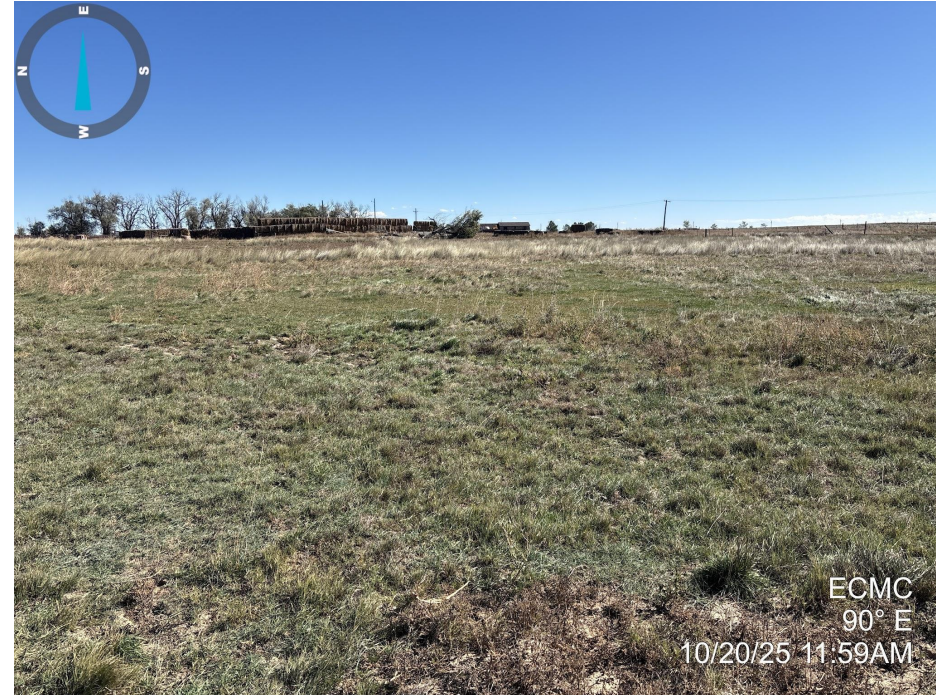
Photo 2. Photo taken of the well location, facing east. See comments under Photo 1.

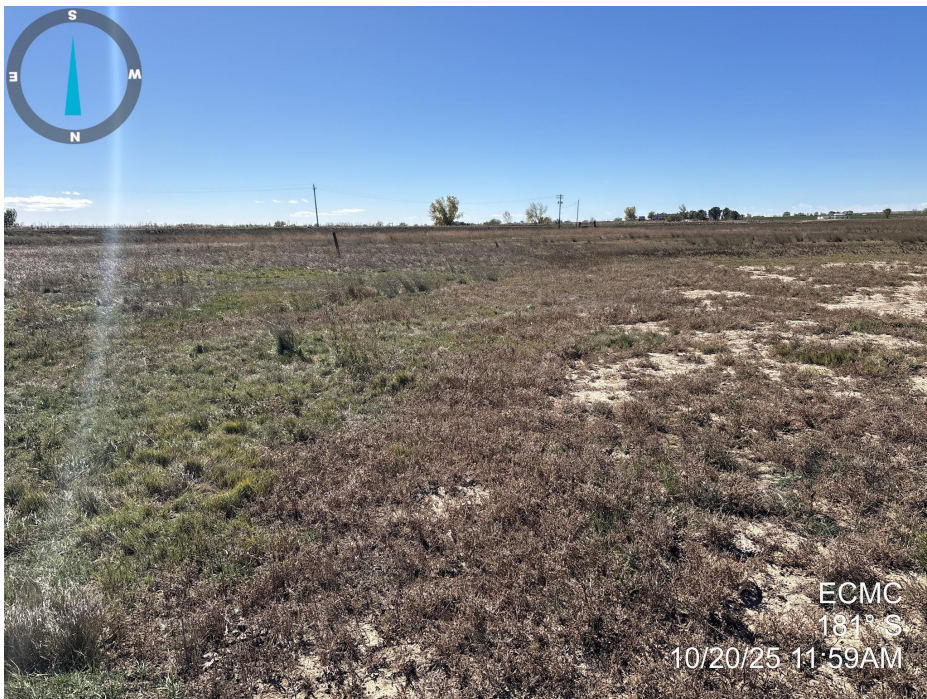
Photo 3. Photo taken of the well location, facing south. See comments under Photo 1.

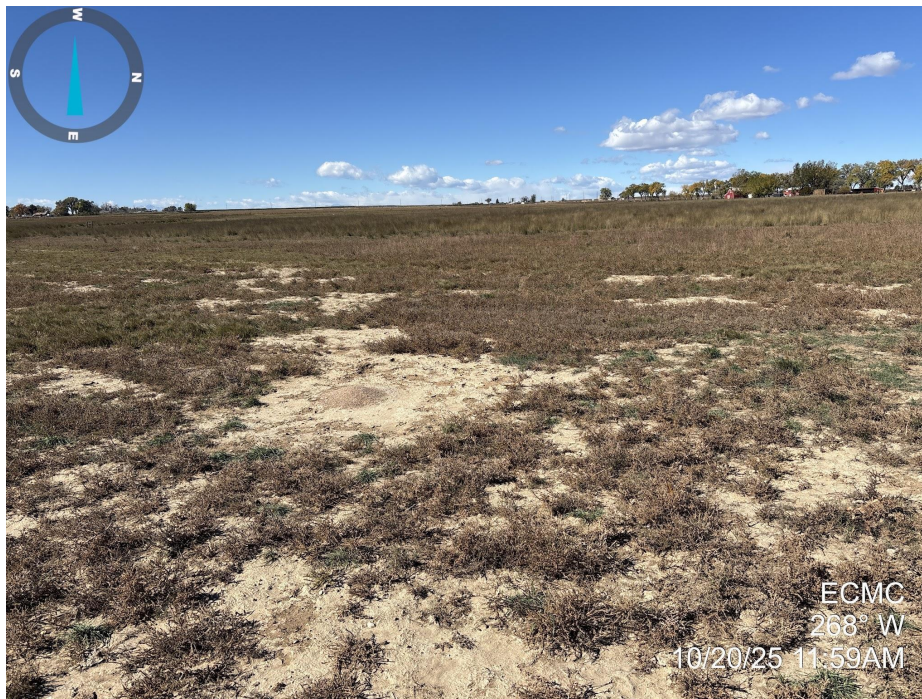
Photo 4. Photo taken of the well location, facing west. See comments under Photo 1.

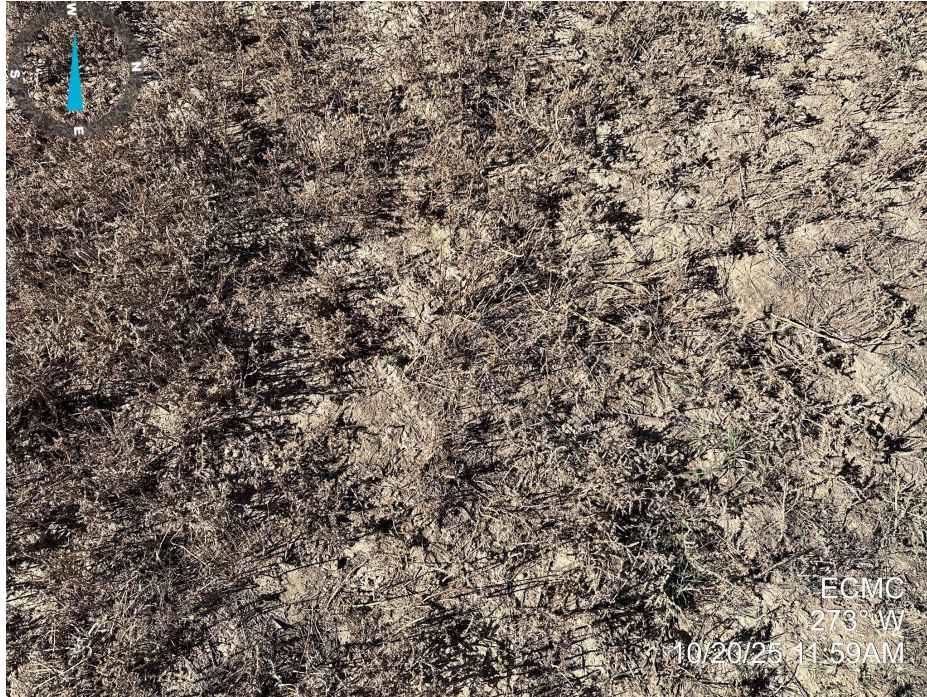
Photo 5. Photo taken of ground cover at the well location. Photo illustrates weedy annual vegetation including kochia (*Bassia scoparia*).

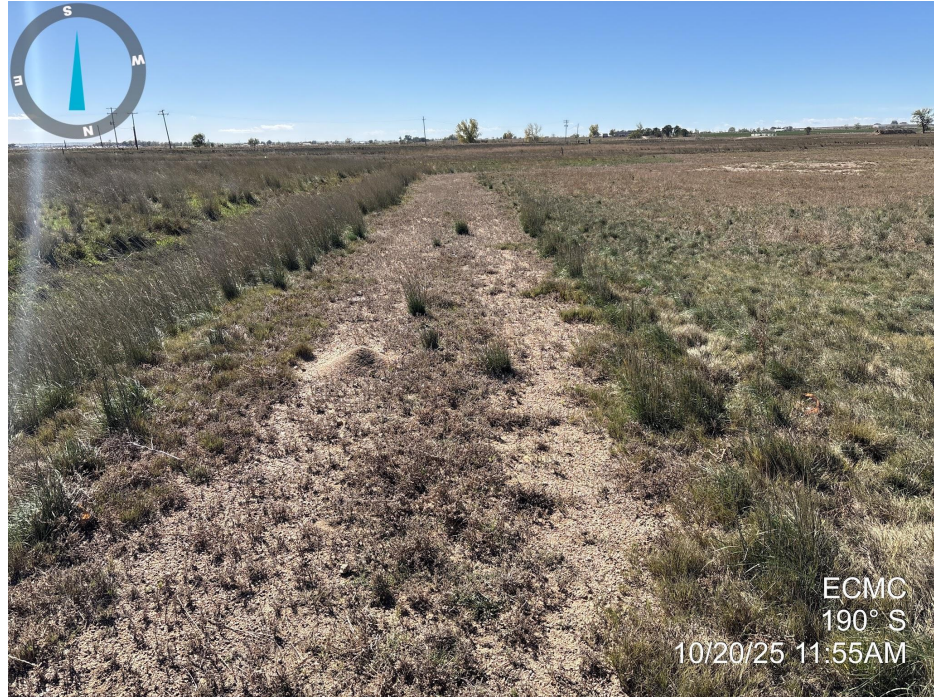
Photo 6. Photo taken of the access road to the location, facing south, towards the location. Photo illustrates that the access road does not meet Rule 1004 standards as gravel, bare ground, and weedy annual vegetation were observed across the road.

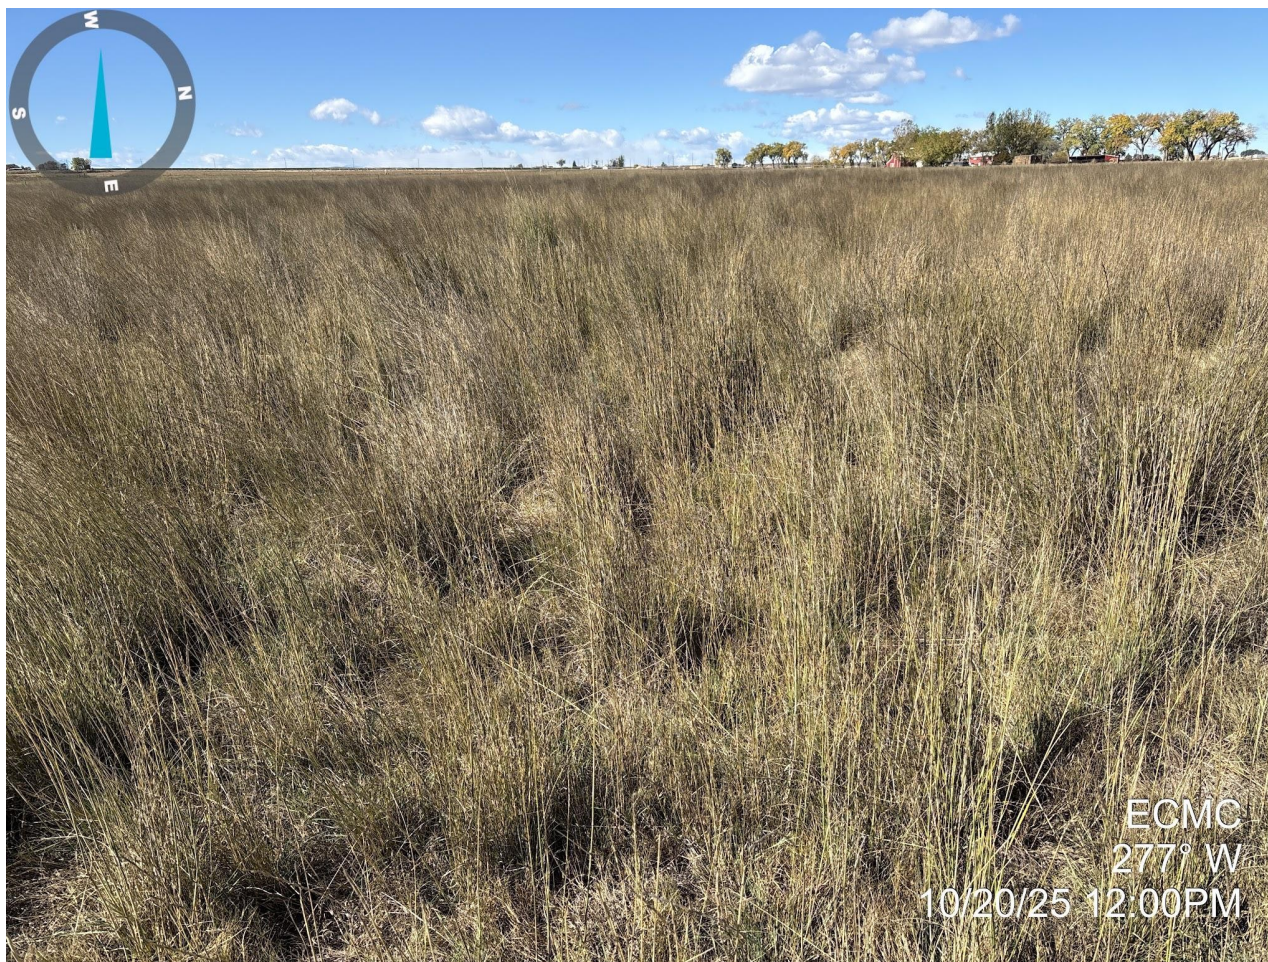
Photo 7. Photo taken of the reference area to the location, west of the location, facing west. Photo illustrates perennial grass vegetation.
