Inspection Photos

Operator: SWN Production Company LLC

Location ID: 313256

Inspection Doc: 719200410

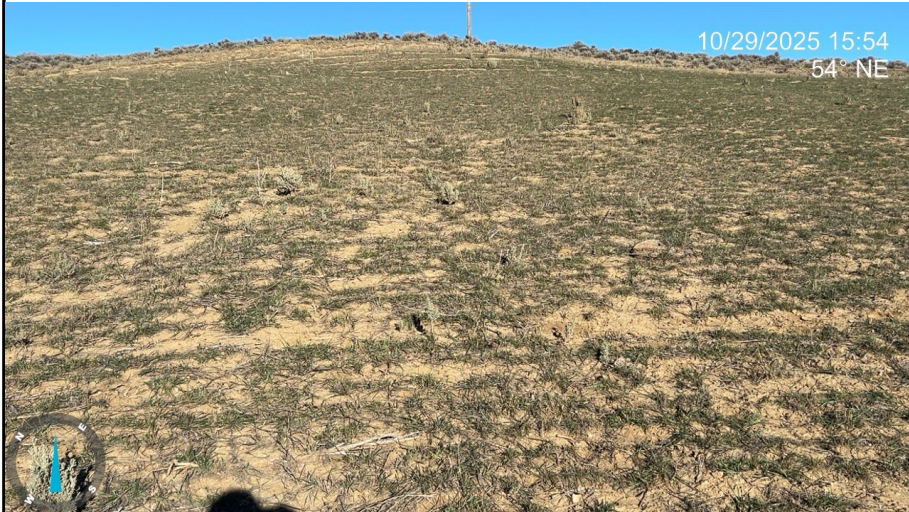
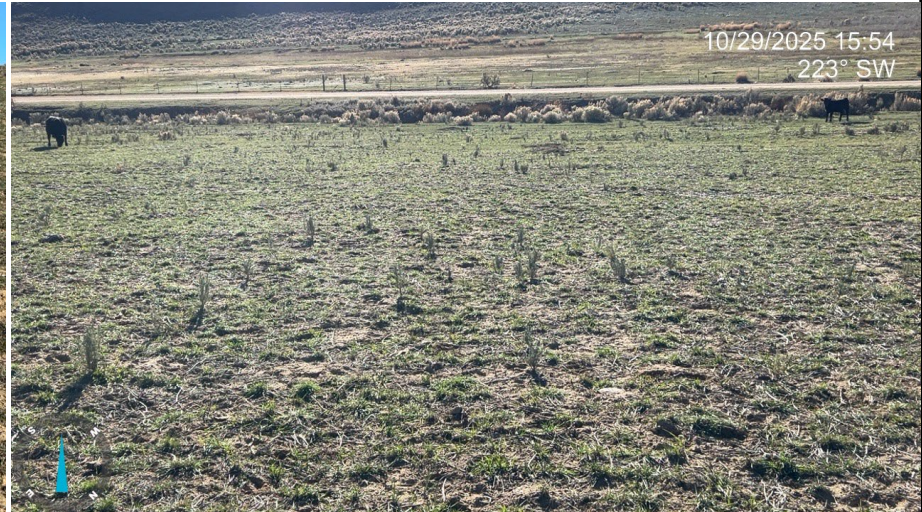
Photo 1: Photos showing an overview of the location looking northeast and southwest, respectively.

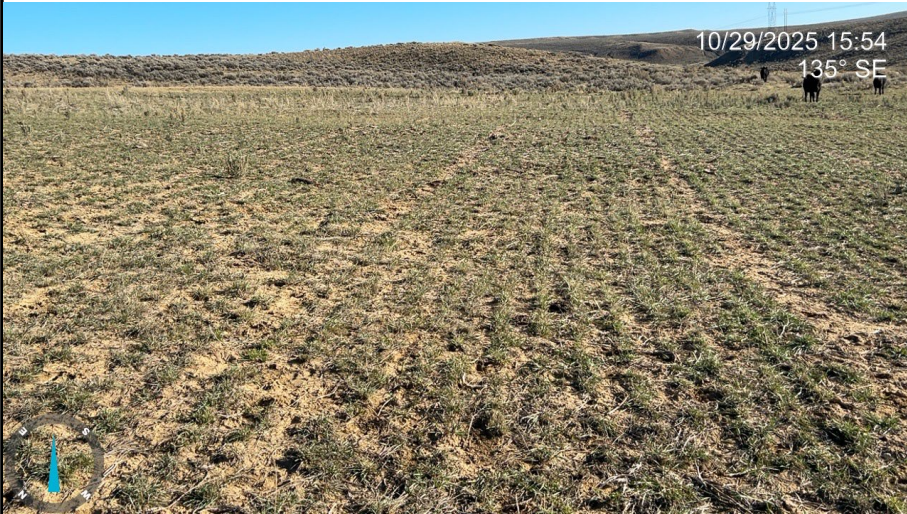
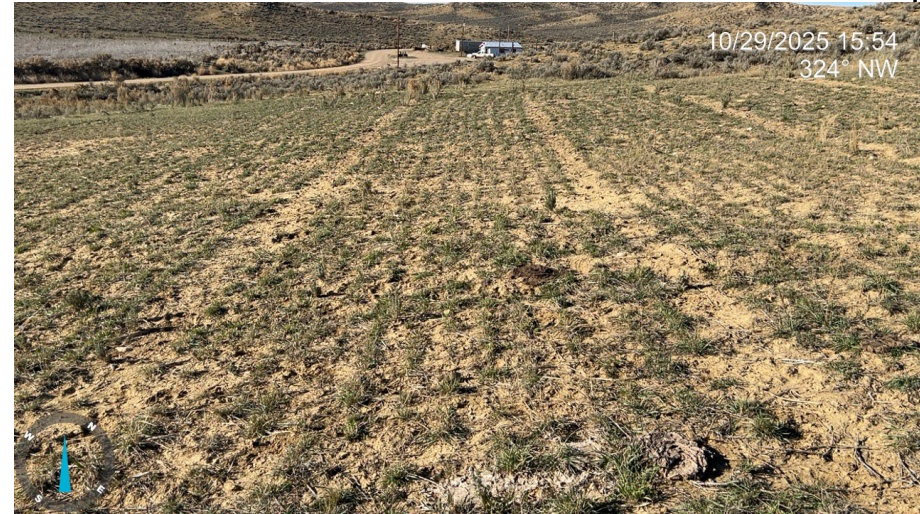
Photo 2: Photos showing an overview of the location looking southeast and northwest, respectively.

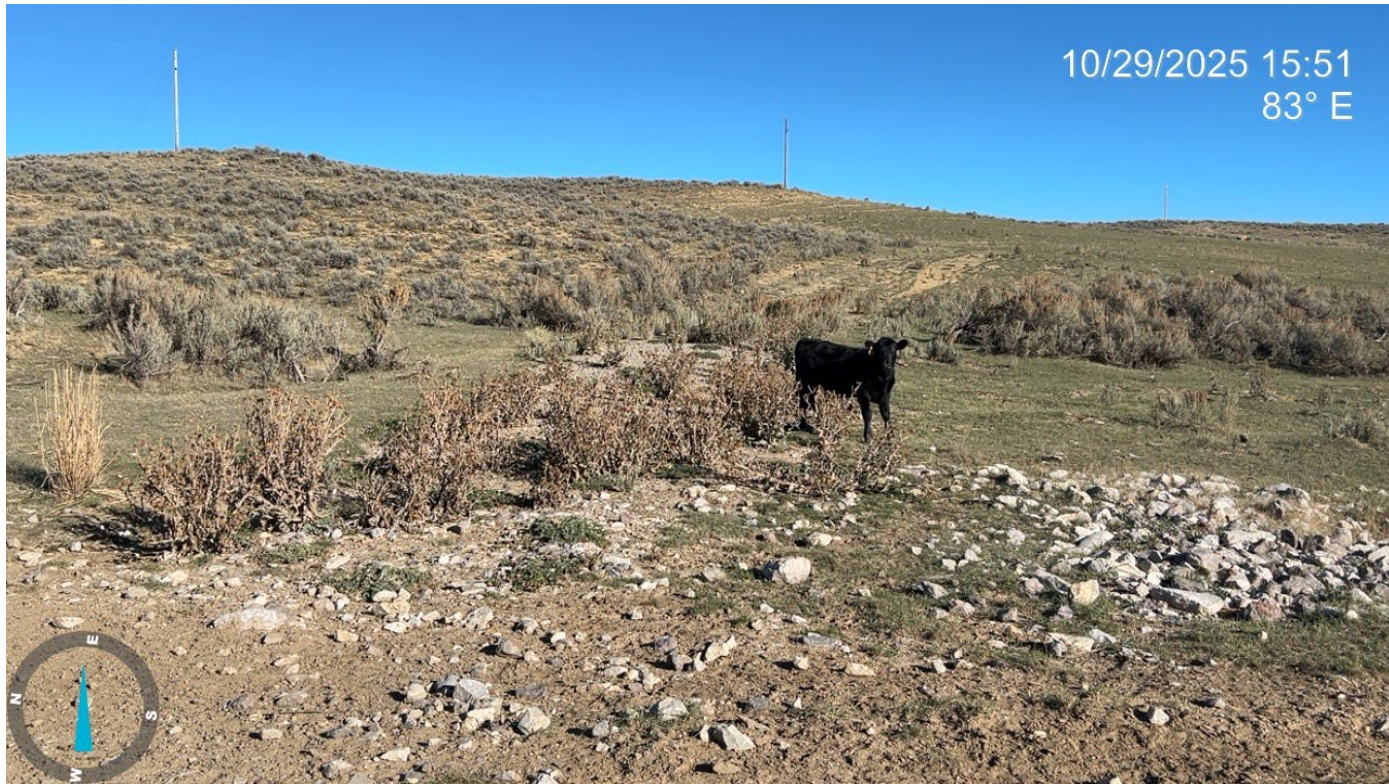
Photo 3: Photos showing the unreclaimed access road and entrance to the location. The access road has been overtaken by Scotch thistle, a List B noxious weed.

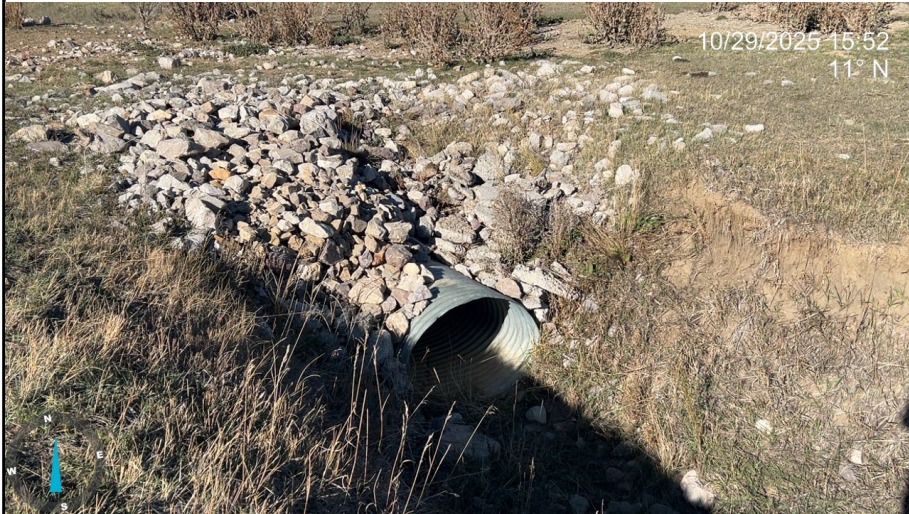
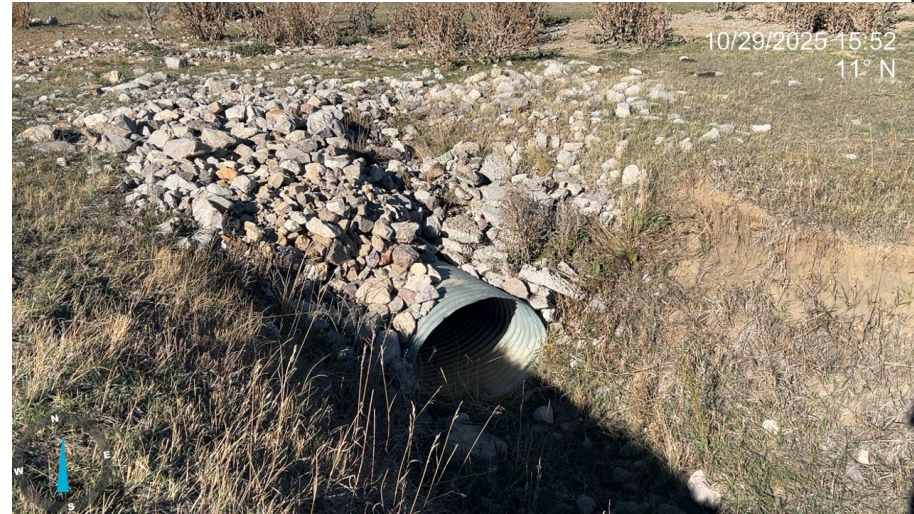
Photo 4: Photos showing a culvert remaining along the unreclaimed access road and entrance to the location. Culvert requires removal.

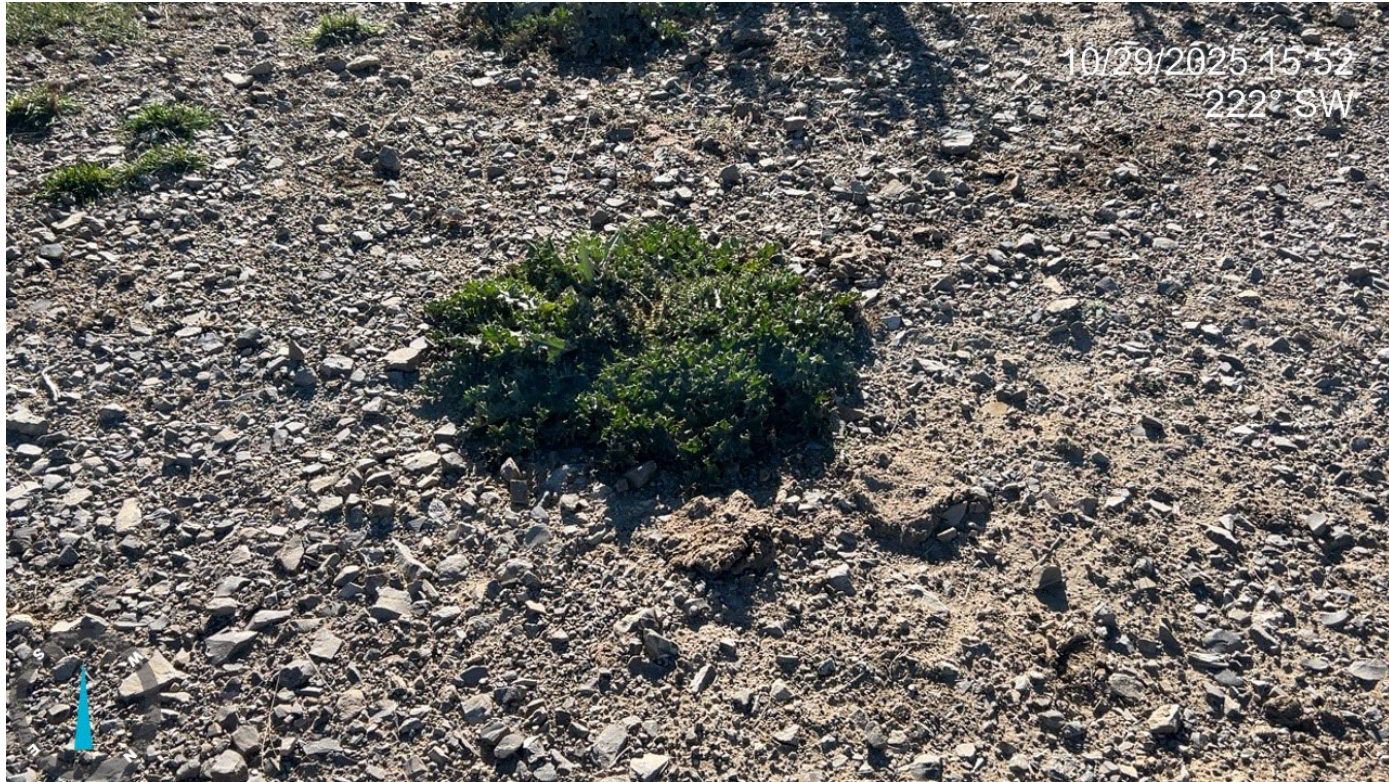
Photo 5: Photos showing an example of Scotch thistle basal rosettes that have established on the access road. It does not appear as though weeds have been managed in 2025.

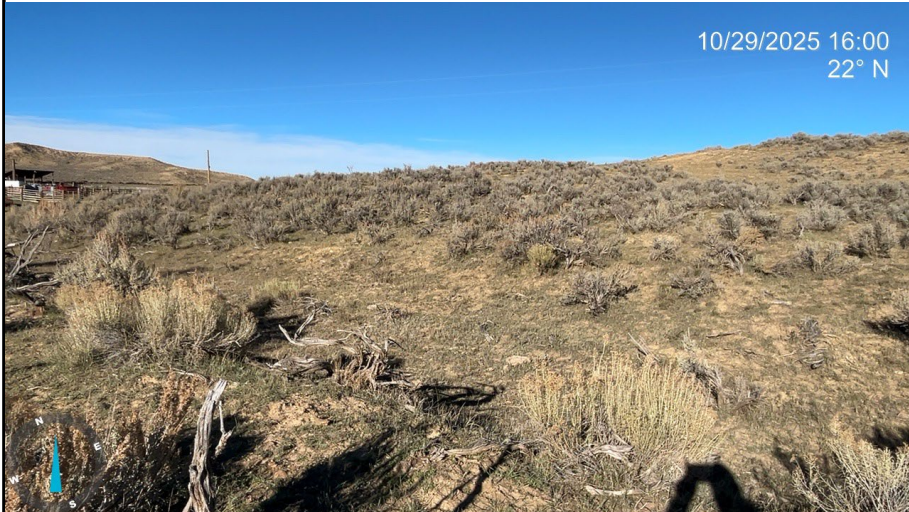
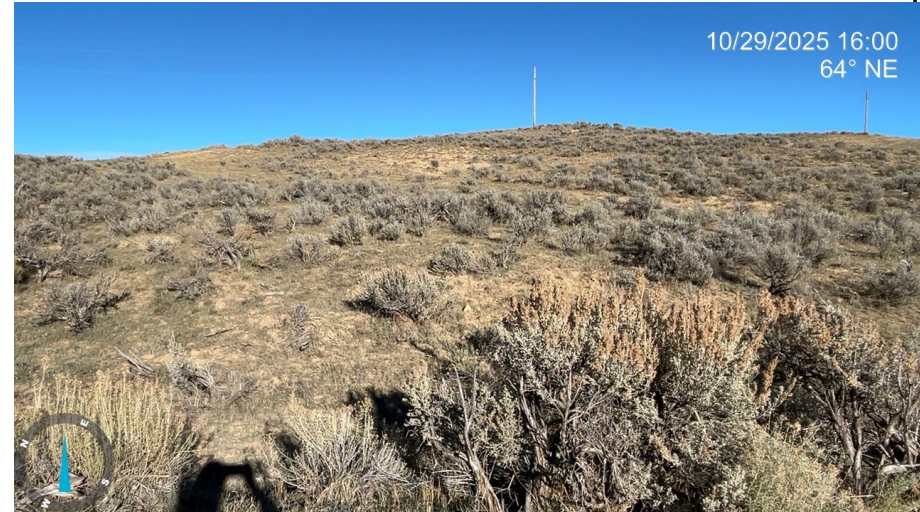
Photo 6: Photos showing the reference area, located to the north of the location. The reference area is characterized by big sagebrush shrubland.
