Inspection Photos

Operator: SWN Production Company LLC

Location ID: 425038

Inspection Doc: 719200412

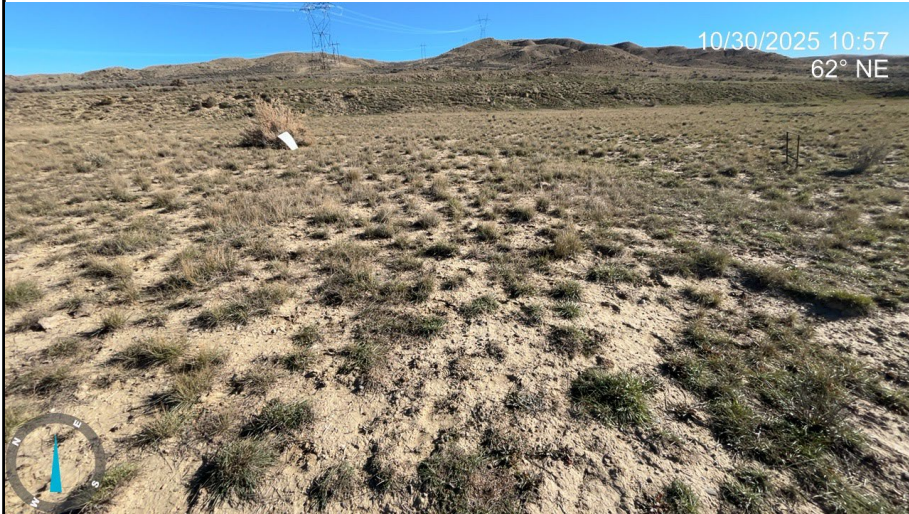
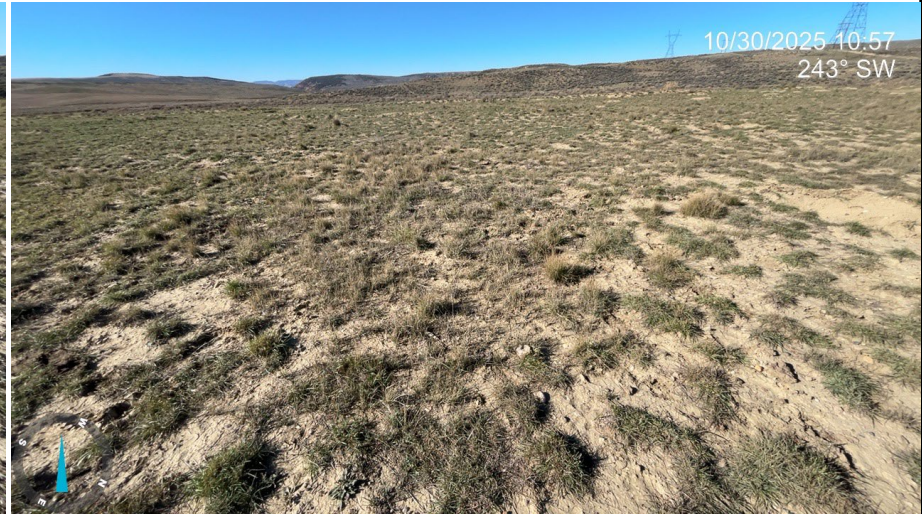
Photo 1: Photos showing an overview of the location looking northeast and southwest, respectively.

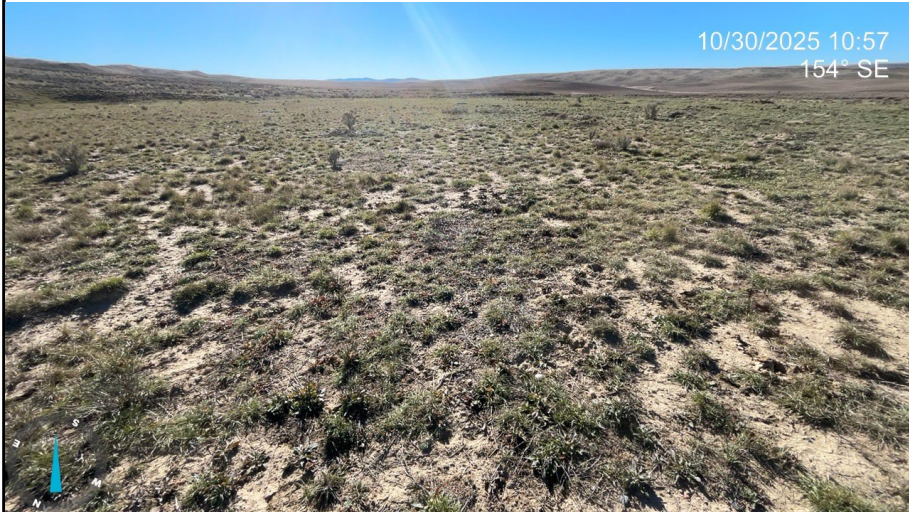
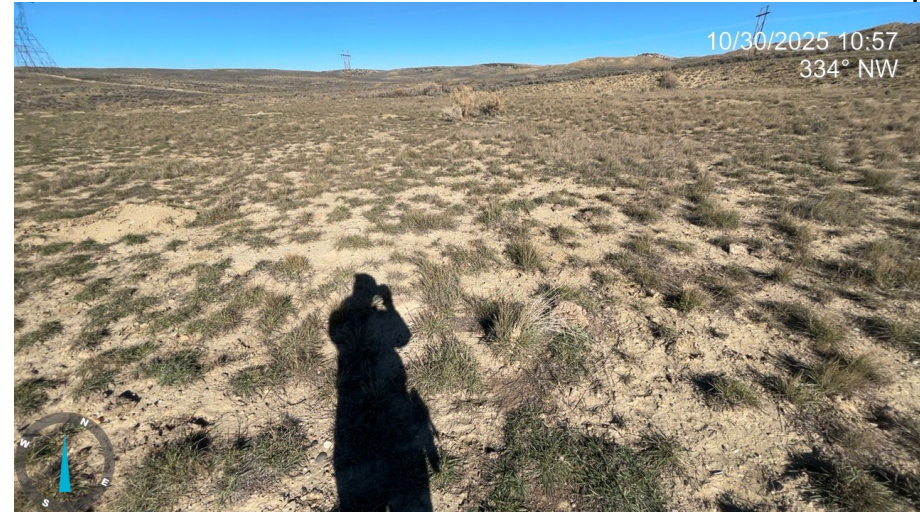
Photo 2: Photos showing an overview of the location looking southeast and northwest, respectively.

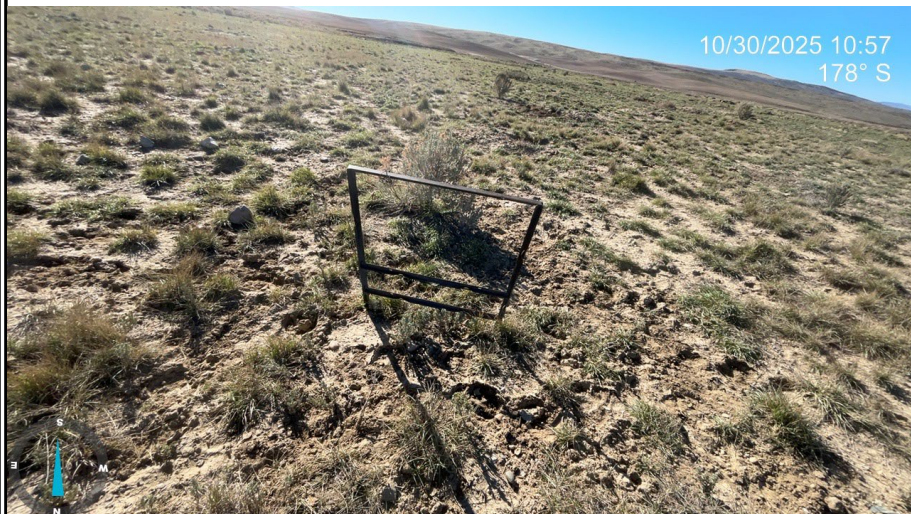
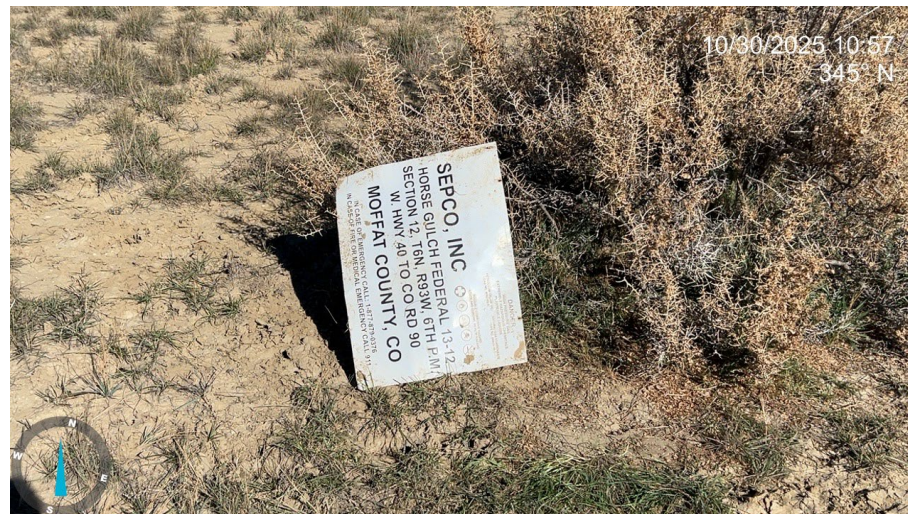
Photo 3: Photos showing old signage debris with incorrect Operator information is present at the location and requires removal.

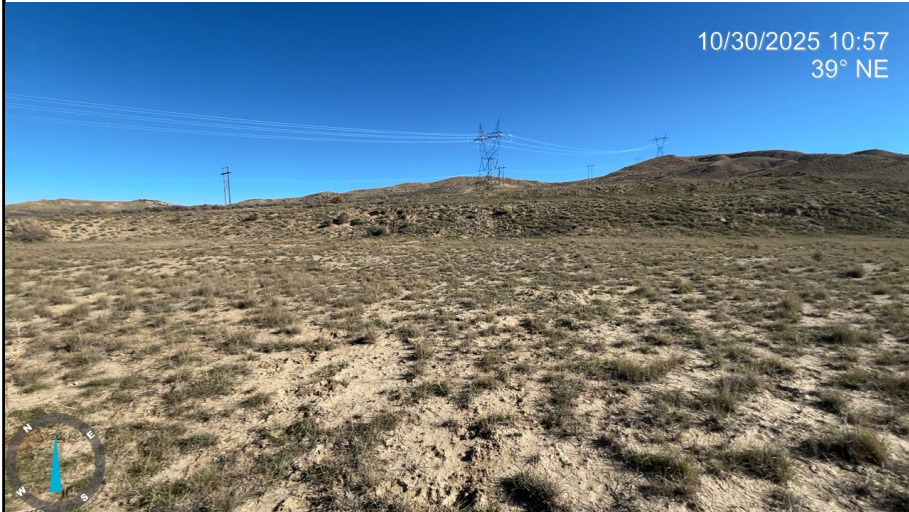
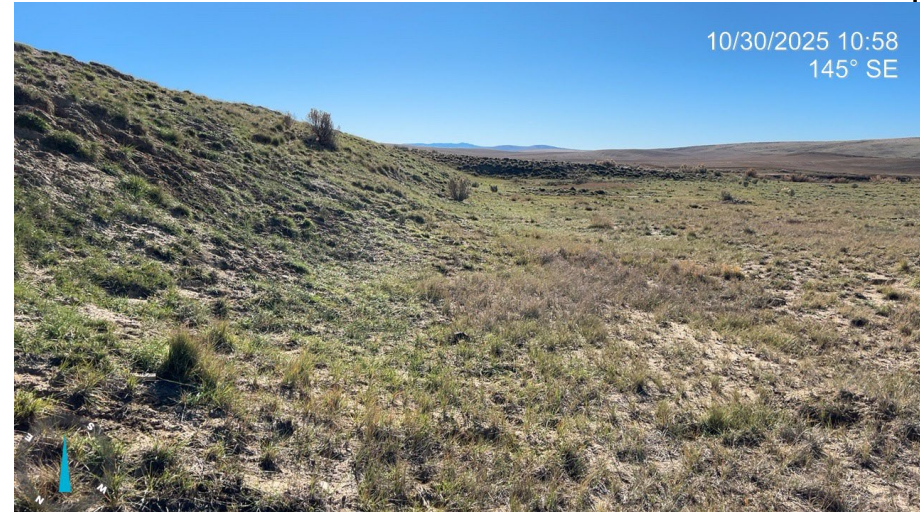
Photo 4: Photos showing cut slopes remain and the location has not been regraded or recontoured pursuant to 1004 Rules.

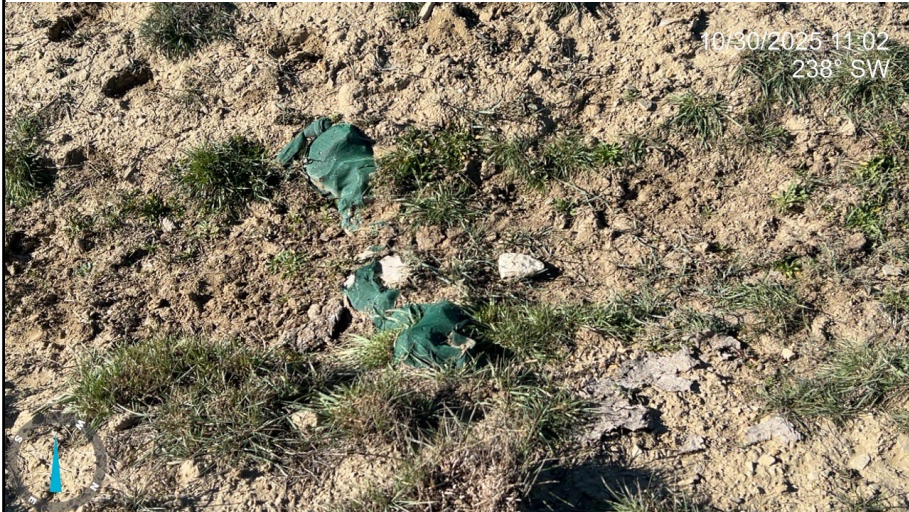
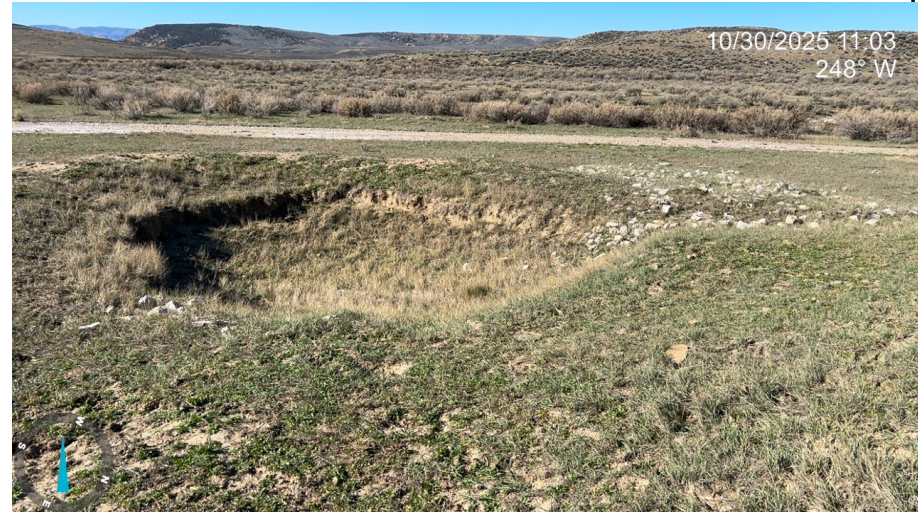
Photo 5: Photos showing damaged rock socks and stormwater controls that remain on the southern and southwestern end of the location. Debris requires removal and stormwater controls have not been reclaimed pursuant to 1004 Rules.

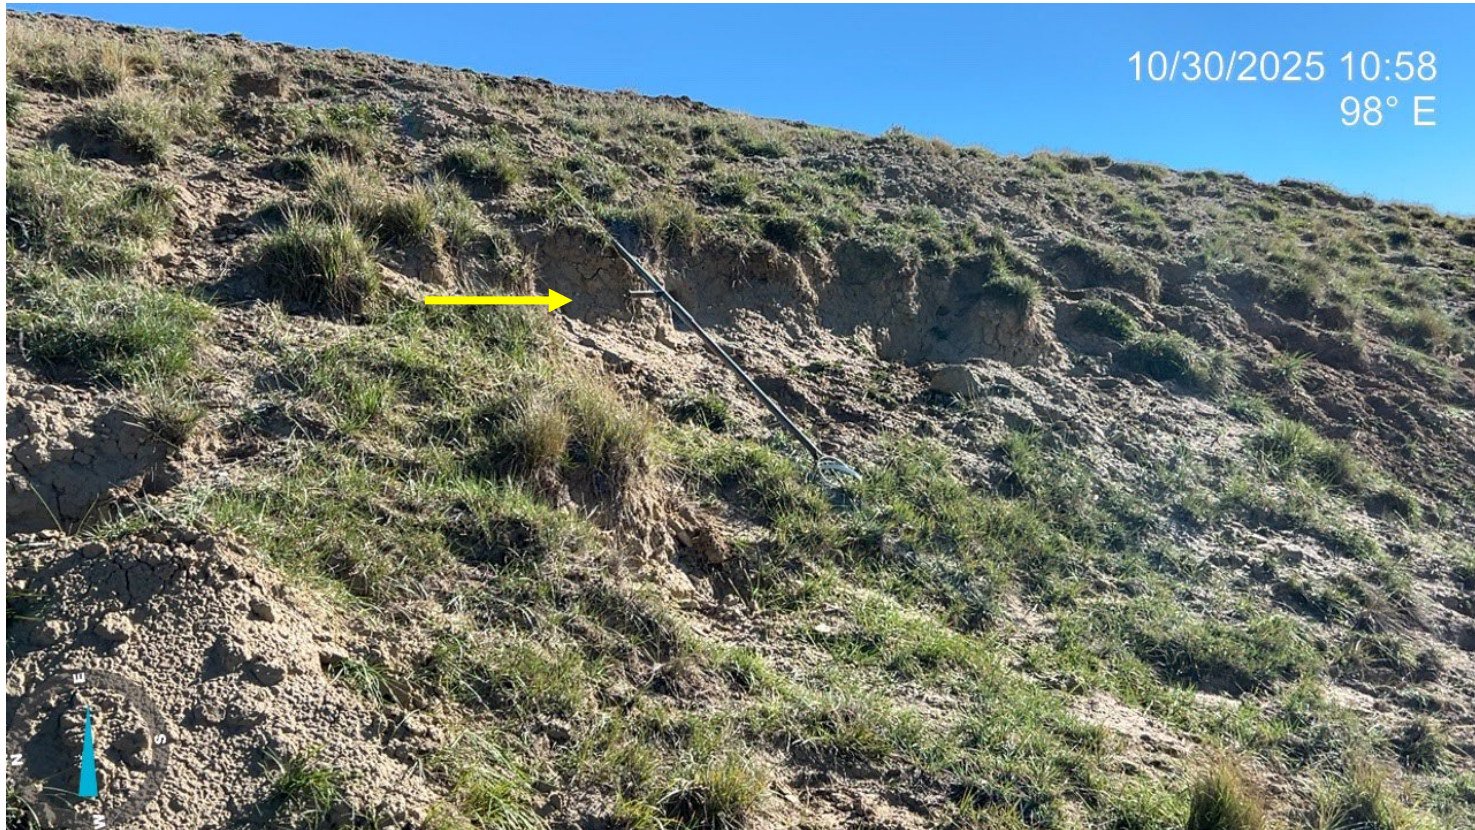
Photo 6: Photo showing pipe debris that is present on the eastern cut slope and requires removal.

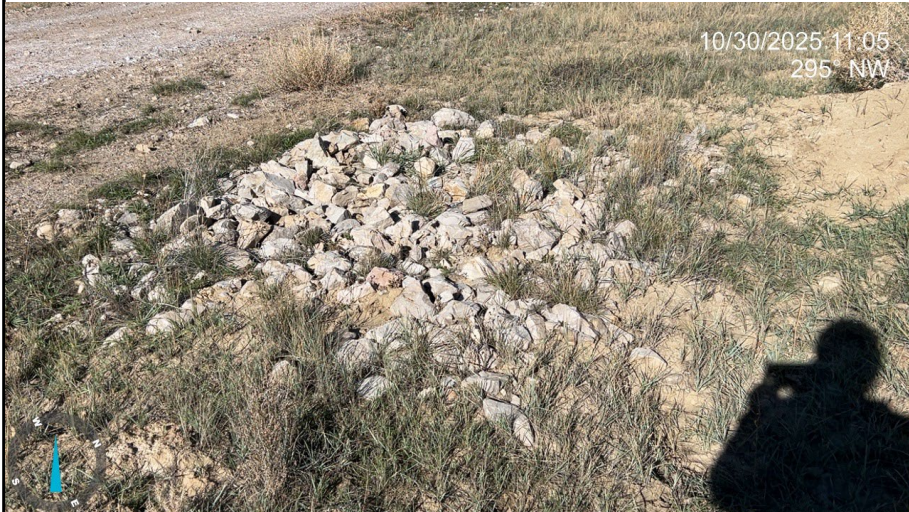
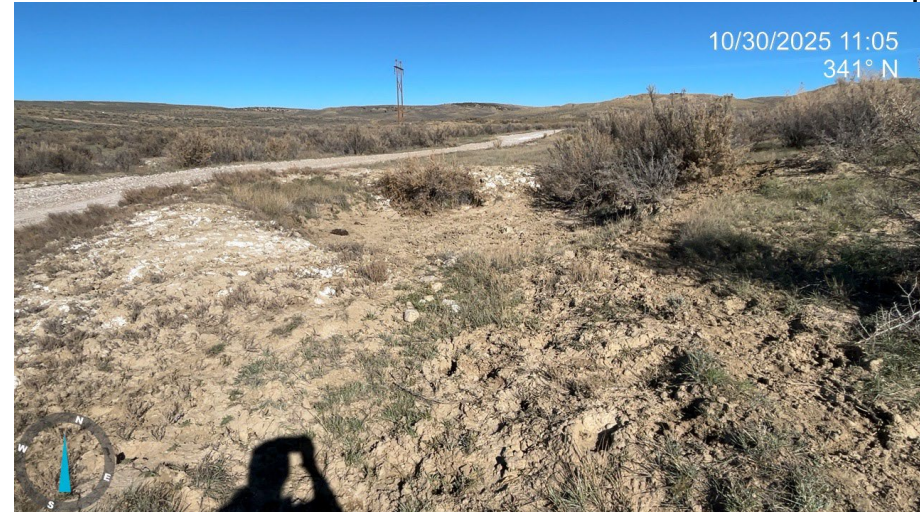
Photo 7: Photos showing stormwater controls remain on the west-central location. Stormwater controls have not been reclaimed pursuant to 1004 Rules.

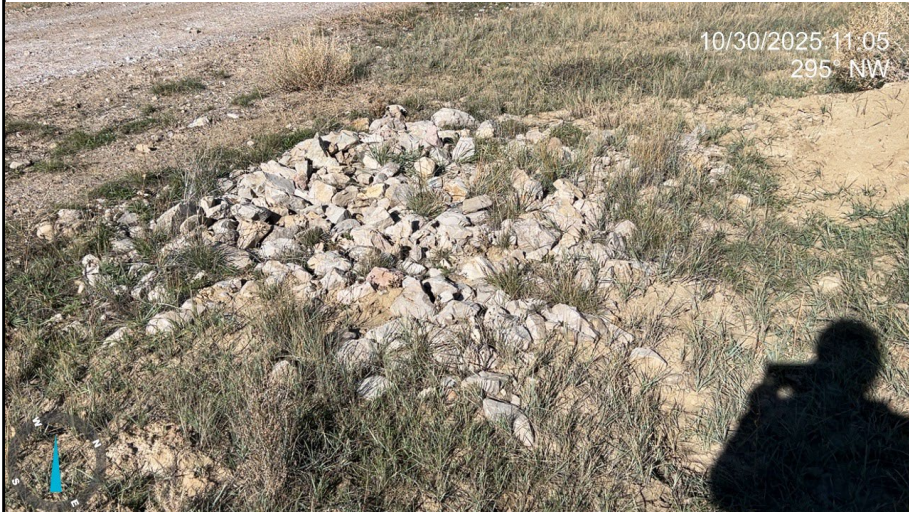
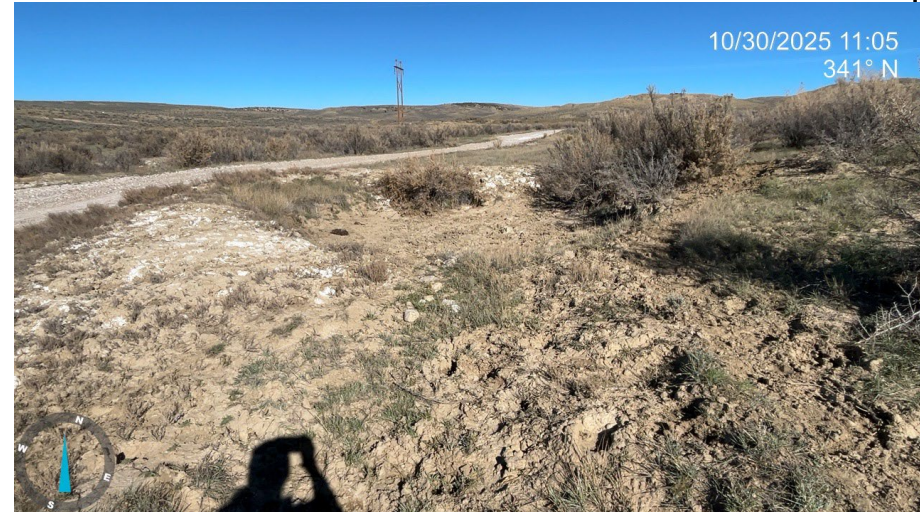
Photo 8: Photos showing stormwater controls remain on the west-central location. Stormwater controls have not been reclaimed pursuant to 1004 Rules.

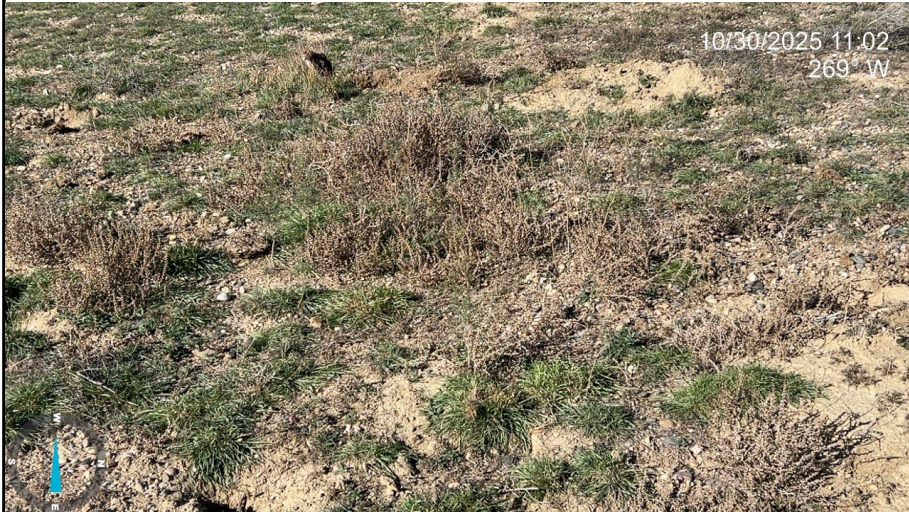
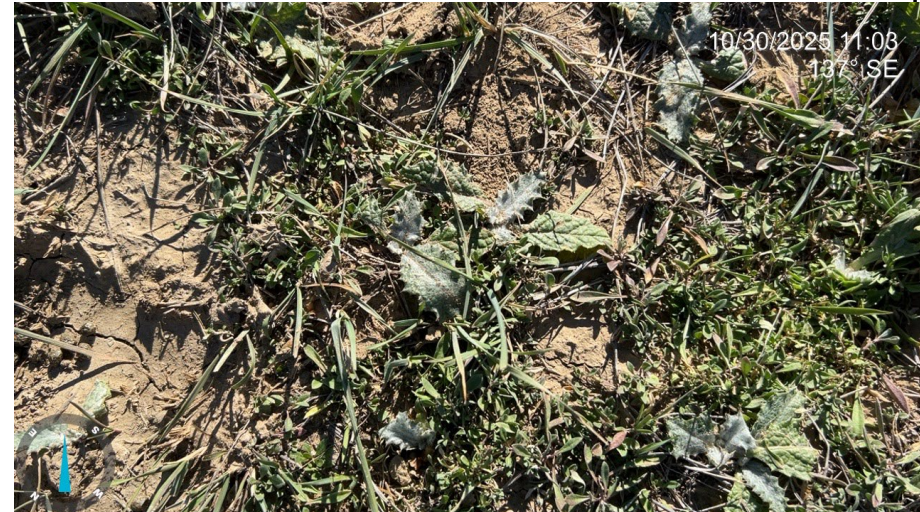
Photo 9: Photos showing prickly Russian thistle (left), an undesirable weedy plant species, is present on the southern portion of the location. Scotch thistle basal rosettes (right), are present on the southwestern portion of the location. Weed management is required.

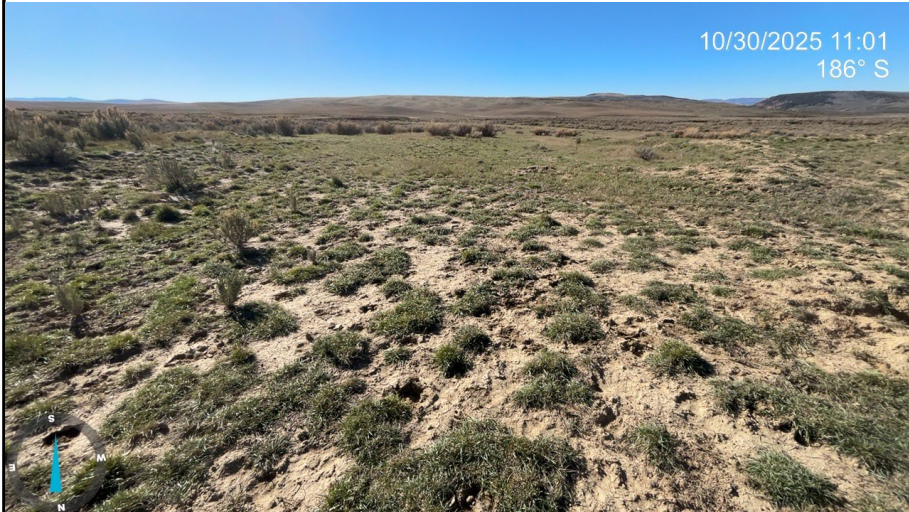
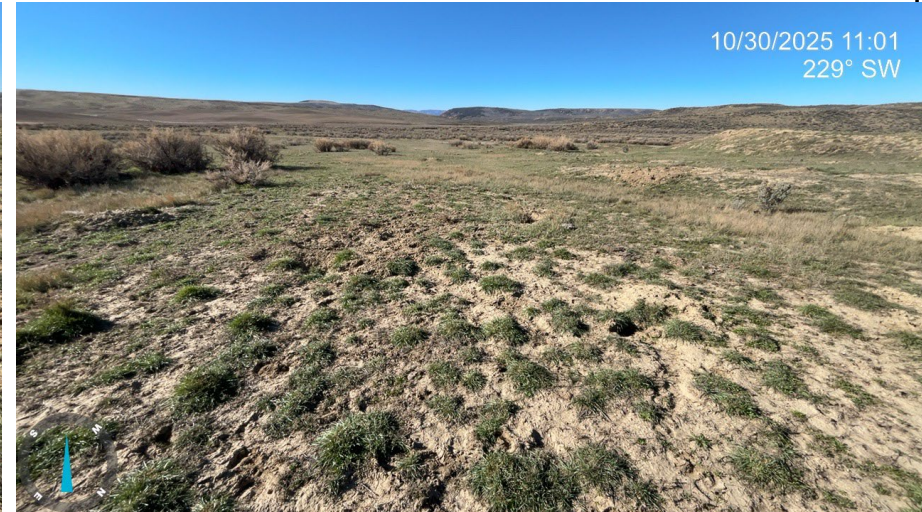
Photo 10: Photos showing the southern access road leading to the location has been reclaimed; gravel has been removed, soils have been decompacted and plant establishment is evident.

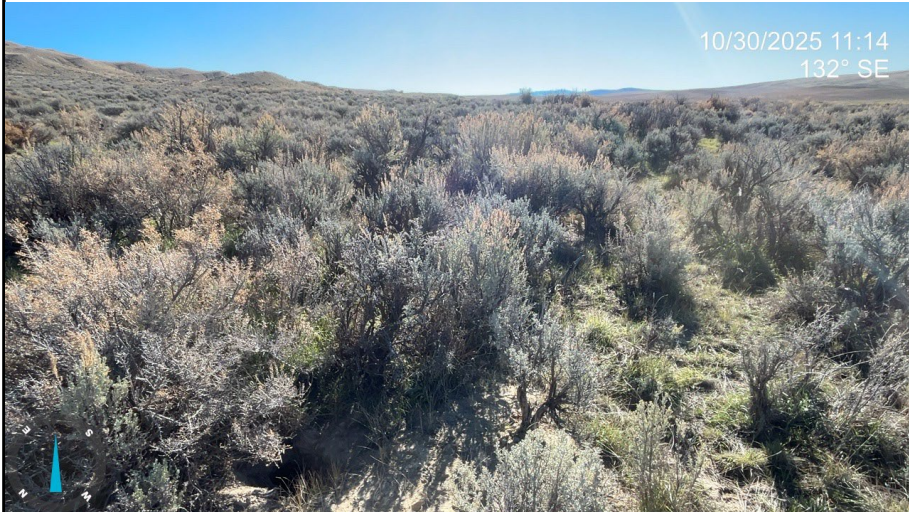
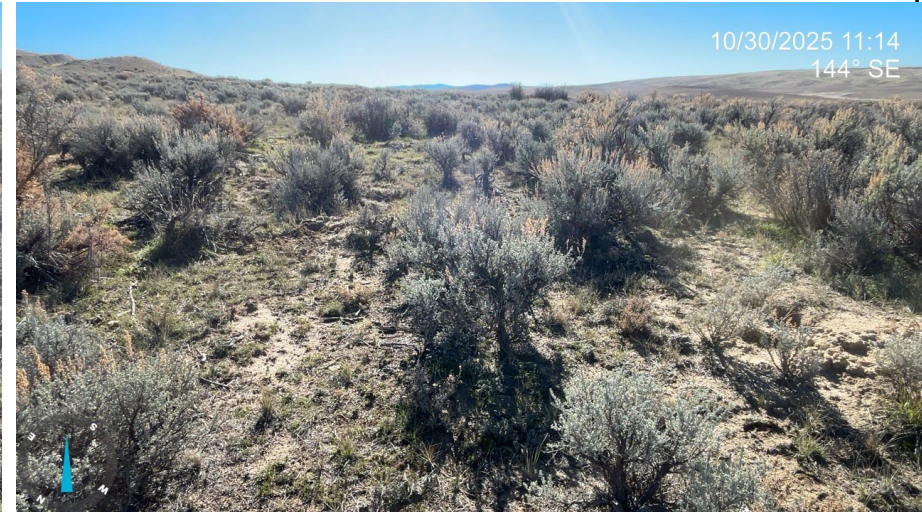
Photo 11: Photos showing the reference area, located to the north of the location. The reference area is characterized by big sagebrush shrubland.
