# Inspection Photos

**Operator:** QB Energy Operating LLC #10844

**Location ID:** 334942

**Inspection Doc:** 719200437

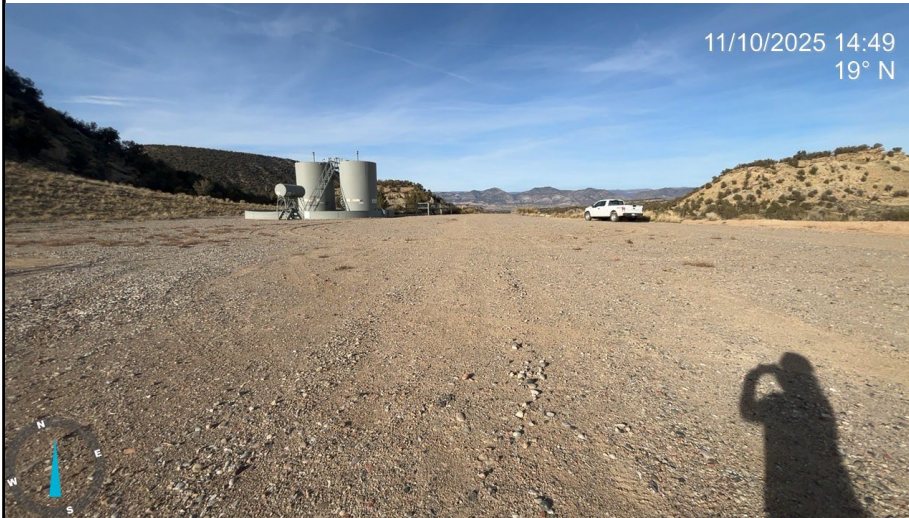
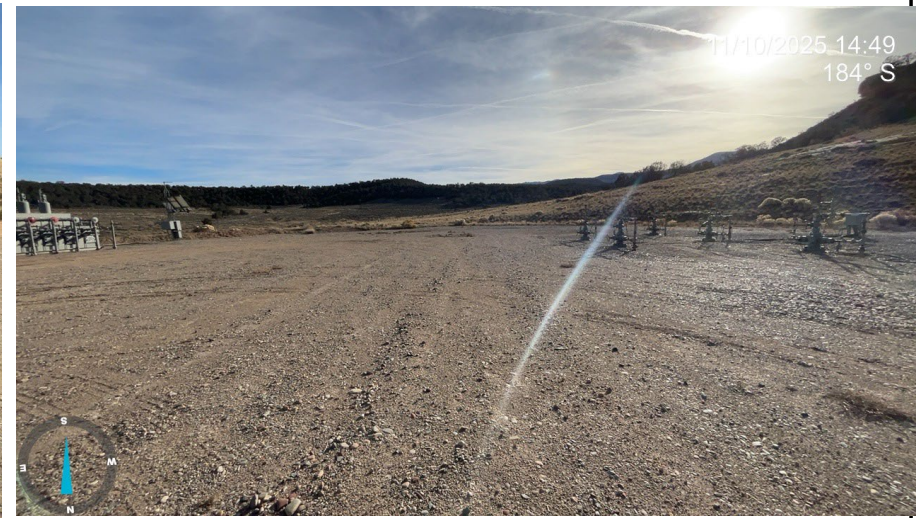
**Photo 1:** Photos showing an overview of the location looking north and south, respectively.

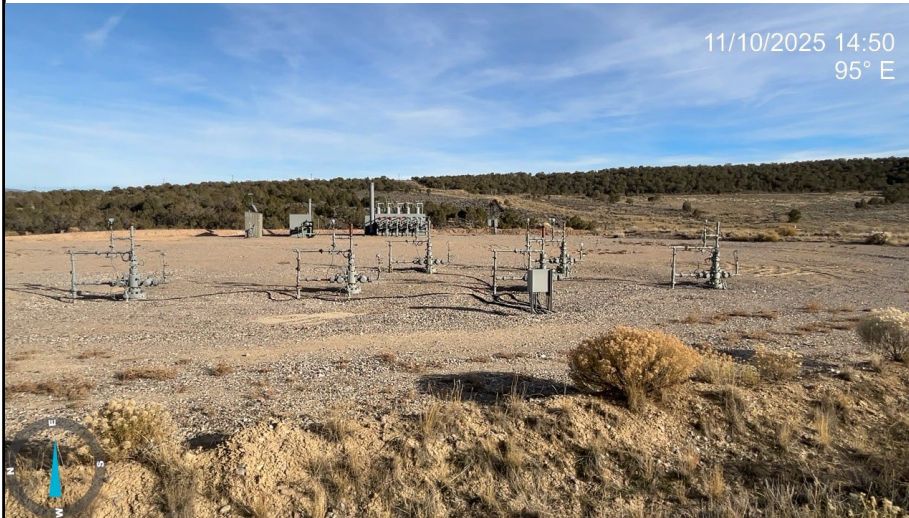
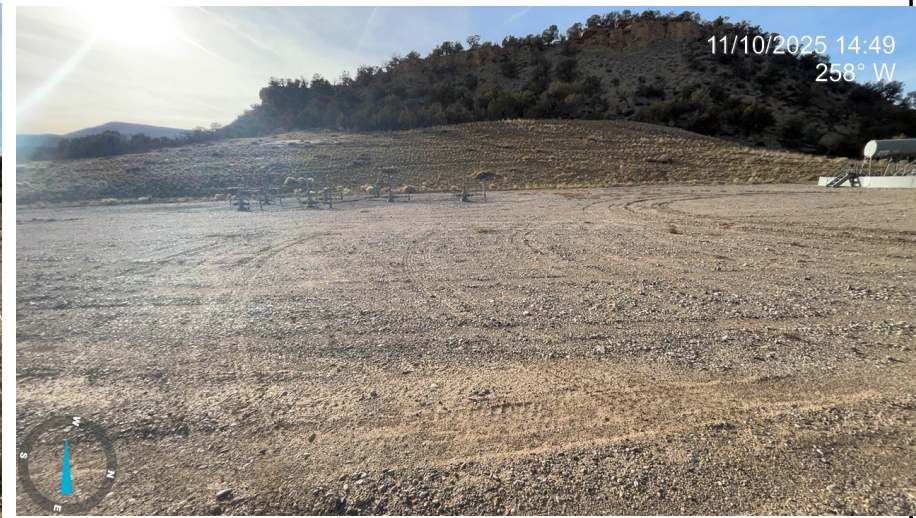
**Photo 2:** Photos showing an overview of the location looking east and west, respectively.

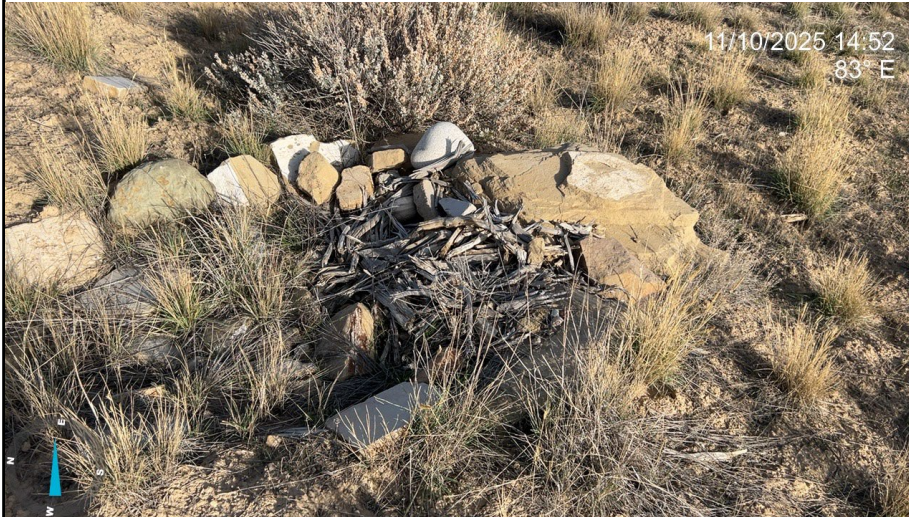
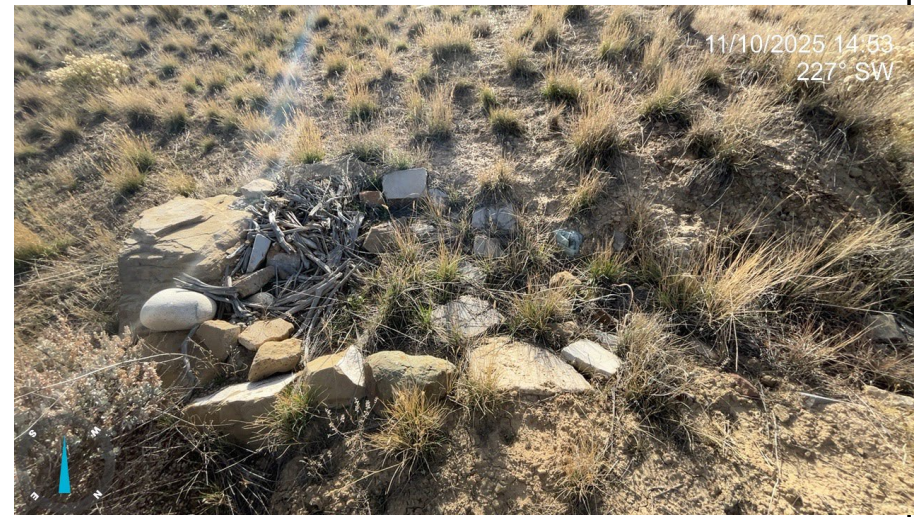
**Photo 3:** Photos showing what appears to be a sediment trap or stormwater control at the southern end of the location are overtaken with debris. Comply with 1002.f. and maintain stormwater controls.

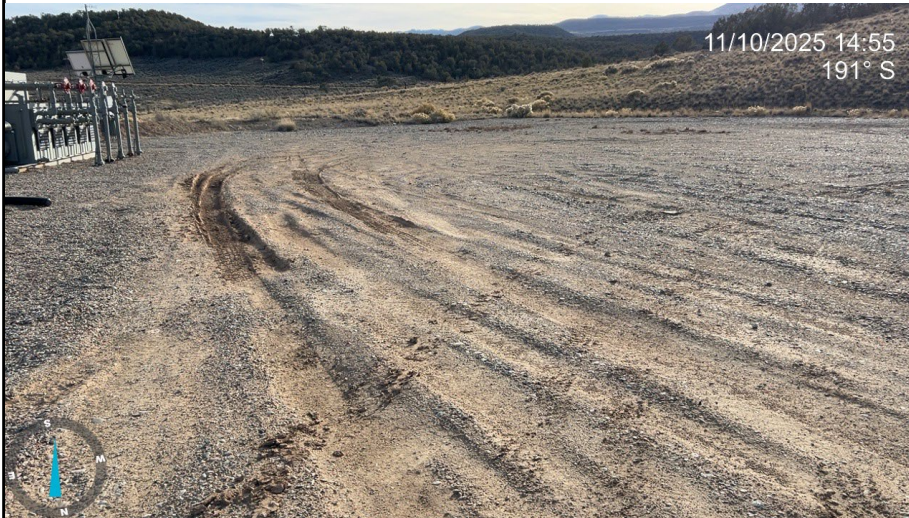
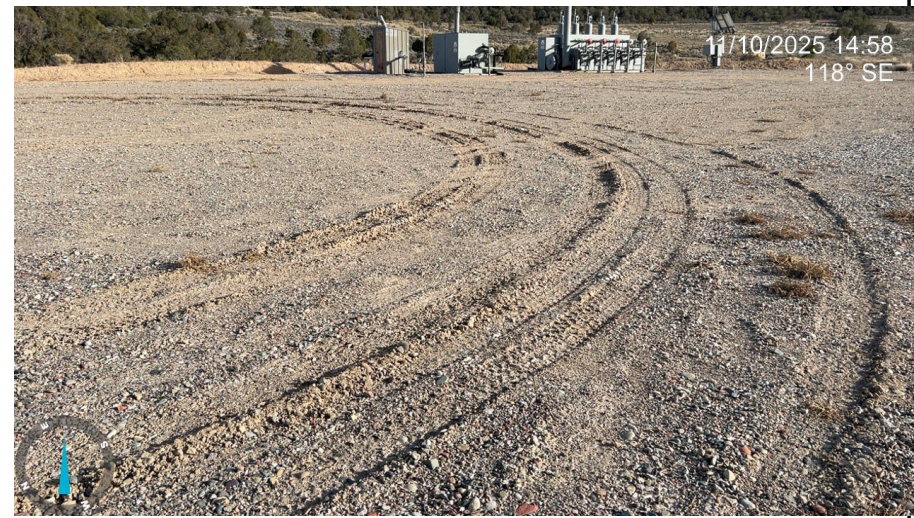
**Photo 4:** Photos showing an example of vehicle tracking that is occurring on the working pad surface; gravel appears to be sparse in some areas. Maintenance is required; comply with 1002.f.

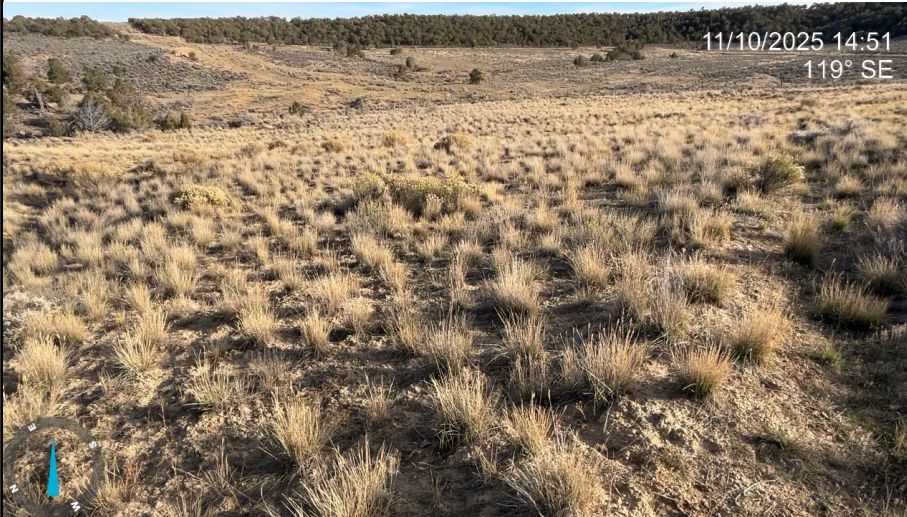
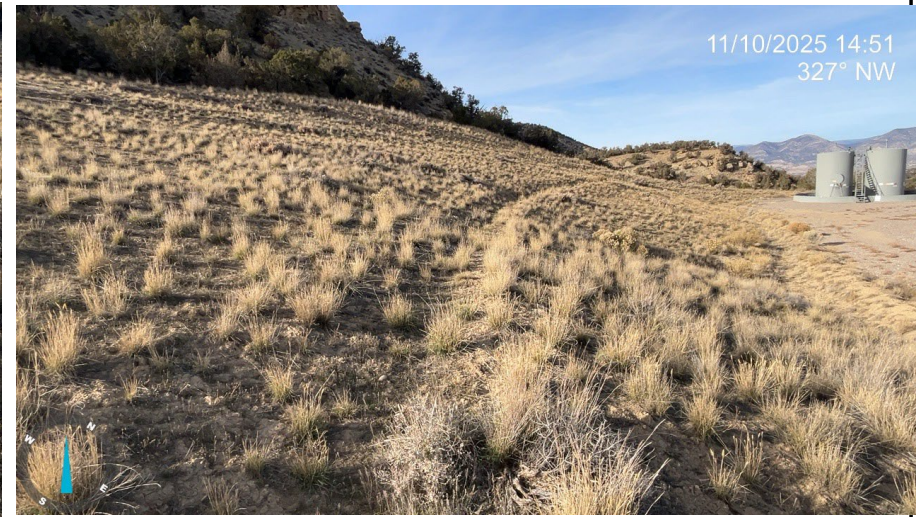
**Photo 5:** Photos showing interim areas at the location are composed of desirable, perennial vegetation and is progressing towards 1003 reclamation requirements.
