# Final Reclamation and Stormwater Inspection

October 31, 2025

Location ID: 433247

Well Name: Swan #21-44

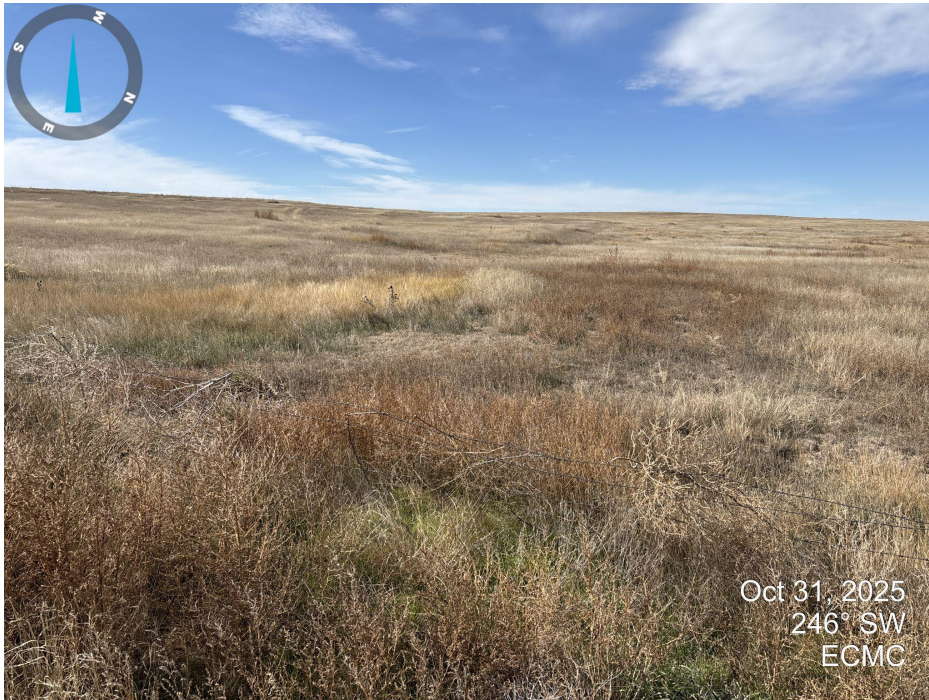
**Photo 1.** Picture taken at the entrance to the access road. A patch of undesirable weed kochia is present near the entrance. Desirable vegetation is present on most portions of the access road.

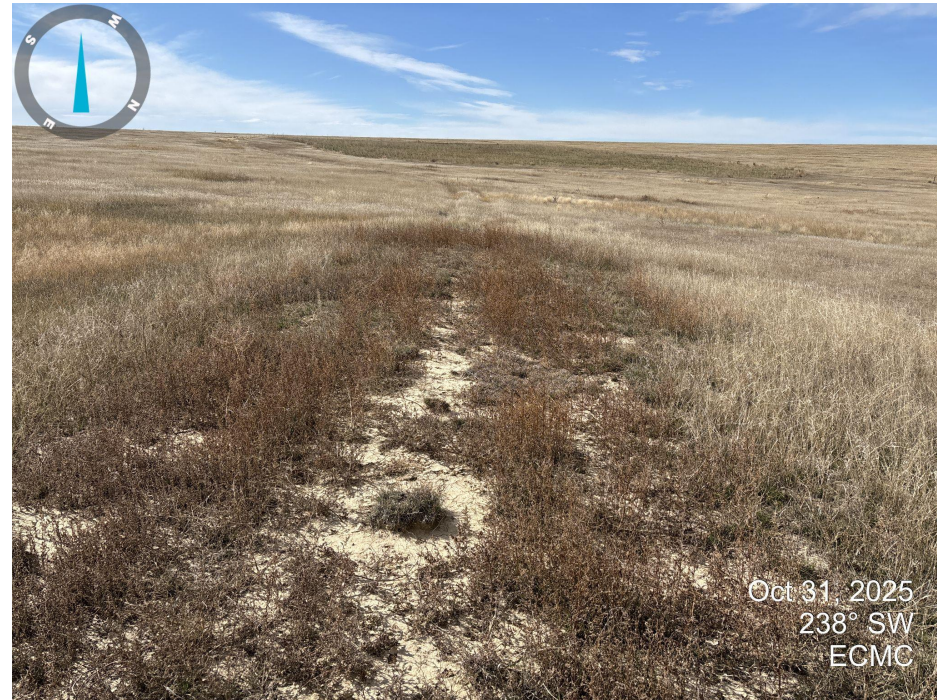
**Photo 2.** Picture taken at midpoint of access road. looking southwest towards the location. A 30 ft patch of undesirable weed kochia with less desirable vegetation establishment than the surrounding reference area is present.

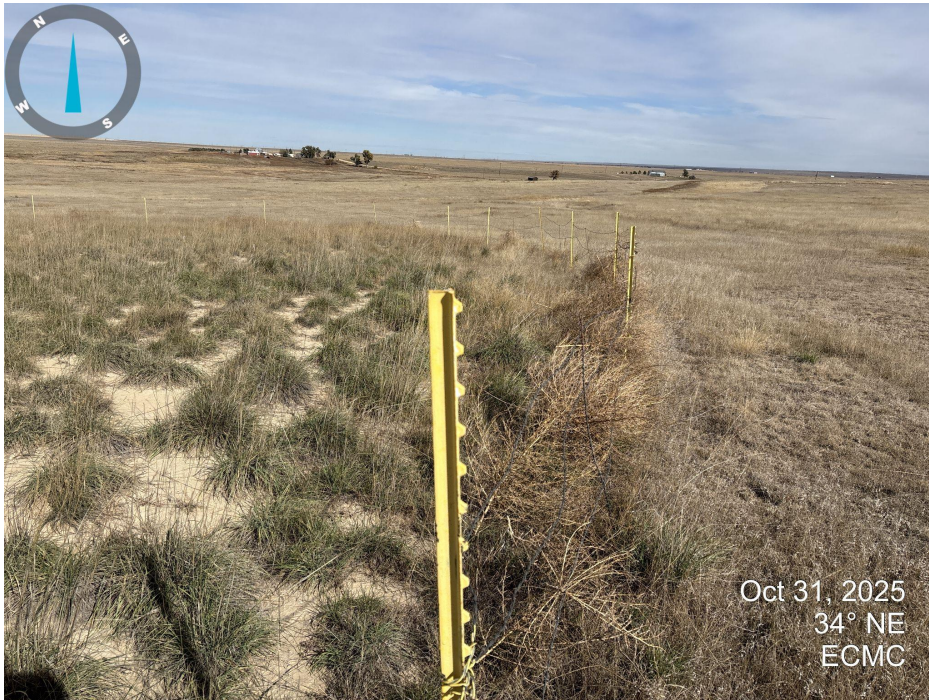
**Photo 3.** Looking north along the east edge of the location. The location is fenced. The fence is loose and down in places. Vegetation on the location is not reflective of the surrounding reference area (reference area right side of picture).

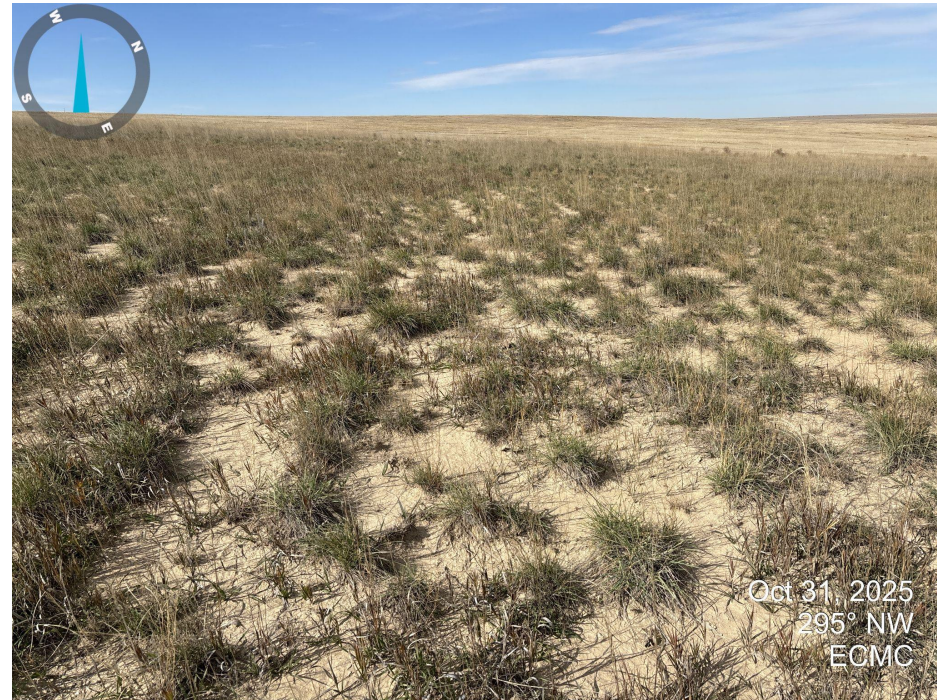
**Photo 4.** Looking west across the location. Perennial vegetation is present on location. The vegetation does not appear to have reached 80% coverage of the reference area.

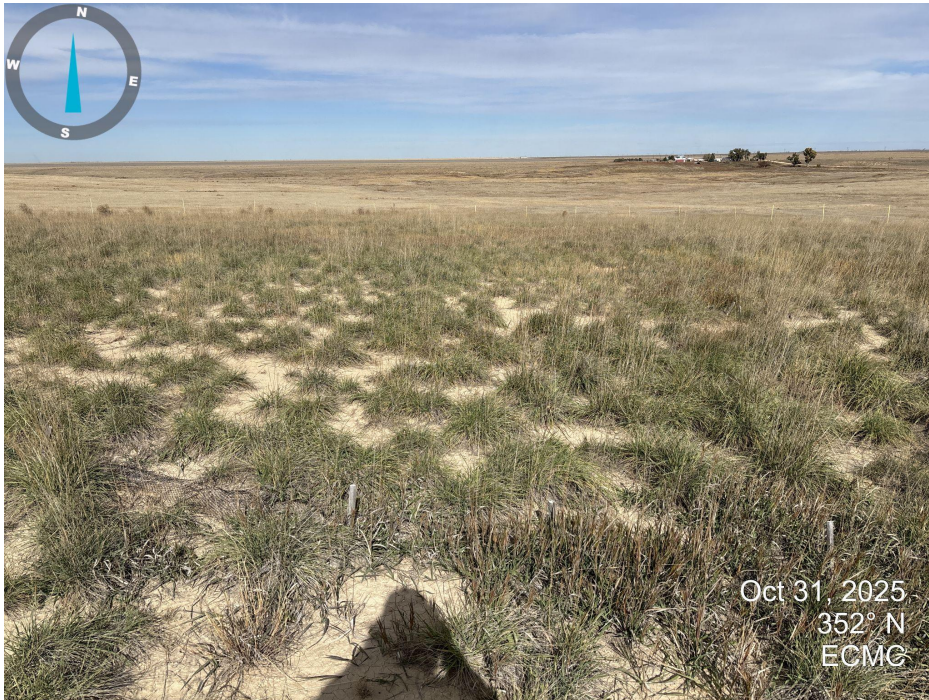
**Photo 5.** Looking north from the wellbore. Desirable vegetation is present on location but does not appear to have reached 80% coverage of the reference area. Vegetation on the location is not reflective of the surrounding reference area. Vegetation on location appears to be predominantly russian wildrye, crested wheatgrass and smooth brome which were not observed in significant amounts in the reference area.

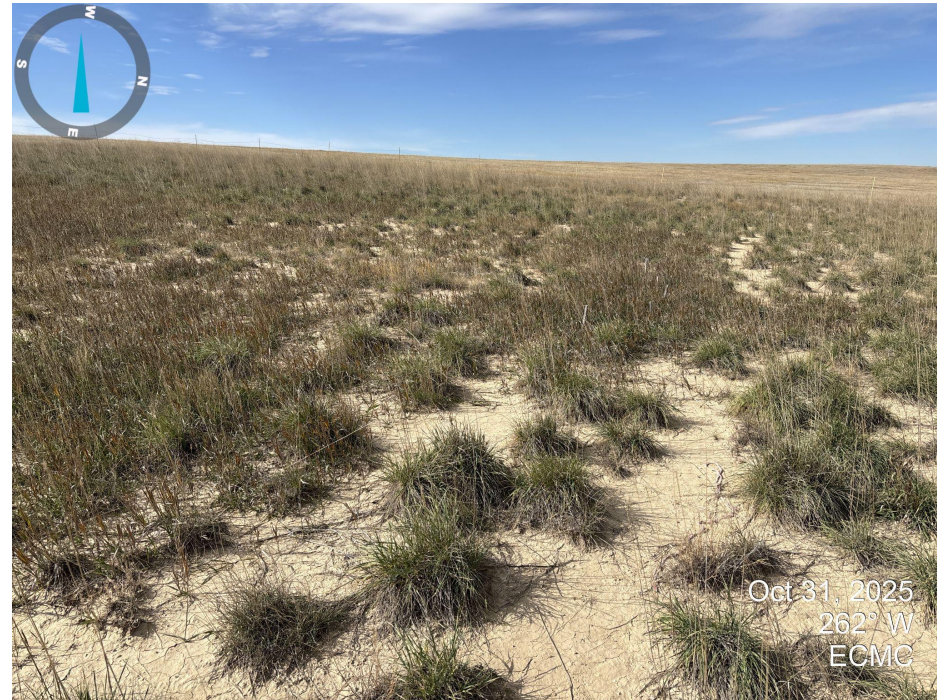
**Photo 6.** Looking west from wellbore. See photo 5 comments.

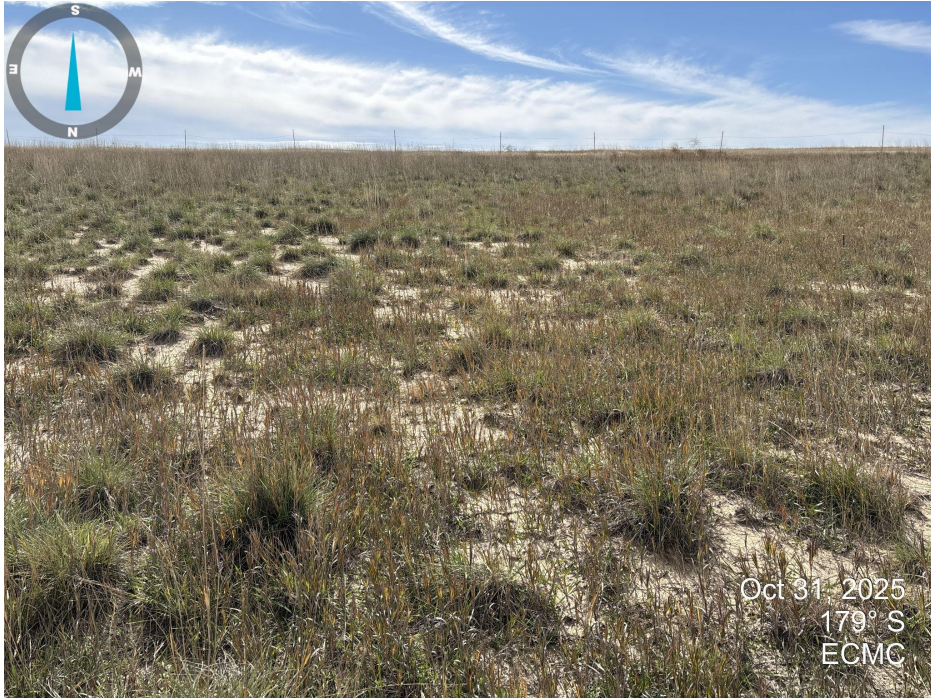
**Photo 7.** Looking south from wellbore. See photo 5 comments.

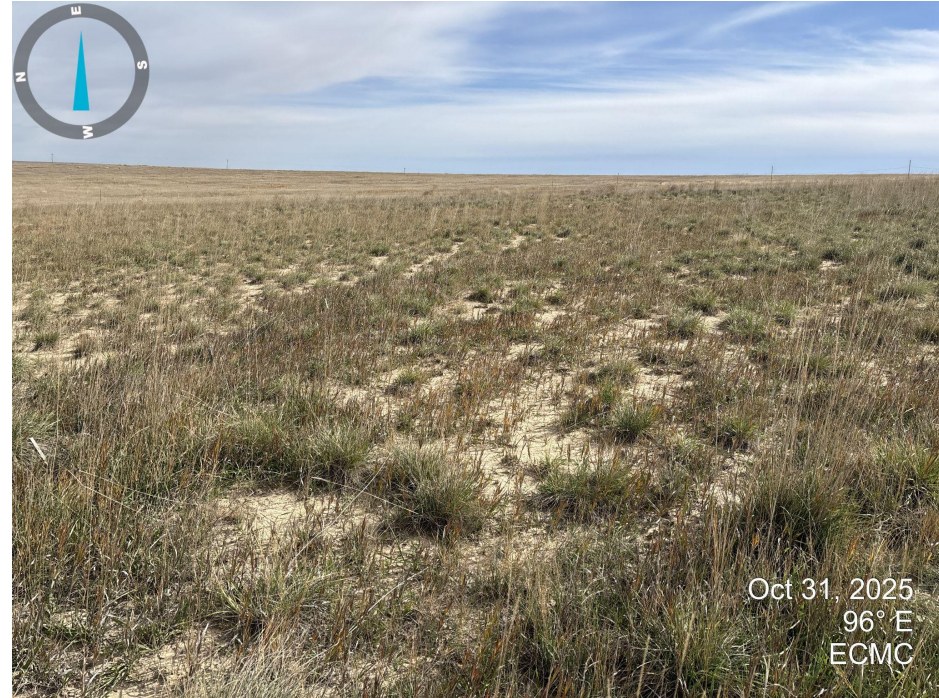
**Photo 8.** Looking east from wellbore. See photo 5 comments.

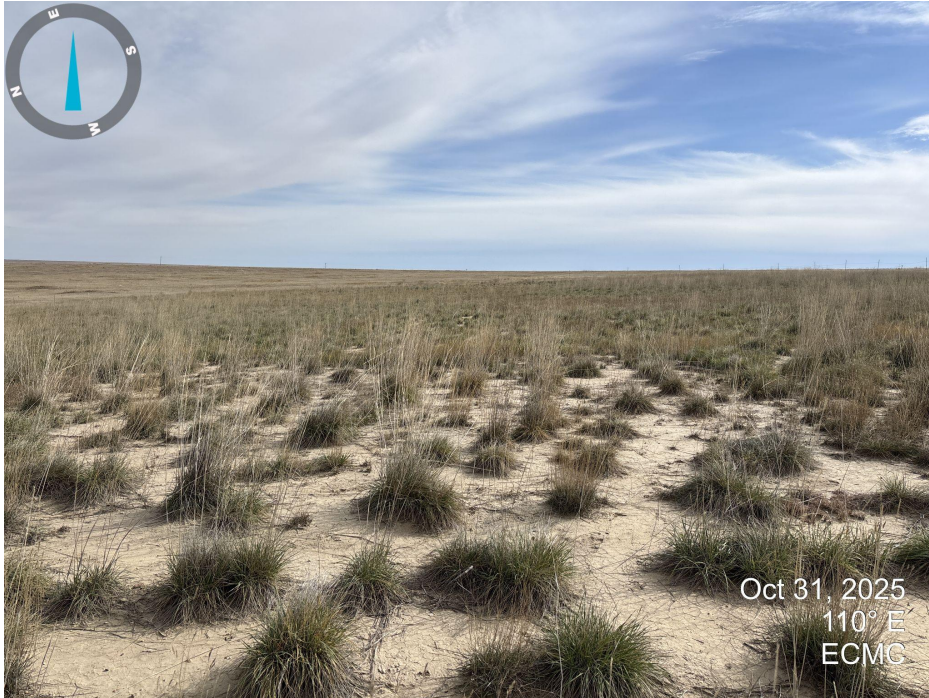
**Photo 9.** Picture taken on the west side of the location looking east. Portions of the location have lower vegetative coverage.

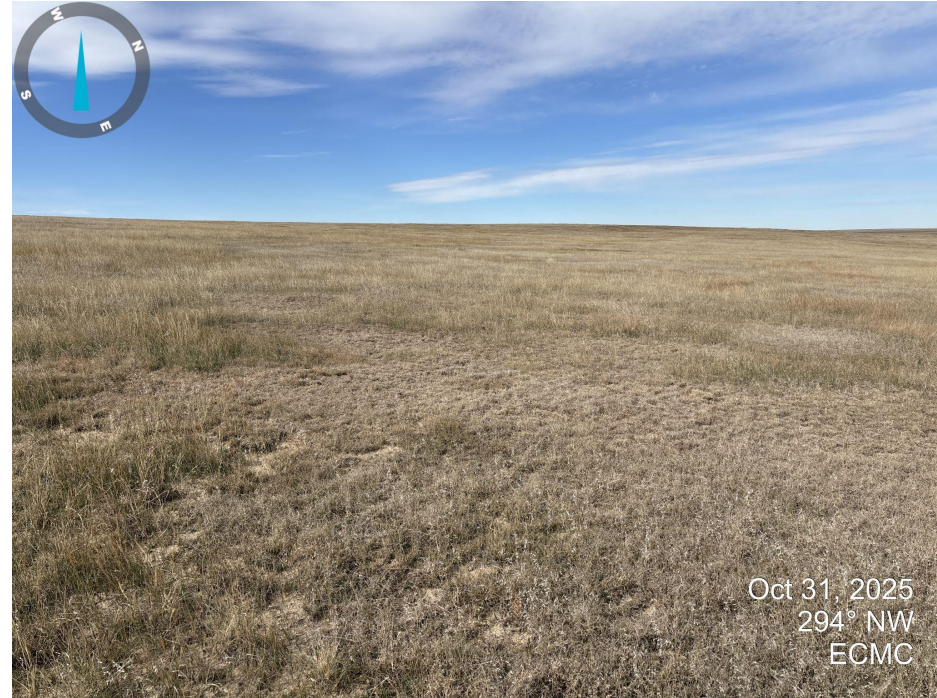
**Photo 10.** Reference vegetation to the west of the well location. Vegetation is primarily buffalograss, blue gramma and other native perennial species. Cheatgrass is also present in the reference area.
