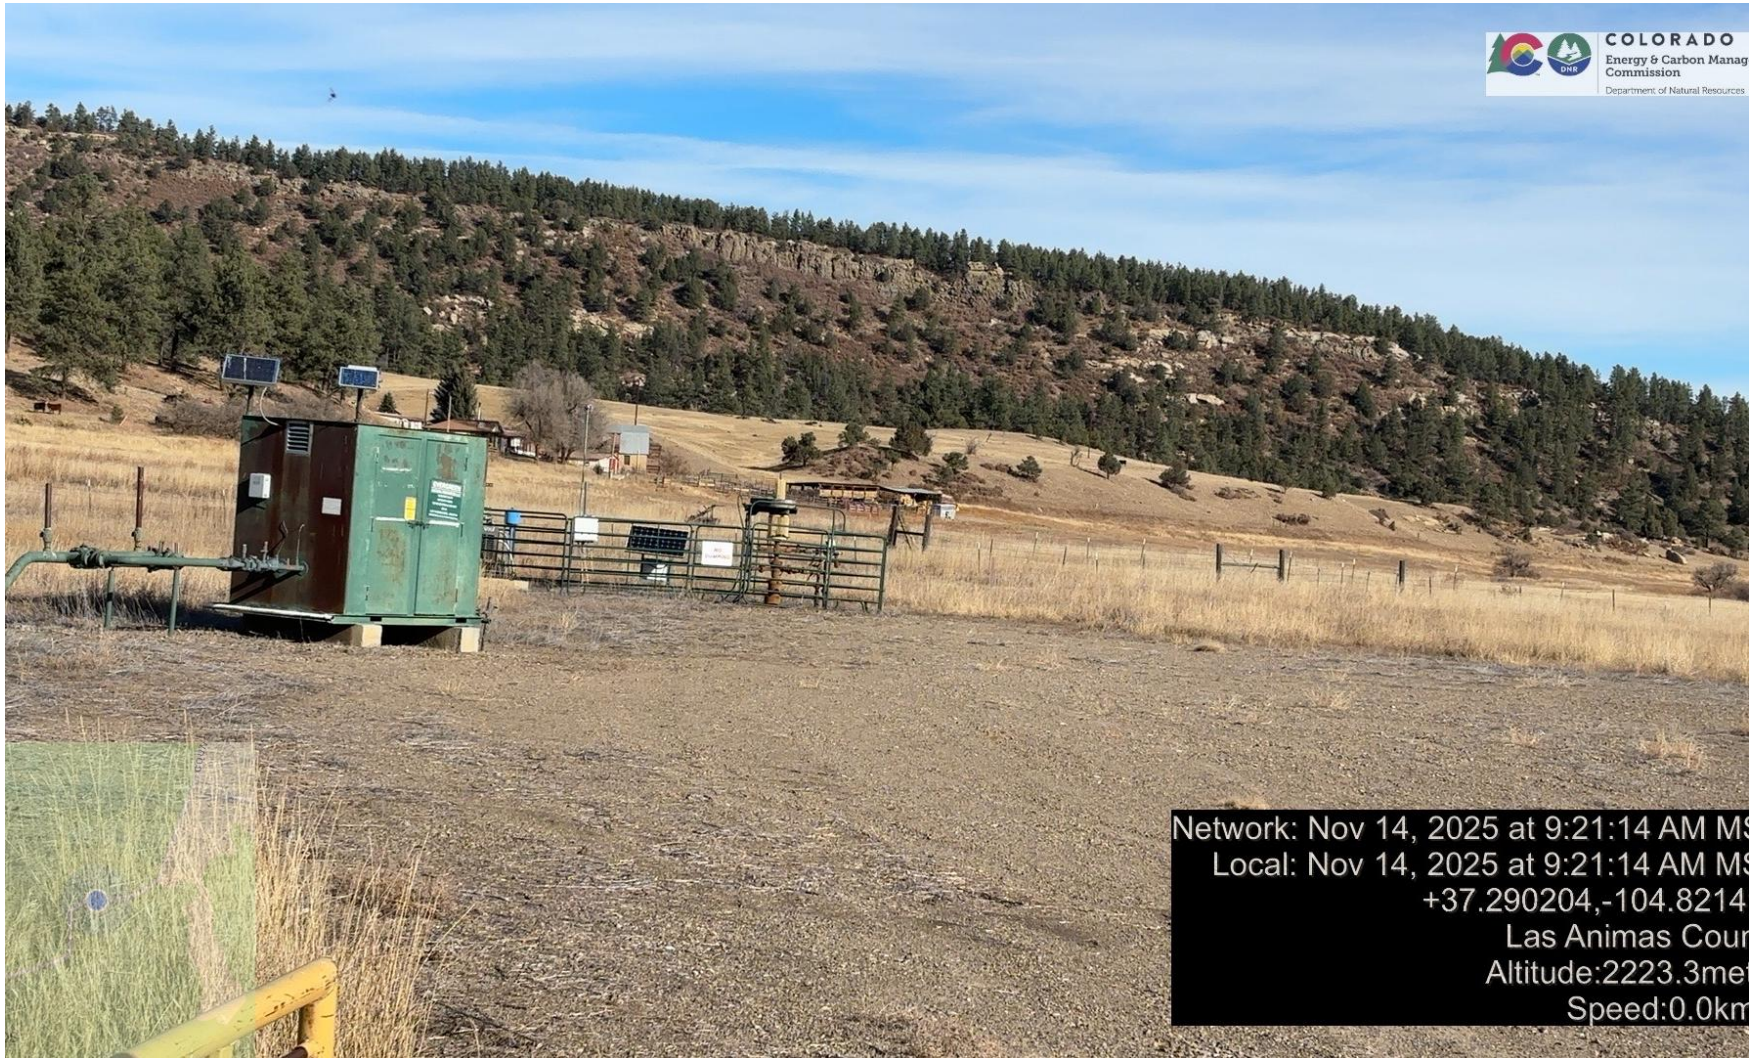
**PHOTO 2: LOCATION.**

Network: Nov 14, 2025 at 9:21:14 AM MST  
Local: Nov 14, 2025 at 9:21:14 AM MST  
+37.290204,-104.8214  
Las Animas County  
Altitude: 2223.3 meters  
Speed: 0.0 km/h

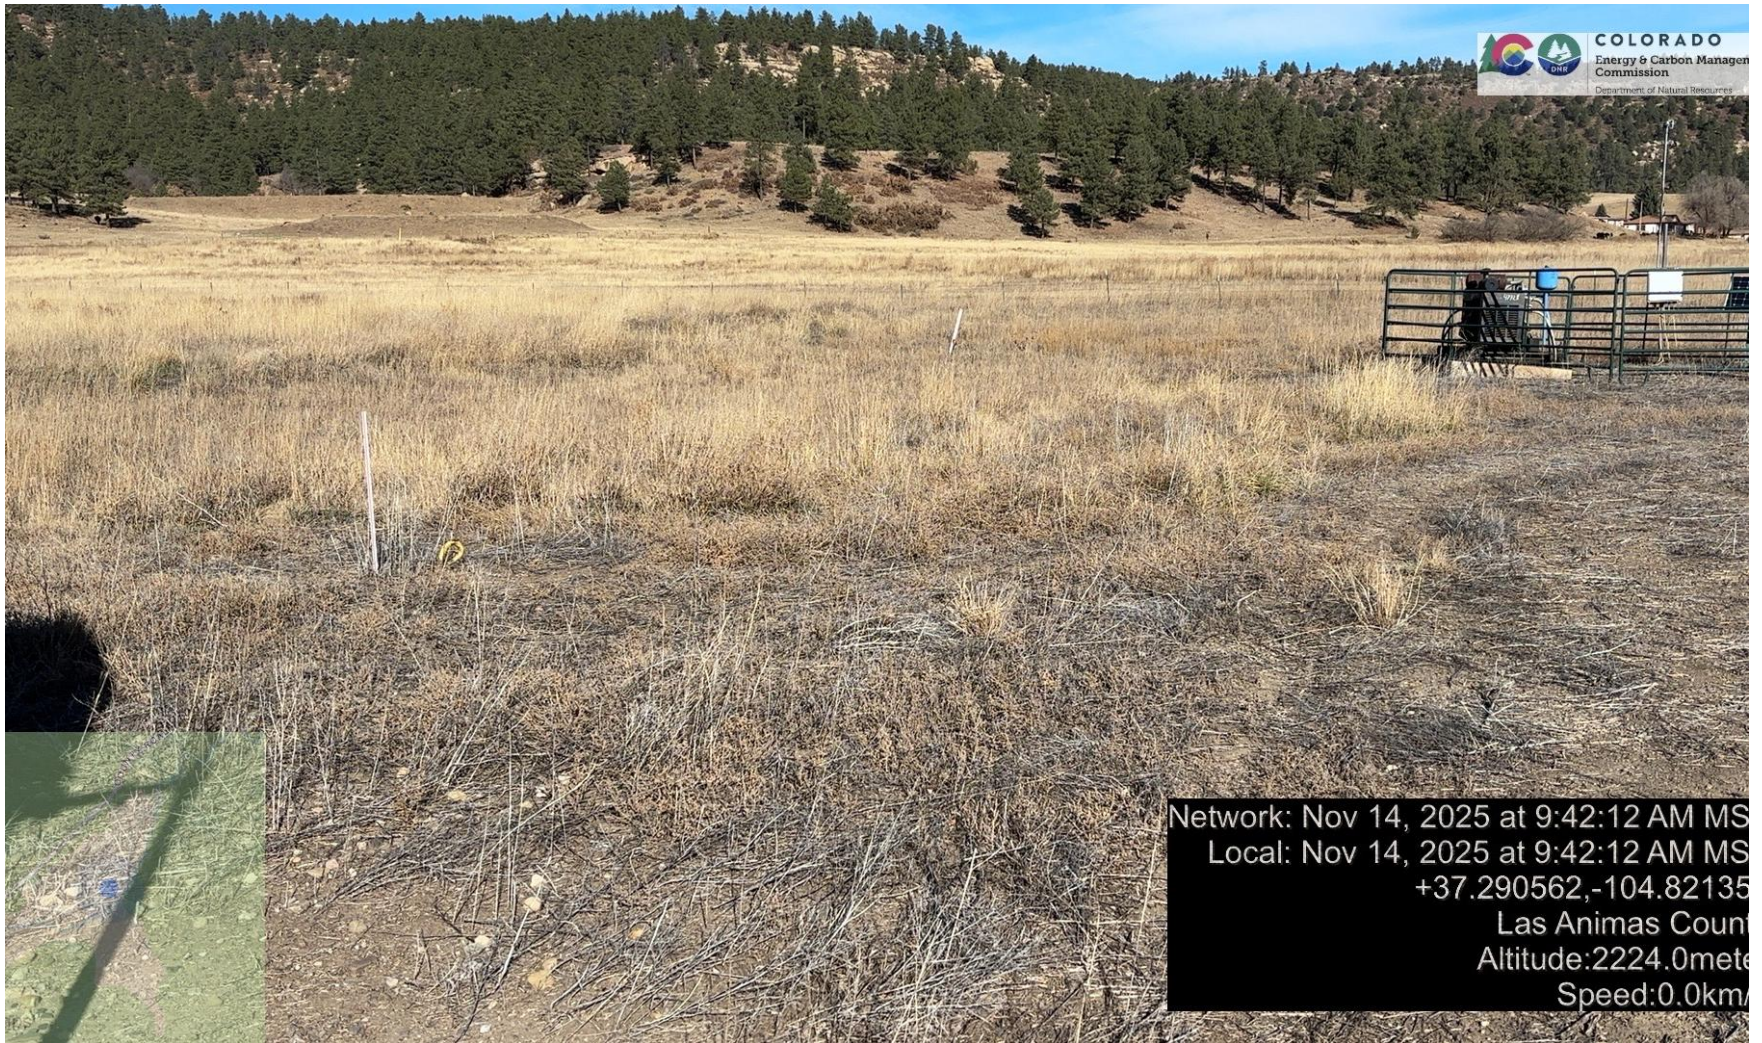
**PHOTO 3: WEEDS OVERGROWN AROUND LOCATION. WEEDS INSIDE ANCHORS NEED TO BE MAINTAINED PER RULE 506. THIS IS THE 2ND NOTICE FOR THIS CA, IMMEDIATE ACTION IS REQUIRED.**

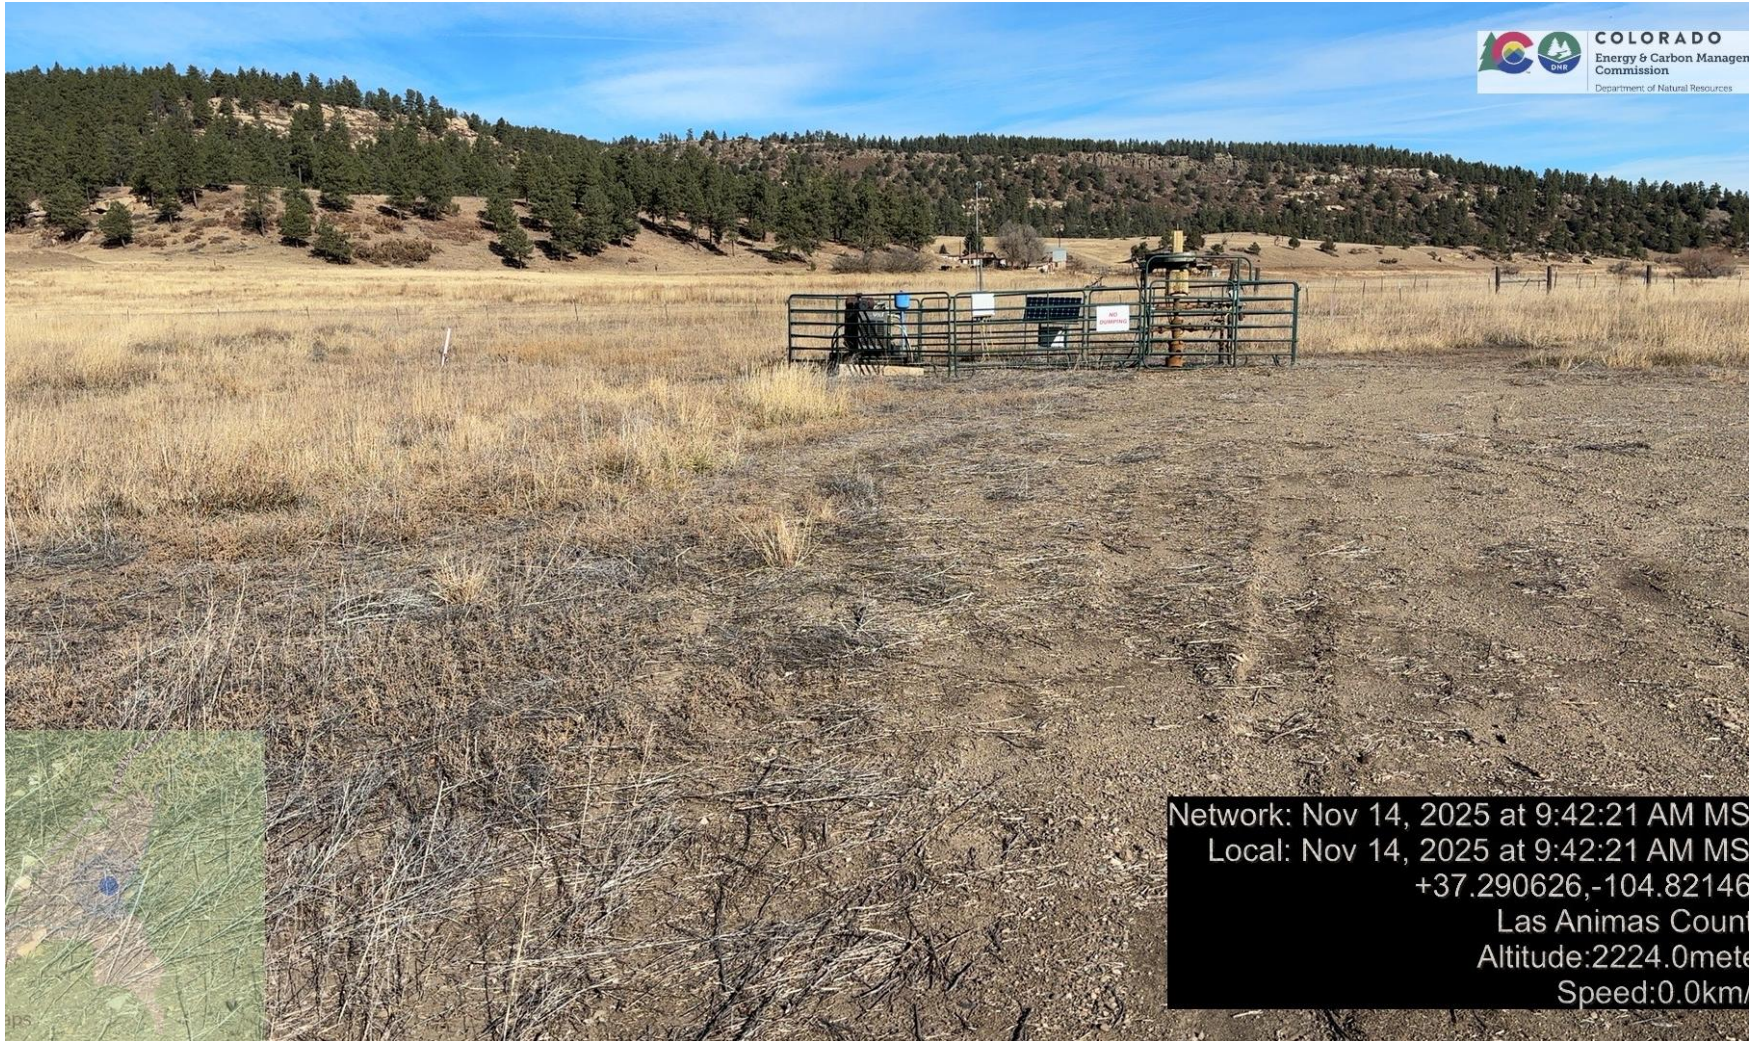
**PHOTO 4: DEAD WEEDS AROUND LOCATION ARE A FIRE HAZARD. CUT AND REMOVE DEAD WEEDS PER RULE 606. THIS IS THE 2ND NOTICE FOR THIS CA, IMMEDIATE ACTION IS REQUIRED.**

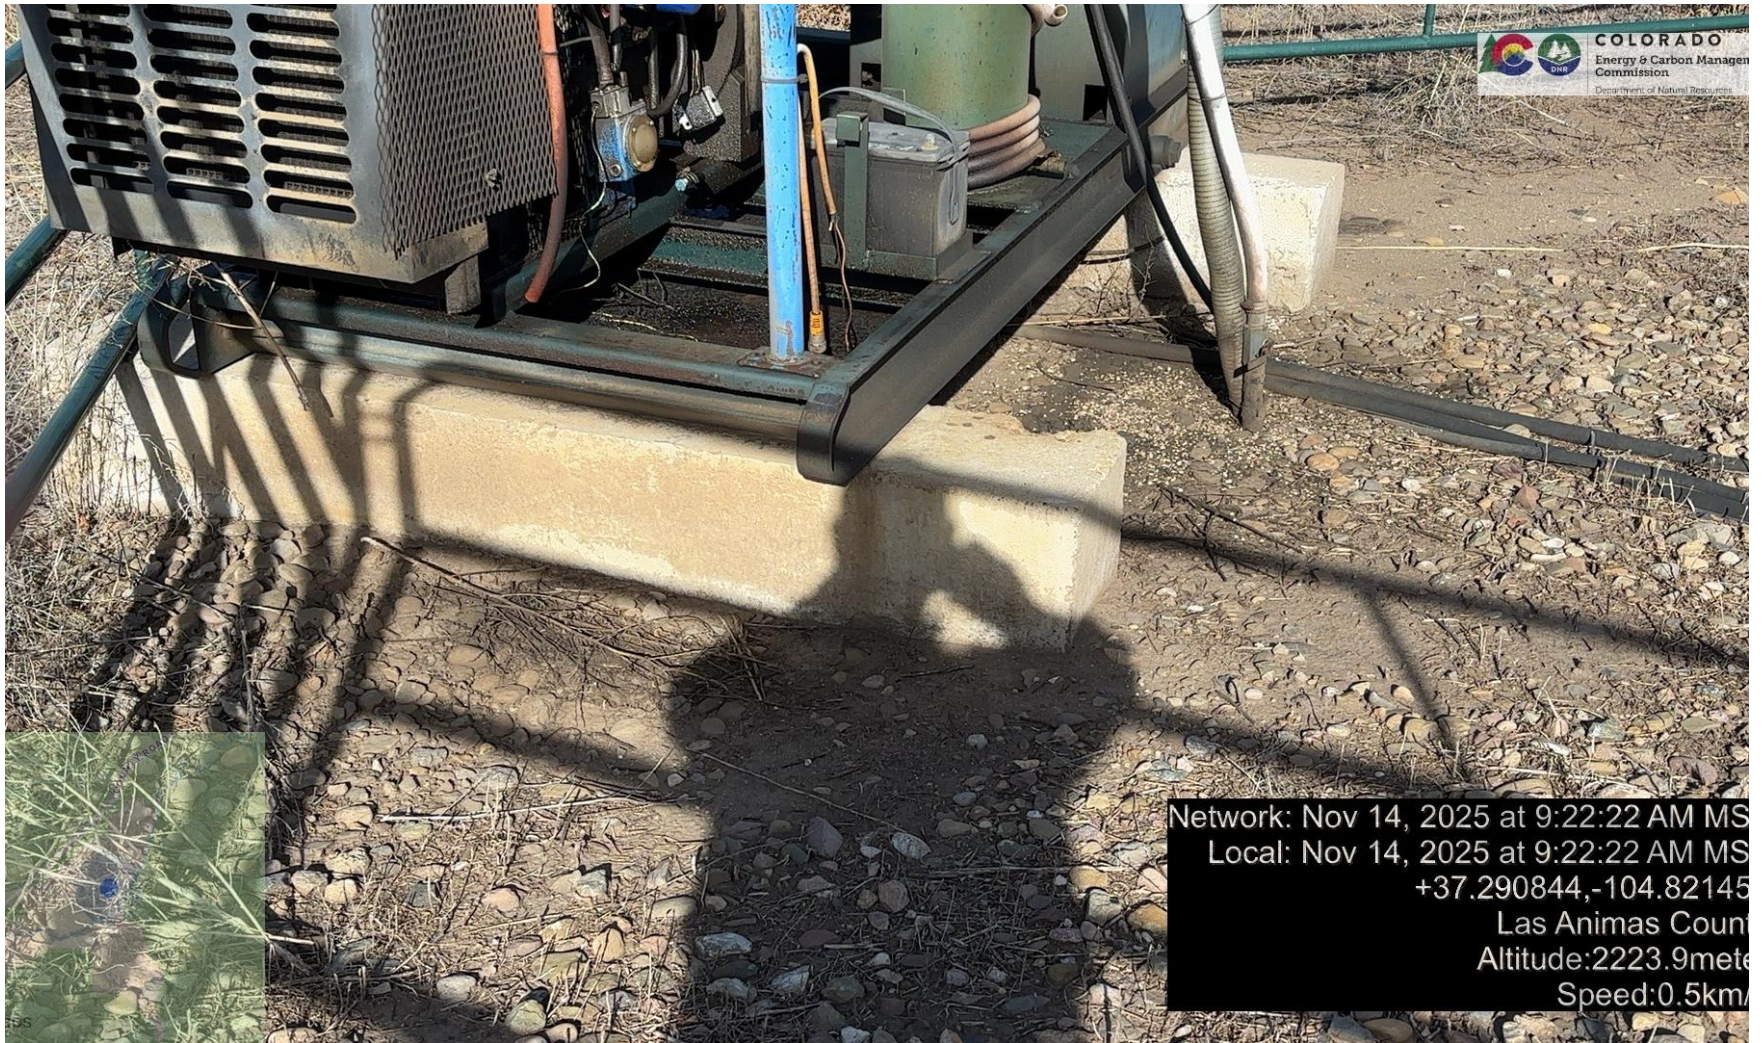
**PHOTO 5: THERE IS AN AREA OF IMPACED SOILS AROUND THE PRIME MOVER ENGINE SKID. Conduct maintenance on equipment, cleanup stained material and review self inspection processes. COMPLY WITH RULE 1002., (2).D. THIS IS THE 2ND NOTICE FOR THIS CA, IMMEDIATE ACTION IS REQUIRED.**

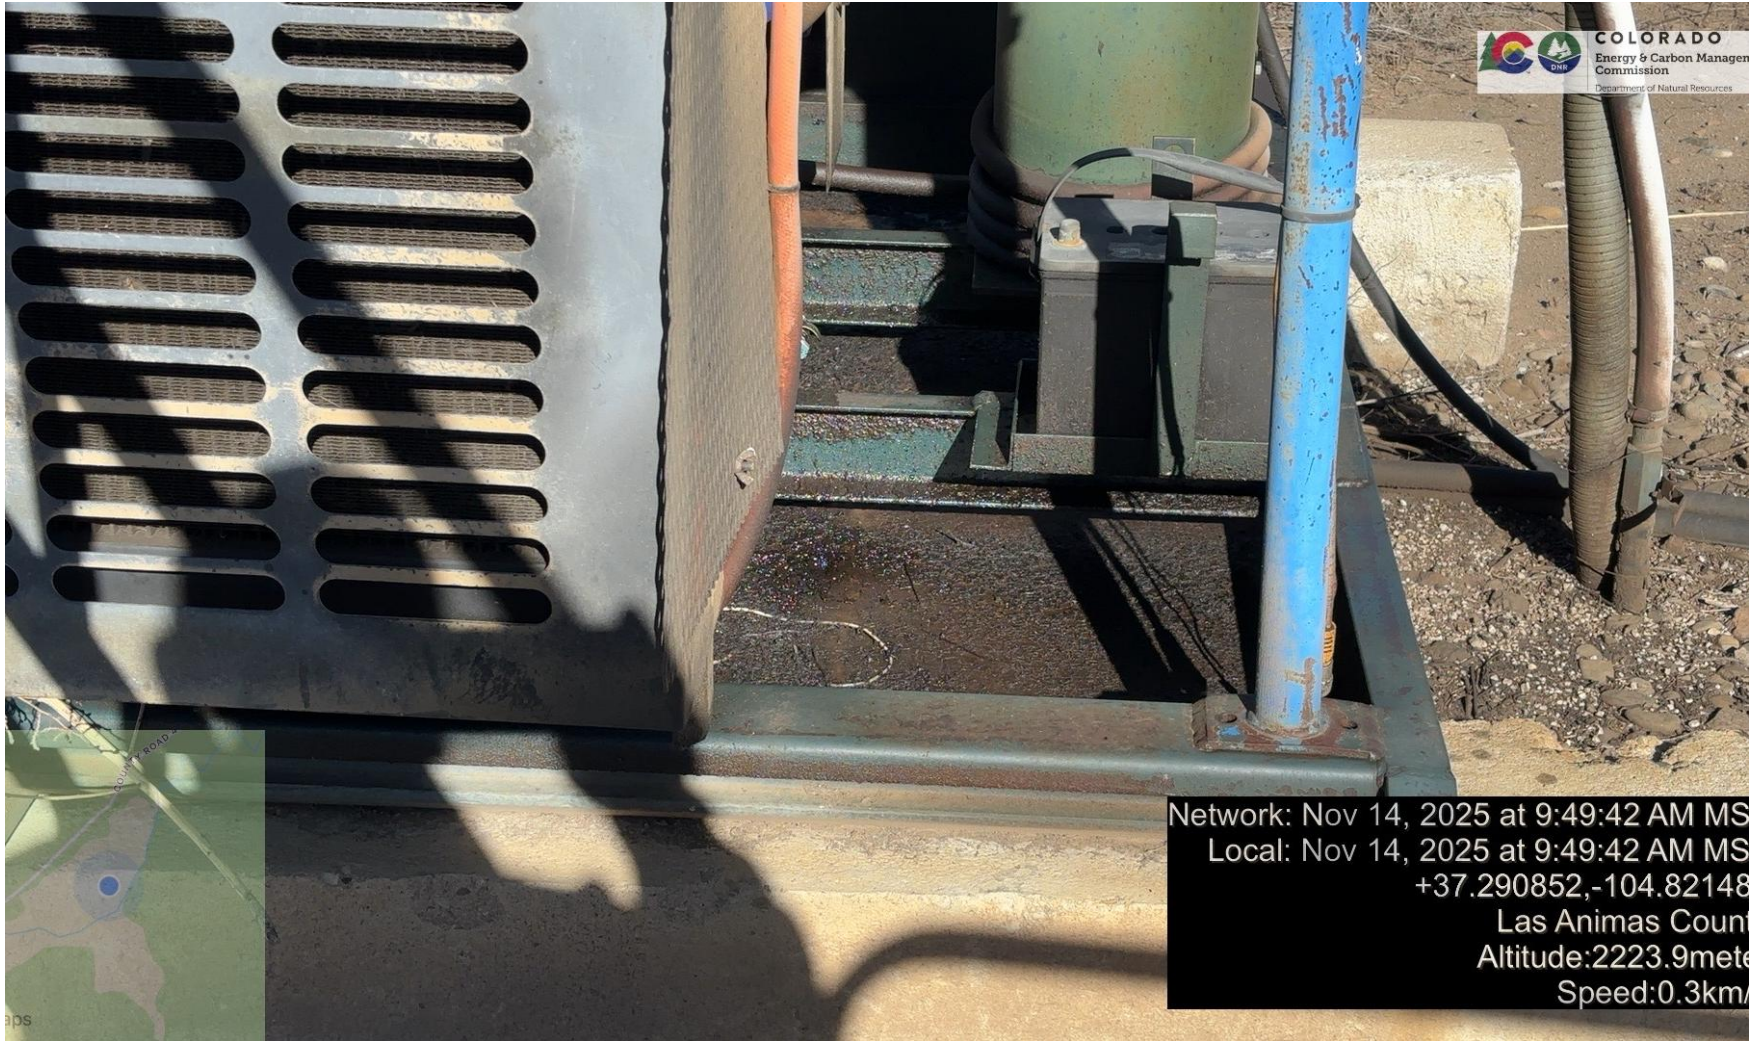
**PHOTO 6: THE CA FOR OILY WASTE IN PRIME MOVER ENGINE SKID HAS BEEN ADDRESSED HOWEVER THESE ENGINE SKIDS SHOULD BE CLEANED AND MAINTAINED IN BETER CONDITIONS TO PREVENT STORMWATER FROM MIXING WITH OILY WASTE AND CAUSING RULE VIOLATIONS AFTER EVERY STORM EVENT.**

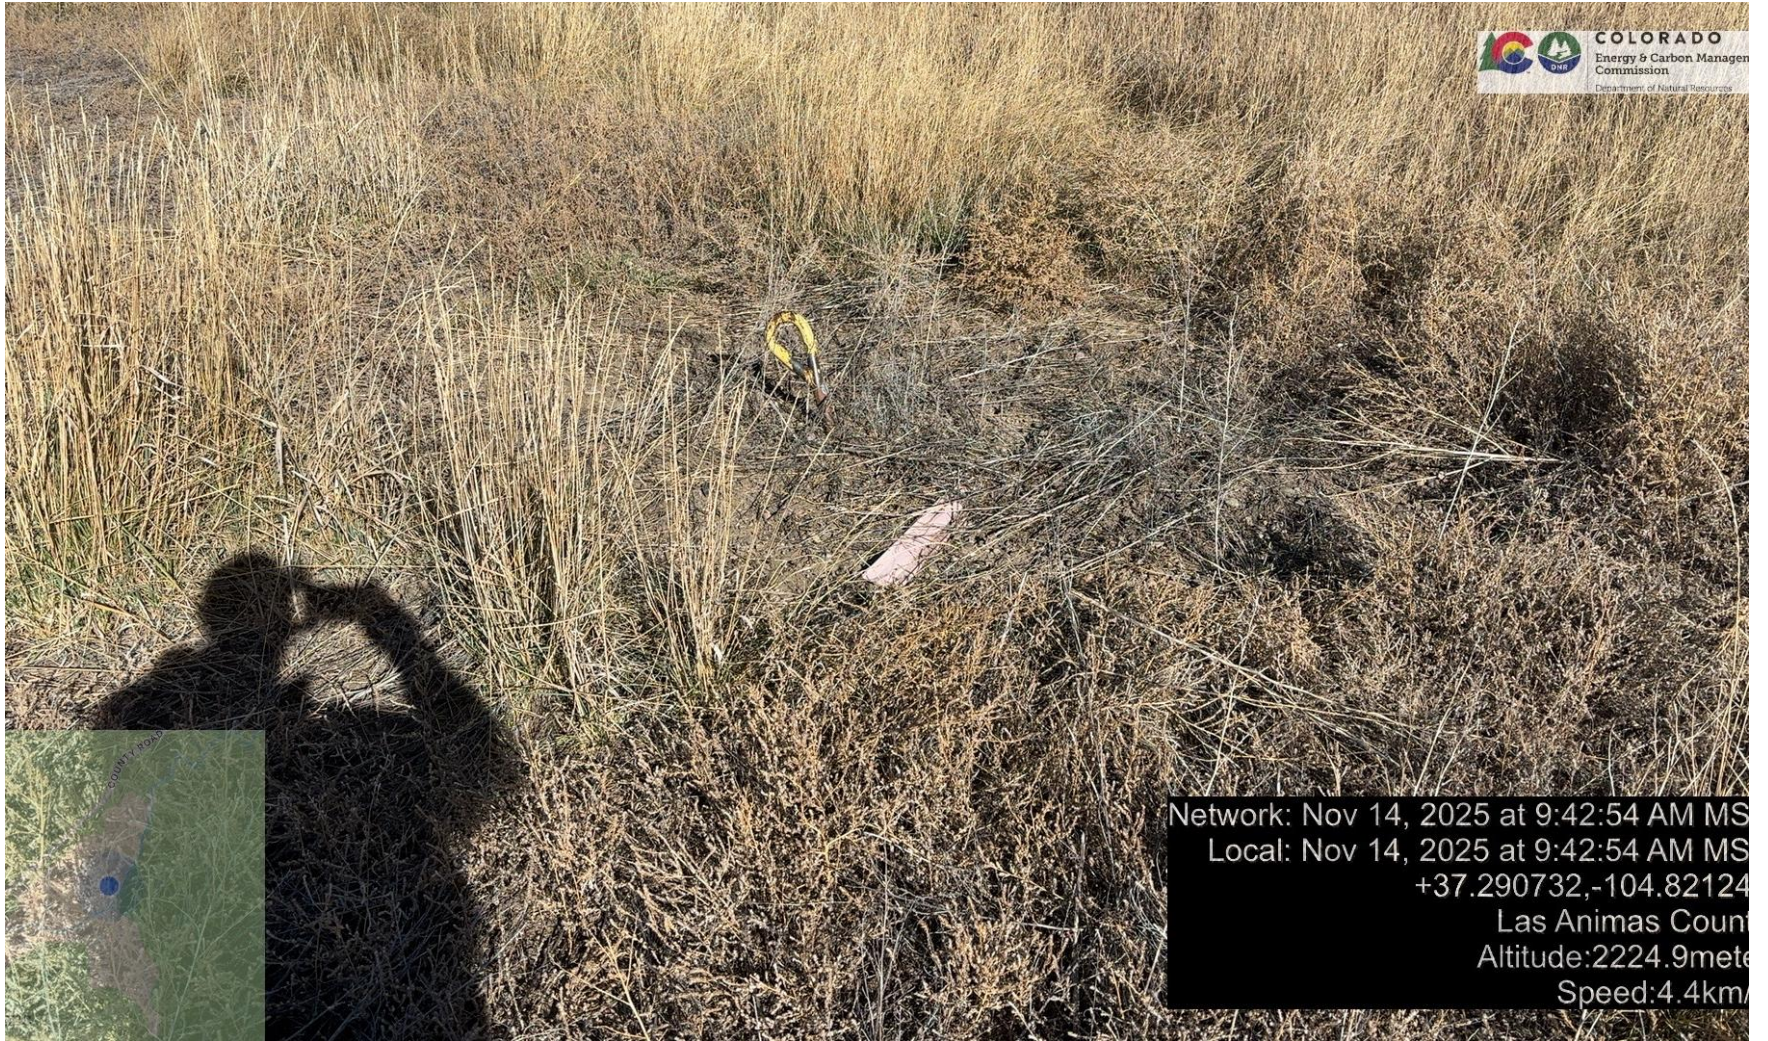
**PHOTO 7: ANCHOR MARKER IS DOWN ON THE NORTHEAST ANCHOR FROM WELLHEAD. Install proper guy line markers per Rule 1003.a. THIS IS THE 2ND NOTICE FOR THIS CA, IMMEDIATE ACTION IS REQUIRED.**
