Inspection Photos

Operator: Chevron USA Inc #16700

Location ID: 314514

Inspection Doc: 719200445

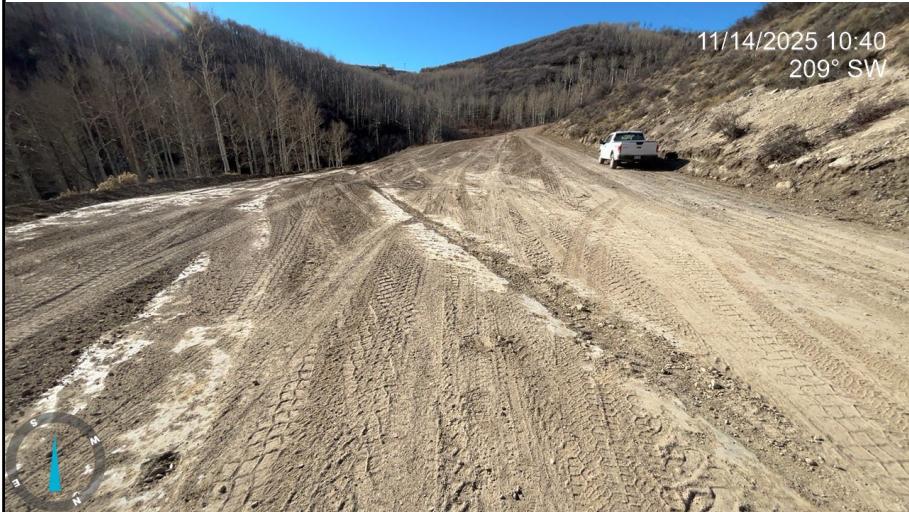
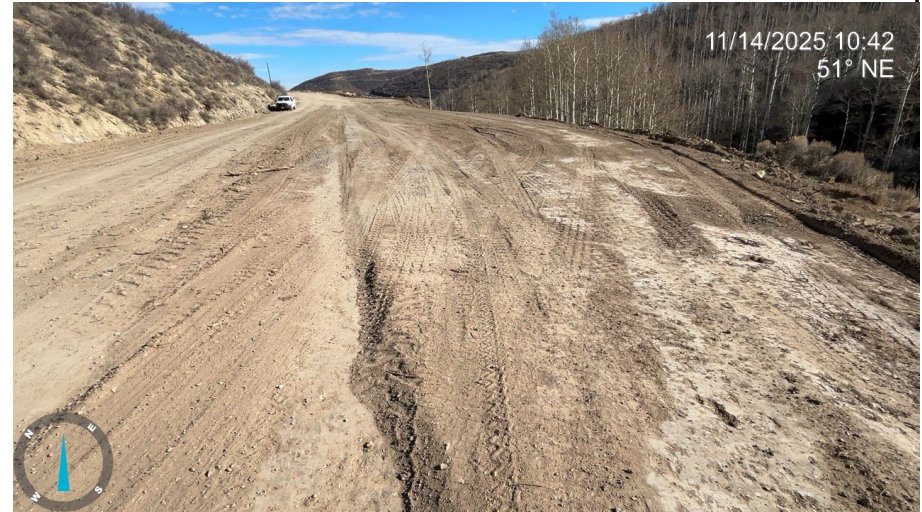
Photo 1: Photos showing an overview of the location looking southwest and northeast, respectively. 1004 reclamation efforts are not evident; the access road has been widened.

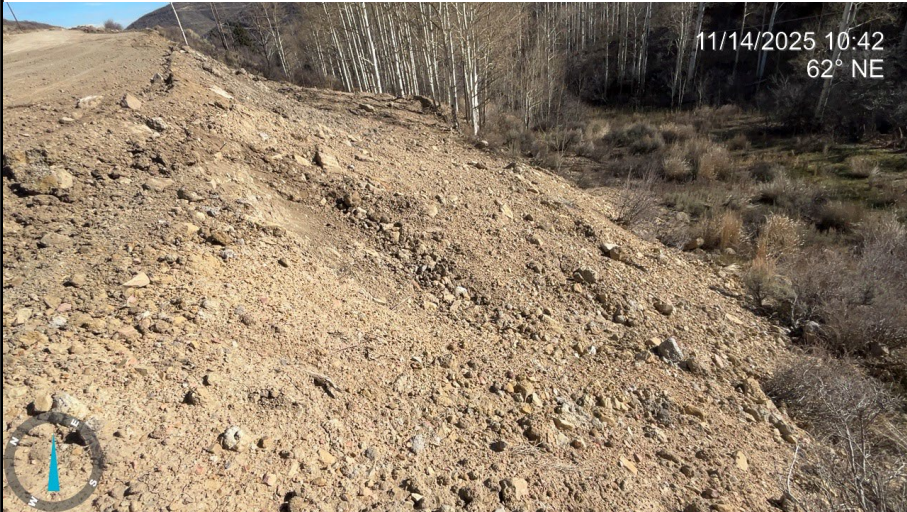
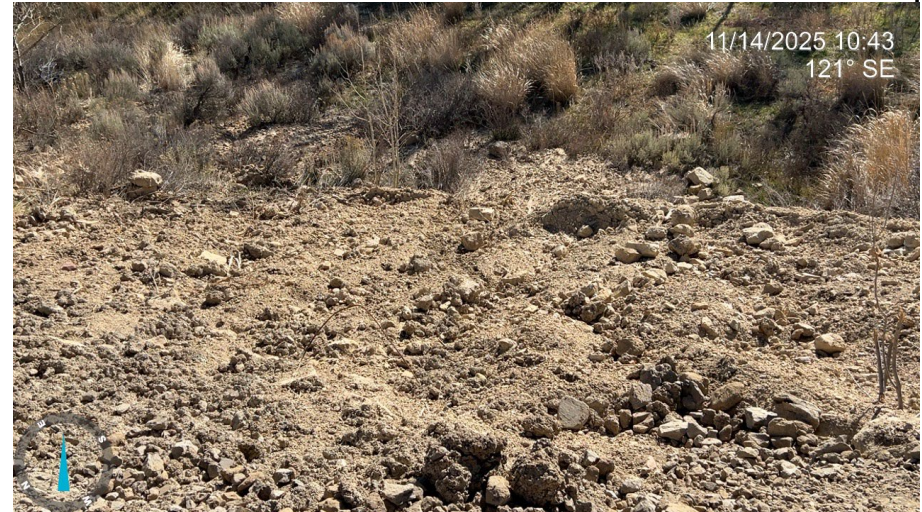
Photo 2: Photos showing examples of cut/fill slopes at the location. Stormwater BMPs appear to be missing or insufficient; comply with 1002.f. and implement or maintain stormwater BMPs.

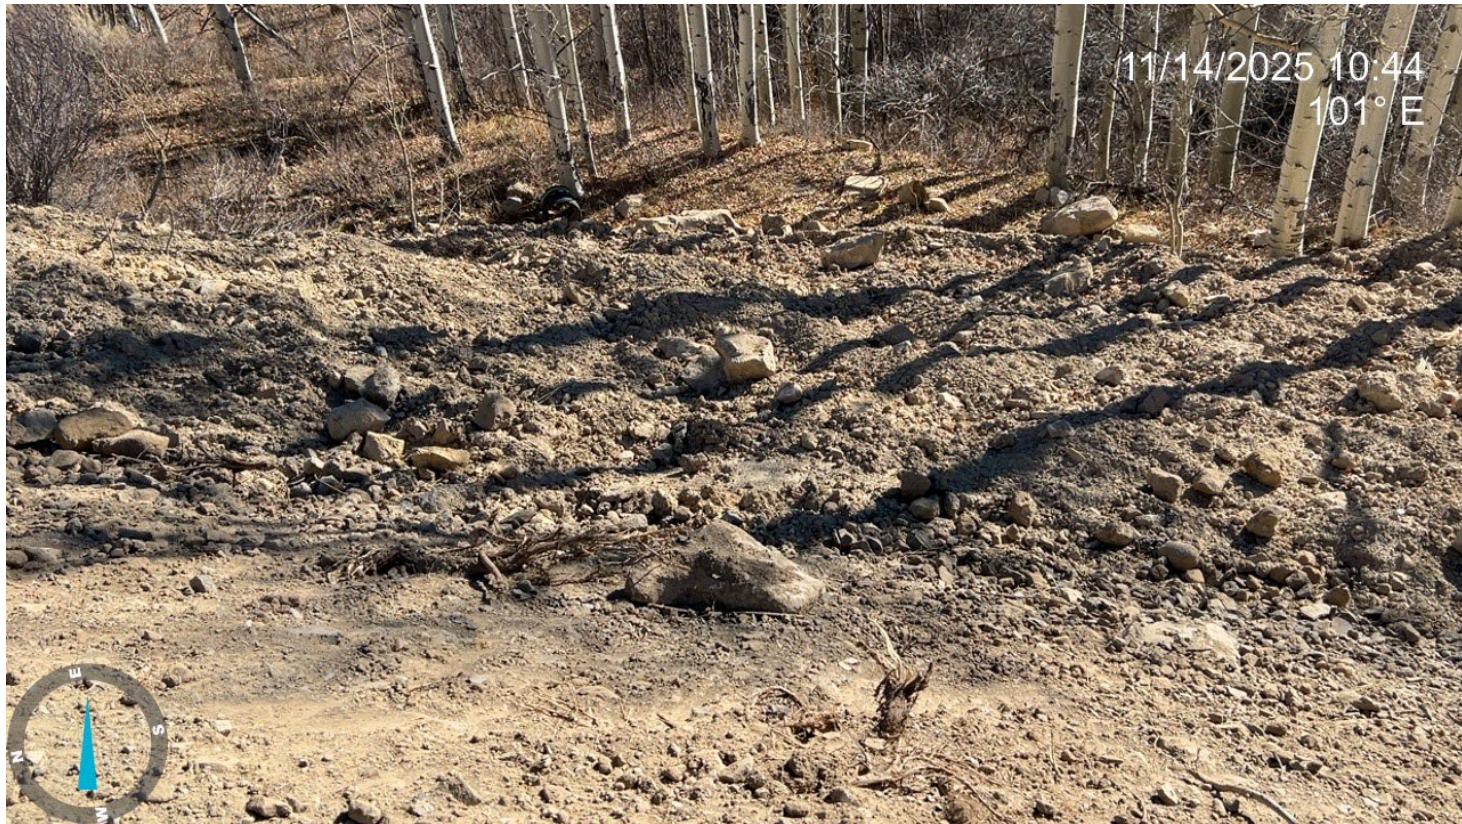
Photo 3: Photos showing examples of the toe of cut/fill slopes at the location. Stormwater BMPs appear to be missing or insufficient; comply with 1002.f. and implement or maintain stormwater BMPs.
