Final Reclamation Inspection

Operator: NOBLE ENERGY INC - 100322

Location ID: 331976

Inspection Document #: 718800967

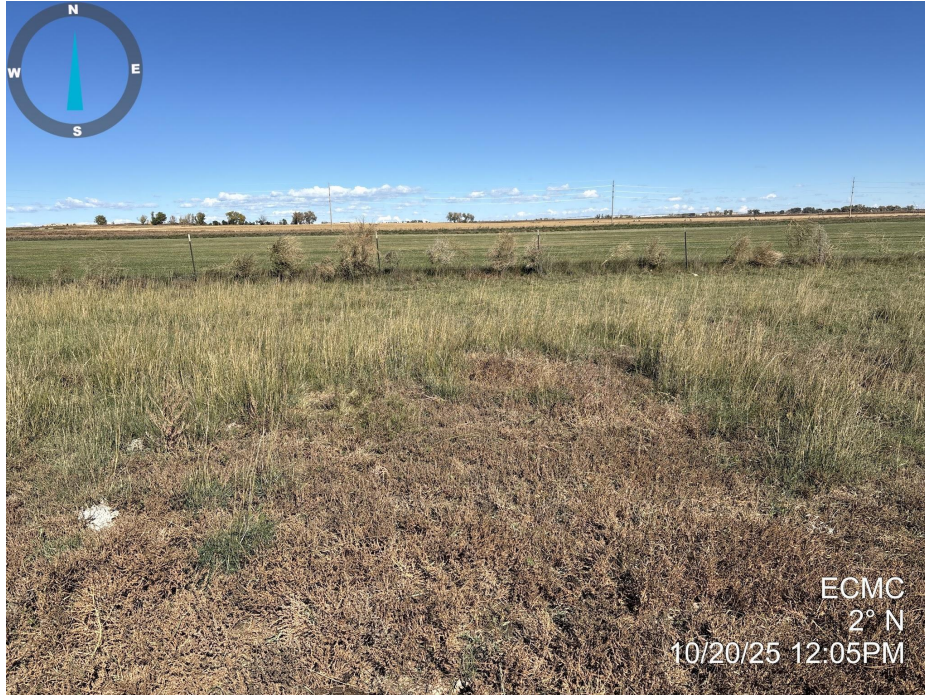
Photo 1. Photo taken of the well location, facing north. Photo illustrates that final reclamation activities have taken place. However, vegetation has not established to Rule 1004 standards at the location as weedy annual vegetation including kochia (*Bassia scoparia*) was observed across the location.

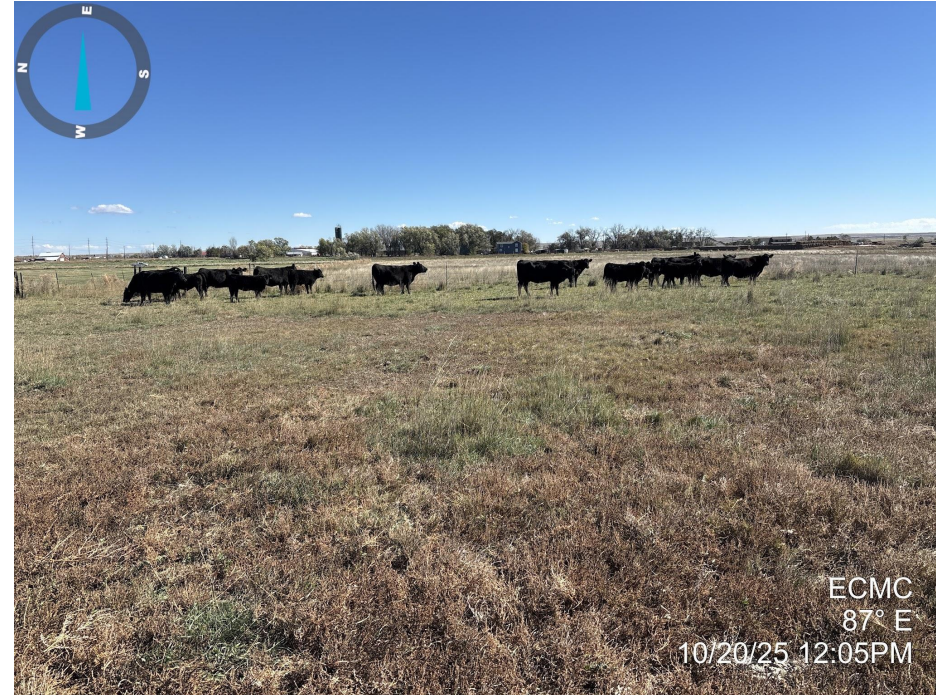
Photo 2. Photo taken of the well location, facing east. See comments under Photo 1.

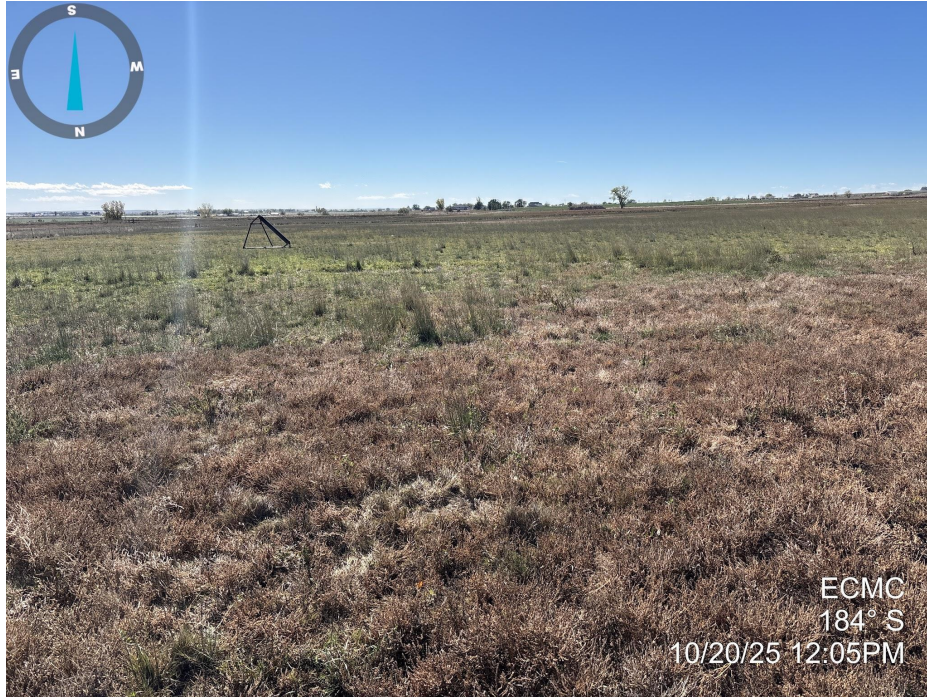
Photo 3. Photo taken of the well location, facing south. See comments under Photo 1.

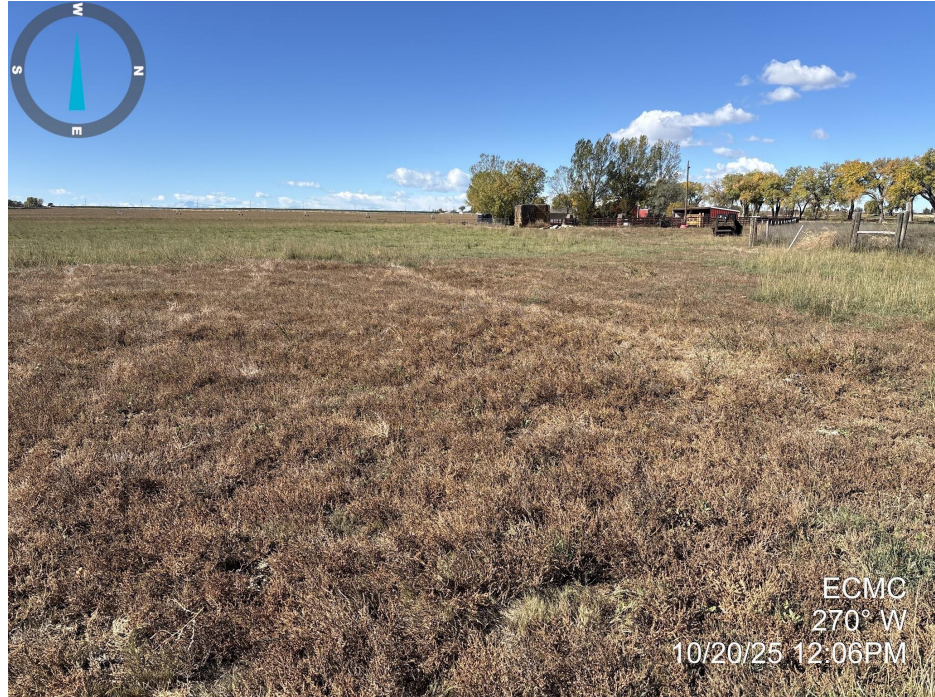
Photo 4. Photo taken of the well location, facing west. See comments under Photo 1.

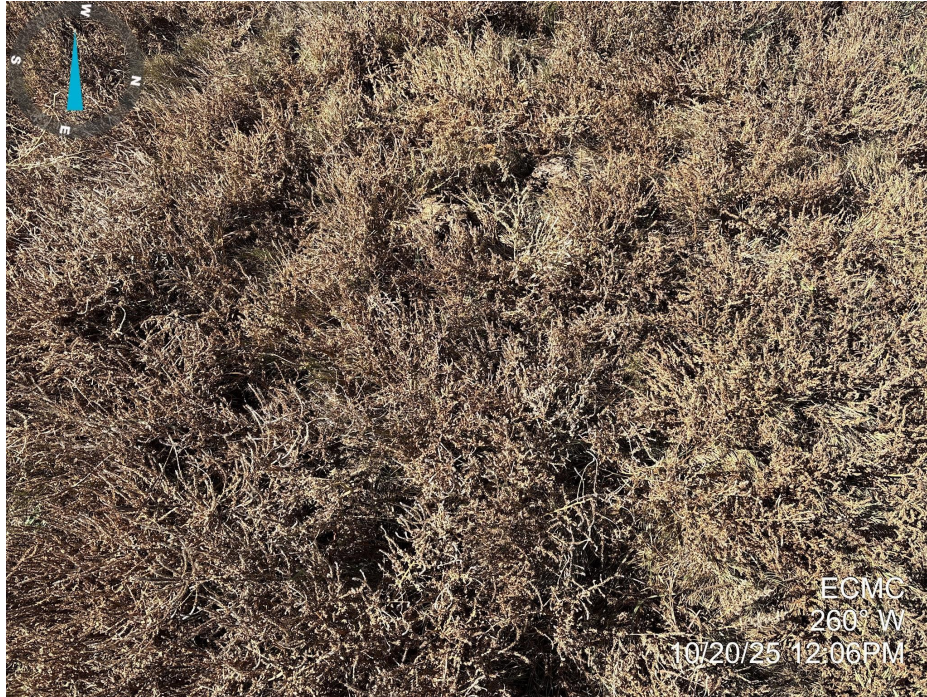
Photo 5. Photo taken of ground cover at the well location. Photo illustrates weedy annual vegetation including kochia (*Bassia scoparia*).

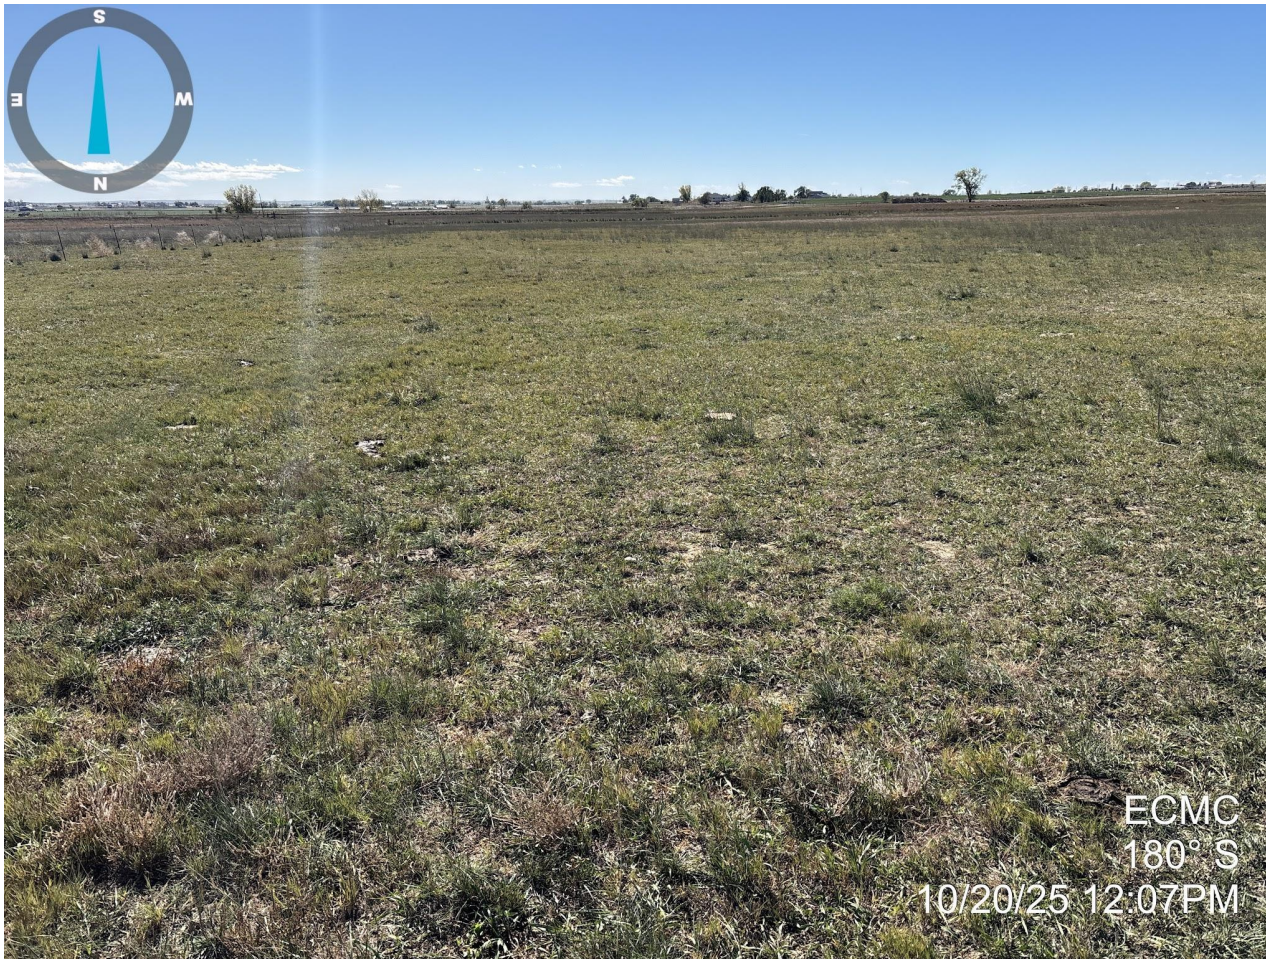
Photo 7. Photo taken of the reference area to the location, south of the location, facing south. Photo illustrates perennial grass vegetation that has been grazed.
