# Inspection Photos

Operator: Chevron USA Inc #16700

Location ID: 314520

Inspection Doc: 719200449

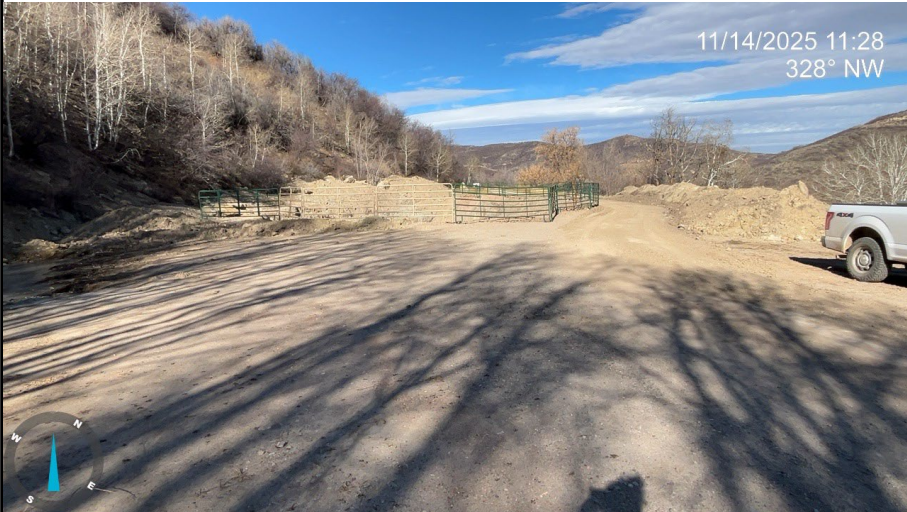
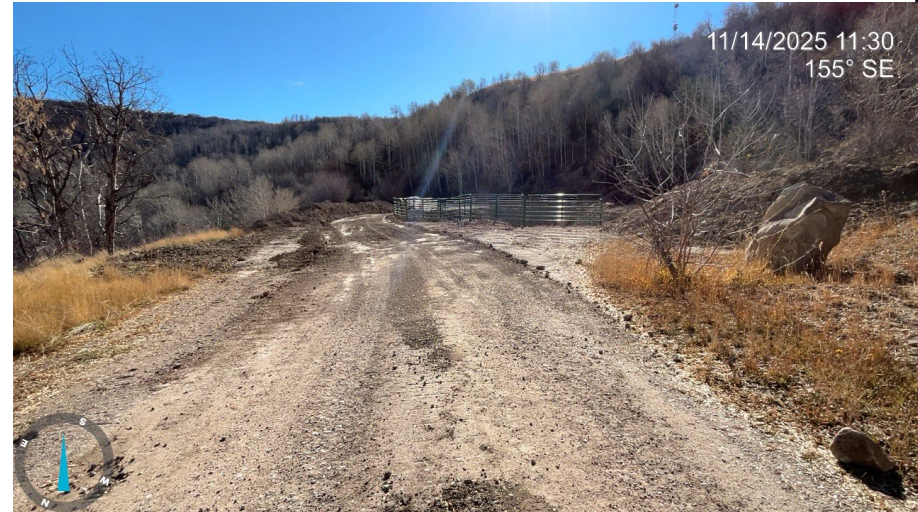
**Photo 1:** Photos showing an overview of the location looking northwest and southeast, respectively. The location is an open excavation and an ongoing remediation project is occurring. It is recommended that the excavation is fully fenced to prevent access.

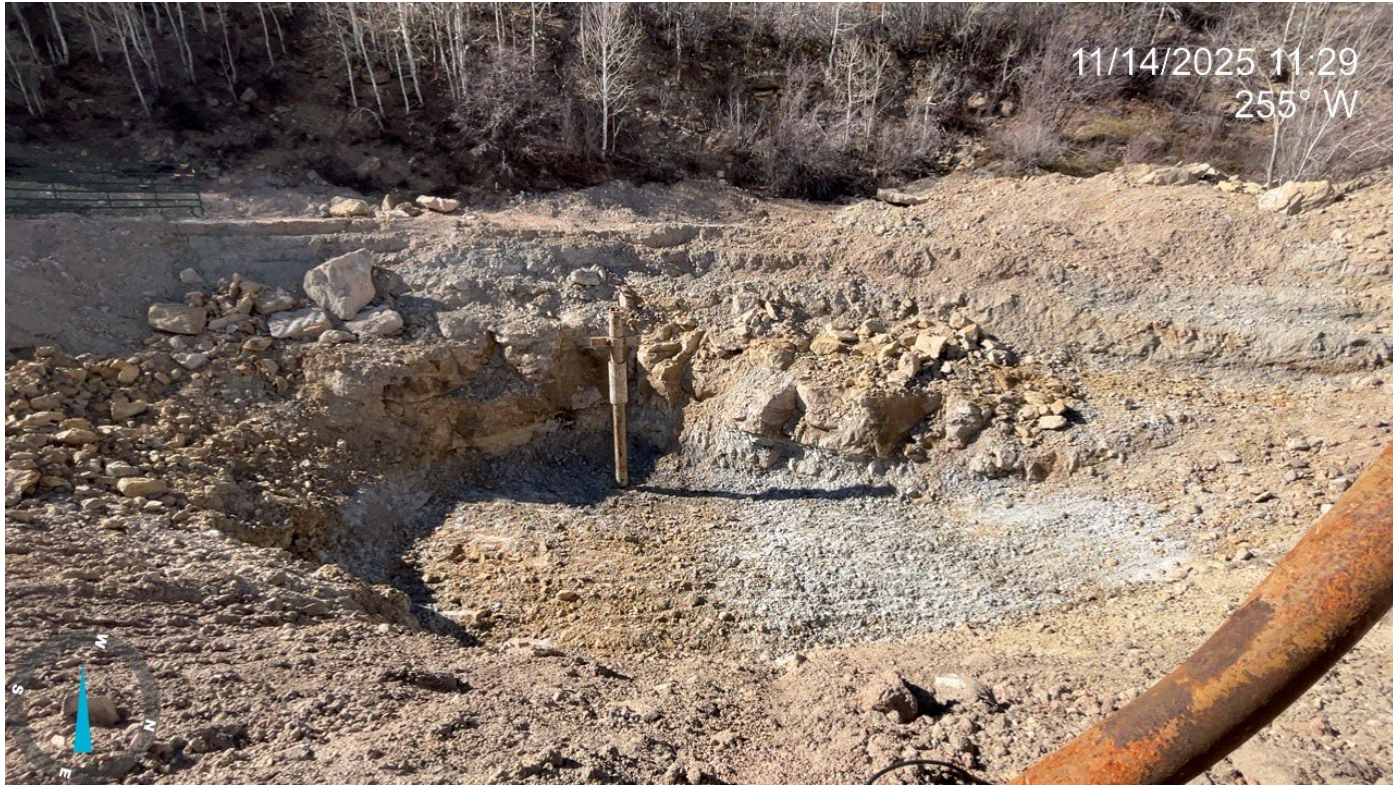
**Photo 2:** Photo showing plugged and abandoned well #05-103-05902.

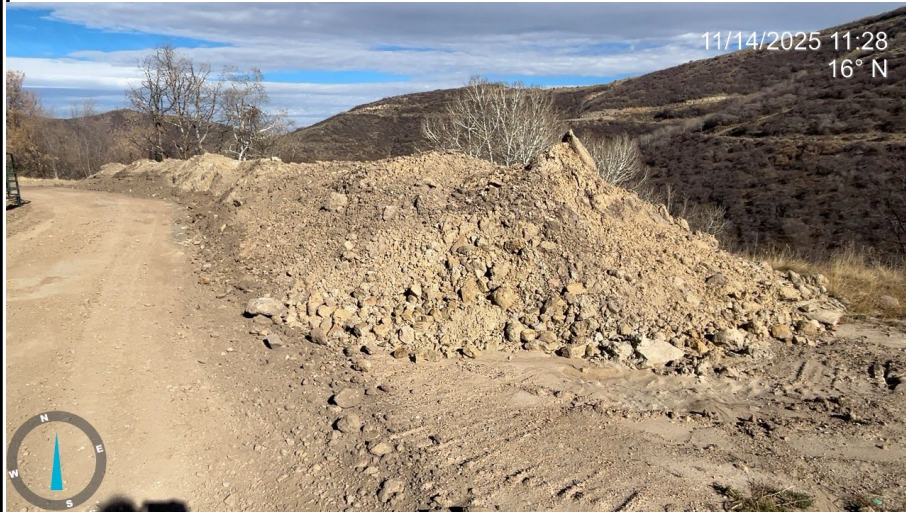
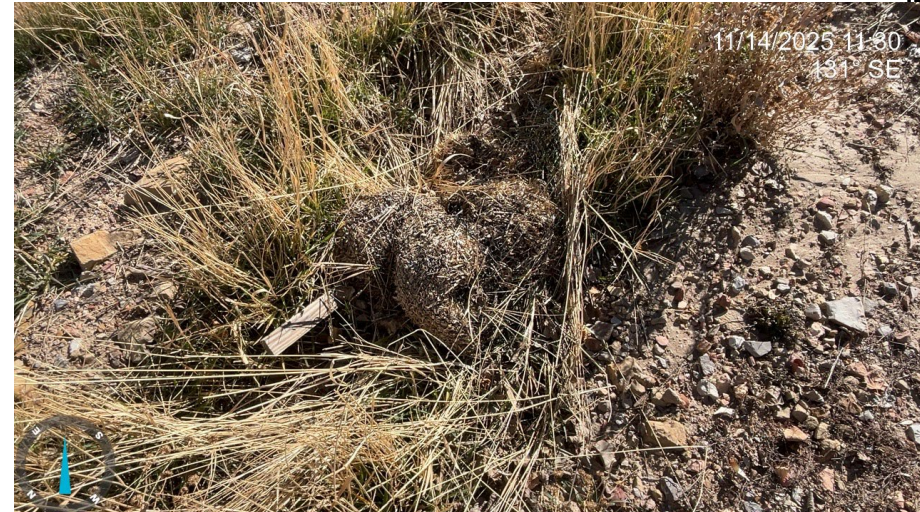
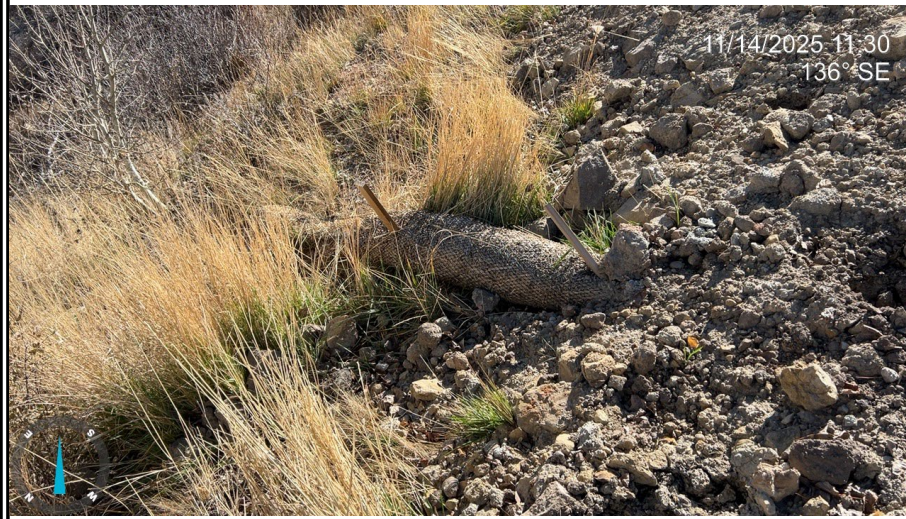
**Photo 3:** Photo upper left showing the topsoil pile on the eastern end of the location. Photos lower left and upper right show examples of straw wattles on the east side of the topsoil pile are in disrepair; comply with 1002.f. and maintain stormwater BMPs.

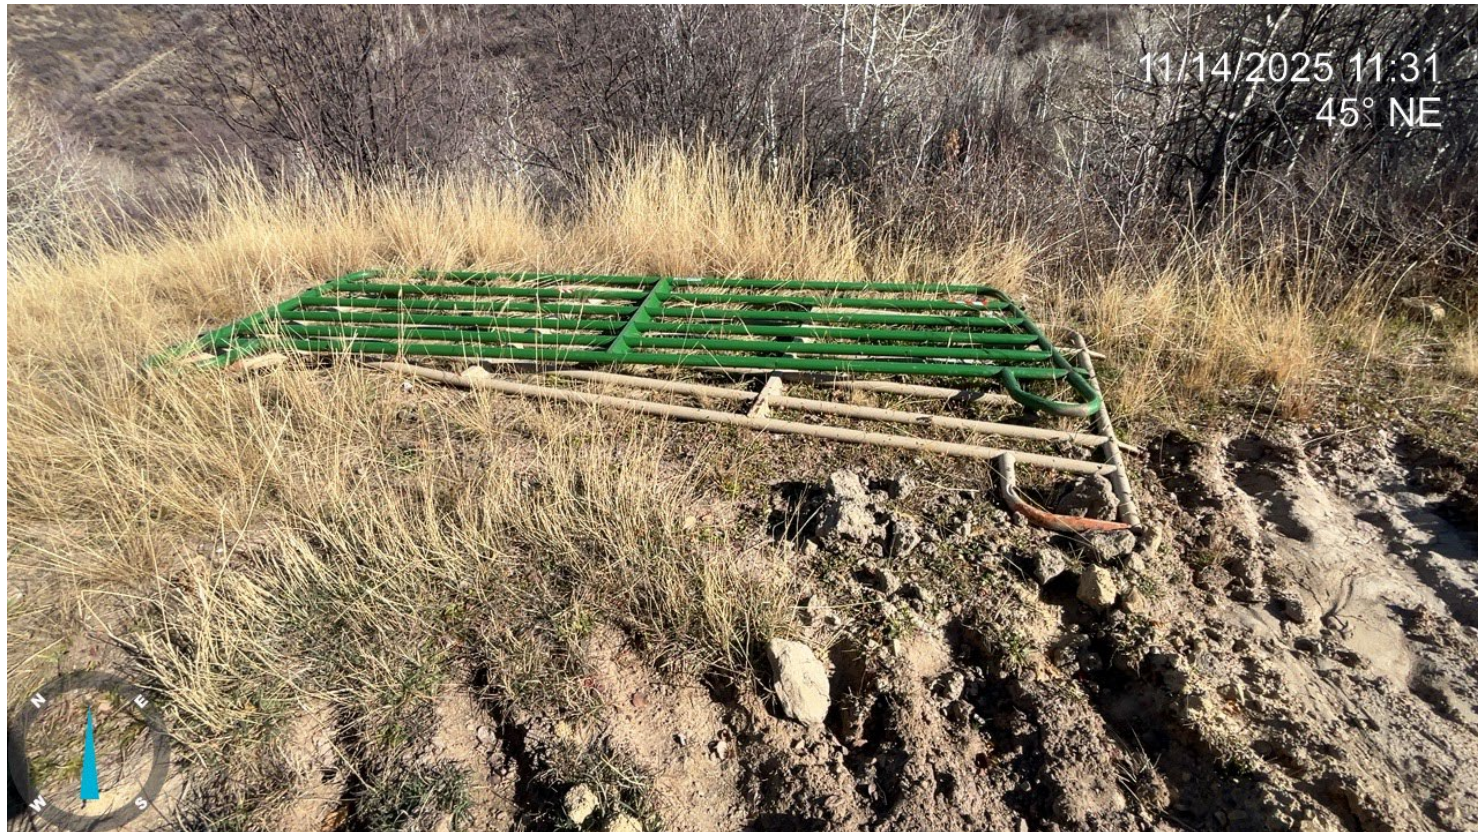
**Photo 4:** Photo showing fencing panels that do not appear to be in use at the southern end of the location. Comply with 606.a. and remove unused equipment.
