# Inspection Photos

Operator: Chevron USA Inc #16700

Location ID: 314521

Inspection Doc: 719200452

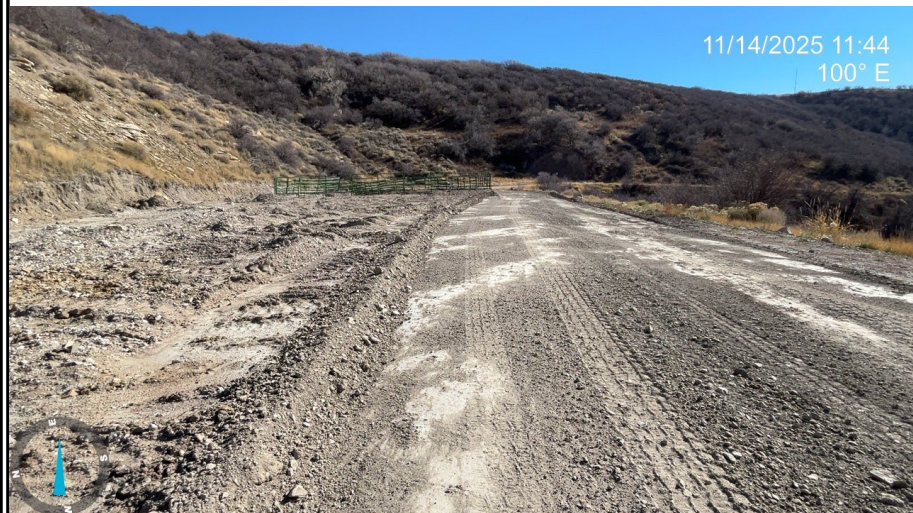
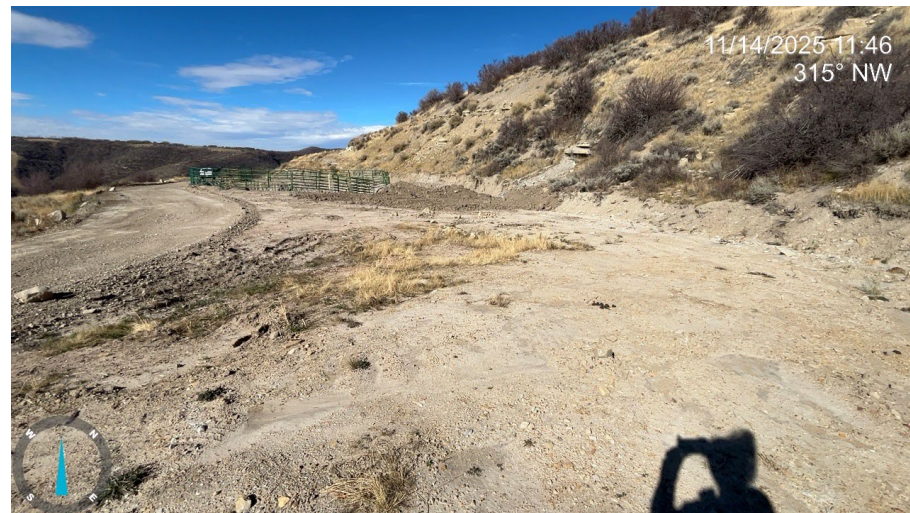
**Photo 1:** Photos showing an overview of the location looking east and northwest, respectively. The location is an open excavation and an ongoing remediation project is occurring.

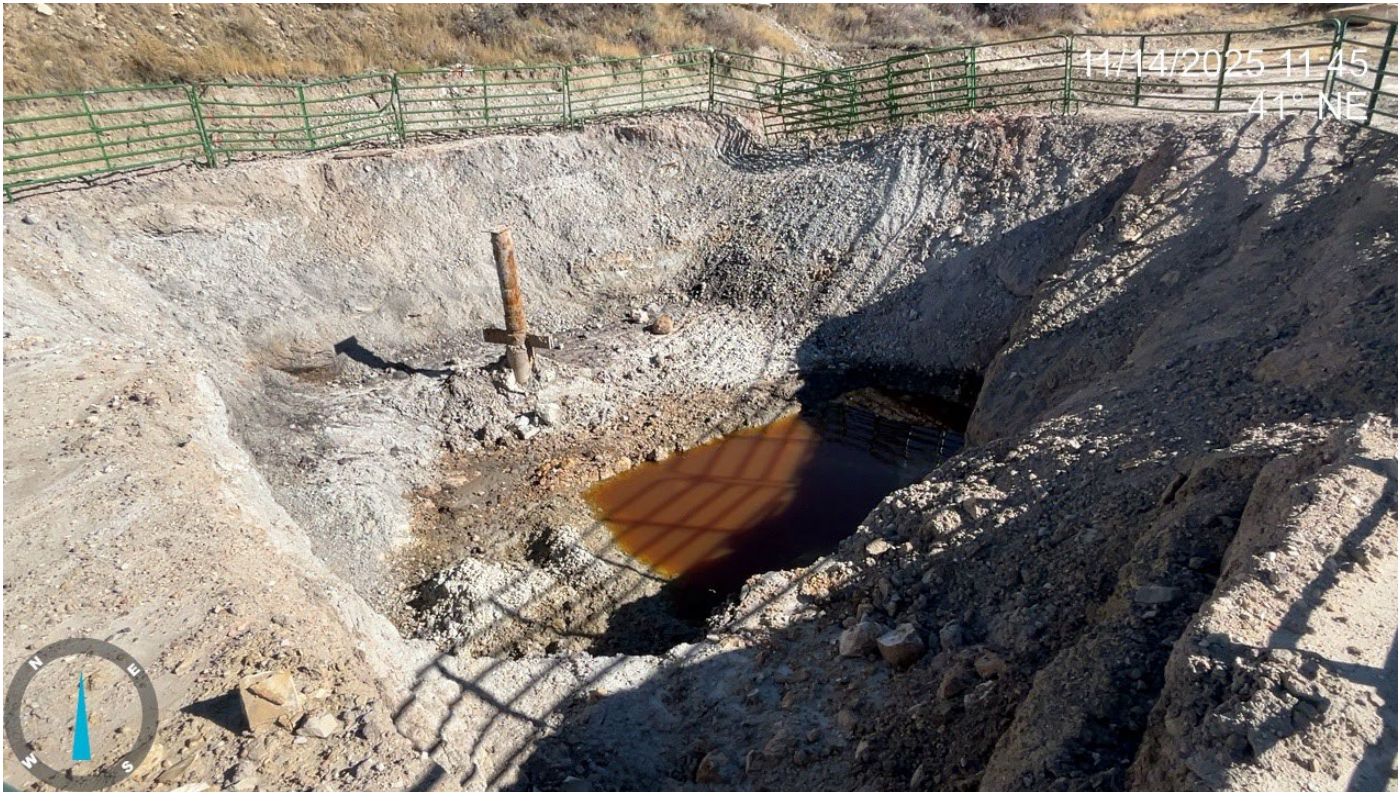
**Photo 2:** Photo showing the fenced and open excavation at the location.

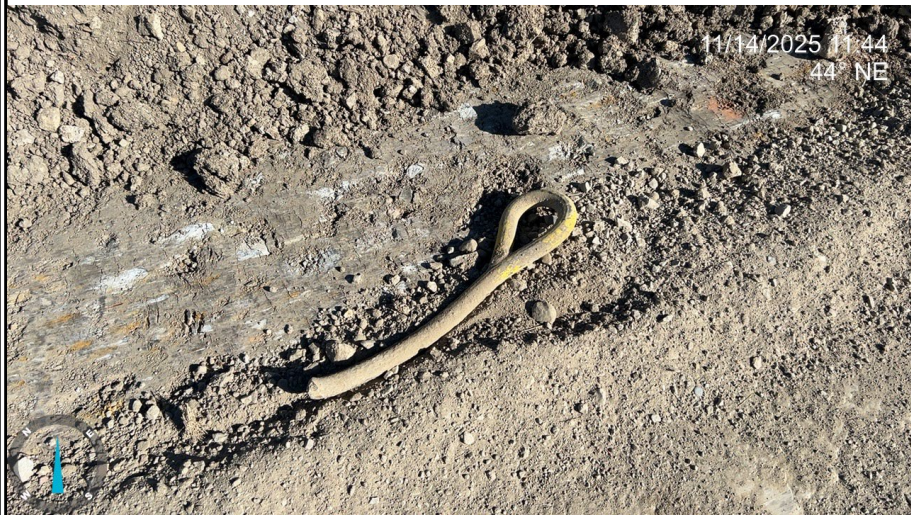
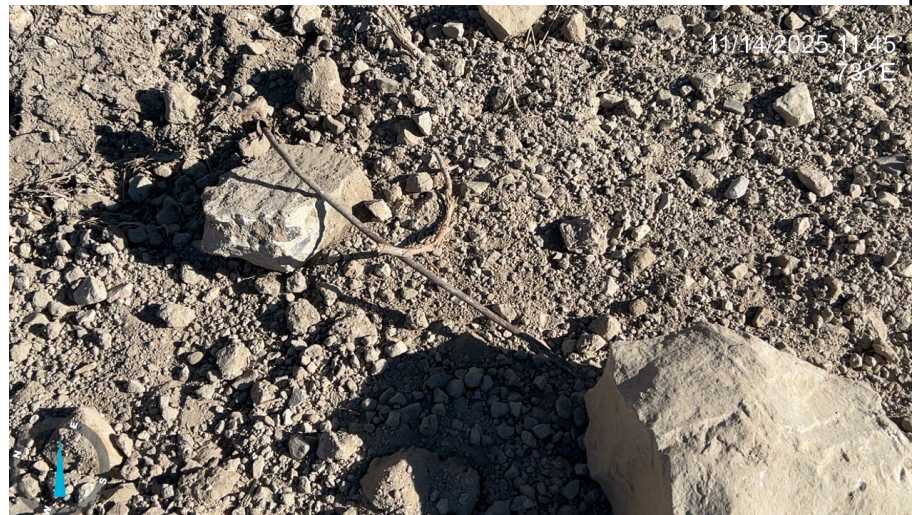
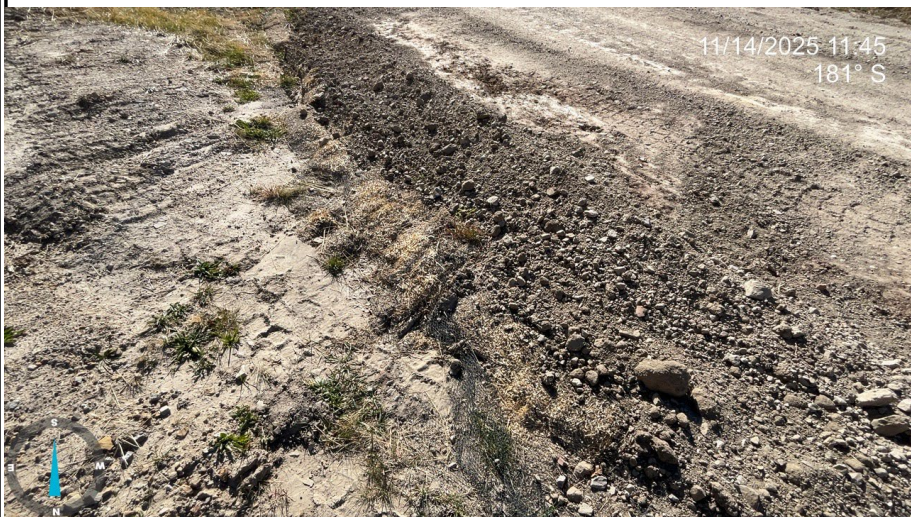
**Photo 3:** Photos showing debris and trash that is scattered throughout the location and requires removal pursuant to Rule 606.d.

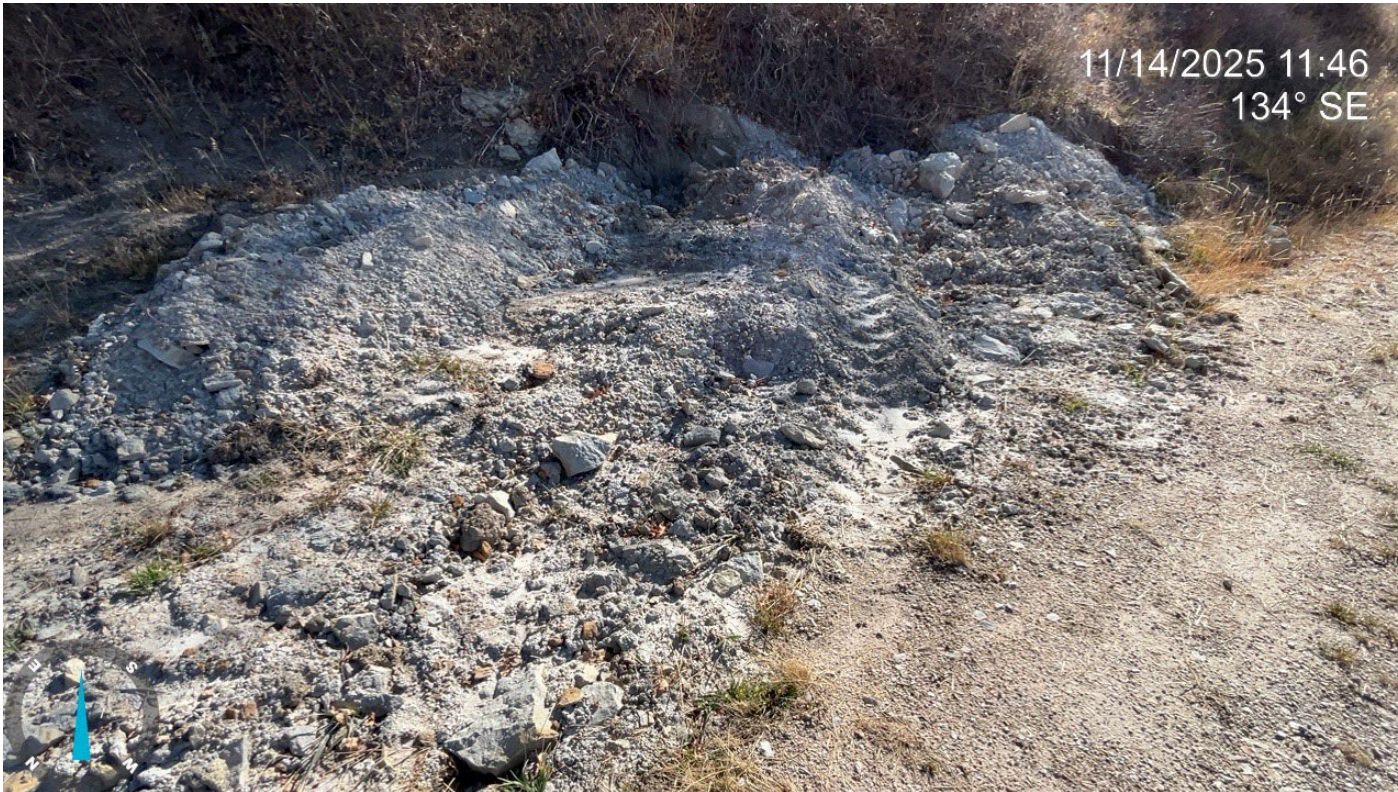
**Photo 4:** Photo showing an unknown grey-colored material is present at the southeast end of the location at the edge of the access road. Removal is required.
