Inspection Photos

Operator: Chevron USA Inc #16700

Location ID: 397075

Inspection Doc: 719200461

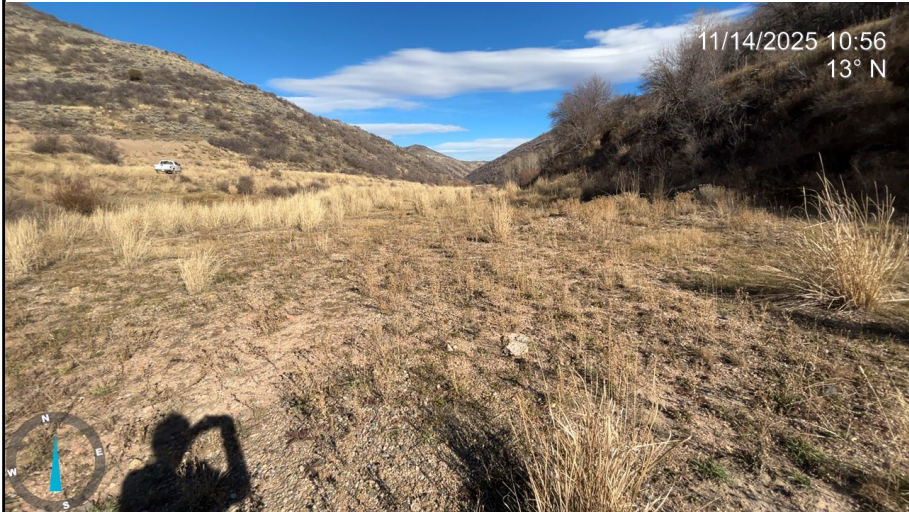
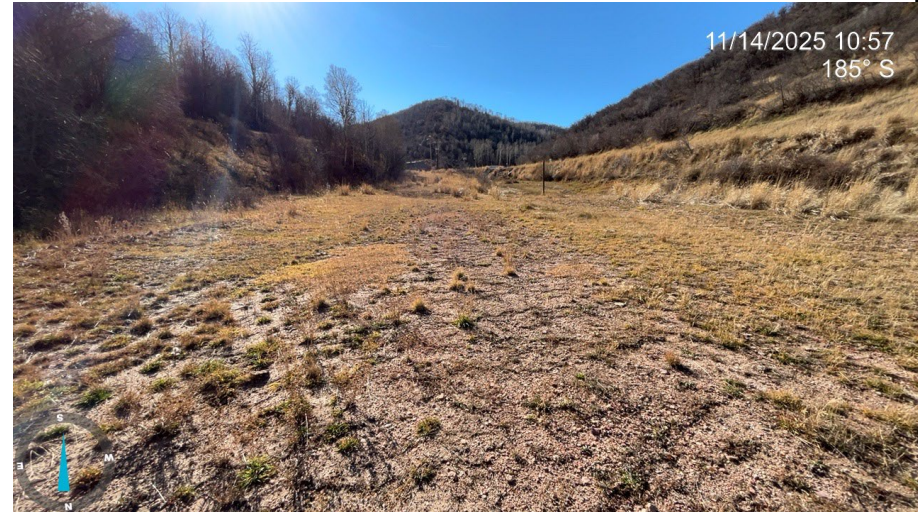
Photo 1: Photos showing an overview of the location looking north and south, respectively. Gravel and compaction is evident throughout the location. The location has not been reclaimed pursuant to 1004 reclamation requirements.

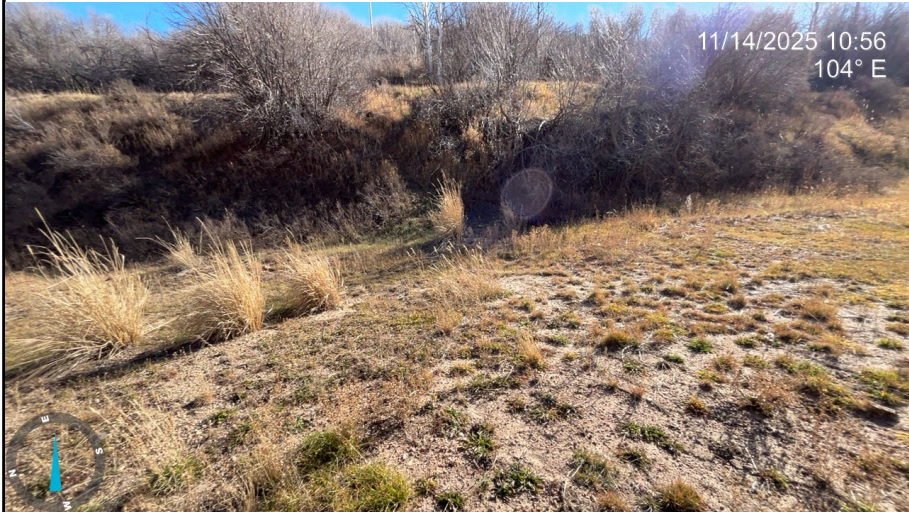
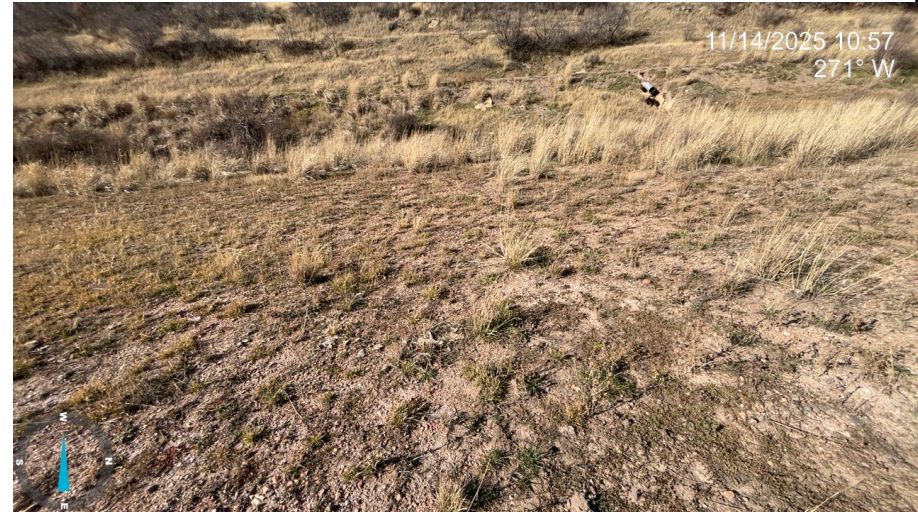
Photo 2: Photos showing an overview of the location looking east and west, respectively. Gravel and compaction is evident throughout the location. The location has not been reclaimed pursuant to 1004 reclamation requirements.

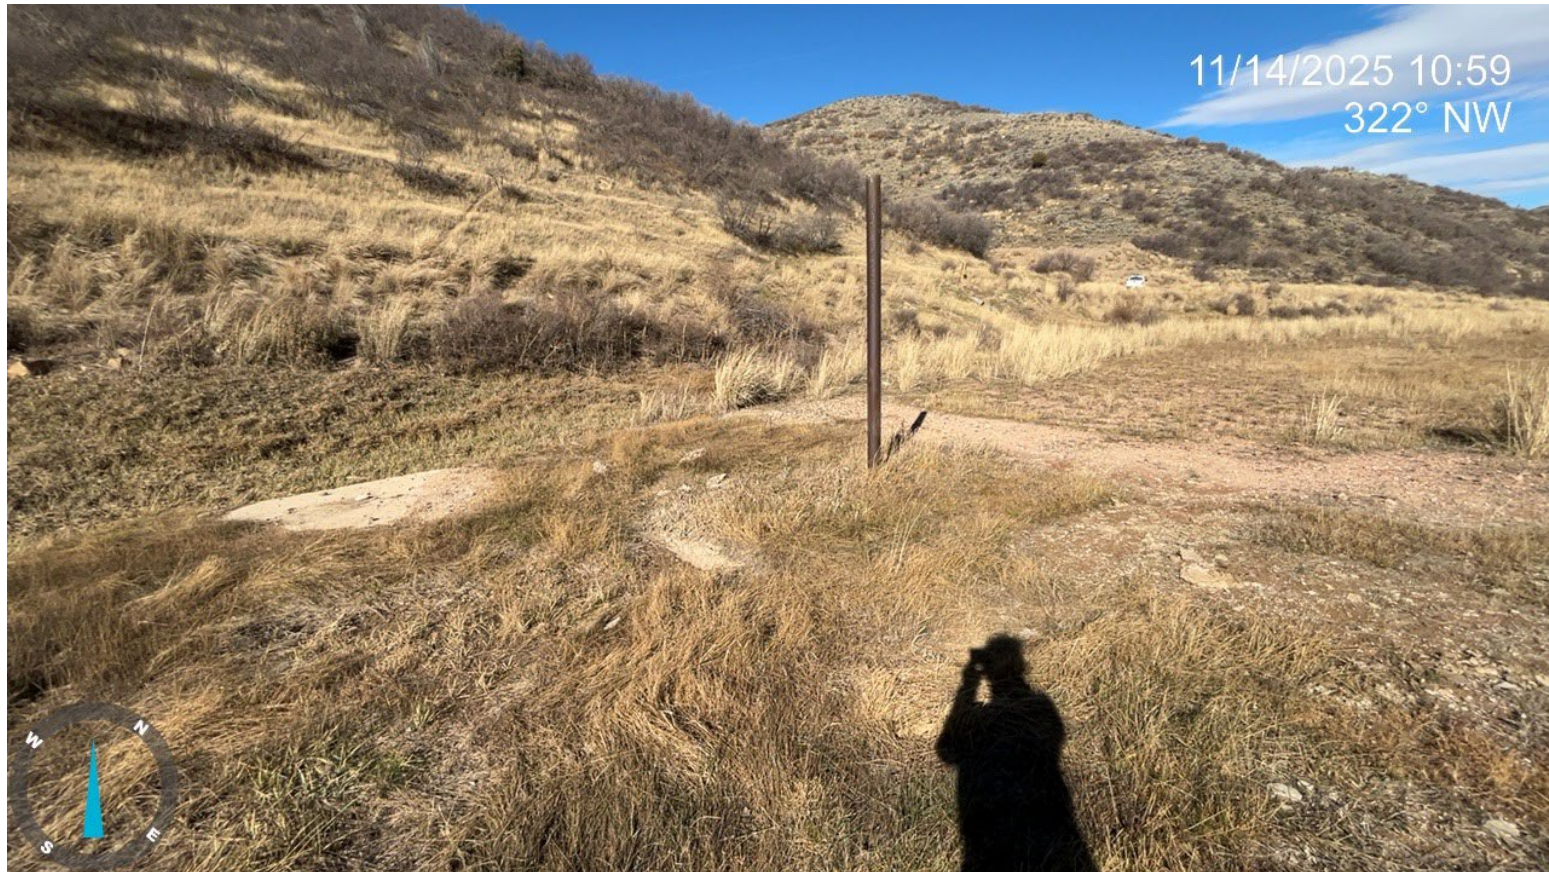
Photo 3: Photo showing the plugged and abandoned well marker at the location.

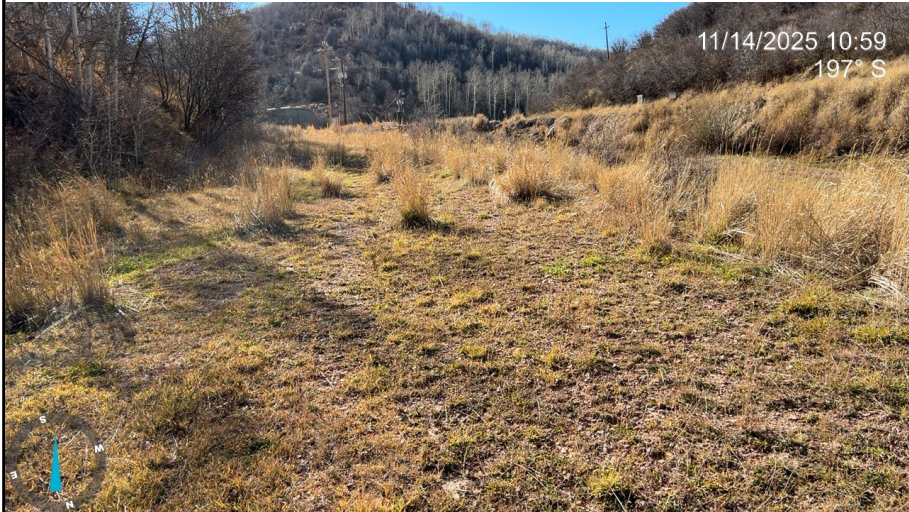
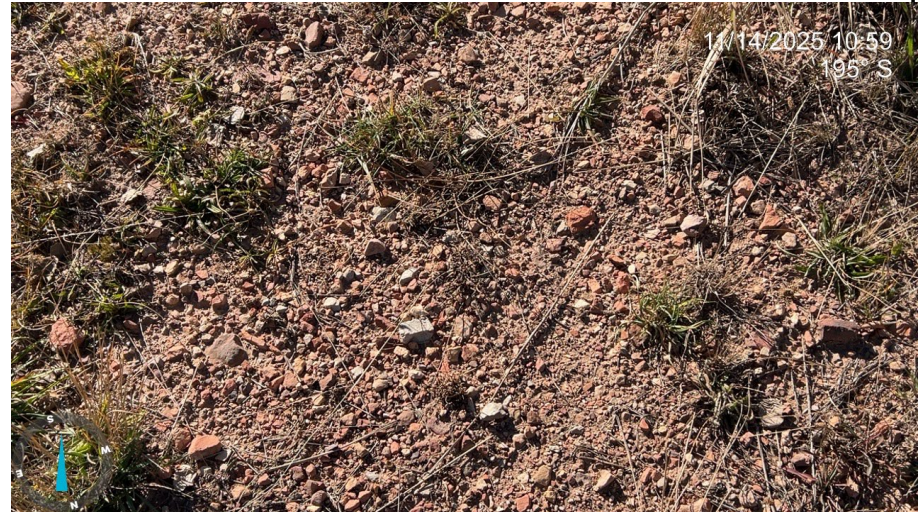
Photo 4: Photos showing an overview of the southern access road leading to the location. The access road does not appear to be reclaimed per 1004 reclamation requirements; gravel and compaction is evident.

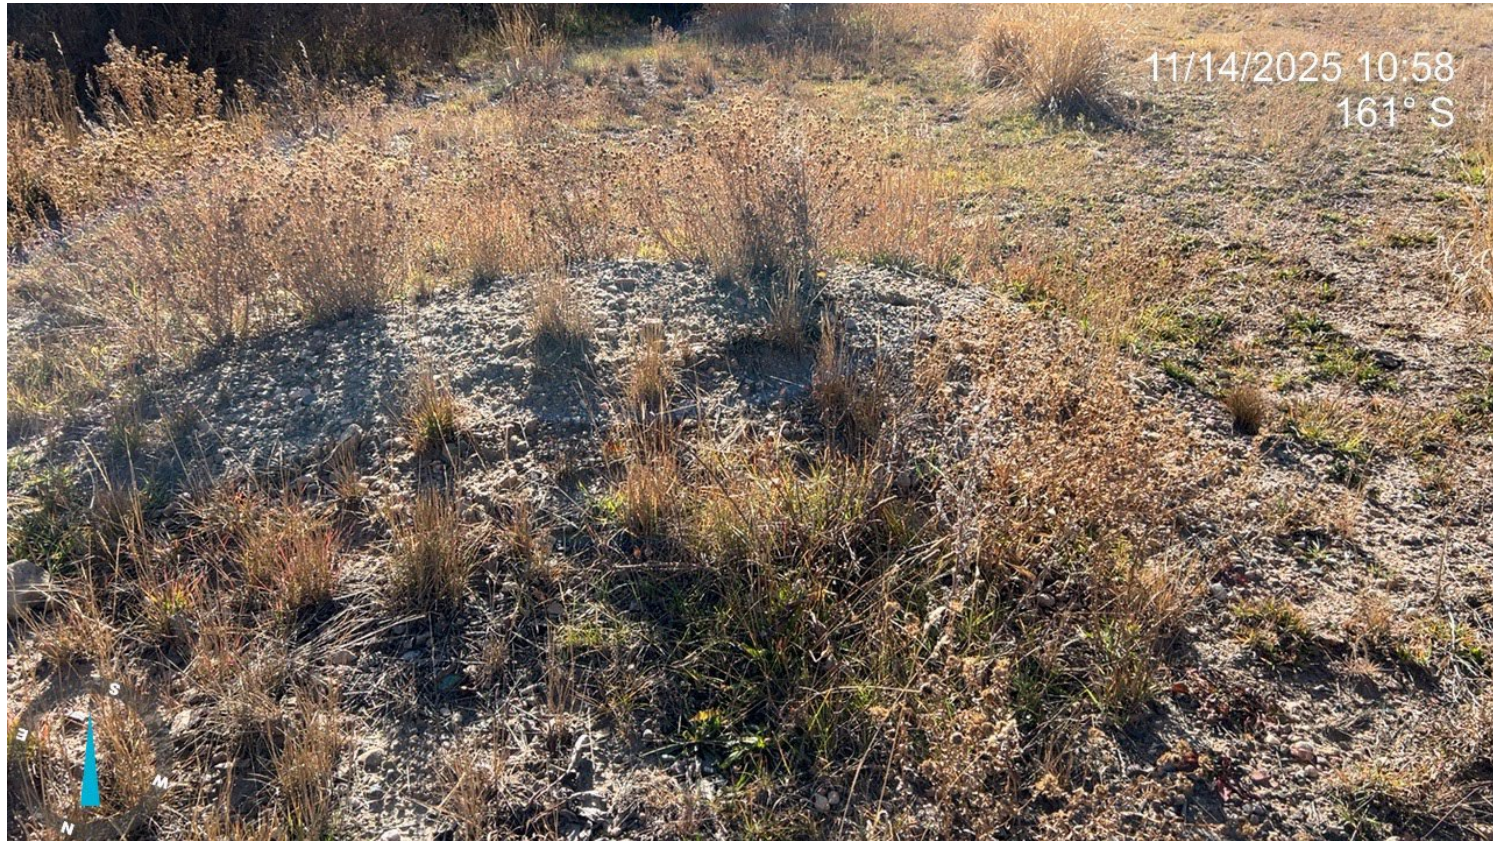
Photo 5: An unknown grey-colored waste material, likely concrete, is present at the southeast end of the location and requires removal pursuant to Rule 906.

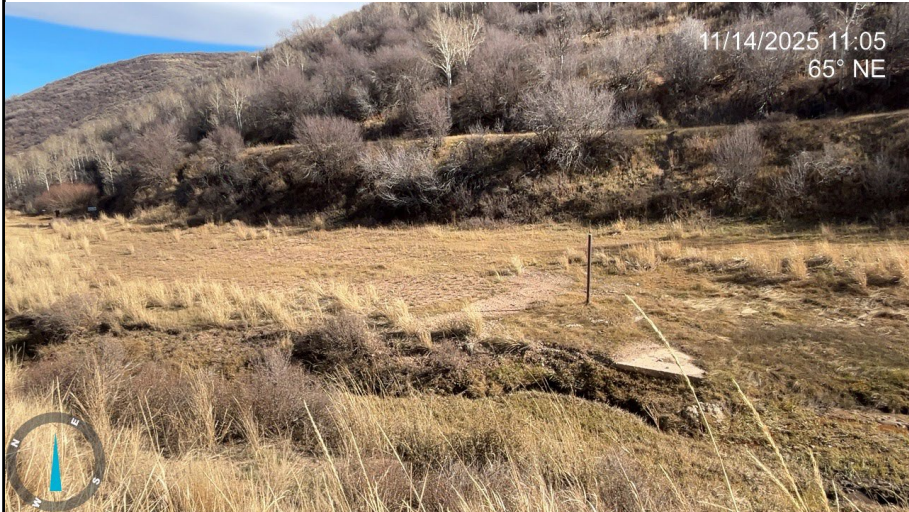
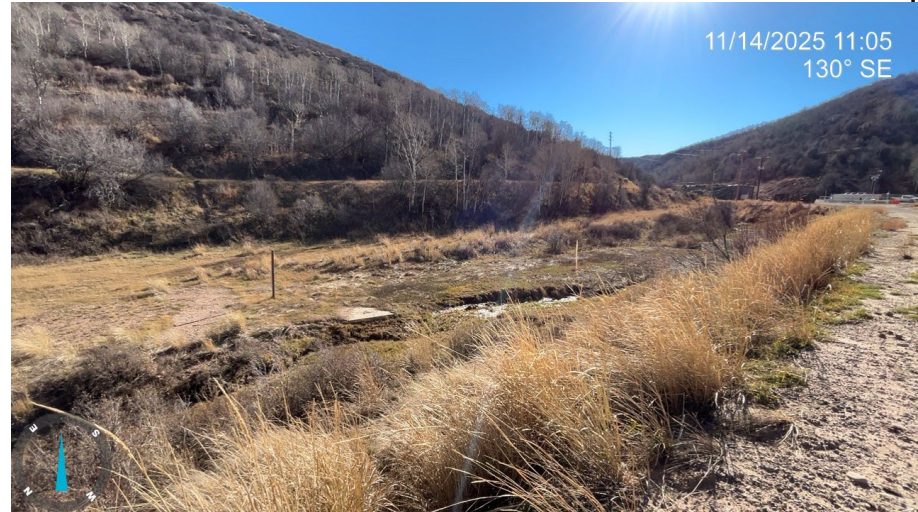
Photo 6: Photos showing an overview of the location. An intermittent stream, which was flowing at the time of inspection, lies directly west of the location.
