# Final Reclamation Inspection

Operator: KERR MCGEE OIL & GAS ONSHORE LP - 47120

Location ID: 328152

Inspection Document #: 718801006

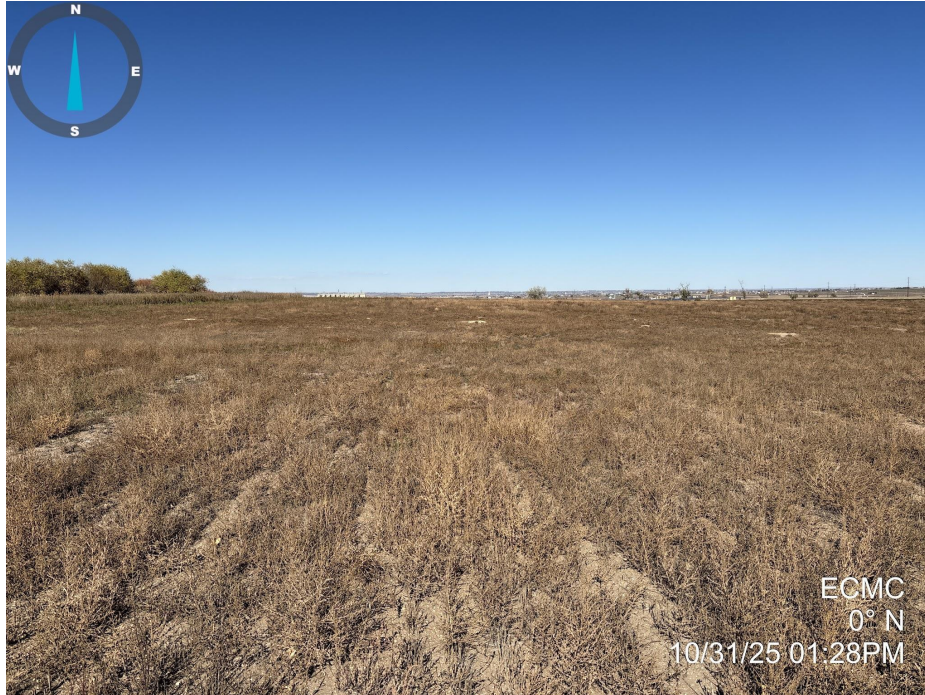
**Photo 1.** Photo taken of the well location, facing north. Photo illustrates that final reclamation activities have taken place. However, vegetation has not established to Rule 1004 standards and the location appears to be within fallow cropland.

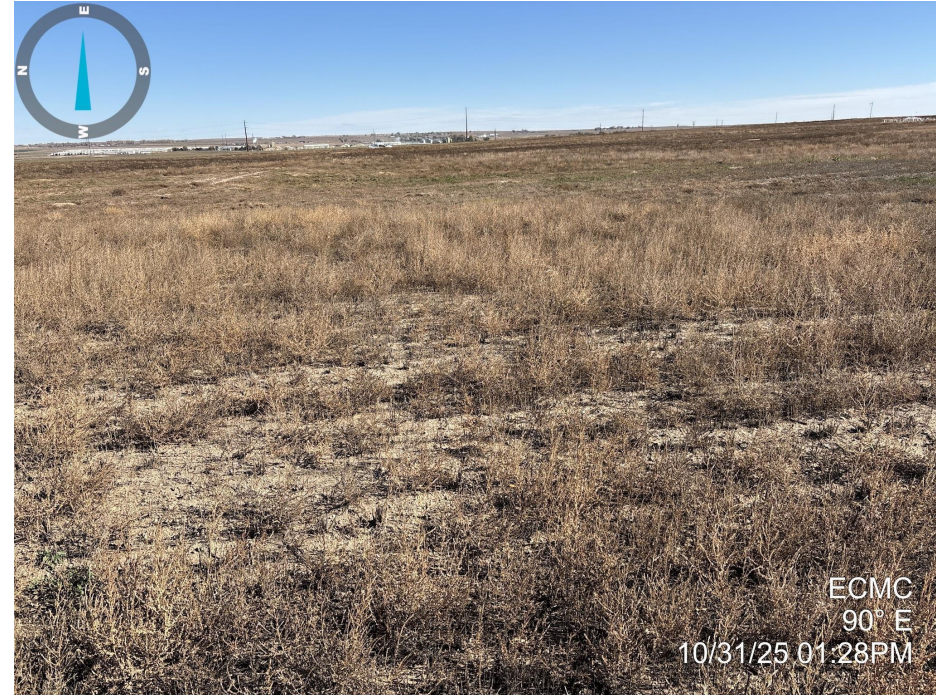
**Photo 2.** Photo taken of the well location, facing east. See comments under Photo 1.

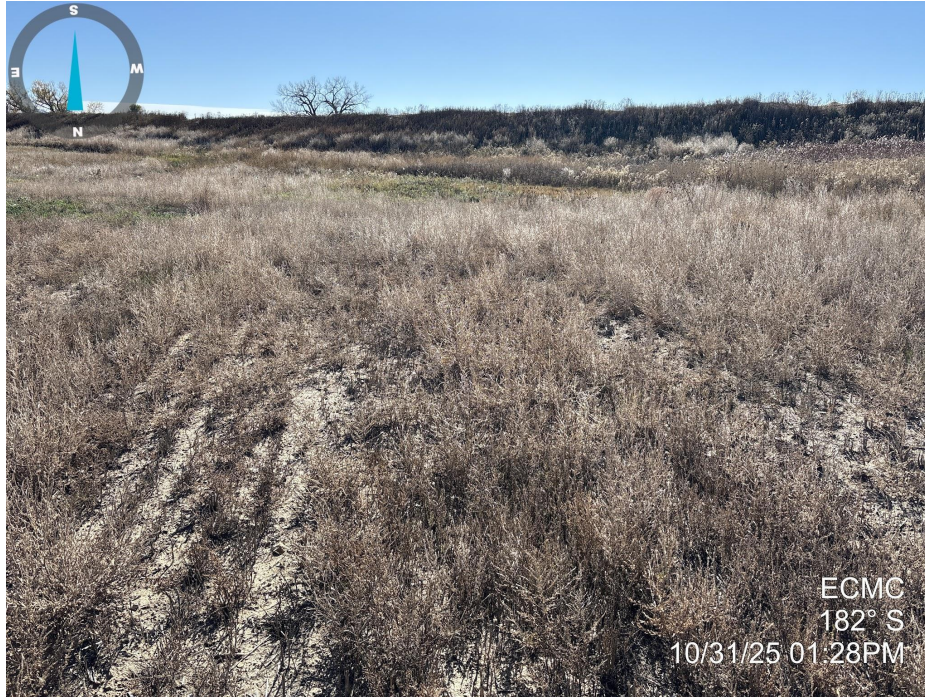
**Photo 3.** Photo taken of the well location, facing south. See comments under Photo 1.

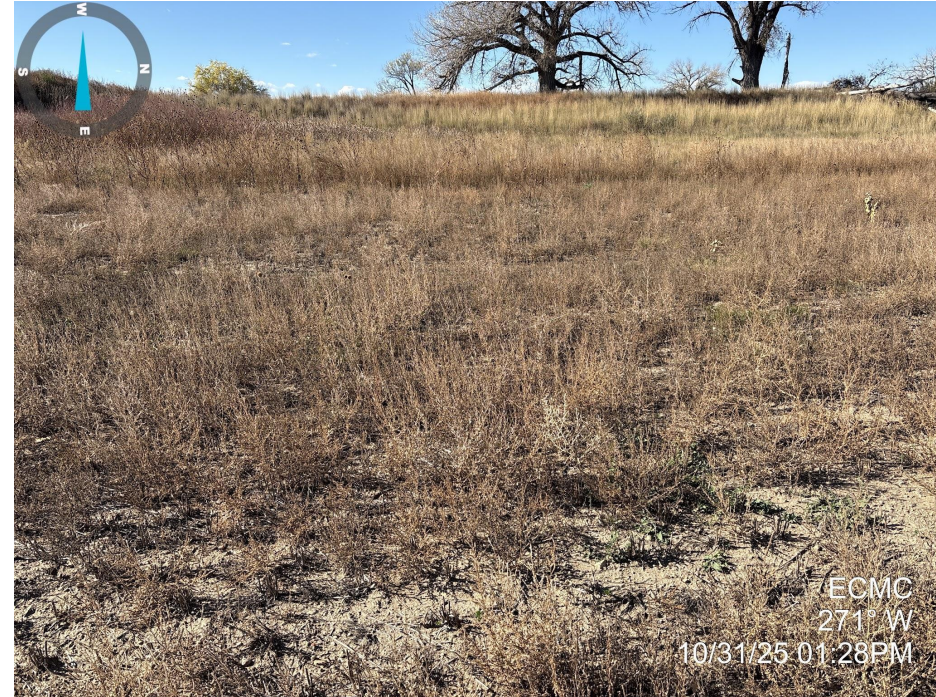
**Photo 4.** Photo taken of the well location, facing west. See comments under Photo 1.

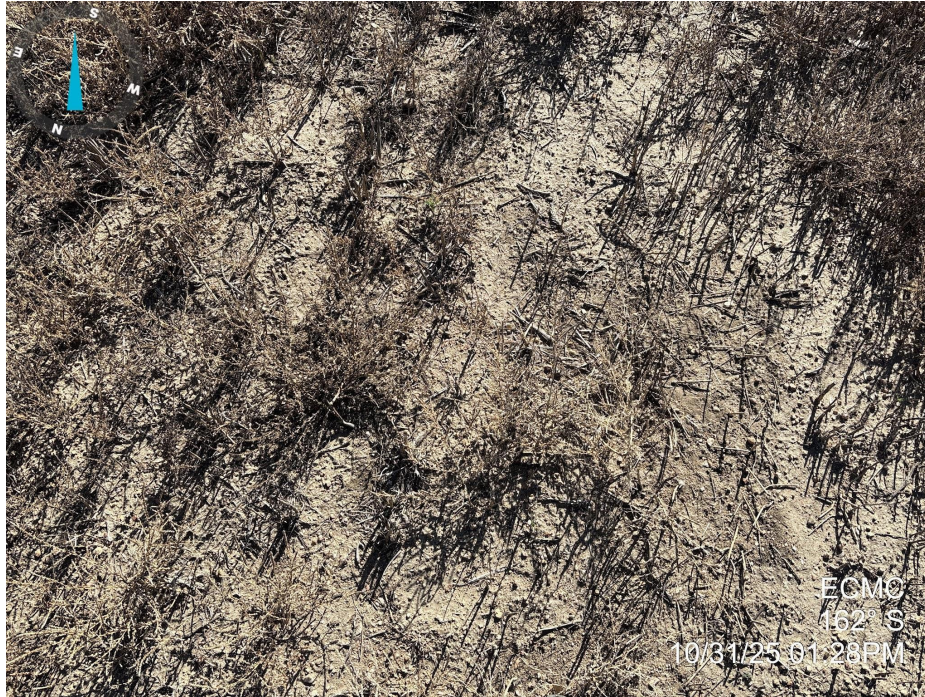
**Photo 5.** Photo taken of ground cover at the well location. Photo illustrates weedy annual vegetation including Kochia (*Bassia scoparia*).

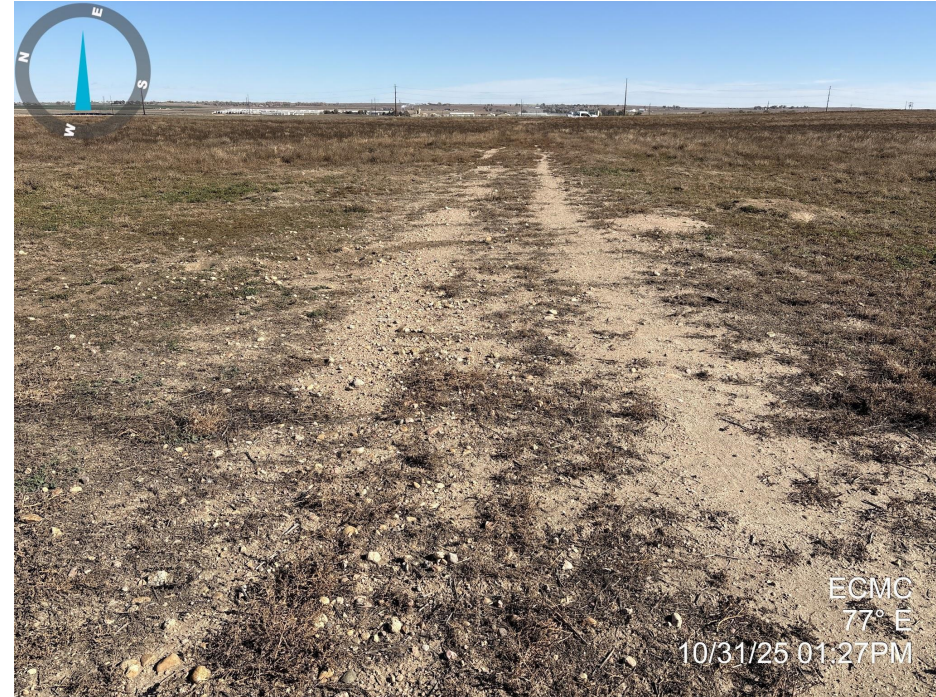
**Photo 6.** Photo taken of the access road the well location, facing east. Photo illustrates that the access road does not meet Rule 1004 standards as gravel, bare ground, and weedy annual vegetation were observed across the road.

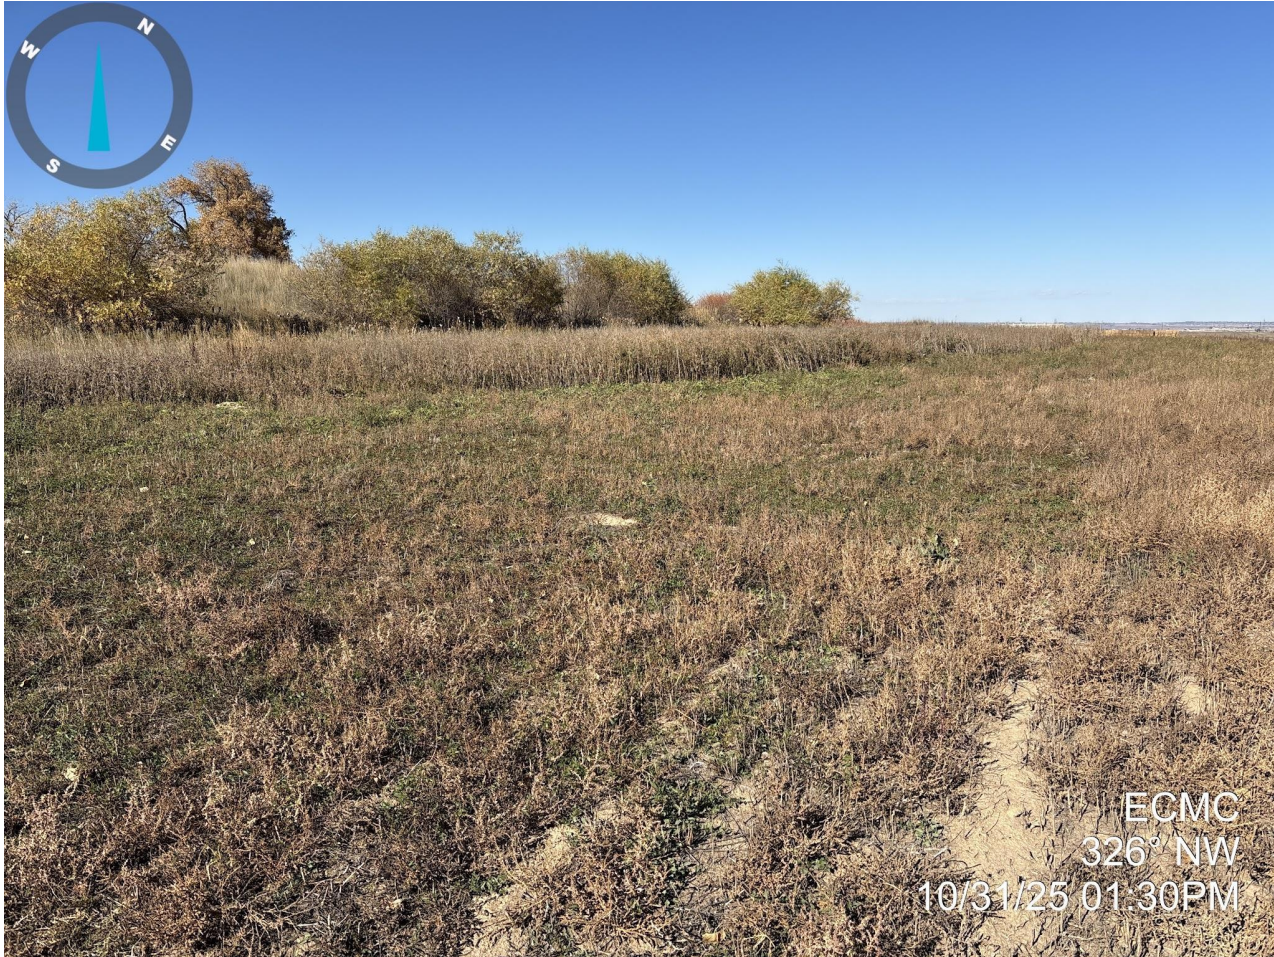
**Photo 7.** Photo taken of the reference area to the location, north of the location, facing northwest. Photo illustrates weedy annual vegetation and appears to be fallow cropland.
