Final Reclamation Inspection

Operator: KERR MCGEE OIL & GAS ONSHORE LP - 47120

Location ID: 336129

Location Name: HSR FEDERAL-63N66W/36SENE

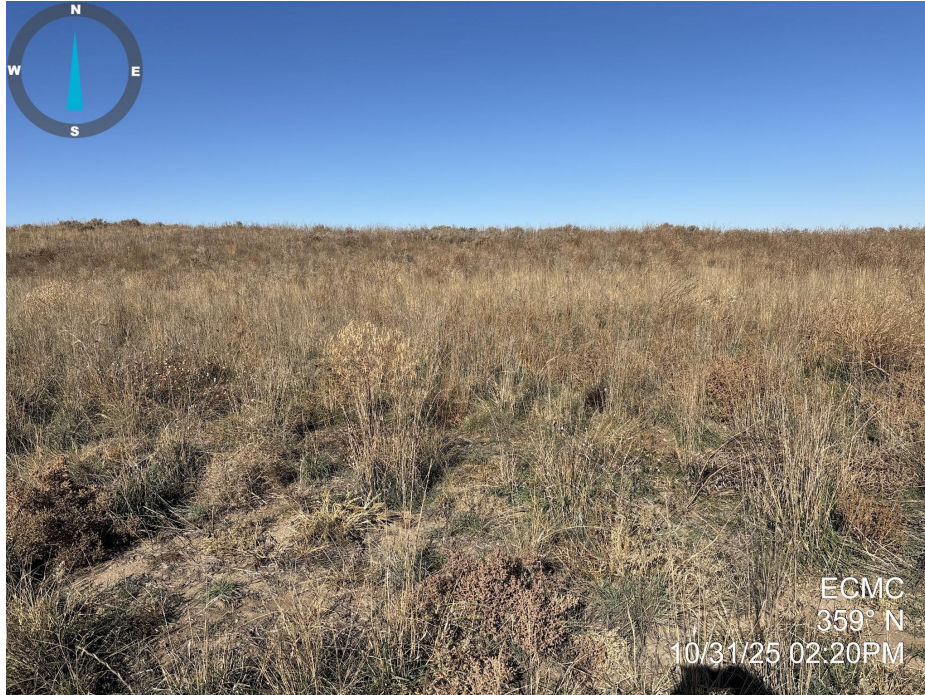
Photo 1. Photo taken of the multi-well location, facing north. Photo illustrates that final reclamation activities have taken place. However, vegetation has not established to Rule 1004 standards and weedy annual vegetation including cheatgrass (*Bromus tectorum*) and russian thistle (*Salsola tragus*) was observed across the location.

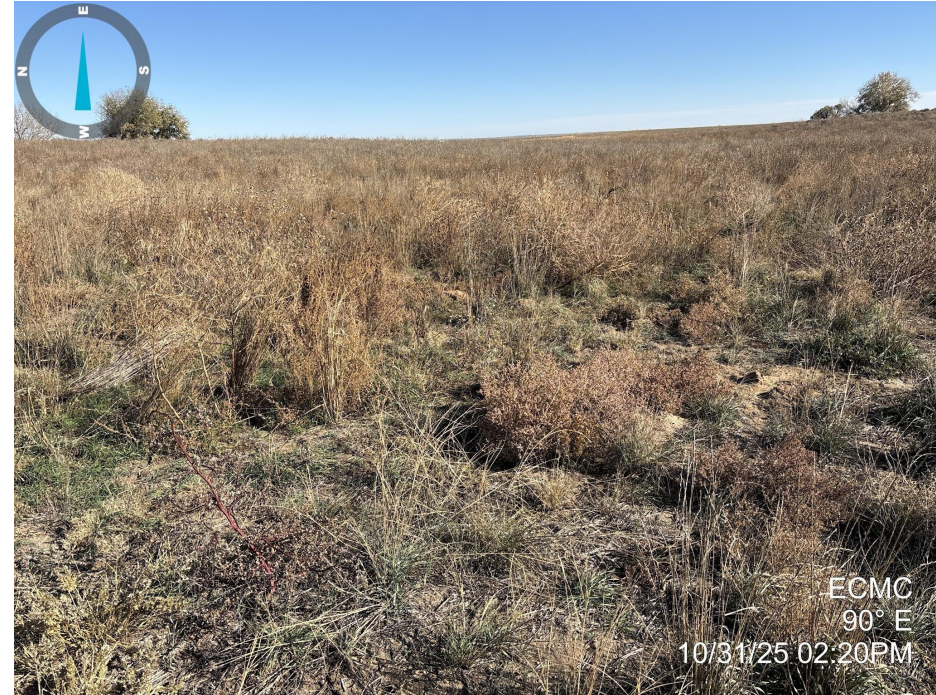
Photo 2. Photo taken of the multi-well location, facing east. See comments under Photo 1.

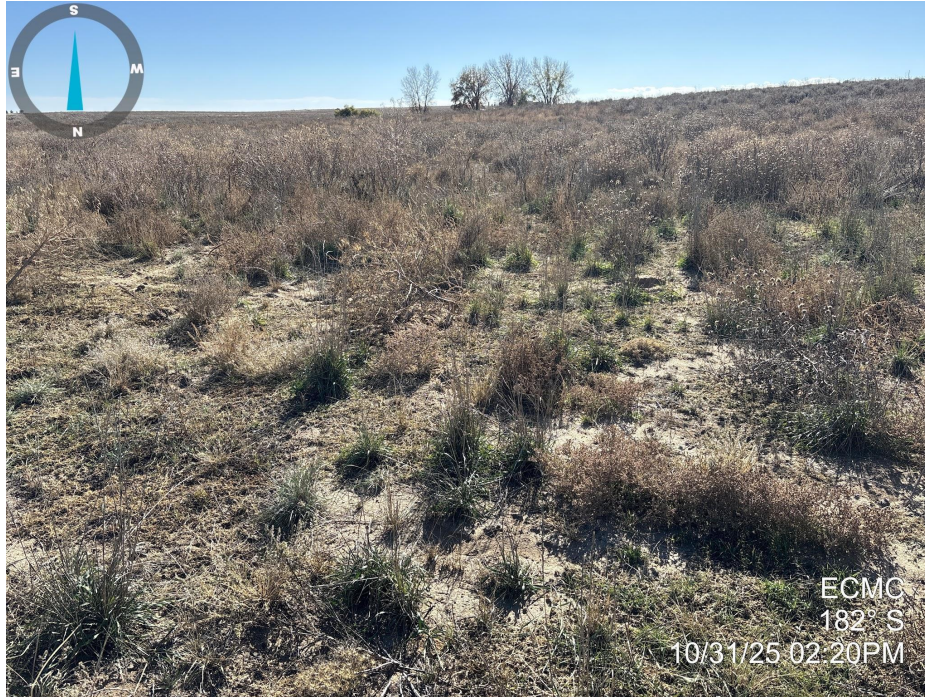
Photo 3. Photo taken of the multi-well location, facing south. See comments under Photo 1.

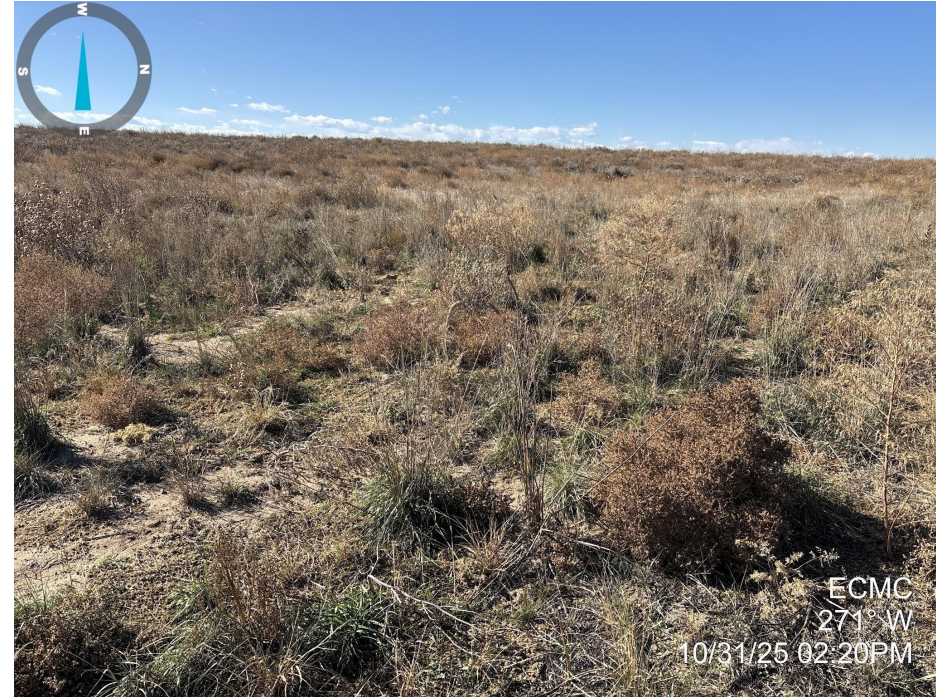
Photo 4. Photo taken of the multi-well location, facing west. See comments under Photo 1.

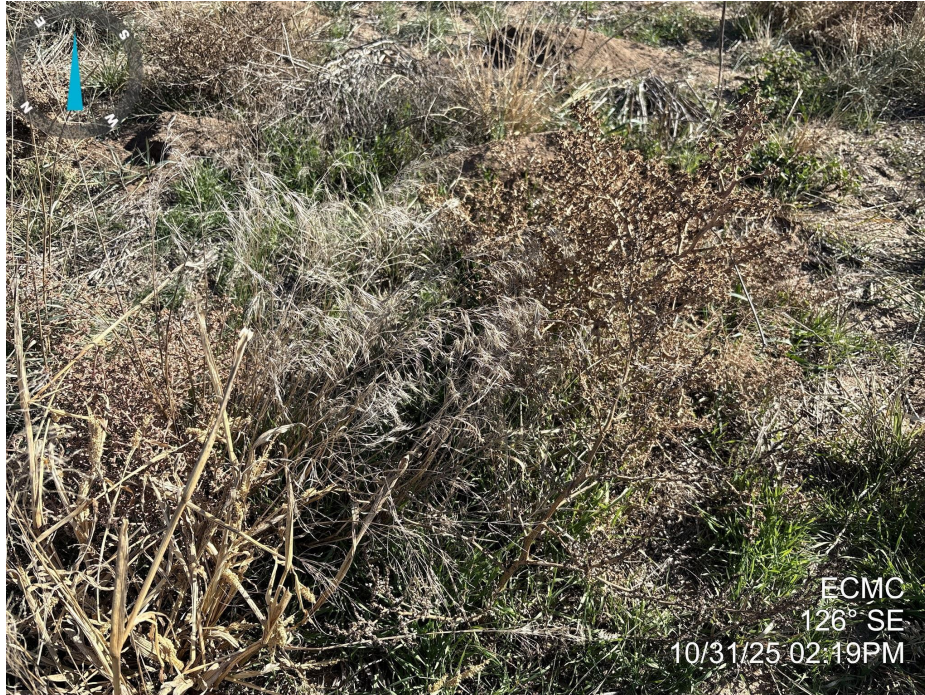
Photo 5. Photo taken of ground cover at the location. Photo illustrates weedy annual vegetation including russian thistle (*Salsola tragus*) and cheatgrass (*Bromus tectorum*), a List C Noxious Weed species.

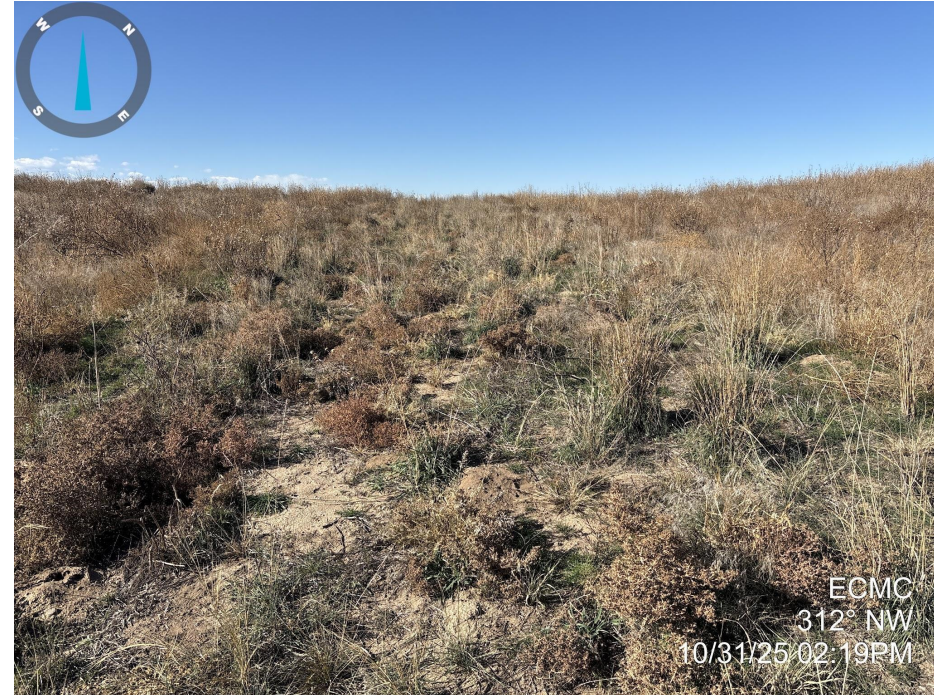
Photo 6. Photo taken of the access road to the multi-well location, facing northwest. Photo illustrates that the access road does not meet Rule 1004 standards.

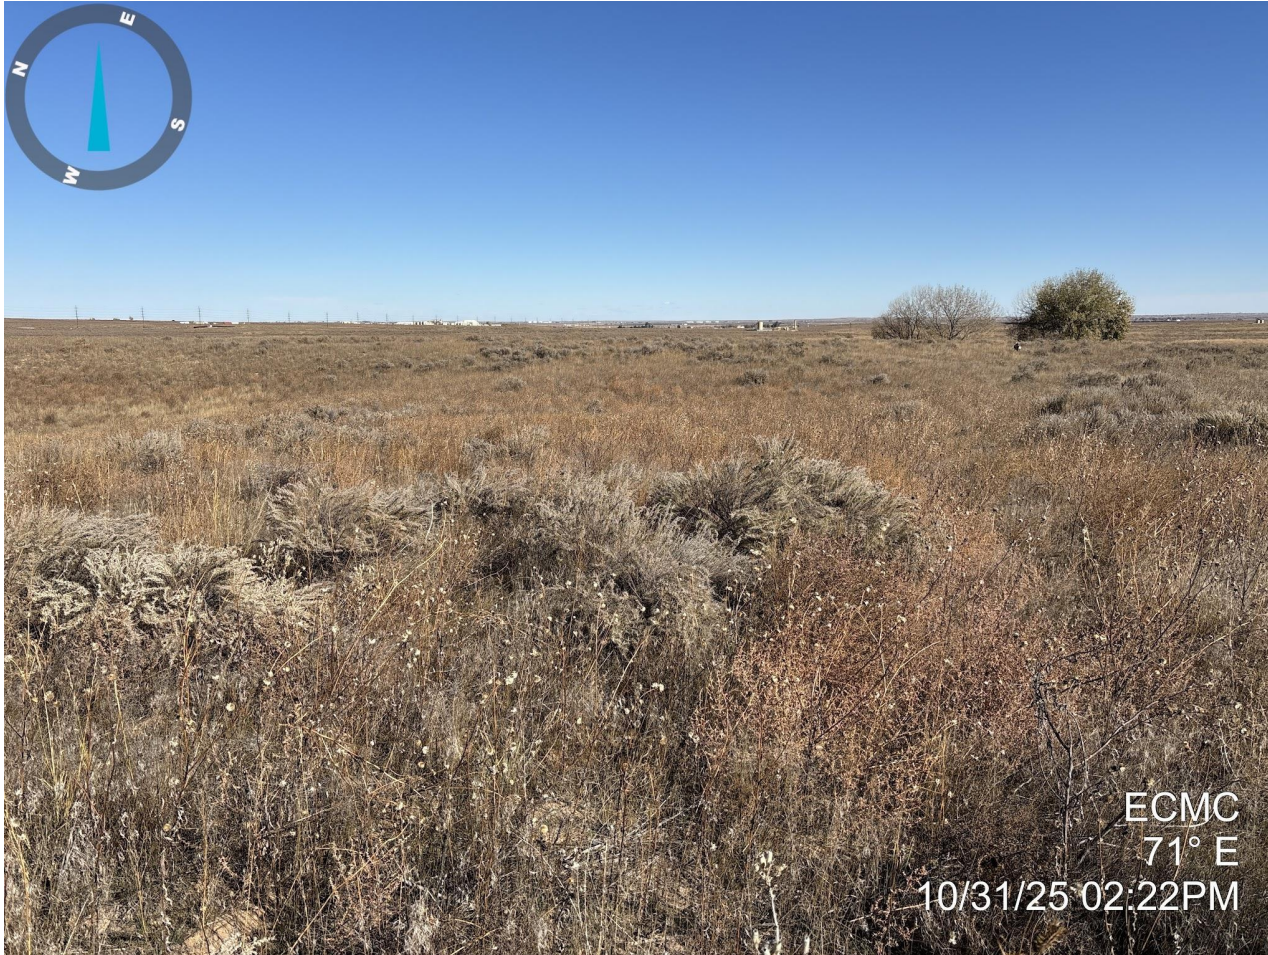
Photo 7. Photo taken of the reference area to the location, east of the location, facing east. Photo illustrates sand sagebrush, perennial grass, and weedy annual vegetation.
