Final Reclamation Inspection

Operator: KERR MCGEE OIL & GAS ONSHORE LP - 47120

Location ID: 330114

Location Name: ANTENNA FEDERAL #31-36

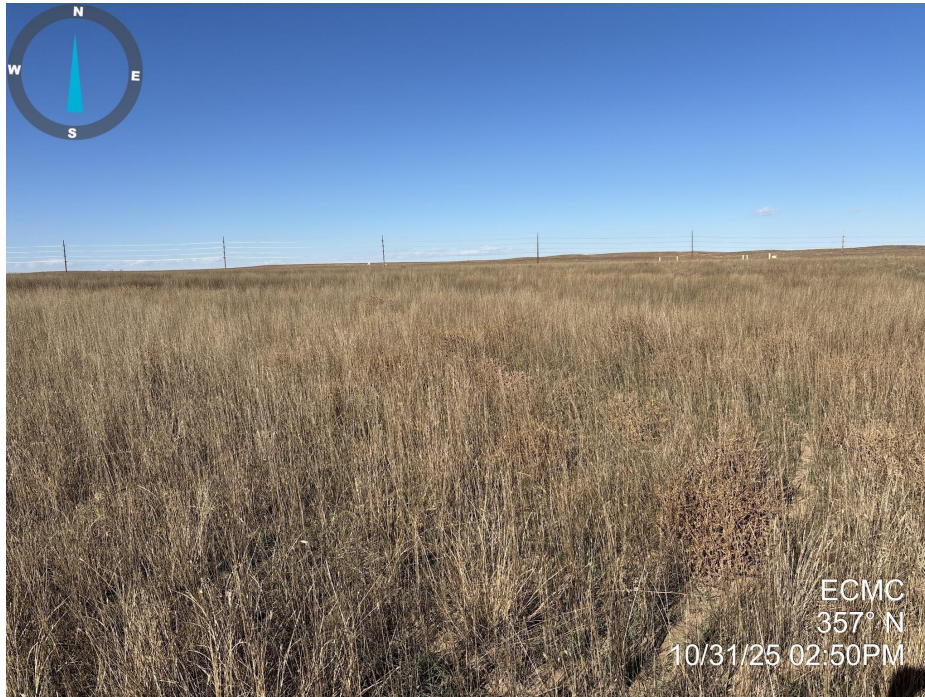
Photo 1. Photo taken of the well location, facing north. Photo illustrates that final reclamation activities have taken place, but vegetation has not established to Rule 1004 standards as weedy annual vegetation including russian thistle (*Salsola tragus*) was observed across the location.

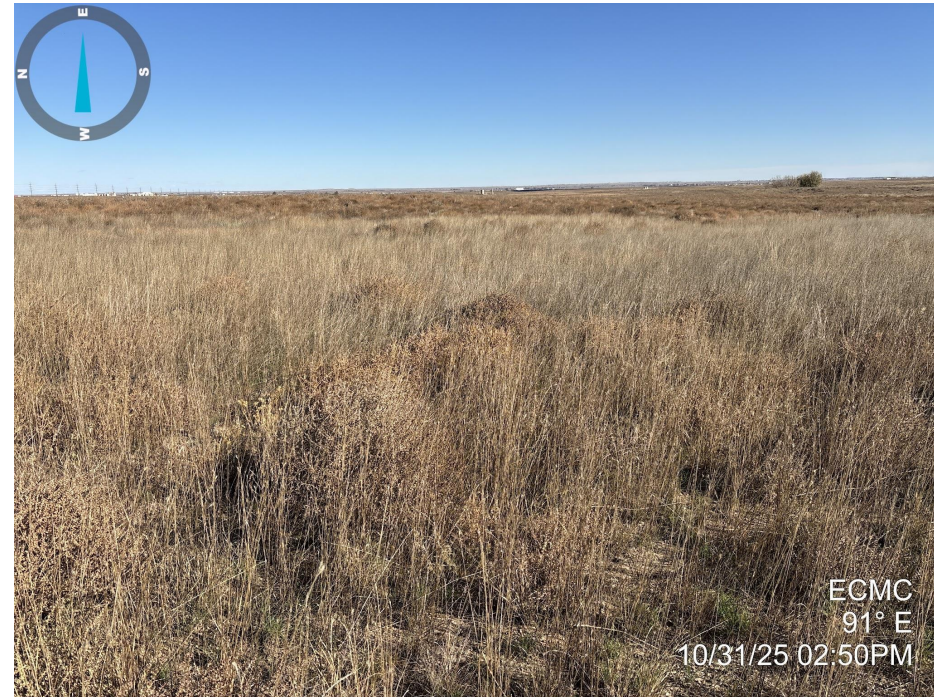
Photo 2. Photo taken of the well location, facing east. See comments under Photo 1.

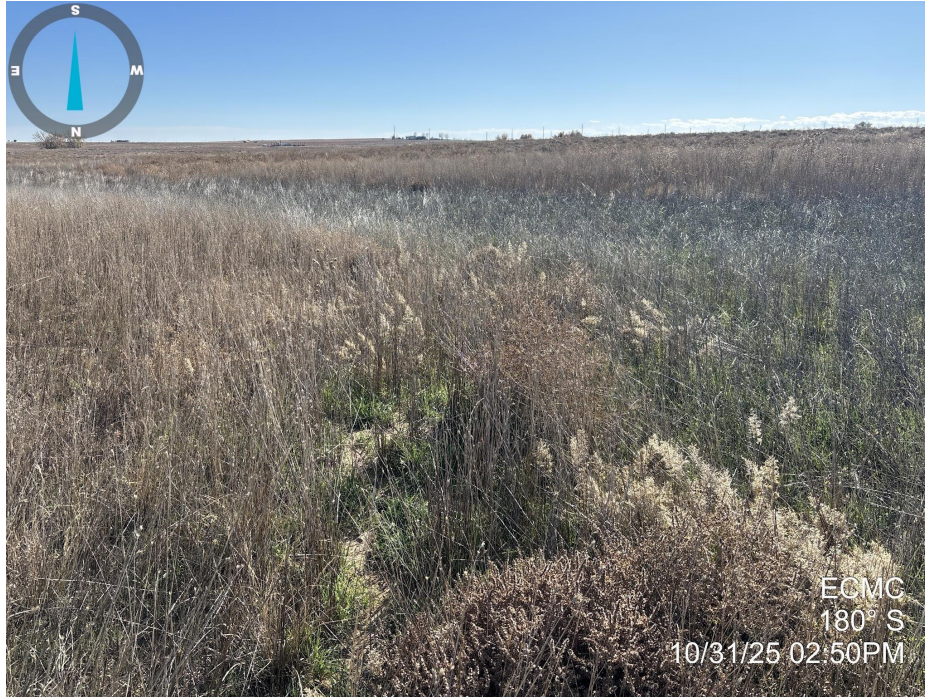
Photo 3. Photo taken of the well location, facing south. See comments under Photo 1.

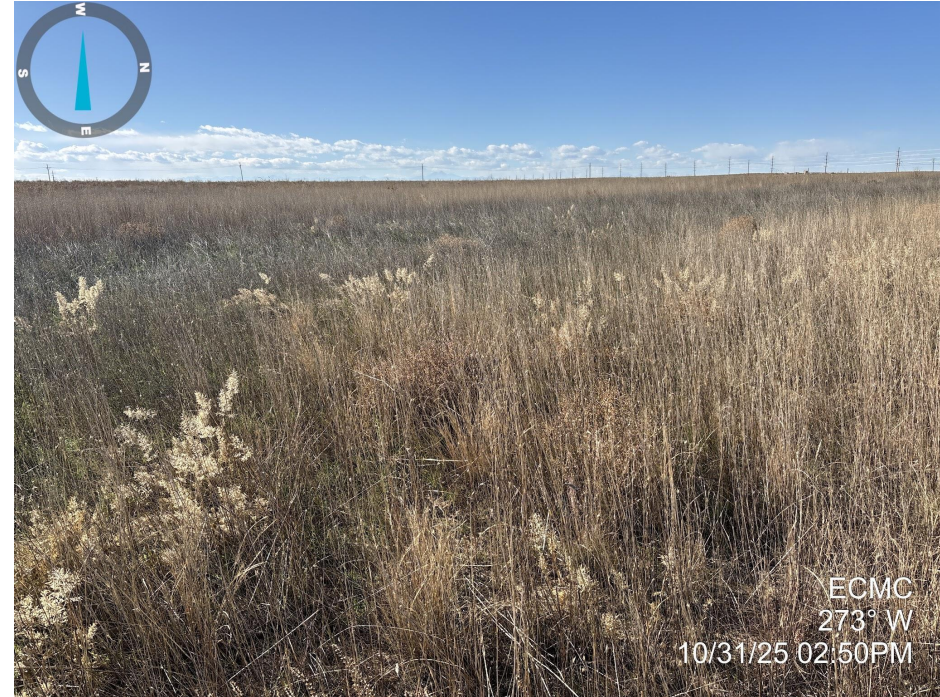
Photo 4. Photo taken of the well location, facing west. See comments under Photo 1.

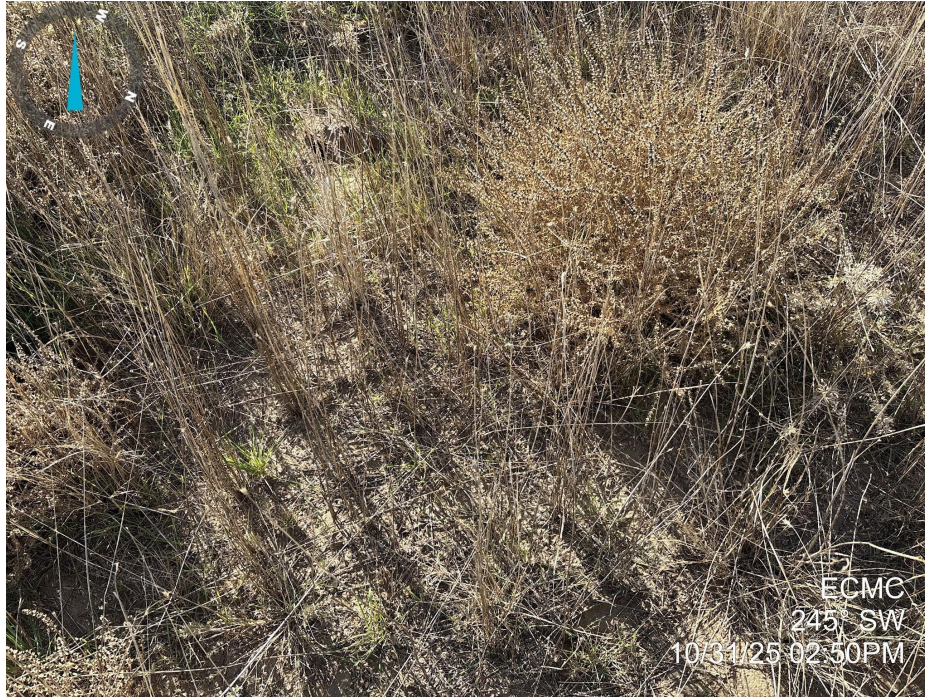
Photo 5. Photo taken of ground cover at the location. Photo illustrates weedy annual vegetation including russian thistle (*Salsola tragus*).

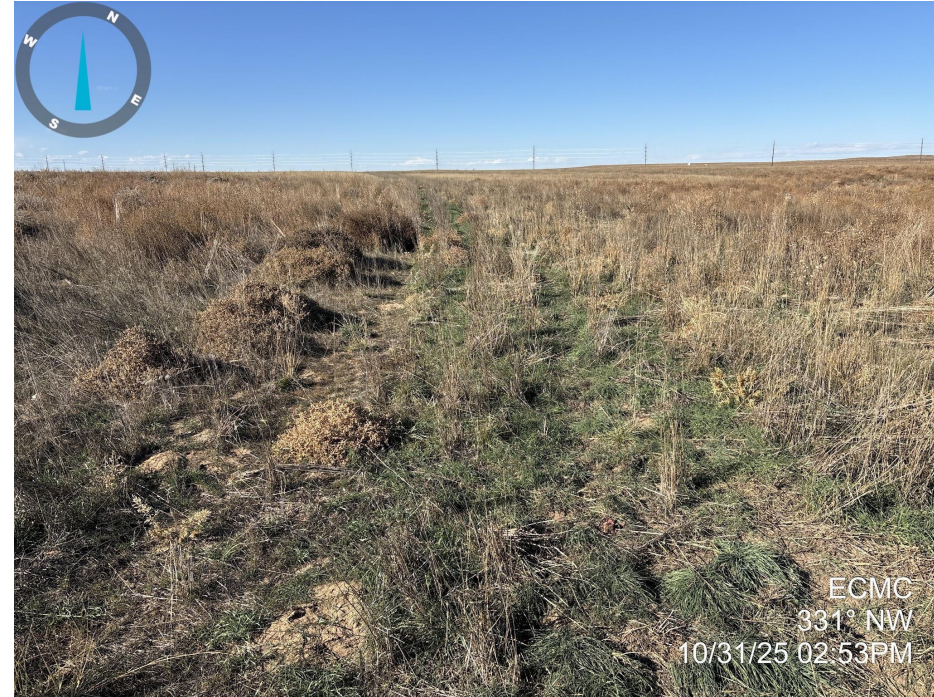
Photo 6. Photo taken of the access road to the well location, facing northwest. Photo illustrates that final reclamation activities have taken place along the access road.

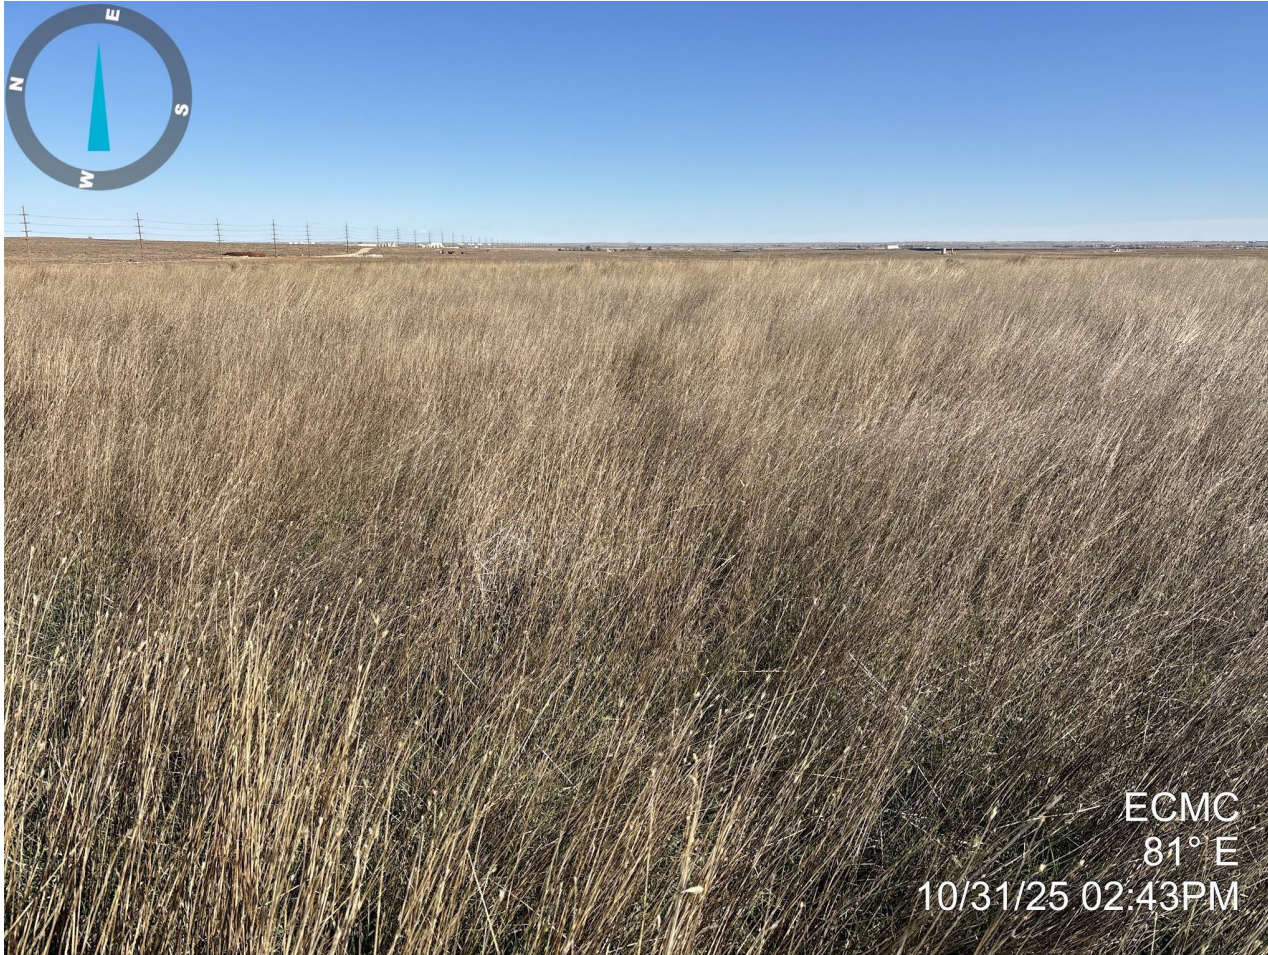
Photo 7. Photo taken of the reference area to the location, north of the location, facing east. Photo illustrates perennial grass.
