Inspection Photos

Operator: TEP Rocky Mountain LLC #96850

Location ID: 450340

Inspection Doc: 719200467

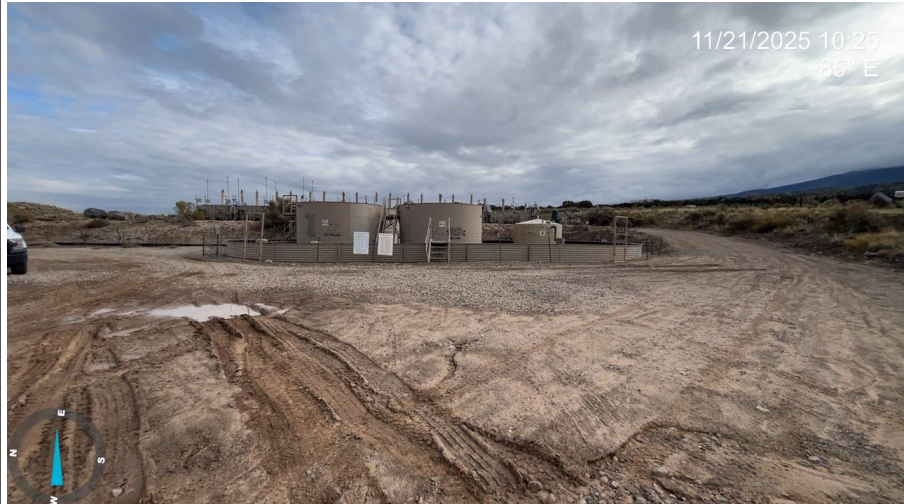
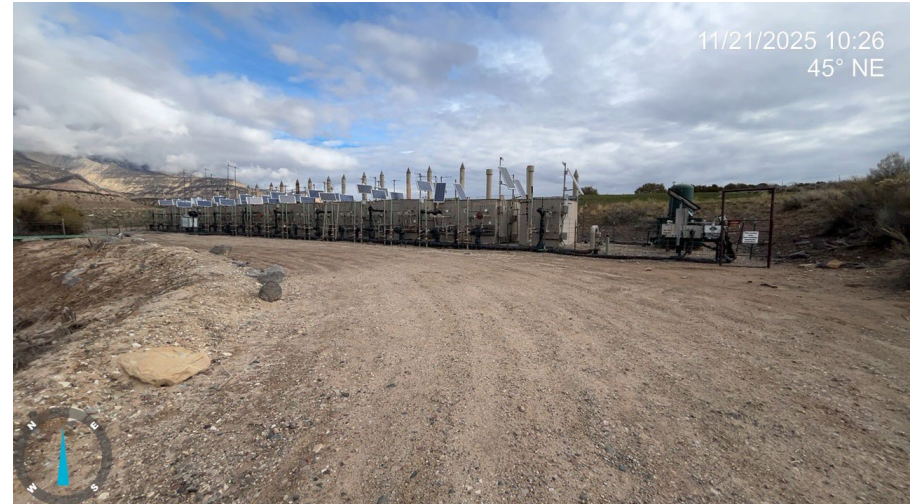
Photo 1: Photos showing an overview of the lower and upper portions of the pad, respectively.

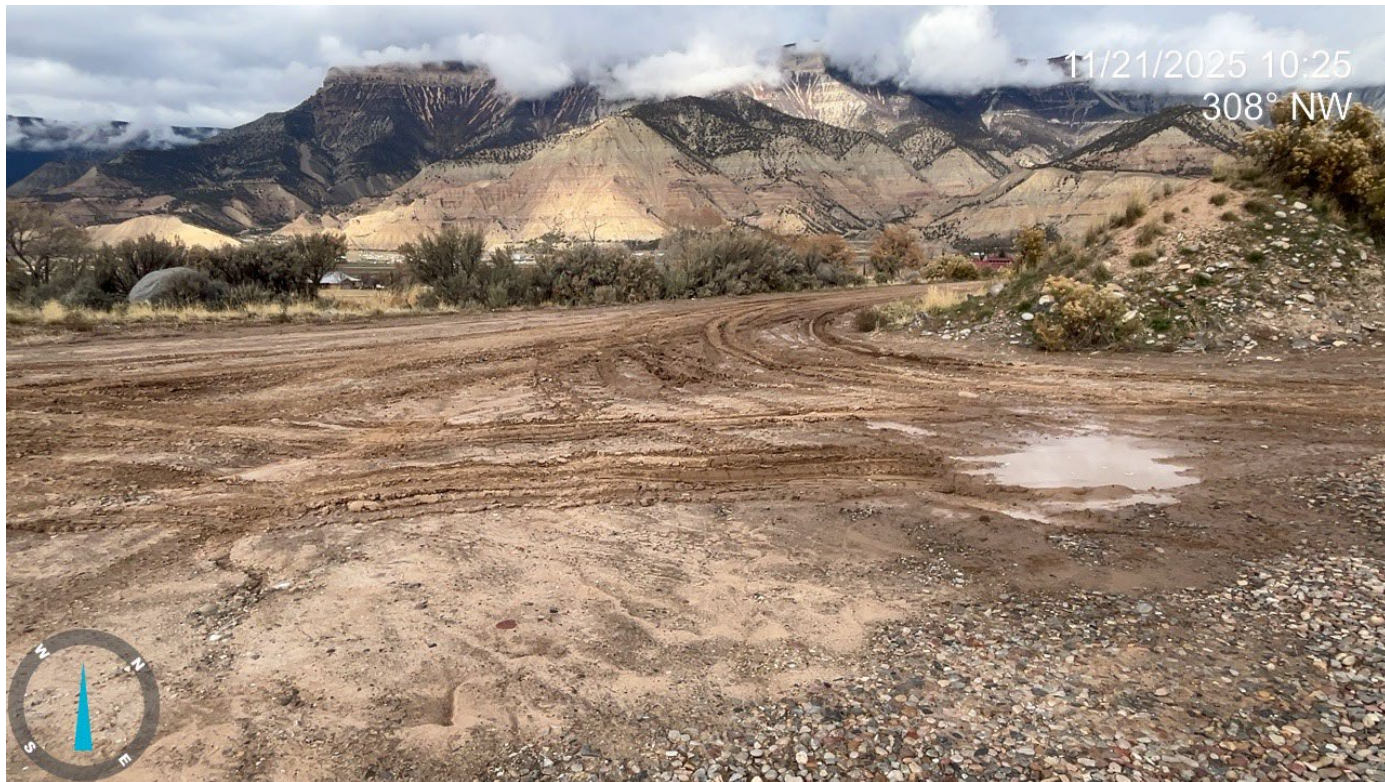
Photo 2: Photo showing an example of vehicle tracking and ponded water at the location entrance. Gravel is sparse in some areas. Comply with 1002.f. and maintain stormwater BMPs.

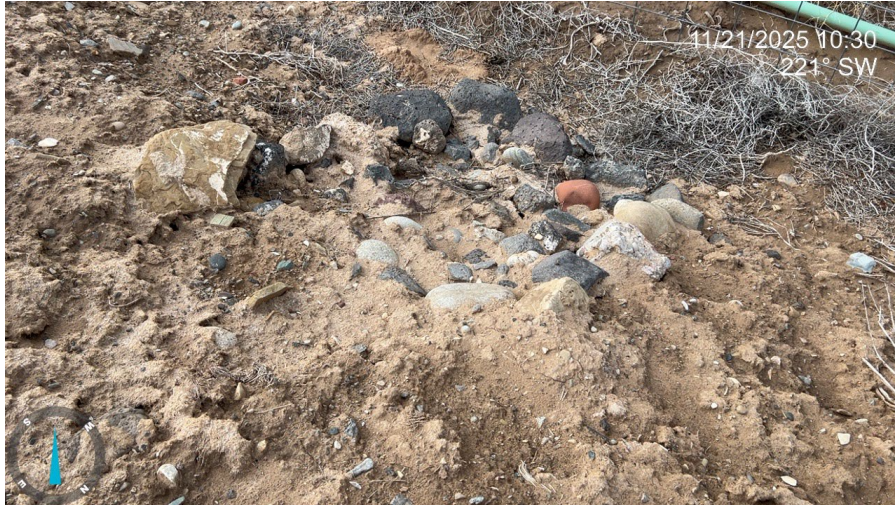
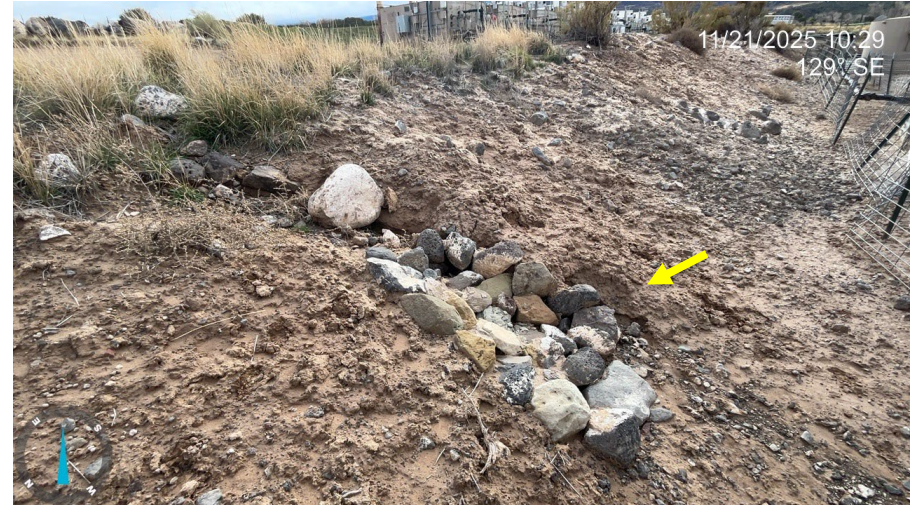
Photo 3: Photos showing examples of stormwater controls on the cut slope behind tank equipment; some are laden with sediment, reducing capacity. Erosion, rilling and degradation is occurring at others. Comply with 1002.f. and maintain stormwater BMPs.

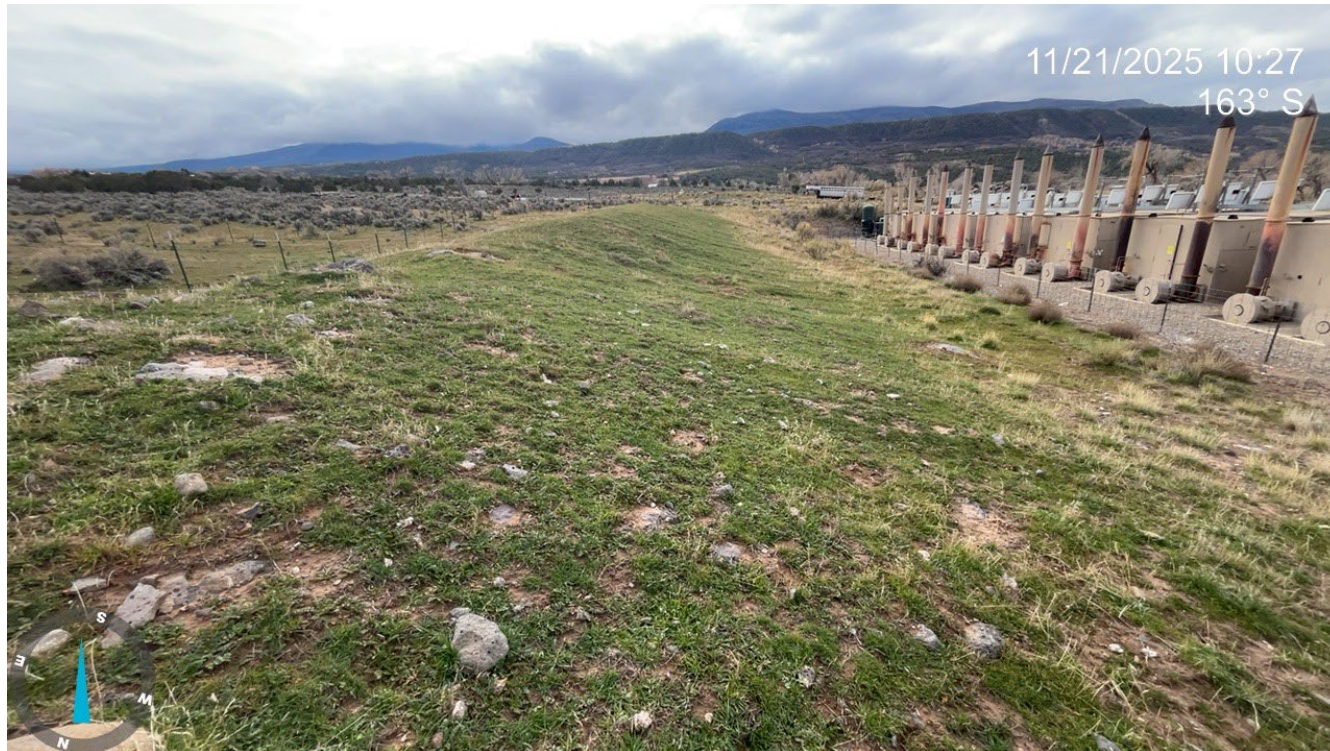
Photo 4: Photos showing examples of the eastern interim area. The area appears to be dominated by cheatgrass and other weedy annuals. A follow-up inspection will be conducted during future growing seasons to determine compliance with 1003 reclamation requirements.

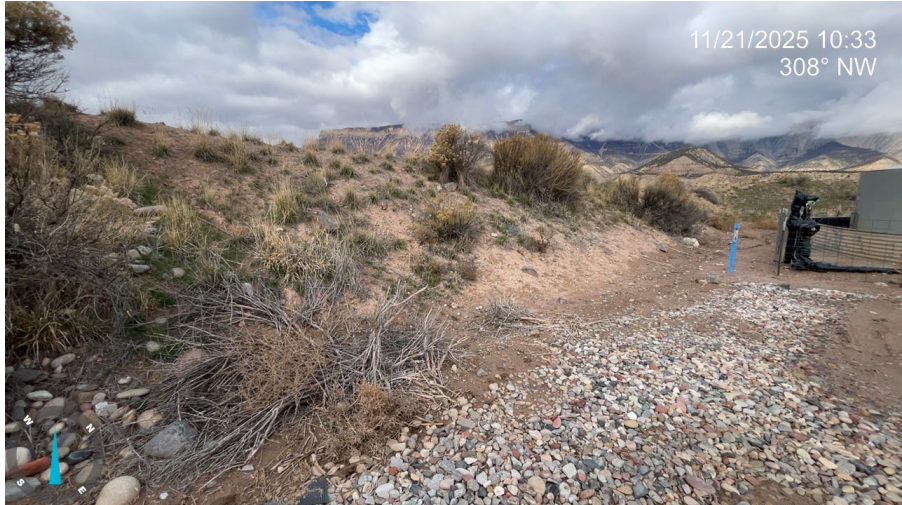
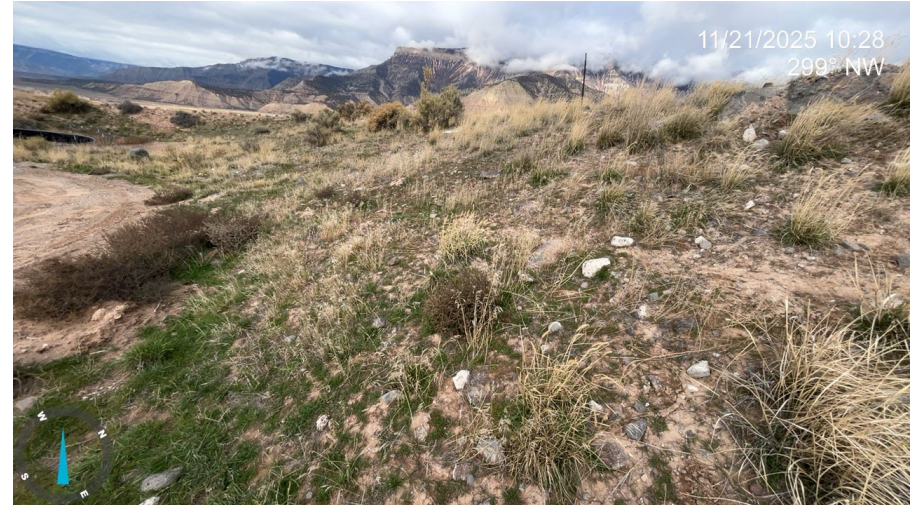
Photo 5: Photos showing examples of the northern and southern interim areas, respectively. Rubber rabbitbrush, crested wheatgrass and other perennial grass species have established. Northern and southern interim areas are progressing towards 1003 requirements.

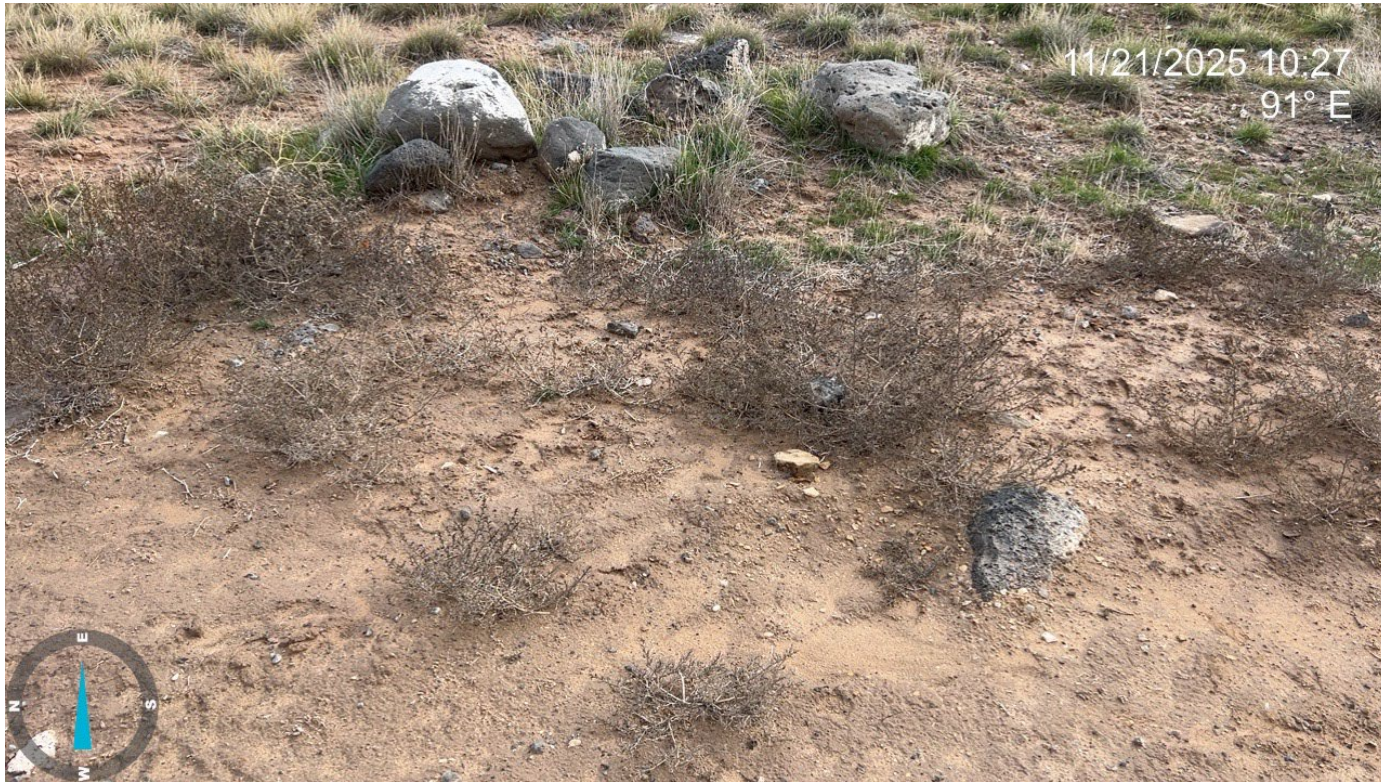
Photo 6: Photo showing an example of prickly Russian thistle, an undesirable annual weed, that is present along the margins of the working pad surface. Weed maintenance will be required on the working pad surface and within the interim areas in 2026.
